## Fractographic Analysis of Tensile Failures of Aerospace Grade Composites

This paper describes fractographic features observed in aerospace composites failed under tensile loads. Unidirectional Carbon Fibre Reinforced Plastic (UD CFRP) and Unidirectional Glass Fibre Reinforced Plastic (UD GFRP) composite specimens were fabricated and tested in tension. The morphology of fractured surfaces was studied at various locations to identify failure mechanism and characteristic fractographic features. CFRP composites displayed transverse crack propagation and the fracture surface showed three distinct regions, viz., crack origin, propagation and final failure. Significant variations in the fractographic features were noticed in crack propagation and final failure regions. Crack propagation region exhibited brittle fracture with chevron lines emanating from the crack origin. The entire crack propagation region exhibited radial marks on the individual fibre broken ends. On the other hand, the final fracture region revealed longitudinal matrix splitting and radial marks in majority of locations, and chop marks at some locations. The change in fracture mode in the final fracture was attribut

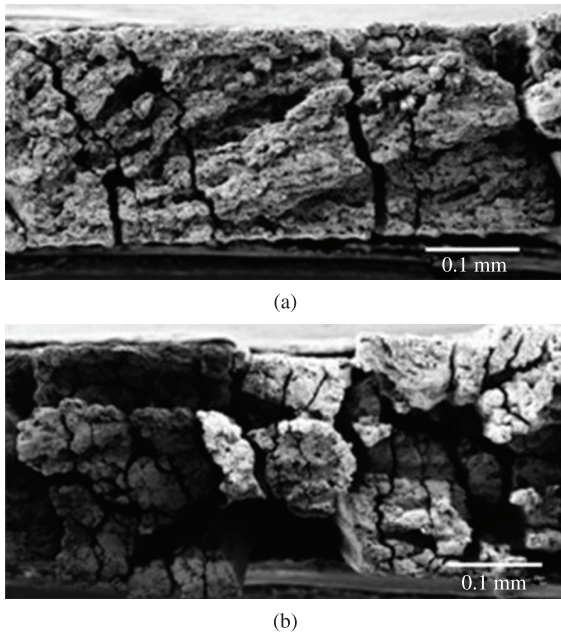
**Figure 3.** Longitudinal splitting in (a) crack propagation region, and (b) final fracture region.

from the crack propagation region. The final fracture region displayed a step fracture at different plane with extensive longitudinal splits. In this case, the step fracture was not related to bridging failure where in interaction of two cracks initiated in different zones during longitudinal fracture of the matrix, rather it was created due to successive fracture. It is important to note that longitudinal splits observed in the final fracture region has an extension to its mating part and hence, it appears to be a primary fracture event. The macrofractographic features that are present on final fracture region are also helpful in identifying the failure origin.

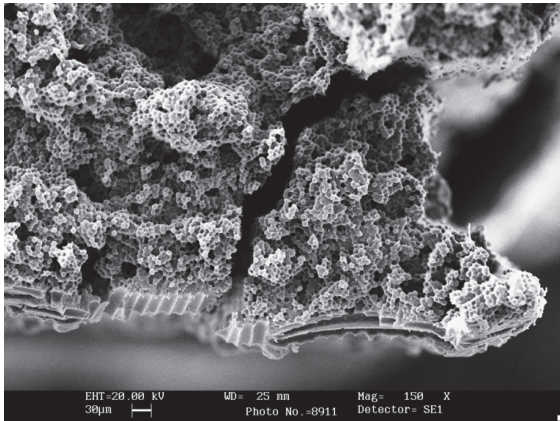
**Figure 4.** Close-up view of the crack initiation region.

The crack initiation, propagation and final fracture regions were examined in detail under SEM. At crack origin, a set of fibre bundles was found to be broken (Figure 4). This acted as stress concentrator for initiation and propagation of crack under tensile load. The entire fracture surface revealed fibre pull out (Figure 5a). However, the pullout lengths were found to be minimal and hence, they exhibited more or less uniform fracture. At higher magnifications, microscopic radial marks were observed on the fractured fibre surfaces. These radial marks are a typical characteristic feature of tensile failure of composite (Figure 5b). The crack origin and propagation direction identified in the macroscopic study were further confirmed by examining the radials direction on the individual fractured fibres. The local crack propagation direction (Figure 6) was resolved by examining the direction of individual fibre fracture ends. Directly Attributable Fibre Failures (DAFF) concept<sup>11</sup> was used for identification of local crack propagation direction. The resultant of local crack propagation directions at several regions on the fracture surface were correlated to find out the overall crack propagation direction (Figure 7). The crack propagation direction identified in this manner was found to match well with the direction of chevron lines that were present on the overall fracture surface. Longitudinal split surface revealed hackles<sup>24</sup>. In this case, the hackles were not well delineated because of the toughened nature of the matrix. Figure 8a shows hackles bending towards left. This

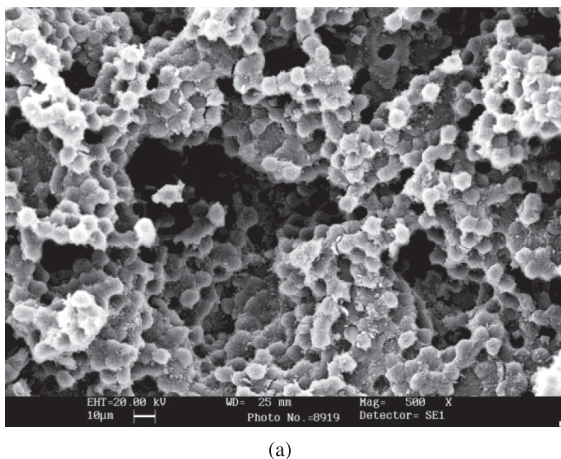
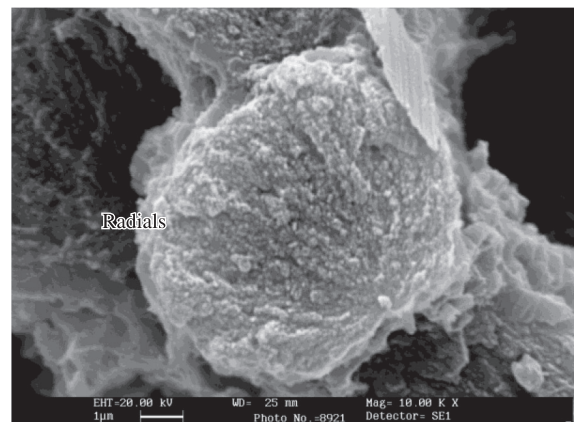
**Figure 5.** Microfractographic features showing (a) fibre pull out, and (b) fibre radials.

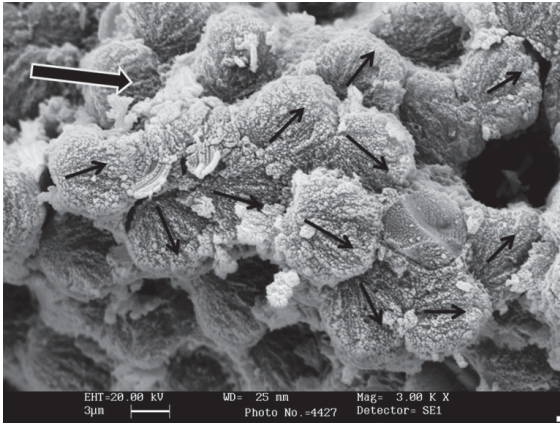
**Figure 6.** Identification of local crack propagation direction; small arrows indicate individual fibre fracture directions and big arrow represents crack propagation direction in a localized zone.

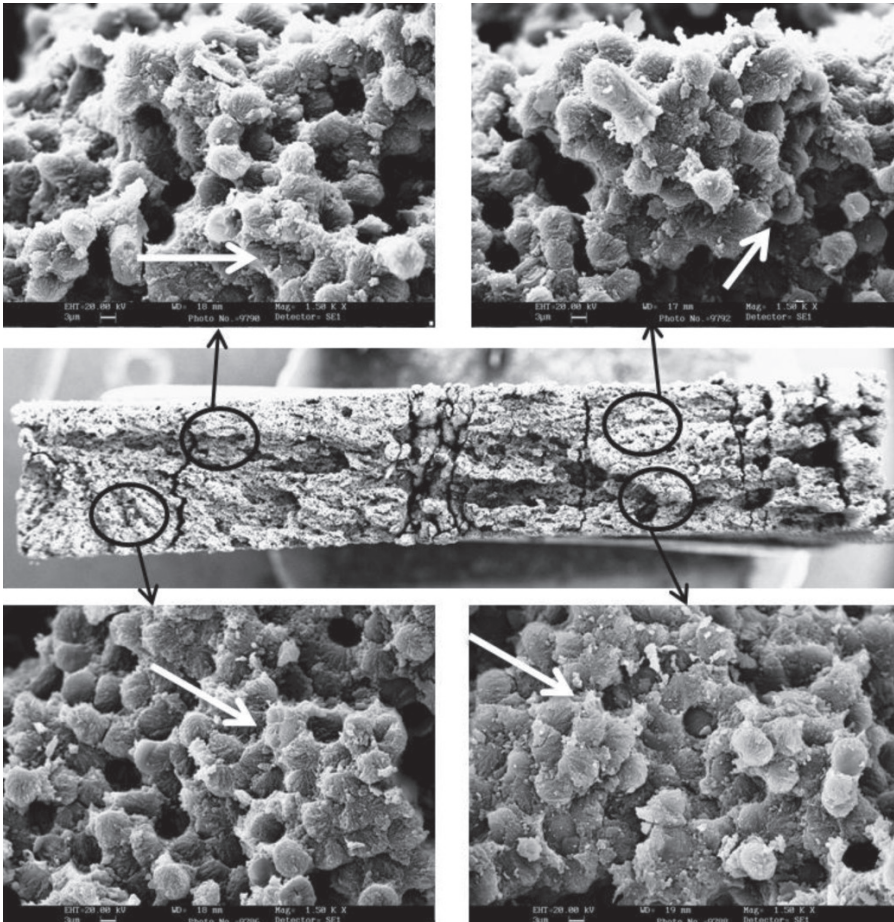
**Figure 7.** Map of overall crack propagation direction; white arrows indicate local crack propagation direction; dotted arrow indicate the over all crack propagation direction.

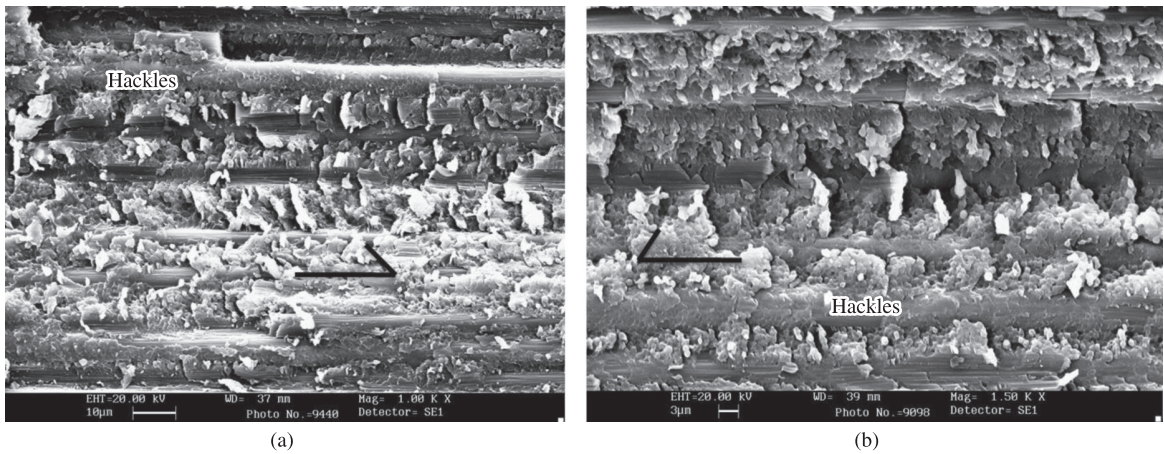
indicates that the mating surfaces sheared in a direction shown by half arrow. However, it is interesting to note that the orientation of hackles is in opposite direction on a similar surface of the mating transverse fracture (Figure 8b). This indicates that the transverse fracture occurred prior

**Figure 8.** Hackles observed in the longitudinal split surface at crack propagation region; half-arrow shows the shear direction.

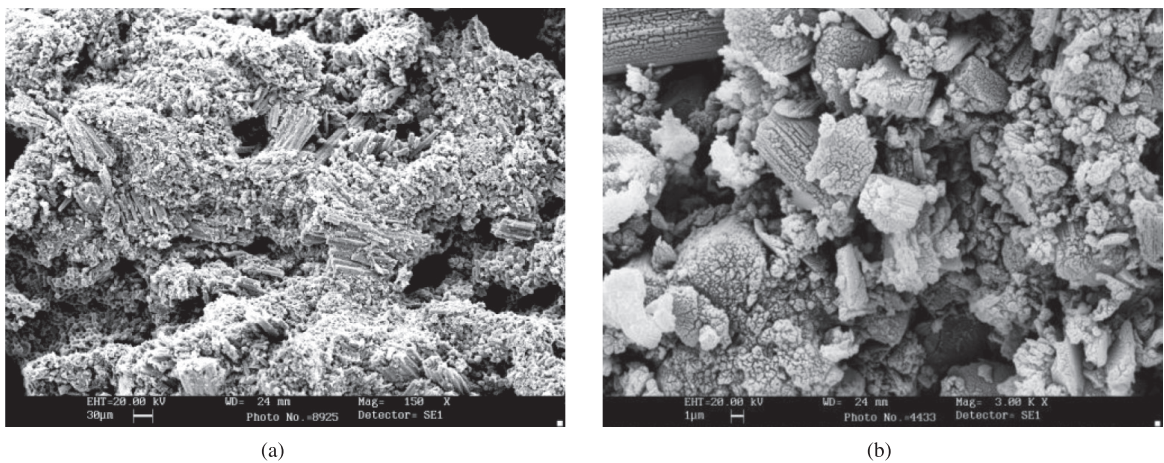
**Figure 9.** Microfractographic features in final fracture region showing (a) crushed fibres, and (b) fibre and matrix debris.

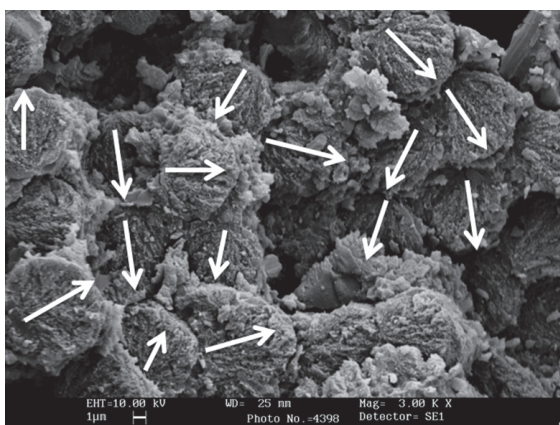
**Figure 10.** Random fibre fracture directions indicated by white arrows.

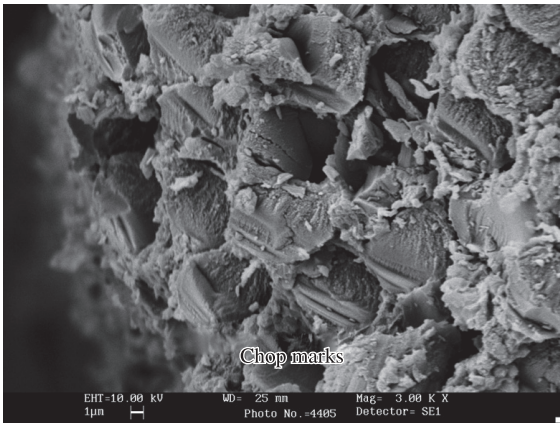
debonding. This is evident from the SEM image where hardly any bare fibres are visible. The final fractured area exhibited buckled fibres and chop marks at few locations. Chops marks represent bending of fibres. It is unusual to observe these features during tensile failure of composite. The presence of chop marks can be explained through the study of state of stress.

Figure 11. Chop marks indicative of buckling failure.

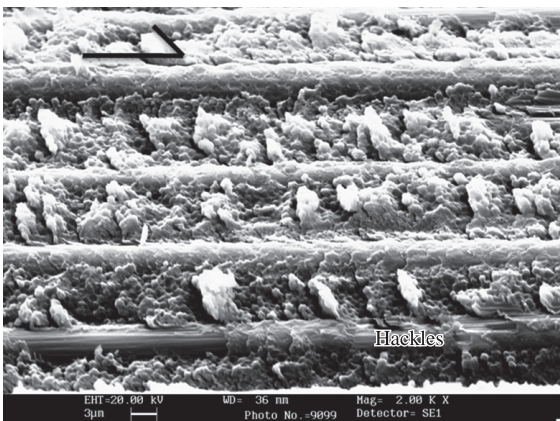
Figure 12. Hackles observed in the longitudinal split surface at final fracture region; half-arrow shows the shearing direction.

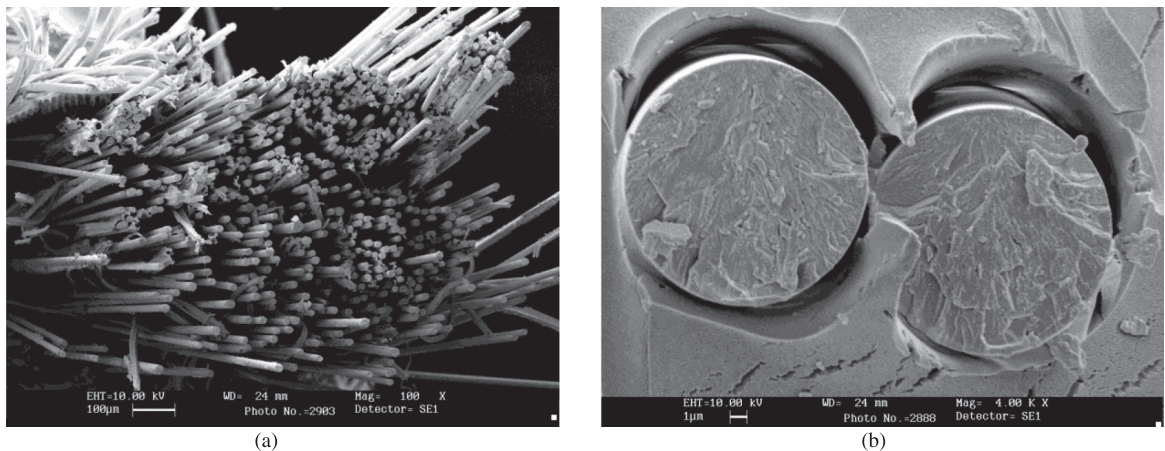
In GFRP composites, fibre bundles got separated from the matrix along their length like in a broom. There was extensive longitudinal splitting. The longitudinal

splitting observed could be a primary or a secondary event. However, in the present case, longitudinal splitting was a primary event. The mechanism by which longitudinal splitting occurs due to debonding is induced in fibre reinforced composites was first identified by Cook and Gordon<sup>9</sup>. When the crack initiates and propagates through the matrix in unidirectional laminates, the tensile stress ahead of the crack  $\sigma_c$ , is associated with shear  $\tau_m$  and the ultimate shear stress near the fibre  $\tau_{mu}$ . The fibre matrix interface strength is weak in GFRP composites, and the debonding stress  $\tau_d$  is less than the ultimate shear stress of the matrix,  $\tau_{mu}$ . Hence, longitudinal splitting due to debonding is favoured. This leads to broom-like failure (Figure 14). The longitudinal splitting due to debonding produces large difference in heights between the ends of the individual fractured fibres. Secondary transverse fractures of individual fibres occur in certain regions. Examination of fibre fracture ends revealed that the tensile fracture features like pull outs (Figure 15a) radials (Figure 15b) were oriented in random direction in each fibres. Since the tensile fracture was like broom, it was not possible to identify the crack propagation direction on the fracture surface.

**Figure 15.** Fractographic features showing (a) longitudinal splitting, and (b) fibre radials (GFRP specimen).
