Blast Furnace Hearth Lining: Post Mortem Analysis

Bruno Vidal de Almeida^{a*}, Elton Silva Neves^b, Sidiney Nascimento Silva^b, Fernando Vernilli Junior^a

^b Companhia Siderúrgica Nacional, CSN, Rio de Janeiro, Brazil

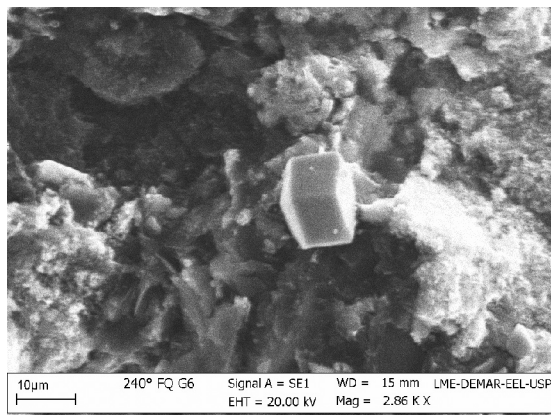
This region is located between the Tap Holes and the Opposite Side of the BF#2 Hearth, previously indicated in Figure 1. In a detailed analyze of the microstructure, Figure 4, it was possible to observe sulfur rhombohedral crystals deposited on the carbon matrix microstructure. This compound was found in the three elevations analyzed.

These results indicate that sulfur vapors generated inside the blast furnace atmosphere percolated through the open porosity of the refractory lining and then condensed on the isotherm near to 450°C. The phase analyzes by X ray diffraction confirms the sulfur presence only in the hot face sample. In spite of the sulfur presence in the hot face region, there was no difference between the both hot and cold face apparent porosity.

The sulfur crystals depositions are deleterious to refractory lining because it deteriorates graphite crystals' hexagonal plates. This affected region becomes weakly and it creates an easier way to both hot metal and slag penetration happens. After it the graphite flakes losses the adhesion between them promoting an easier penetration way for other elements present into the bath. The presence of sulfur was confirmed by XRD. The specific real mass, specific apparent mass and apparent porosity are similar despite of sulfur presence on the hot face, Table 2.

Figure 4. Detailed rhombohedral sulfur crystal in the bright phase from hot face sample.

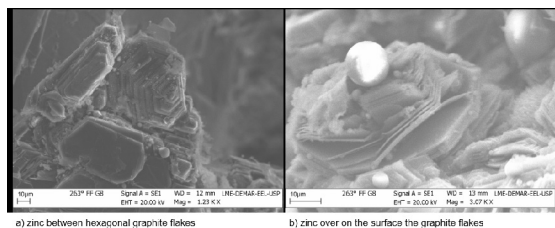
The microstructural analysis reveals the presence of several types of degradation on this refractory lining region, such as infiltration of phosphorus, zinc, slag and hot metal. The Figure 5 showed a damaged microstructure through zinc deposition between (a) and (b) over the hexagon carbon flakes. These samples also showed slag and hot metal infiltration in the sample microstructure, proved by XRD results. It is the last refractory state before it becomes completely obsolete.

**Figure 5.** Microstructure's image by SEM/EDS indicating zinc deposition: a) between hexagonal graphite flakes and b) over on the surface the graphite flakes.

The penetration of zinc is a result of hot gas infiltration. The zinc has a boiling point at 907 °C. The #2BF operates at 1550°C and its give high chemical activity for these two elements. The zinc vapor suffer oxidation, and then occurs its solidification and deposition in the isotherm near to 800°C, Equation 1.
