# Fretting Fatigue In-service Failure of X20CrMo13 Stainless Steel Turbine Blade

To identify the probable causes that led to premature failure of the X20CrMo13 steel turbine blade of a 25 MW cogeneration power plant, techniques of chemical analysis by optical emission spectroscopy, infrared absorption

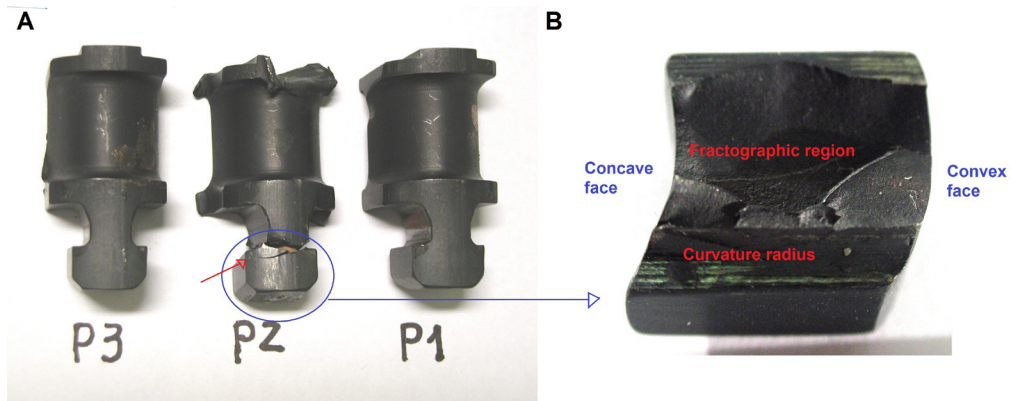
Figure 3A shows the investigated parts represented by the numbers P1, P2, and P3. The P1 and P3 blade (2500h service exposed) mounted on the turbine rotor, adjacent to the failed blade (P1 before, and P3 after the P2 blade). The virgin blade (VB), without service, is shown in Figure 4, to compare the microstructure and surface finishes. The samples selected for the metallographic analysis took from the longitudinal section of the virgin's blade lamination direction and fractured blades. The samples were then ground and polished with diamond, alumina, and colloidal silica solutions, based on standardized sample preparation

**Figure 3.** (A) Blades named P1 (adjacent blade), P2 (failed blade), and P3 (adjacent blade). (B) Detail of the fracture surface of the P2 blade base.

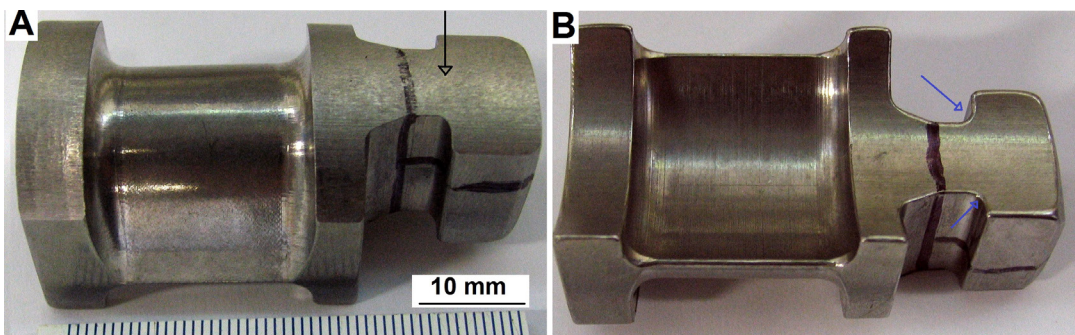
**Figure 4.** Blade called a virgin blade (VB) without service, seen in the opposite position. (A) The black arrow shows the region in which the metallographic (longitudinal cross-section) analysis was performed. (B) The blue arrow shows a stress concentration region at the blade's base, inherent in the project.

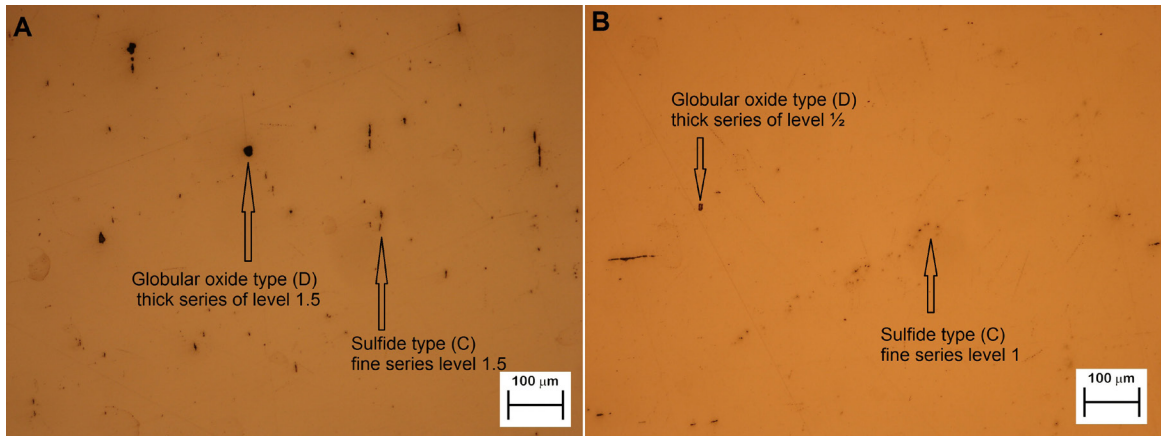
The presence of inclusions of the oxide and sulfide types are acceptable, according to the manufacturer's quality control standards, see Figure 5. Figure 5A shows inclusions of the globular oxide type (D) thick series of level 1.5, and sulfide type (C) fine series level 1.5, at a region below the fracture surface of the P2 blade, and Figure 5B shows inclusions of the globular oxide type (D) thick series of level ½, and sulfide type (C) fine series level 1, at a region of the VB blade base.

**Figure 5.** Optical images of unetched cross-sectional surfaces of the X20CrMo13 type steel blades. (A) Inclusions of the globular oxide type (D) thick series of level 1.5, and sulfide type (C) fine series level 1.5, at the fracture surface of the P2 (B) Inclusions of the globular oxide type (D) thick series of level  $\frac{1}{2}$ , and sulfide type (C) fine series level 1, at a region of the VB blade base.

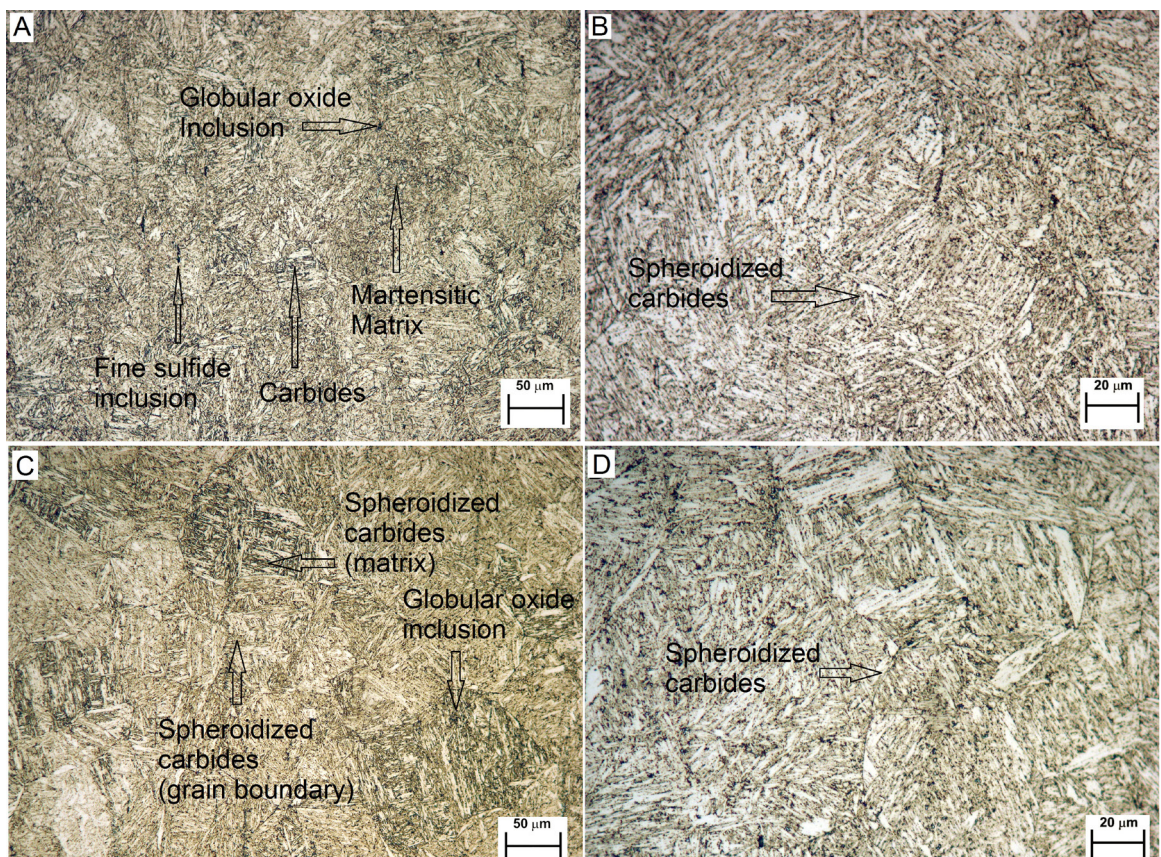
A typical microstructure of martensitic stainless steel, with spheroidal carbides, is detected in P2 failed blade, as shown in Figure 6A, carbides are precipitated mainly in

the grain boundaries. The existence of inclusions of the globular and elongated oxide types, of the sulfide or silicate type, is also observed. This microstructure of spheroidized carbides is coherent with the heat treatment of quenching and tempering applied to the material. Carbides precipitate typically at the grain boundaries, as shown in Figure 6B.

**Figure 6.** Optical images of etched cross-sectional surfaces of the X20CrMo13 type steel blades. (A) The region below the P2 blade's fractured surface. (B) Detail of (A) showing spheroidized carbides precipitated in the grain boundaries. (C) Cross-sectional region at the base of the VB blade (without service). (D) Detail of (C) showing spheroidized carbides precipitated at the grain boundaries (Vilella's etchant).

A photomicrograph of a cross-sectional region at the base of the VB blade (without service) is shown in Figure 6C, presenting a typical microstructure of tempered martensitic stainless steel with the presence of small spheroidal carbides precipitated at the matrix and the grain boundaries. The high-temperature service conditions probably induced carbides growth and made it more significant than in the virgin blade, as shown in Figure 6D.

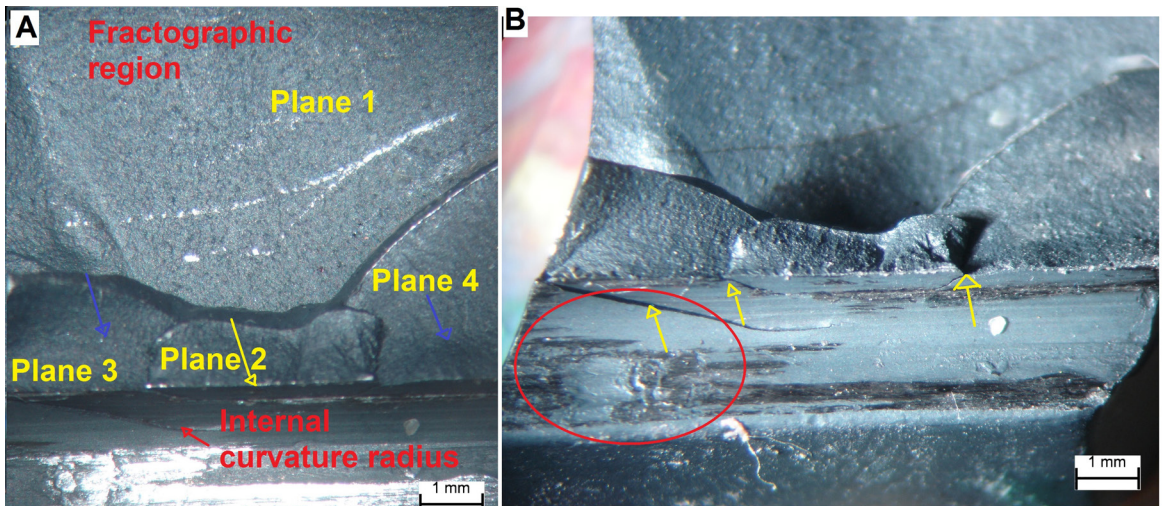
From the fracture surface analysis, it is possible to evidence the low levels of work loading involved, as shown in Figure 7. There are four different fatigue crack propagation planes shown in Figure 7A, plane 1 (bottom), planes 2, 3, and 4 (top). Figure 7B shows the principal crack plane (plane 1), secondary cracks (yellow arrow), and plastic deformation marks located in the curvature radius of the blade top base, typical of the wear process called fretting. The fretting process only occurs when two surfaces in contacts are mechanically loaded and undergo relative movements of low amplitude<sup>12</sup>. Secondary cracks were activated during

**Figure 7.** Stereographic images of the fracture surface of the P2 blade. (A) The crack nucleation sites (yellow arrow). There are four different fatigue crack propagation planes, plane 1 (bottom), planes 2, 3, and 4 (top). (B) Detail of (A) observed by another angle.

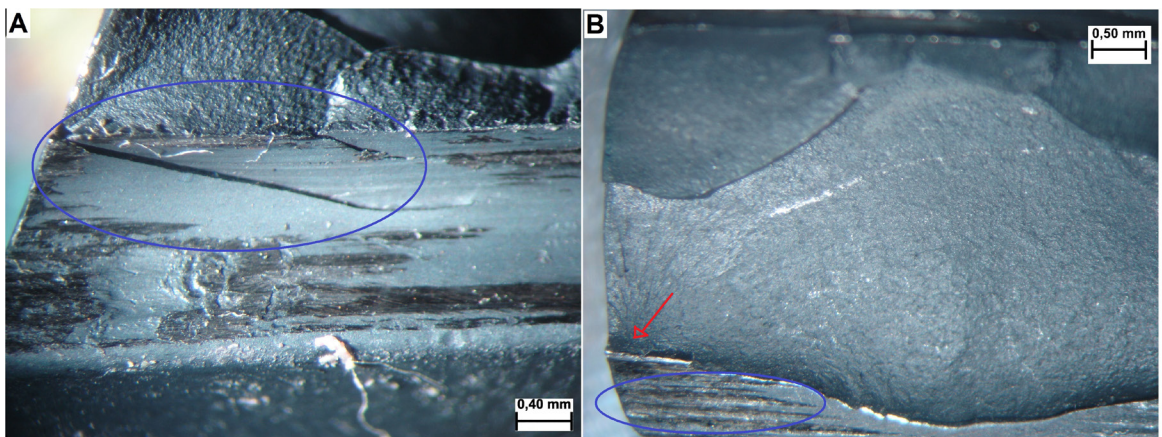
the final blade fracture stage<sup>21</sup>, as shown in Fig 8A. The fatigue crack propagation that caused the P2 blade failure is shown in Figure 8B, where progression lines are observed that characterize the leading crack nucleation site and the plastic deformation marks caused by fretting.

**Figure 8.** Stereographic images of the fracture surface of the P2 blade. (A) Detail with higher magnification of the region shown in Figure 7. (B) Detail of the principal plane (plane 1) of fatigue crack propagation.

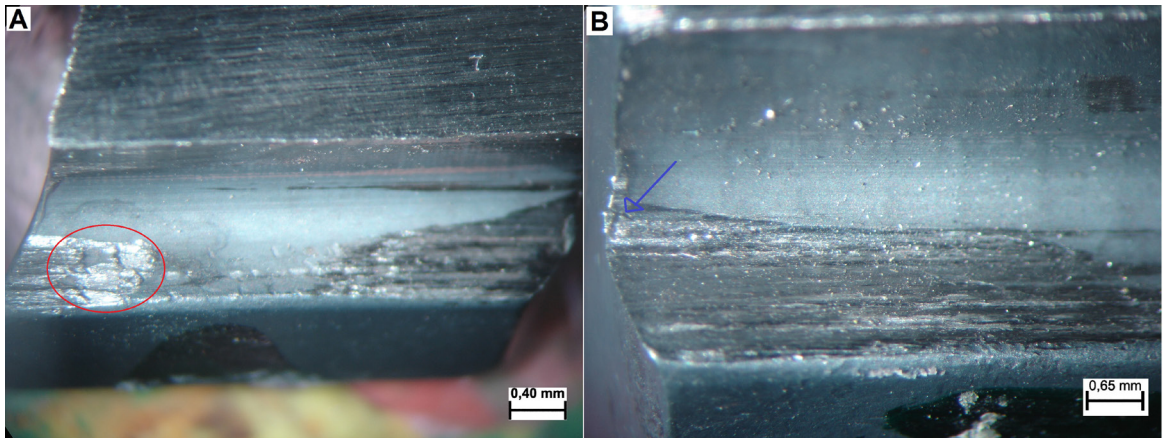
The non-failed blade P1, located adjacent to the failed blade P2, showed the existence of shiny areas, probably due to the friction of the parts that removed the oxide layer, and plastically deformed material, characteristic of fretting, developed at the edge of the convex face, as shown in Figure 9A. At sharp plastic deformation of the material occurred, it is also detected the origin of a crack at the edge between the radius of curvature and the blade's concave face, as shown in Figure 9B, nucleated and propagated by fretting fatigue mechanism<sup>14</sup>.

**Figure 9.** Stereographic images of the non-failed blade P1. (A) Showing shiny areas and plastically deformed material (red ellipse). (B) Plastic deformation at the origin of a crack at the edge between the curvature radius and the concave face of the blade (blue arrow).

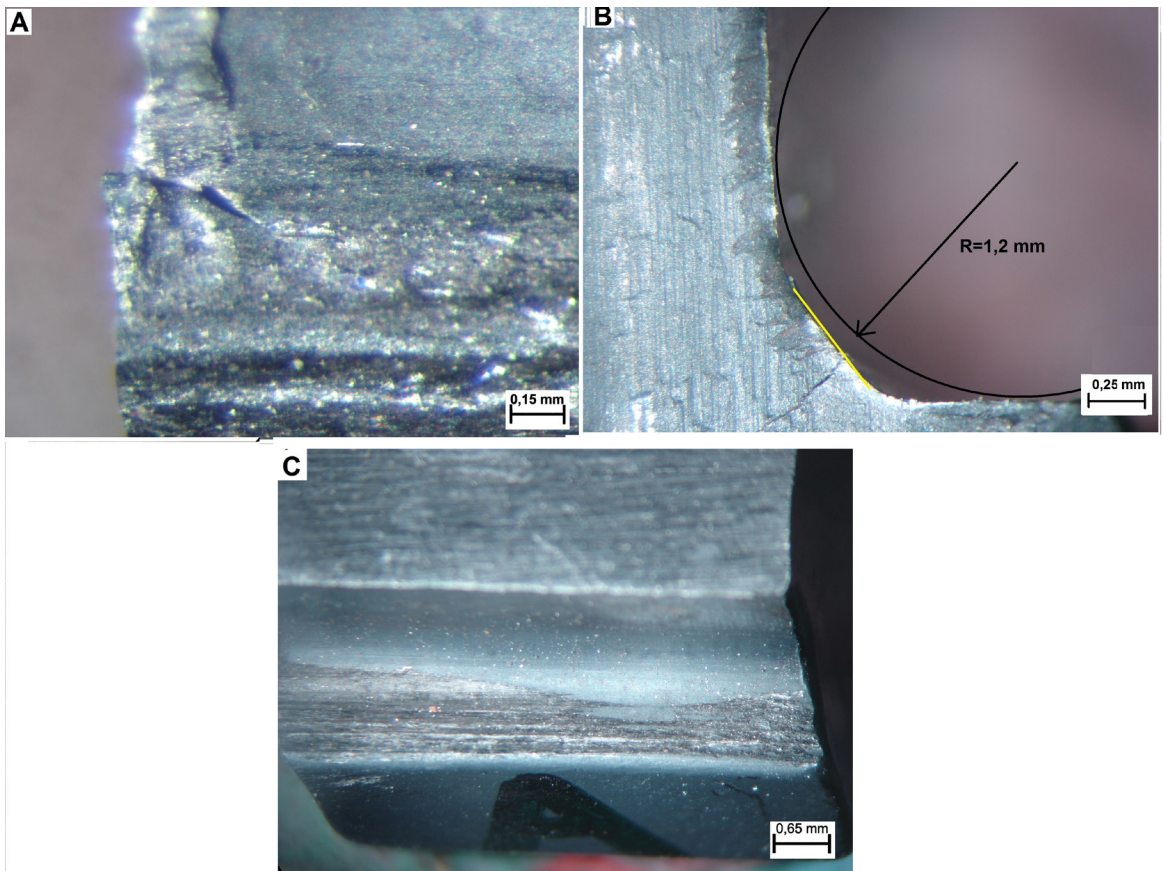
blade, that is, at the edge between the radius of curvature and the concave face of the blade, as shown in Figure 10A. The crack propagated towards the part interior in which the outer face has many scratches from the machining process, as shown in Figure 10B. (yellow arrows). It is also possible

to visualize, near the crack nucleation site, the debris of oxidized material, which was generated during fretting<sup>4</sup>. On the concave face, see Figure 10B, where a curvature radius of approximately 1.2 mm has been simulated (part design) where it is possible to observe an error in the

**Figure 10.** (A) Detail with higher magnification of the region shown in Figure 7. (B) The concave face view (yellow lines) of Figure 10B, where a curvature radius of approximately 1.2 mm has been simulated (part design, stress raiser level (yellow line)). (C) Curvature radius stereography at the base of the P3 blade.

machining of the curvature radius, causing in addition to the stress raiser a level (yellow line) which, after mounting on the rotor, increases the contact force between the parts, facilitating the nucleation of cracks by fretting. The same fretting fatigue damage structures detected in P1 and P2 blades were also observed at the base of the P3 blade, see Figure 10C.

- b) Improve the process of machining the base blade curvature radius, a place conducive to the nucleation of cracks by fretting.
- c) During the blade assembly operation, care must be taken not to introduce mechanical damage to the blade base, as this is a favorable region for the propagation of damage by the fatigue mechanism.

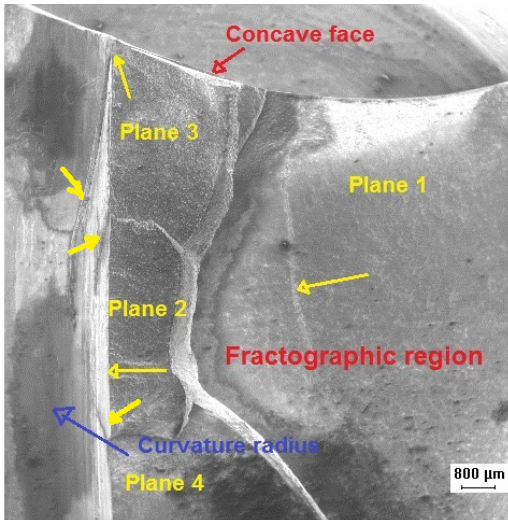
Figure 11. SEM images showing the fracture surface of the P2 blade.

From the SEM images are shown in Figure 11, one observes the occurrence of secondary cracks located in the radius of curvature of the coupling with the rotor, the convex face of the blade, and the four fracture planes, named in this work as principal plane 1 and secondary planes 2, 3 and 4. From the analysis of the crack progression lines, the crack nucleation sites were detected, one concludes that this nucleation occurred due to fretting. Figure 11 shows a secondary crack site starting from the radius of curvature and propagating across the blade changing orientation (plane) due to the change in the balance of loads. Note the existence of secondary cracks, located in the region of the radius of curvature of the failed blade base.

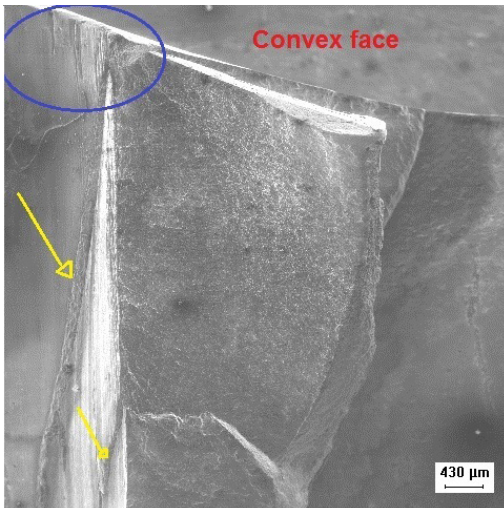
Figure 12. SEM images of the fracture surface of the P2 blade.

In the same part P2, Figure 12 shows numerous typical shear scratches between metals due to plastic deformation, tears, entrainment, and secondary cracks. It is possible to observe dragging and tearing material between the convex region and the curvature radius of the P2 blade, as shown in Figure 12. These damages occur when two metallic surfaces are placed in contact, under mechanical loading, and suffer sliding at low amplitudes and high frequencies.

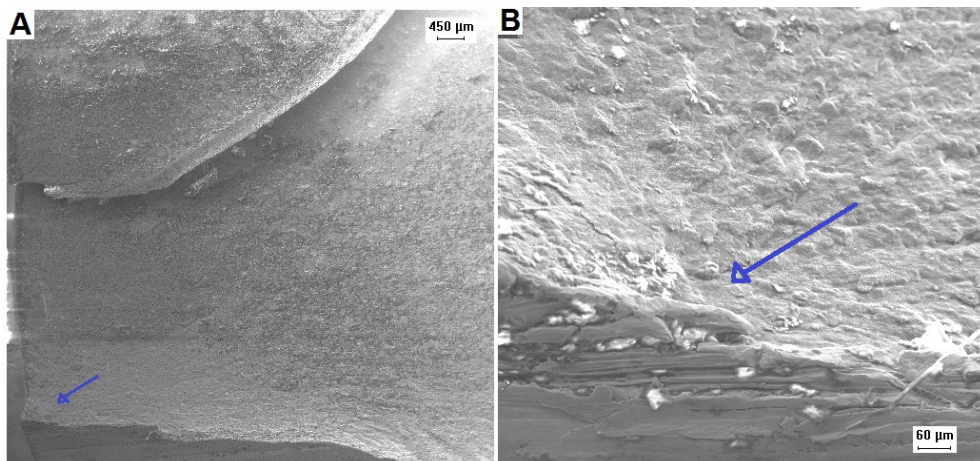
By analyzing a fractured surface of the P2 plane showing two crack propagation planes, as shown in Figure 11, and the fracture progression lines, it was possible to locate the leading crack's nucleation site, as shown in Fig 13A and Figure 13B. Debris generated by fretting<sup>7</sup> was found near the leading crack nucleation site of the P2 blade, as shown in Figure 14. Localized material loss and plastically deformed areas were observed in the P1 blade, as shown in Figure 15A, and crack as shown

Figure 13. SEM images of the fracture surface of the P2 blade. (A) Crack propagation planes, as shown in Figure 11A, and the fracture progression lines, it was possible to locate the nucleation site of the main crack (blue arrow). (B) Detail of previous image evidencing the crack origin.

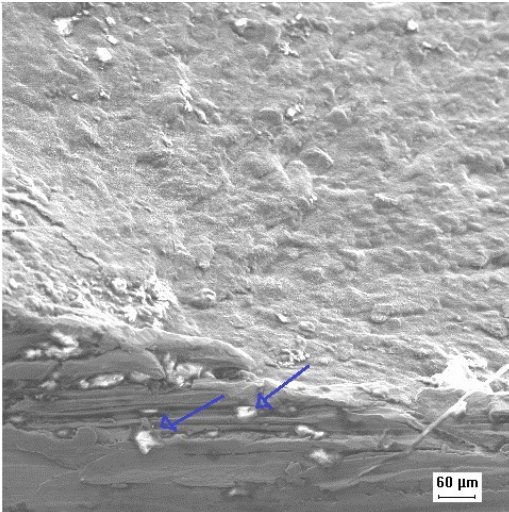
**Figure 14.** SEM images of the fracture surface of the P2 blade. Showing debris generated by fretting (blue arrows) located near the leading crack nucleation site.

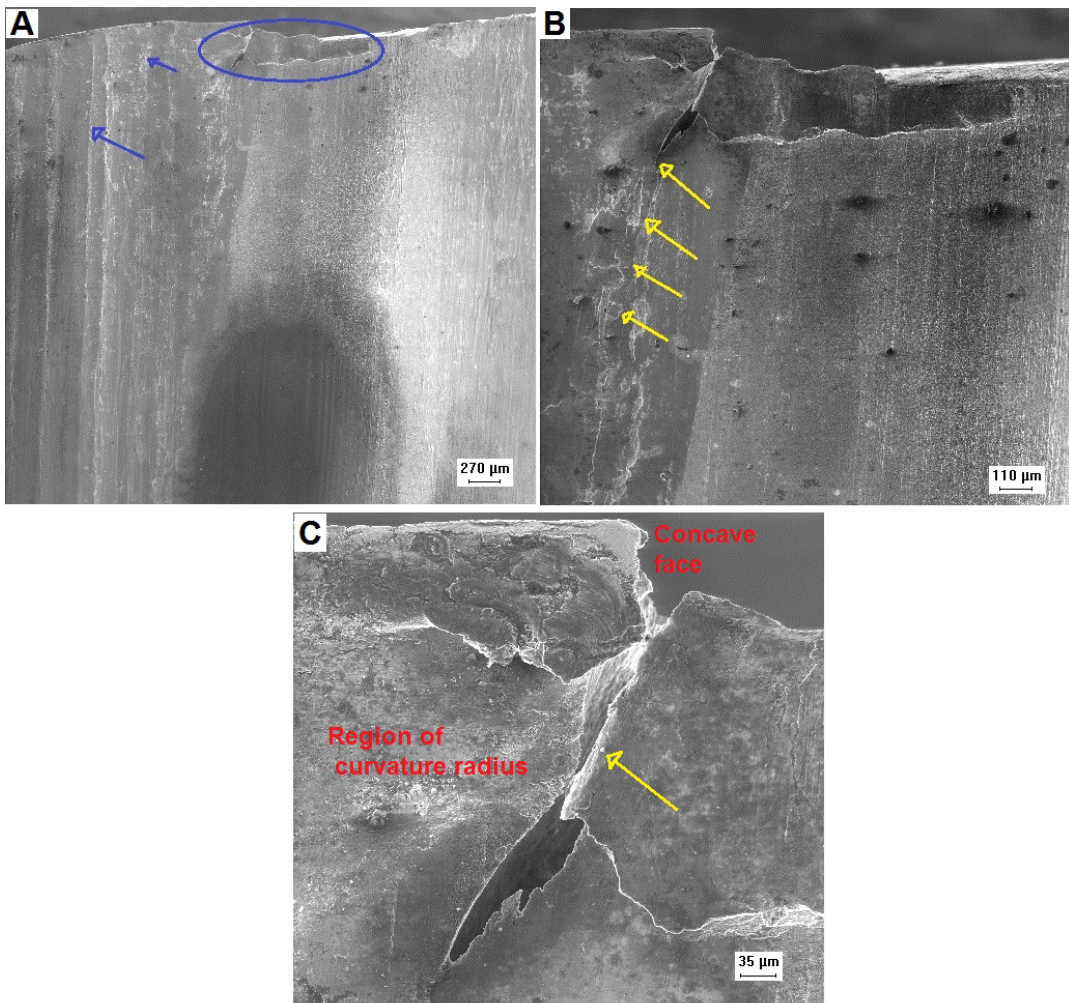
in Figure 15B and Figure 15C, corroborating fretting fatigue in the system.

**Figure 15.** SEM images of the fracture surface of the P1 blade. (A) Localized material loss (blue ellipse) and plastically deformed areas (green arrow). (B) Fretting fatigue crack (yellow arrows). (C) Higher magnification of the previous image evidencing the fretting fatigue crack (yellow arrow).
