Evaluation of medical X-ray machines in Paraíba state radiology centers between 2008 and 2009*

Mendes ACR, Ramos CL, Abreu DWM. Evaluation of medical X-ray machines in Paraíba state radiology centers between 2008 and 2009. *Radiol Bras.* 2011 Jul/Ago;44(4):244-248.

* Study developed at Agência Estadual de Vigilância Sanitária da Paraíba (Agevisa-PB), João Pessoa, PB, Brazil.

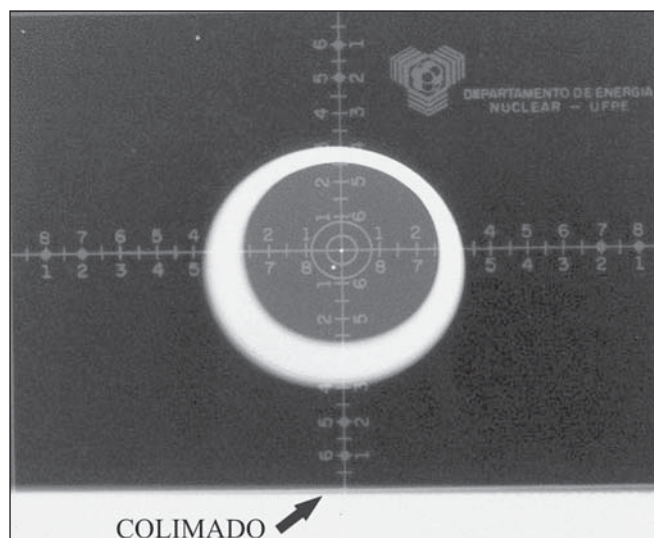
The congruence between the light and radiation fields was evaluated for analysis and interpretation of the images of the collimator test. The largest distance between the borders of the light field and those of the radiation field was measured. The greater the congruence between the light and the radiation fields, the better is the alignment. The difference between the borders of the radiation field and the borders of the light field must not be greater than 2% of the focus-film distance that is ± 2 cm away from the line corresponding to the device's rectangle^(9,11). The images generated on this test are represented on Figures 1 and 2.

Figure 1. Collimation system accuracy test. Image demonstrating compliant fields congruence.

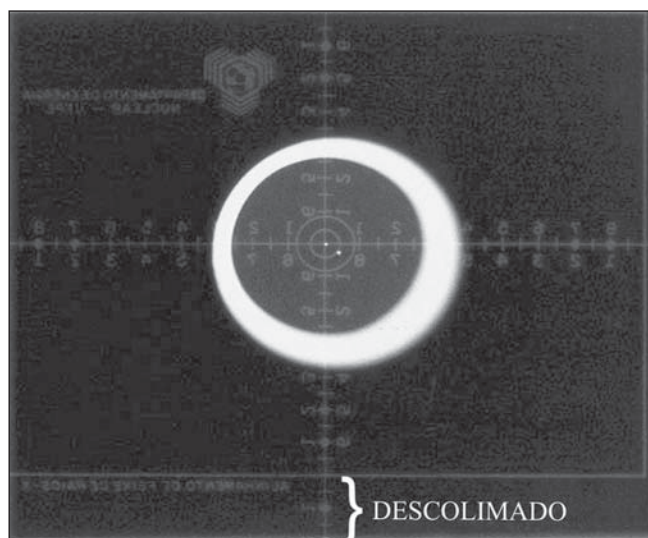
Figure 2. Collimation system accuracy test. Image demonstrating non compliant fields congruence.

After the evaluation of the tests results, in those cases in which the X-ray apparatuses were not in compliance with the standards, the institutions to which they belonged were notified and deadlines were established for corrective maintenance, after which the inspection team would perform new tests in the same apparatuses to check on the adjustments made.

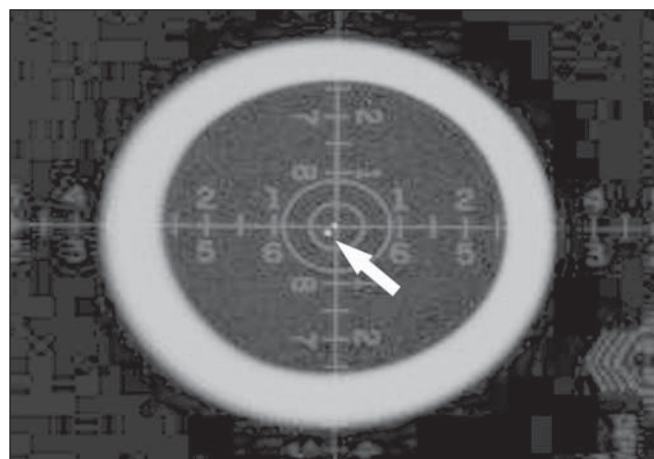
location of the image of the sphere on the top of the cylinder was verified. If the image of the upper sphere was within the first circle, the inclination corresponded to $< 1.5^\circ$. In those cases where the image of the upper sphere was located between the first and the second circles, the inclination was $< 3^\circ$ ⁽¹¹⁾. Whenever the image of the upper sphere intercepted the second circle, the perpendicularity of the central ray must be corrected⁽⁸⁾. Figures 3 and 4 represent the images of the X-ray beam central axis alignment test.

Figure 3. Central ray perpendicularity test. Image demonstrating the compliant incidence of the X-ray beam central ray.

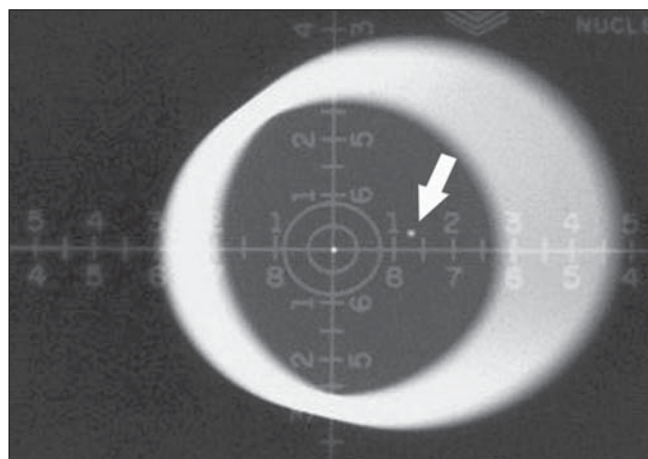
Figure 4. Central ray perpendicularity test. Image demonstrating the non compliant incidence of the X-ray beam central ray.

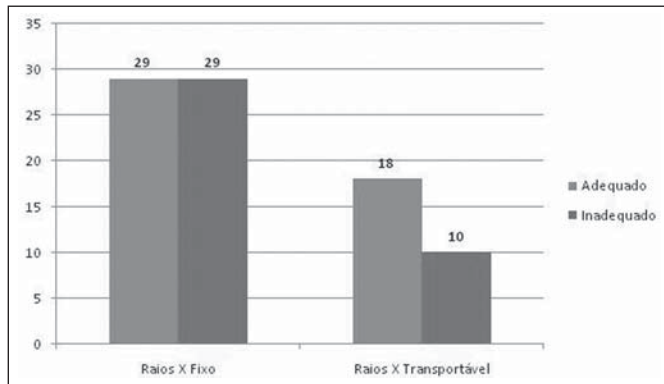
Among the 121 tested apparatuses, 32.23% ($n = 39$) presented problems regarding the collimation system accuracy and/or alignment of the X-ray beam central ray, most of those 39 apparatuses ($n = 22$) belonging to private centers. Among the tested apparatuses, 23.96% ($n = 29$) were classified as fixed X-ray apparatuses with problems, while 8.26% ($n = 10$) were portable apparatuses that were not compliant with the quality assurance standards.

Figure 5. Chart demonstrating the classification of the X-ray apparatuses into fixed and portable apparatuses, according to the results of the quality control tests performed in the Paraíba state in 2008.

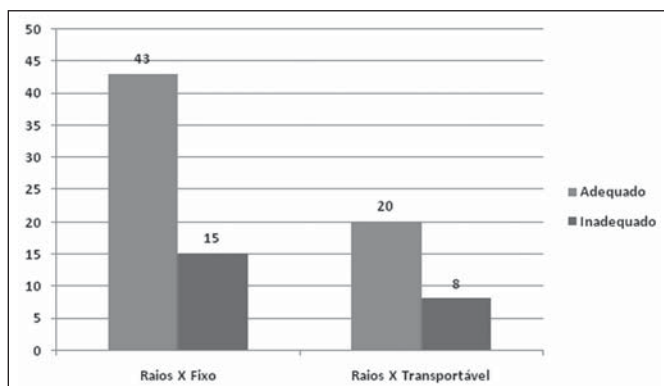
system accuracy and/or X-ray beam alignment, most of them ($n = 13$) belonging to private clinics. As regards the classification of the apparatuses, among all the apparatuses monitored in 2009, 12.82% ($n = 15$) were classified as fixed apparatuses with problems, and 6.83% ($n = 8$), as portable, non compliant apparatuses.

In the present study, 71.07% ($n = 86$) of the apparatuses tested in 2008 were tested again in 2009, with improvement in QCT results of 18.6% ($n = 16$) from one year to another (Figures 5 and 6). The other apparatuses tested in both years obtained the same satisfactory results on the collimation system accuracy and central ray

Figure 6. Chart demonstrating the classification of the X-ray apparatuses into fixed and portable apparatuses, according to the results of the quality control tests performed in the Paraíba state in 2009.
