Problems with reliability and safety of hot dip galvanized steel structures

L. Mraz¹; J. Lesay²

¹Welding Research Institute – Industrial Institute SR, Racianska 71, 832 59 Bratislava, Slovakia

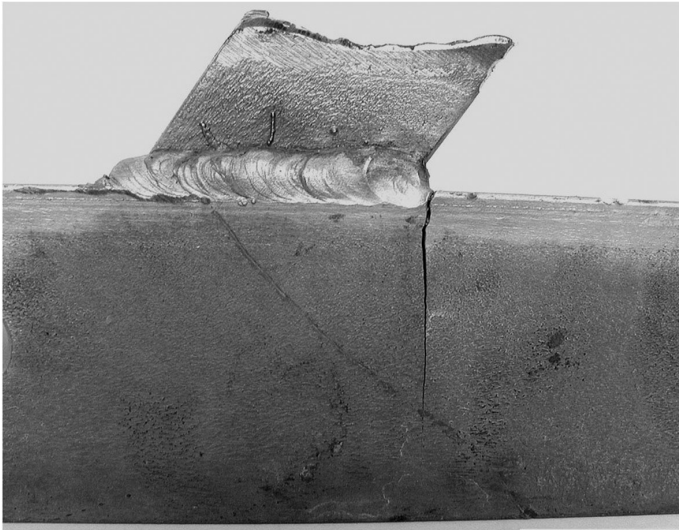
First example of failed steel structure is a weldment in 6 m length fabricated from L profiles in dimension 6 x 80 x 80 mm and 5 x 50 x 50 mm. The cracks sometimes attaining almost 70 mm in length were observed after hot dip galvanizing (Figure 3). These cracks initiated close to the fillet welds and propagated perpendicularly to the profile surface (Figure 4). No cracks were identified by visual testing just after welding.

Figure 3. Fracture in a welded steel structure close to L profile weld.

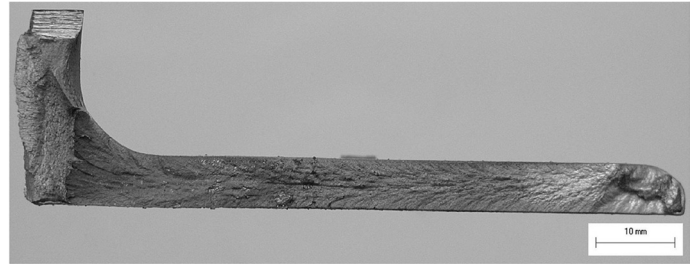
Figure 4. Fracture surface in L – profile.

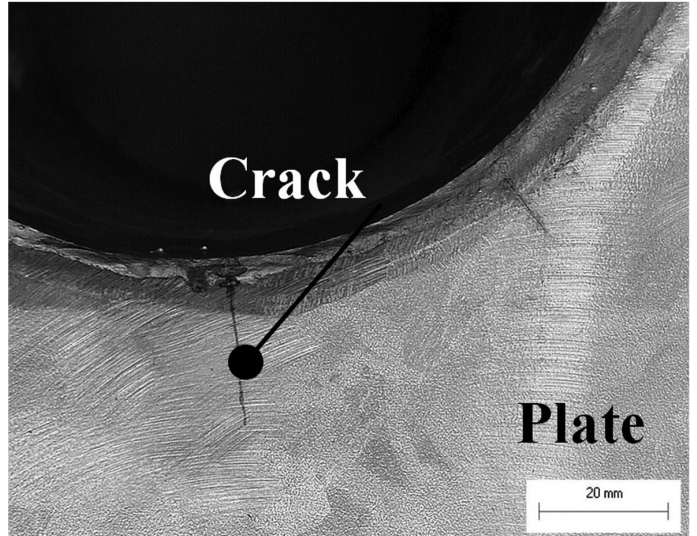
Figure 5. Fracture of circumferential weld between the tube and plate.

Second failed steel structure consisted of a tube welded to 10 mm steel plate. The plate 10 mm in thickness was made of S355 steel grade. Several cracks were identified perpendicularly to the circumferential weld (Figure 5). A number of cracks has been identified by using dye penetrant test when the zinc layer was removed by grinding. The crack surface was covered by zinc layer and it propagated both, in plate and tube as well (Figure 6).

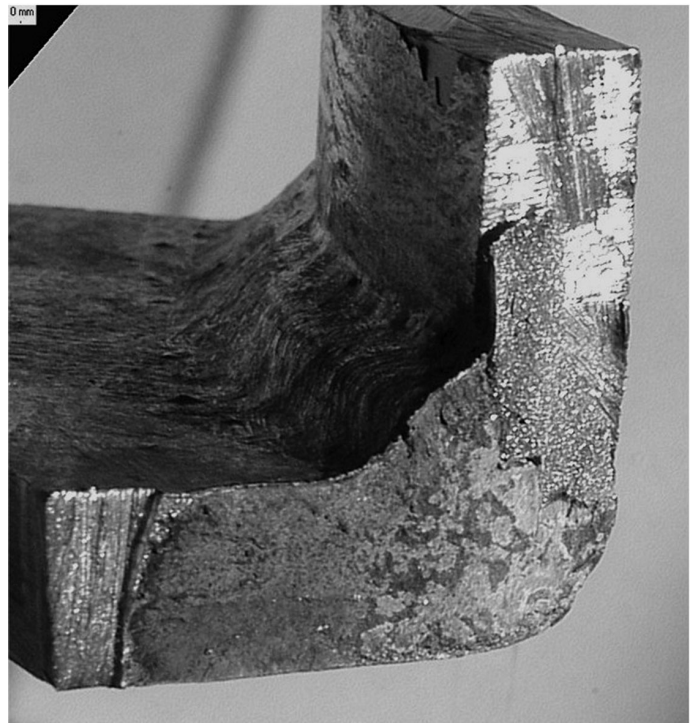
Figure 6. Crack morphology in a circumferential weld between the plate and tube.

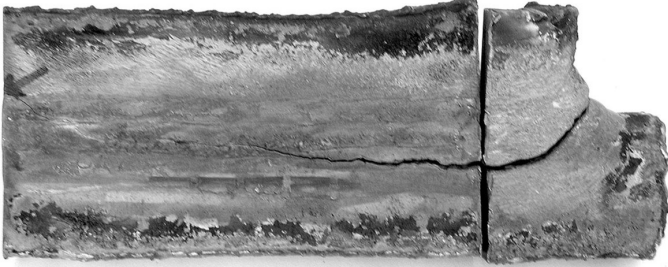
Third case of hot dip galvanized steel structure was the fracture of a sizable steel structure containing multi-pass welds. The structure failed in the location of stress concentration (Figure 7).

Figure 7. Crack in zinc coated welded steel structure.

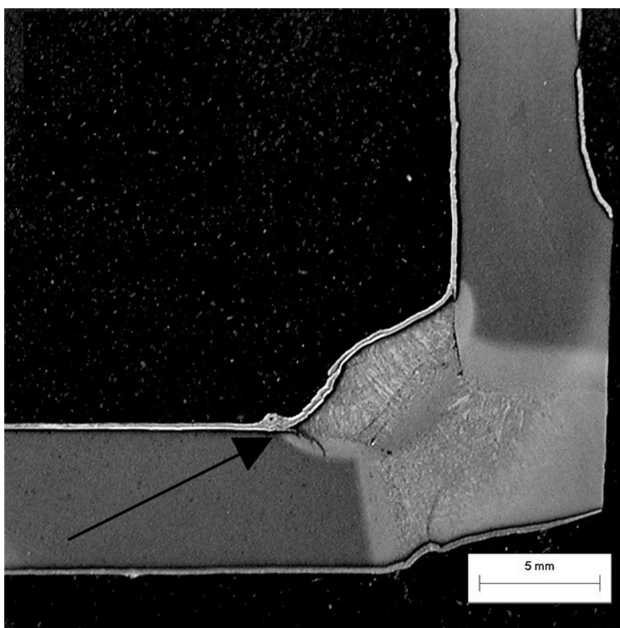
Figure 8. Location of crack initiation (arrow).

Macrostructure of the L – profile fillet weld is shown in Figure 8. The cracks initiated in the notch at the interface between the weld and base metals, e. g. in the HAZ. The crack length is shown in Figures 9 and 10. The cracks propagated perpendicularly to the L-profile length from the HAZ into base metal. The cracks were trans- and intergranular in the HAZ and intergranular in the base metal. The crack surface is covered by zinc layer (Figure 11).

Hardness measurements have shown that the HAZ hardness in the tube to plate weldment attained 274 HV5 and the HAZ hardness in L – profile of structure attained 360 HV5.

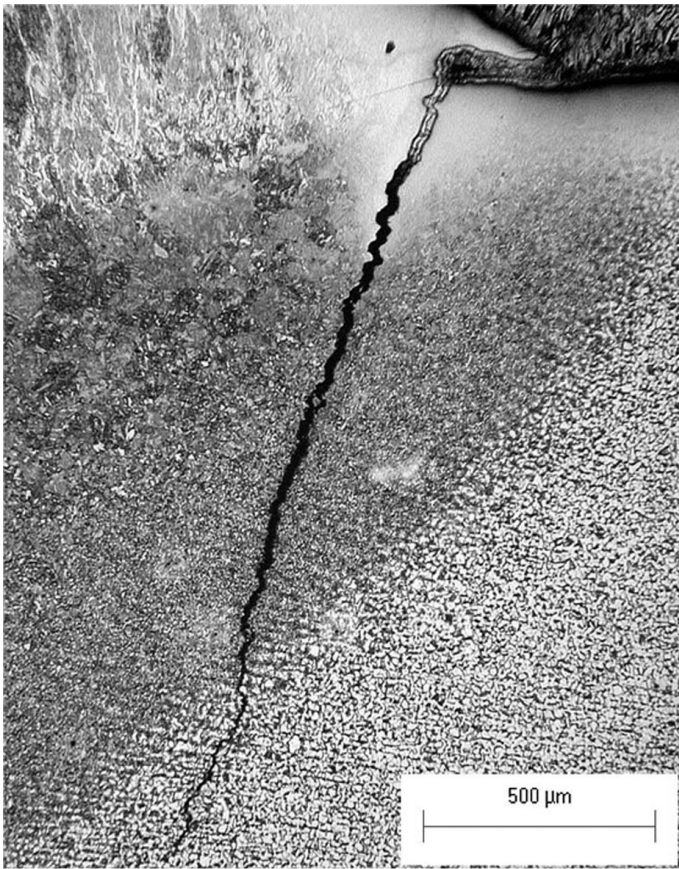
Figure 9. Crack initiation and propagation.

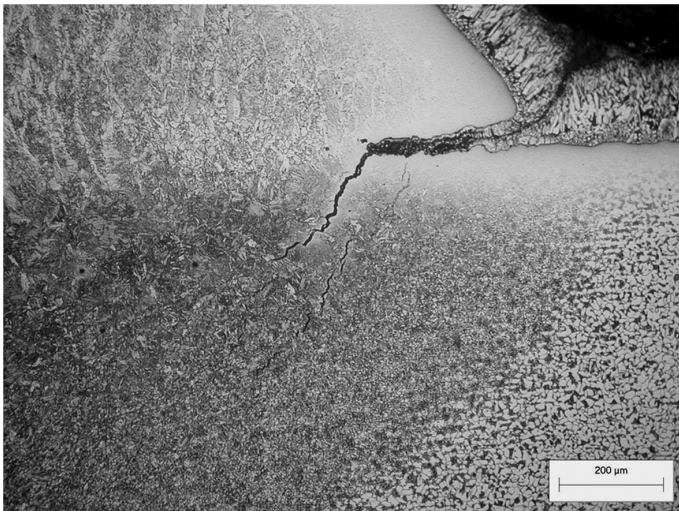
Figure 10. Crack initiation in the HAZ.

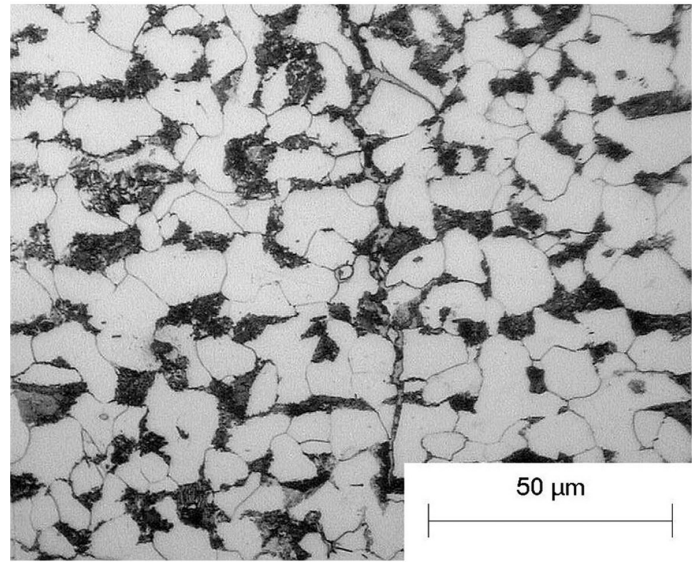
Figure 11. Crack propagation in the base metal.

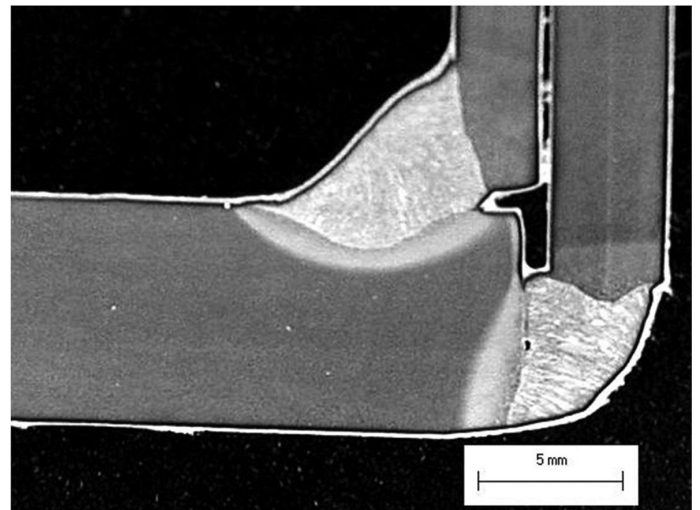
Macrostructure of the tube to plate circumferential weld is shown in Figure 12. The cracks were oriented perpendicularly to the circumferential weld (Figure 13) and propagated into plate and also into the tube. In some areas the cracks oriented parallel to weld seam were observed. Fine trans- and intergranular microcracks were observed in the HAZ close to the main circumferential crack (Figure 14). The intergranular cracks were observed in the base metal.

Figure 12. Cross-section of the circumferential weld.

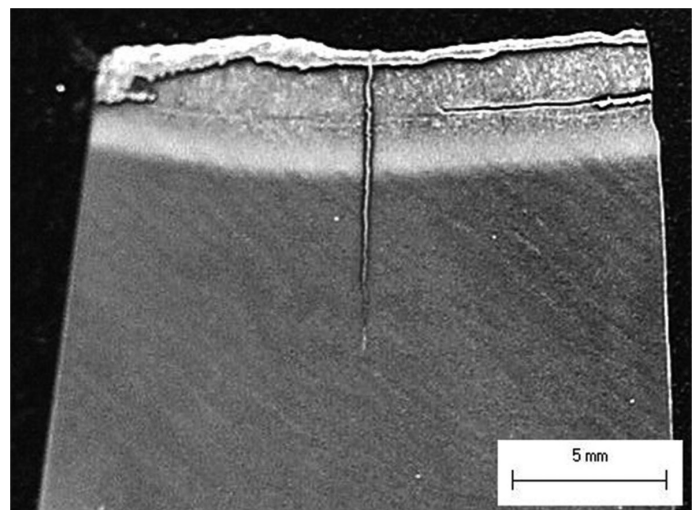
Figure 13. Crack in the circumferential weld.

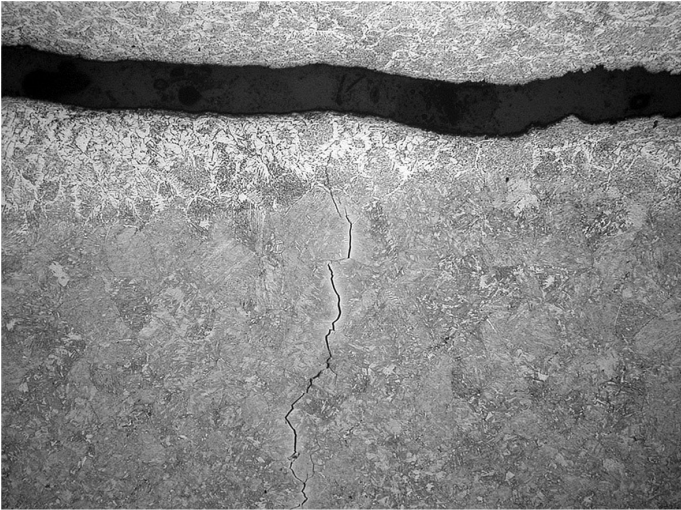
Figure 14. Crack in the circumferential weld.

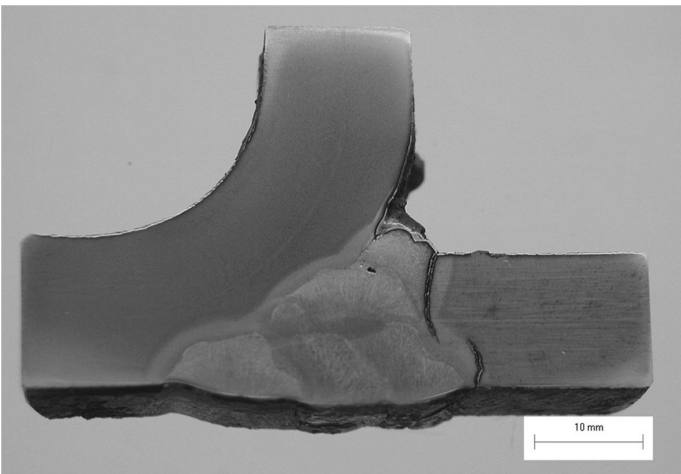
The presence of cracks was identified in a large weldment in the vicinity of multi-pass welded joint located in the stress concentration area. Cracks initiating from the weld surface and weld root were identified in one cross-section (Figure 15). The crack initiation area could not be identified. The cracks of branched type were observed with intergranular propagation in the base metal and filled also by zinc layer (Figure 16).

Figure 15. Crack location in the steel welded structure.

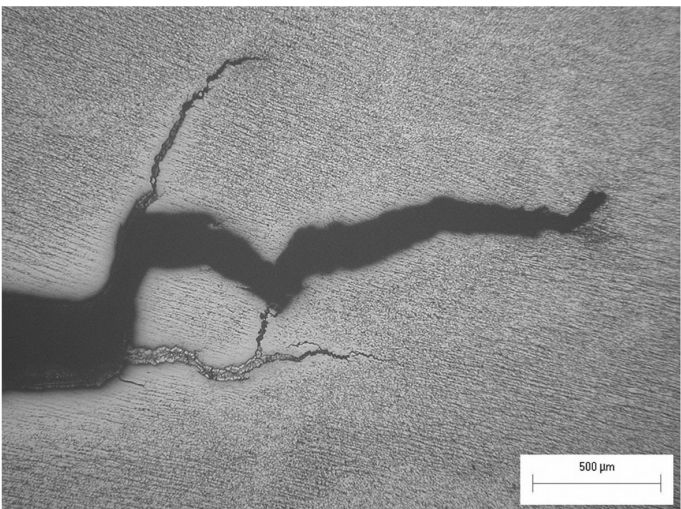
Figure 16. Crack propagation in the base metal.
