Surface Contact Fatigue Failure of a Case Hardened Pinion Shaft

An investigation was made to determine the causes of surface contact fatigue failure of a case hardened driver pinion located in the intermediate shaft of a reducer gearbox used in a sugar and alcohol mill. The examination of the component revealed the presence of a cemented layer substantially thicker than that generally specified for pinions devised for this application. This, associated with the massive presence of brittle threadlike carbon-rich cementite phase (Fe_3C) in prior austenite grain boundaries of the pinion teeth, favored surface crack nucleation and propagation during cyclic loading, leading to spallation of the contact surface with the counterpart gear, which impaired the system's operation. Poor carburization practice was discovered as the root cause of the mechanical failure, thus demanding the implementation of a new manufacturing route to avoid problems in similar load-bearing rotating components.

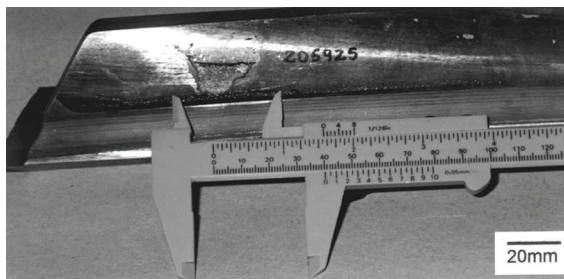
Figure 2 shows a pinion tooth subjected to failure analysis due to the extensive deterioration it suffered during in-service conditions. The types of damage typically found in the contact line of assessed teeth were classified as scaling and pitting, which undoubtedly resulted from fragmentation of the case hardened layer.

However, the progressive enlargement of scales and pits can lead to a type of damage known as cyclone, which is illustrated in Figure 2.

Figure 2. Representative case of a badly damaged pinion tooth surface.

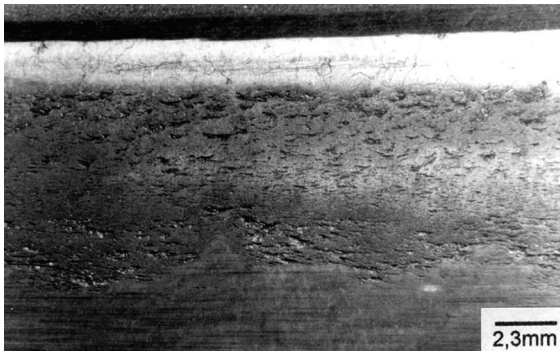
Figure 3 depicts the contact line of the counterpart gear tooth, clearly showing the presence of pits. This is normally the first stage of RSCF under relatively low applied stresses, and is corroborated here by the absence of noticeable plastic deformation of the inspected surface. In fact, in this position (contact or pitch line) the maximum bearing (compression) stresses develop between the pinion and its counterpart gear surfaces. On the other hand, the peak location of subsurface stress resulting from the sum of rolling and sliding stresses occurs elsewhere below the surface.

Figure 3. Detailed view of the contact line and neighboring regions of counterpart bigger gear viewed with a binocular stereoscope (microscopic pitting).

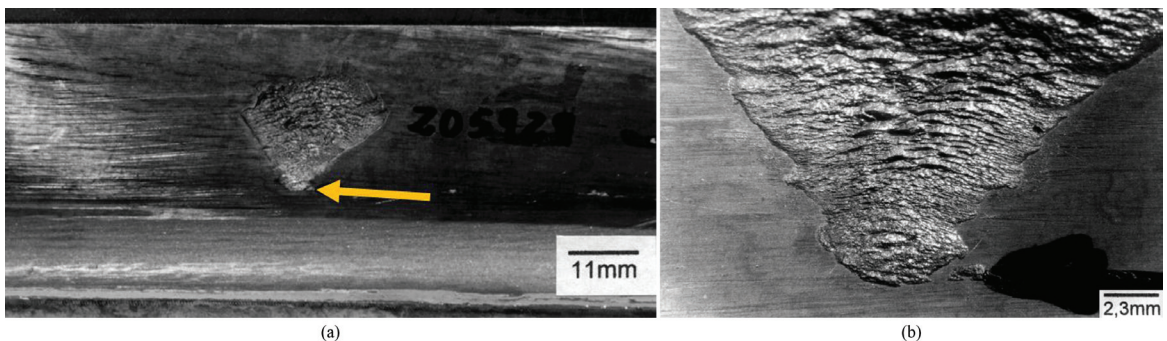
Figures 4a and 4b show the so-called cyclone pattern shown in Figure 2, developed under surface contact fatigue in the pinion pitch line, which is created by continuous and extensive fragmentation of the case hardened layer of the pinion tooth in the rolling direction.

Figure 4. Surface contact fatigue damage of the cemented and subsequently Q&T SAE 8620 steel pinion tooth flank: (a) Typical cyclone morphology, with the likely initiation site indicated by an arrow; (b) Detailed view of the formed cavity (classified as severe spalling) seen under a binocular stereoscope.

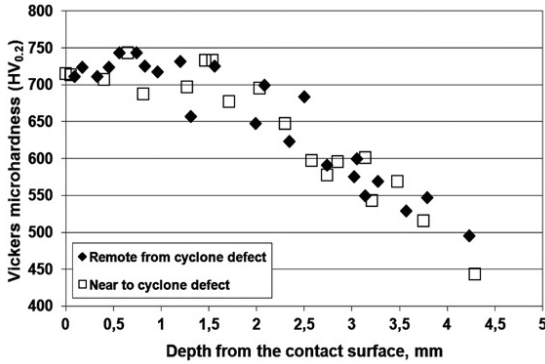
Microhardness values are plotted in Figure 5, where the data points indicate a hardened case depth of 3.2 to 3.5 mm, assuming that the nominal thickness of the cemented layer corresponds to the position where a value of 550 HV_{0.2} is reached from the top layer surface after the Q&T heat treatment, according to the DIN 50190 standard. Compared to the typical target value of 2.6 mm specified for this pinion shaft size, it can be concluded that the thickness of the hardened case exceeded 0.6–1.1 mm.

According to the plotted HV_{0.2} microhardness data in Figure 5, no evidence of surface decarburization of the cemented pinion during consecutive Q&T heat treatment can be detected.

Figure 5. HV_{0.2} microhardness profiles of the case hardened layer in the wake of two distinct linear paths of a pinion shaft tooth flank containing a cyclone type defect.

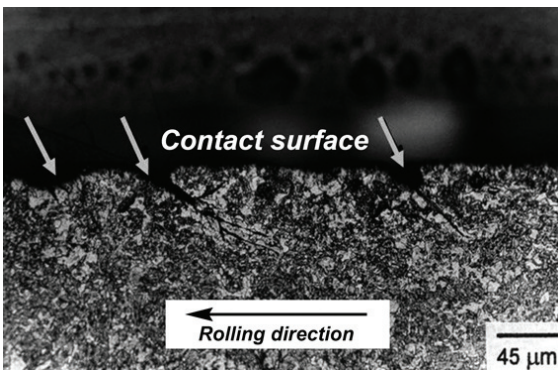
Figure 7 displays various pit morphologies developed on the pitch line surface of a case hardened pinion tooth. Note that fatigue cracks grow and branch out from the pit tips, although cracking remains restricted to the cemented layer due two main factors: (i) cracks face a much tougher microstructure in the pinion core, and (ii) driving force for crack growth due to the sum of rolling and sliding (shear) stresses decays rapidly towards the tooth core from the peak value attained elsewhere below the rotating component surface. This is especially true when a thicker than normal cemented layer is identified and measured, according to plotted data points in Figure 5. It can be assumed that the state of deterioration of the pinion surface when the Figure 7 image was captured is compatible with the degradation stage documented in Figure 3 for the tooth belonging to

Figure 7. Cross-section view of a pinion tooth showing several pits (indicated by arrows) from which fatigue cracks branch out towards the bulk microstructure during periodic contact with the counterpart gear tooth surface. Etched with Nital 2%.

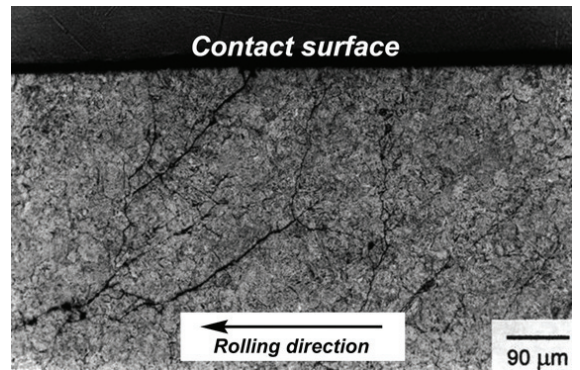
Figure 8 shows several subsurface cracks emerging from the pinion tooth surface, causing the release of fragments of the hardened case thus favoring the generation of cyclone type damage, as already depicted in both the Figures 2 and 4.

Figure 8. Emerging cracks in a slightly worn portion of the contact surface in the case hardened pinion tooth. Etched with Nital 2%.

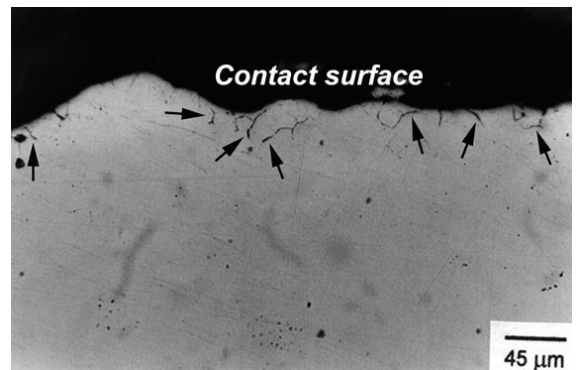
The micrograph in Figure 9 shows the examined tooth root where grain boundaries are quite visible due the presence of brittle films of metal oxides and/or Fe₃C. These constituents are potential sites for crack nucleation and offer preferential pathways for crack propagation.

Figure 9. Evidence of secondary phase(s) in prior austenite grain boundaries (i.e., martensite packet bounds) at the root region of a cemented pinion tooth, without chemical etching. An identical pattern was sometimes observed at the flank of other pinion teeth.

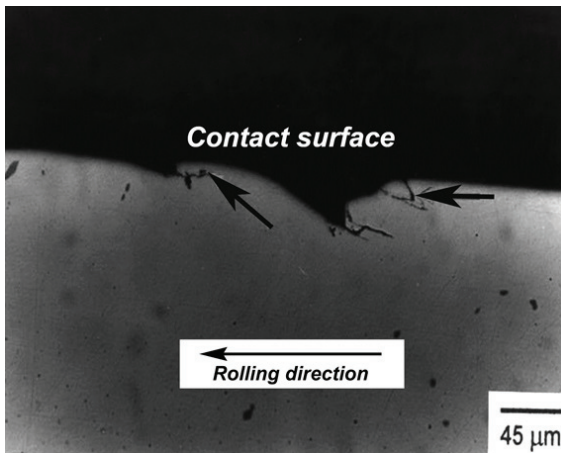
Figure 10 shows the role of the microstructure of the cemented steel layer, in terms of how the nature, content and spatial distribution of inclusions affect the removal rate of material from the pitch line in the pinion tooth. The left hand arrow shows a hard particle in the cemented layer, thus

Figure 10. Brittle particles at the surface of the cemented layer (indicated by arrows), which are about to be dislodged, resulting in pits and contact surface unevenness. No etching.

elucidating its role as stress concentrator favoring matrix cracking. The right hand arrow points out the detachment of a relatively massive case hardened fragment, hence leading to pitting (mass loss) and raising surface roughness of the rotating component.

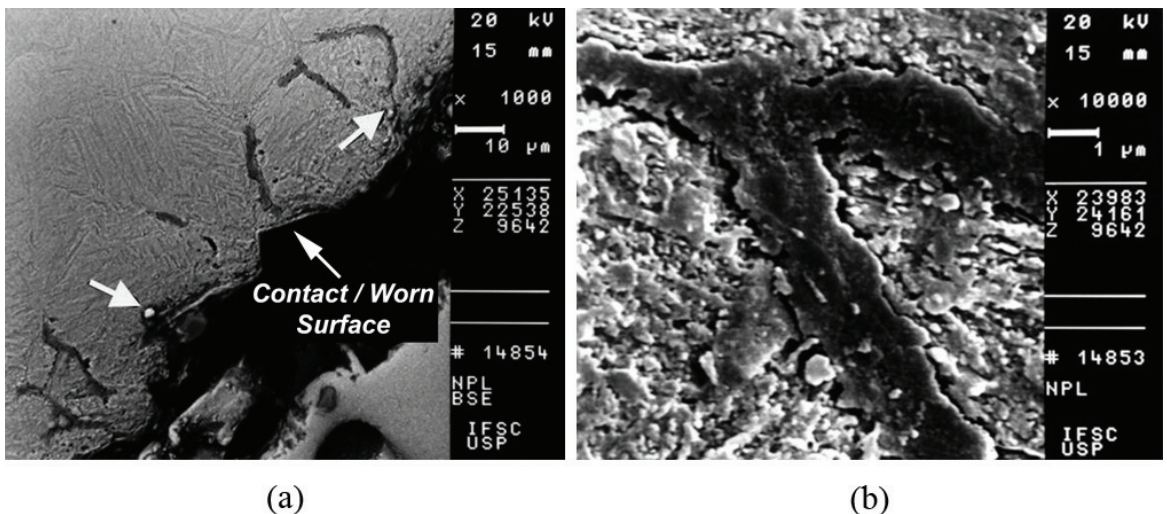
To complete the identification of microconstituents at grain boundaries in the tempered martensitic microstructure at the flanks of the failed pinion tooth, a SEM analysis in backscattered electron (BSE) mode was first performed of this particular region. Figure 11a confirms the presence of a secondary phase in-between neighboring martensitic packets (i.e., prior austenitic grains). SEM-BSE allows phases differentiation on the basis of their distinct densities, where lighter colors refer to higher densities and vice-versa.

As can be seen, the density of the vermicular phase located inside the packet or grain boundary network is much lower than that of the metallic matrix (SAE 8620 steel), thus reinforcing the hypothesis of a massive presence of cementite in that region. Figure 11b proves the existence of a continuous brittle film along the boundaries of the martensite (prior austenite) on the surface of the pinion's cemented layer. Energy dispersive X-ray microchemical analysis of intergranular and intermetallic phases seen in Figure 11 attested them as Fe₃C and CrNiMo microconstituents, respectively.

Figure 11. (a) Vermicular morphology of cementite phase at grain boundaries. The intermetallic particles indicated by arrows are much denser than those of an average steel matrix; (b) Detailed view of the continuous cementite film located at the grain boundaries. Etched with Nital 2%.

The surface contact fatigue process was therefore the failure mechanism of the part, notwithstanding the root cause of pinion failure was its misguided cementation process. Accordingly, a more detailed study should be conducted to improve the efficiency of this secondary manufacturing practice in terms of batch time, temperature and carbon content, to avoid problems in similar structural metallic components.
