Study of salt-induced changes in the Leptinito Gneiss of a column from the Mosteiro de São Bento in Rio de Janeiro, Brazil

CARLA C. FELIX, KÁTIA L. MANSUR & ROBERTO CARLOS C. RIBEIRO

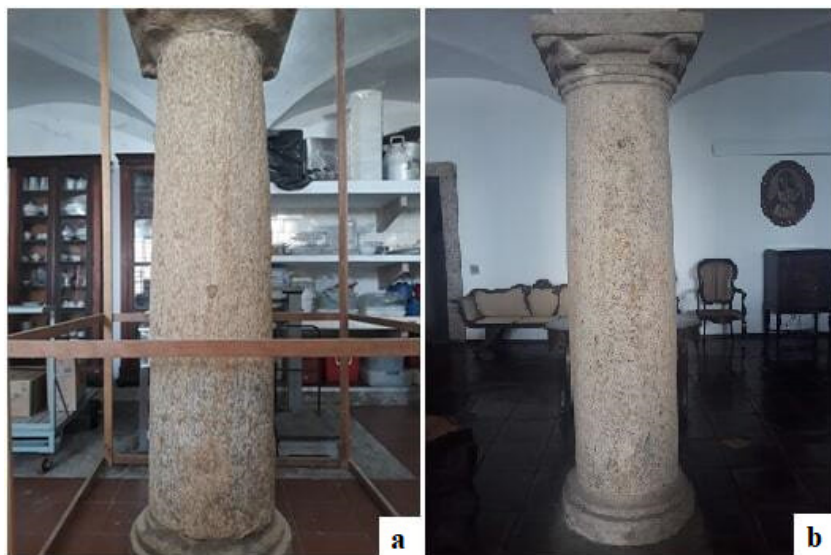
The study material is a column in Leptinito found in a storeroom immediately below the monastery kitchen (Figure 1a). This gneiss is composed mainly of quartz, feldspar, biotite, and garnet and is fine grained. The rock presents well-marked foliation which, in this piece, was in a vertical position, that is, perpendicular to the ground. The column is undergoing an accelerated degradation process, and the tests performed on its structure were also performed, for comparison purposes, on another column carved from intact Leptinito (Figure 1b).

The kitchen has been in operation for years and it was reported that, due to its constant washing, there have already been several leaks from the kitchen that have infiltrated the storeroom. The kitchen floor was only renovated in 2016 with the application of waterproofing. Previously, the floor was made of standard ceramic tiles. After the renovation, an asphalt blanket was applied, and the floor was covered with high-quality ceramic tiles appropriate for the type of use.

Figure 1. a: Column with accelerated alteration located in the deposit. b: More intact column located in the cloister.

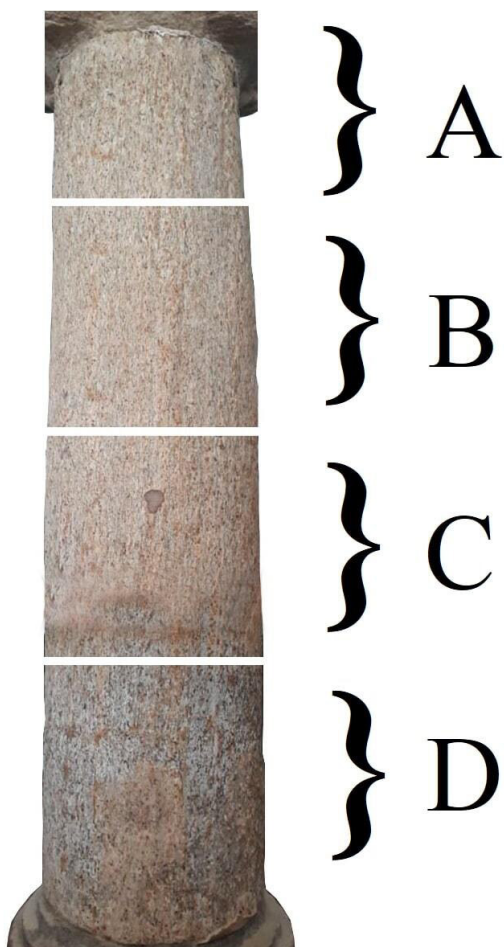
Figure 2. Altered column divided into four equal parts (“A”, “B”, “C”, and “D”).

Using a tape measure, the circumference of each part of the altered column was measured. At its top, part "A", a circumference of 1.51 meters was obtained. The middle parts, "B" and "C", had circumferences of 1.67 and 1.73 meters, respectively,

while at its base, “D”, the circumference was 1.58 meters. This result confirms that the middle portion of the column is more altered than the others, with crystallization of the halite causing internal expansion of the rock structure and, thus, a larger circumference in this part than in the top and bottom sections of the column.

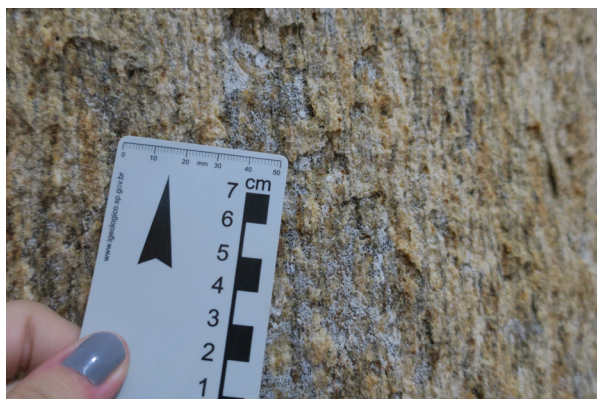
The alteration morphologies present in the altered column were identified and described based on the Illustrated Glossary on Stone Deterioration published by ICOMOS. Efflorescence can be observed on the entire surface of the rock (Figure 3).

Figure 3. Occurrence of efflorescence. Accumulation of poorly coherent salt crystals on the gneiss surface.

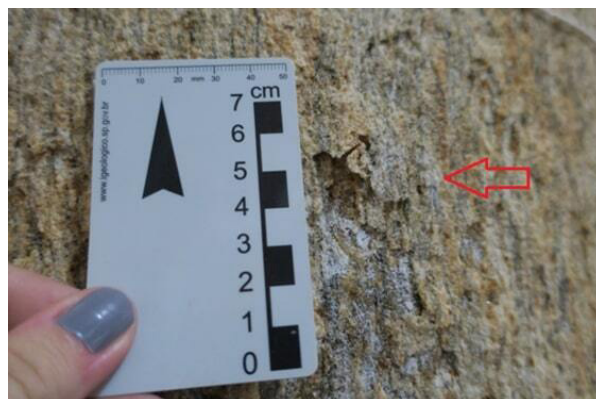
The gneiss presents granular disaggregation, which happens when the grains detach from the rock matrix, and this is confirmed through collection of the disaggregated material. It is also possible to observe the blistering that is occurring around the entire column along with the granular disaggregation (Figure 4). Both morphologies are consequences of saline efflorescence.

Figure 4. Millimeter-order blistering indicated by the red arrow.

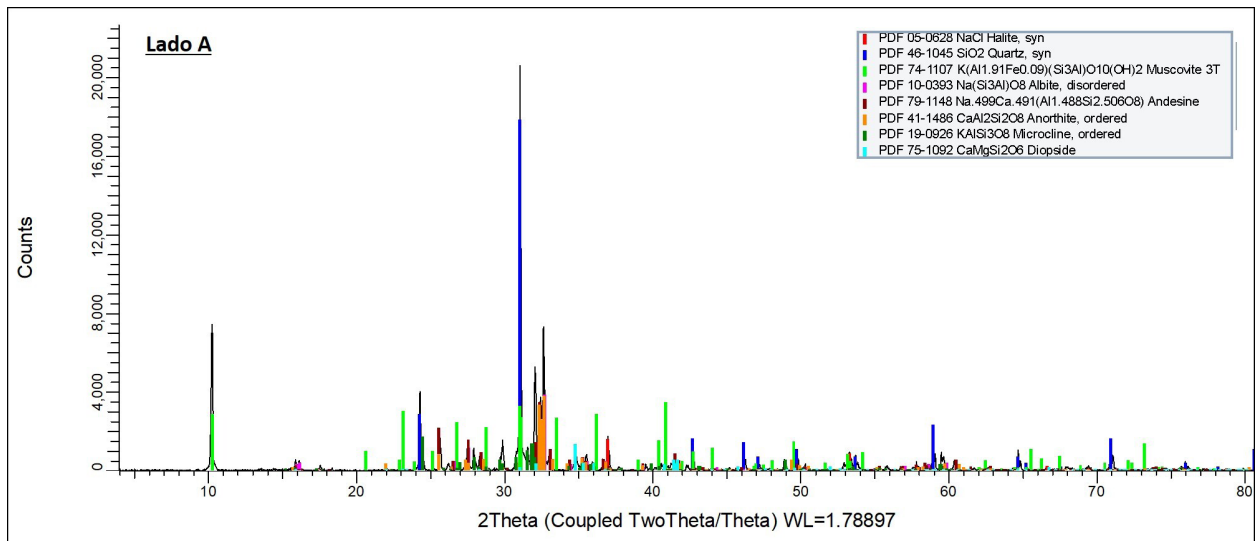
Figures 5 and 6 present the diffractograms (the result of the mineralogical characterization) of fragments from the altered column, with and without the presence of efflorescence, respectively.

Figure 5. Diffractogram of a point in the gneiss where efflorescence is present.

A predominance of halite can be seen on both diffractograms, indicating that this is the salt responsible for the efflorescence in the column, generating rock disaggregation and decreasing its mechanical resistance.

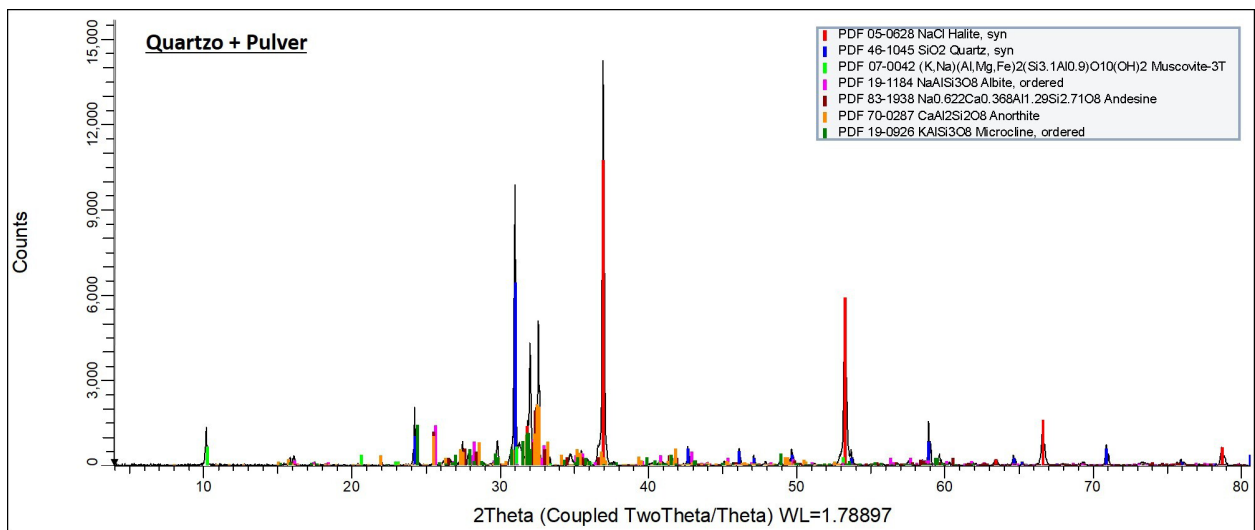
Figure 6. Diffractogram of a point of the gneiss without the presence of efflorescence.
