Failure of Stainless Steel Welds Due to Microstructural Damage Prevented by In Situ Metallography

Abstract: In stainless steels, microstructural damage is caused by precipitation of chromium carbides or sigma phase. These microconstituents are detrimental in stainless steel welds because they lead to weld decay. Nevertheless, they are prone to appear in the heat affected zone (HAZ) microstructure of stainless steel welds. This is particularly important for repairs of industrial components made of austenitic stainless steel. Non-destructive metallography can be applied in welding repairs of AISI 304 stainless steel components where it is difficult to ensure that no detrimental phase is present in the HAZ microstructure. The need of microstructural inspection in repairs of AISI 304 is caused because it is not possible to manufacture coupons for destructive metallography, with which the microstructure can be analyzed. In this work, it is proposed to apply in situ metallography as non-destructive testing in order to identify microstructural damage in the microstructure of AISI 304 stainless steel welds. The results of this study showed that the external surface micrographs of the weld

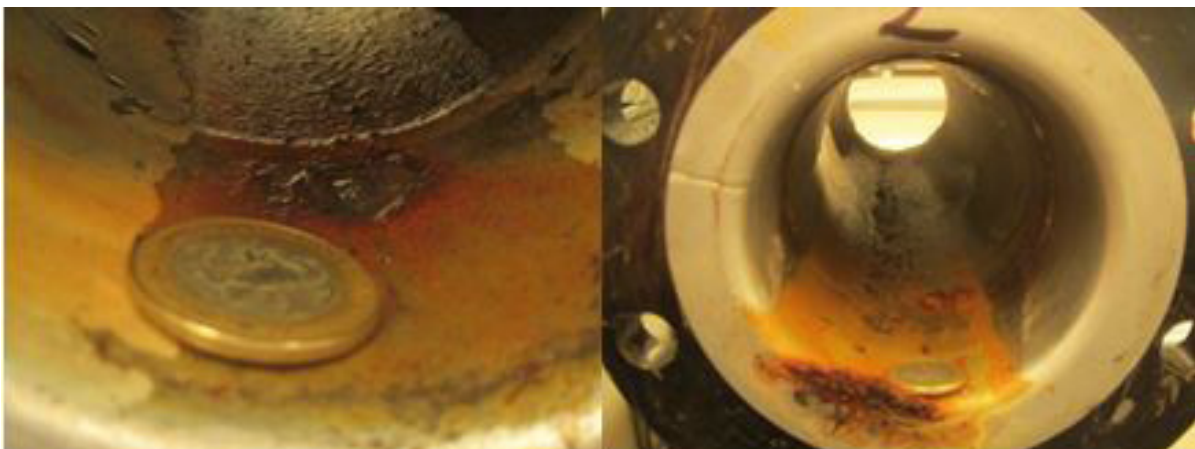
In order to make clear the necessity of monitoring the state of the microstructure in stainless steel weldments, especially in the HAZ; the following case is shown because it illustrates the need for in situ metallography stainless steel welded joints. With this case it is demonstrated that this type of failure can happen after the welding process. In this case, chiller tubes made of AISI 304 austenitic stainless steel were welded and after it they were tested with the pressure test using common tap water. After a few days, those tubes showed leakages in areas adjacent to the weld. In the inner surface of the tubes was evidence of reddish corrosion products as seen in the Figure 1.

Figure 1. Damaged tubes of chiller under analysis. It is seen evidence of reddish corrosion products.

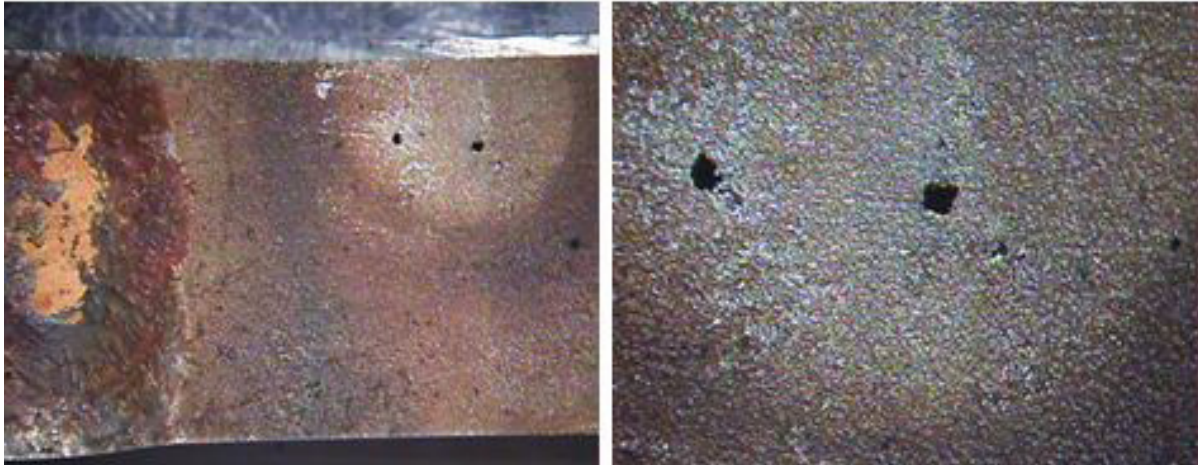
Figure 2 shows the failed tube where conventional metallographic inspections were carried out. In the same way, Figures 3A and 3B show the microstructure with corrosion damage, where metallic carbides and sigma phase are precipitated in the HAZ of this stainless steel weldment [9-13].

Pitting in the HAZ as well as a microstructure in this region with sigma phase and metallic carbides indicated that these microconstituents in conjunction with the chlorine and sulfur of the tap water, which was housed inside this tube, caused the leakages due to corrosion. In literature, as in this case, it has been demonstrated that failures in stainless steel weldments are related to corrosion in the HAZ and they are referred as "weld decay".

Figure 2. Internal surface of the damaged tubes after cleaning. There can be seen corrosion pitting near the weld metal.

In this case, in situ metallography could be applied in welding stainless steel to determine the microstructural integrity of welded joints of stainless steel and to avoid the failure of the component.

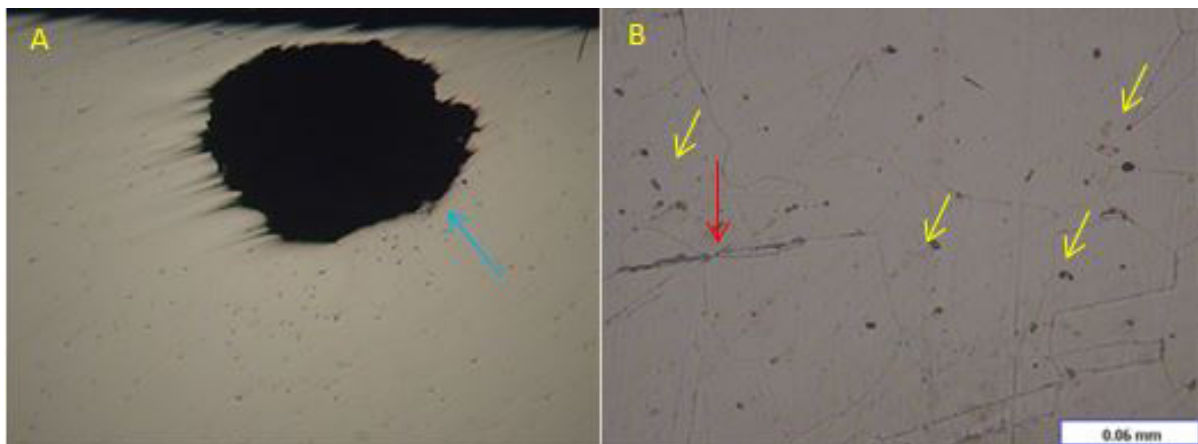
Figure 3. A - Image at 100x of a cavity produced due to corrosion (blue arrow). B - Microstructure in the HAZ of the welding at 500X. Twined grains with sigma phase (red arrow) and metallic carbides (yellow arrow) are seen.

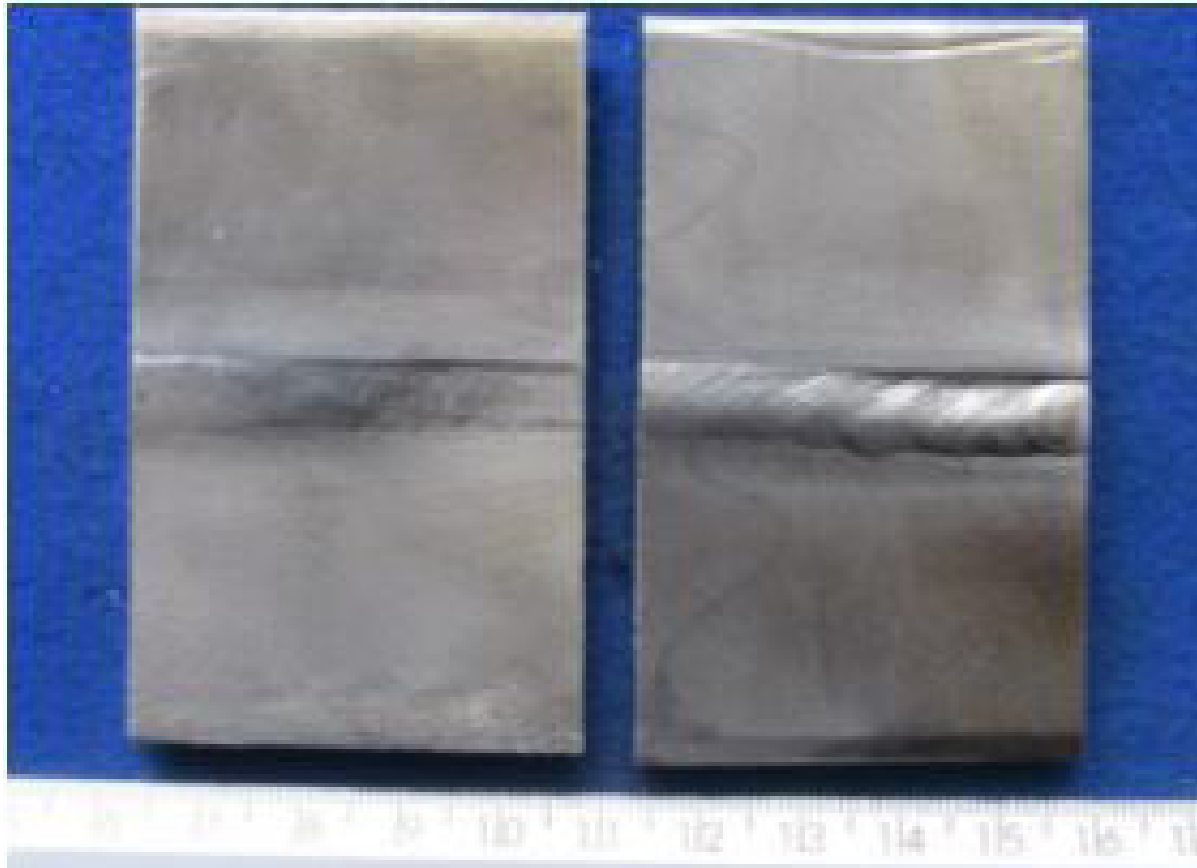
The specimens were inspected through magnifying glasses to determine its surface condition and the general characteristics of the discontinuities exhibited on the weld seam of the 4 specimens. As it is shown in Figure 5 no discontinuities welding as undercuts, arc strikes, splashes or other type of discontinuities were observed.

Figure 5. Visual testing of the welded joints after GTAW process.

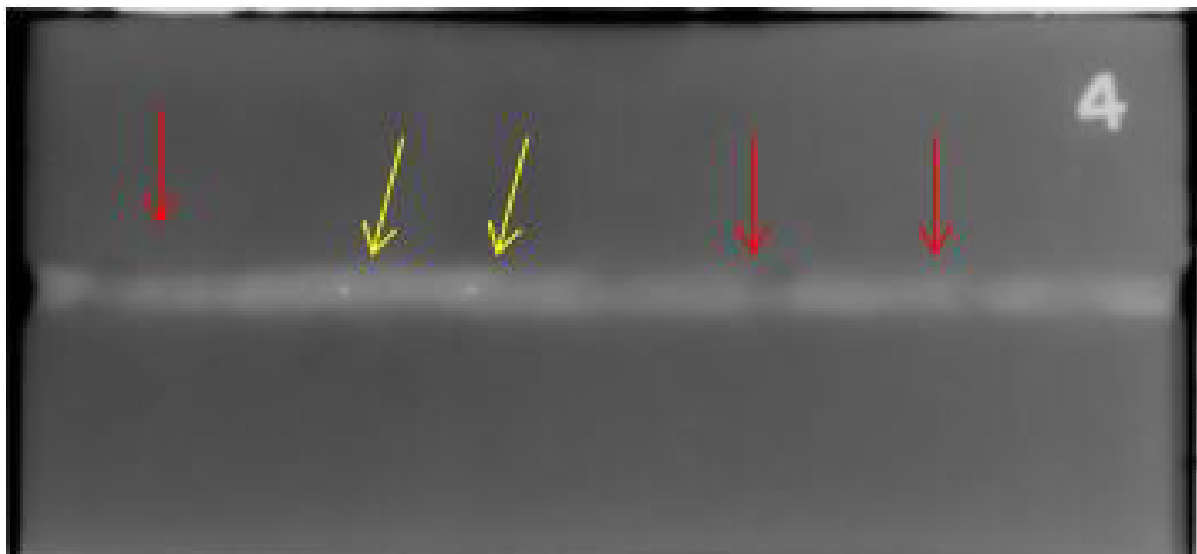
The welded specimens were inspected through visual testing and X-ray radiography. The equipment was a V tube X-IT, and the conditions were: 175kV power, current of 5 mA, 40 cm and with an exposure time of 60 sec. Figure 6 shows discontinuities such as: Tungsten inclusions (yellow arrows) and lack of fusion (red arrows) that were found in one of the welded samples.

Figure 6. Results of the X-ray radiography of one welded joint for repairing.

The welding repairs were carried out selecting the area of interest and then this area of the welded specimen was grinded by abrasive silicon carbide disc. After that, they were grinded for repairing in the locations that the nondestructive testing showed evidence of indication. The specimens were welded through manual GTAW process. One example of the repairs is shown in Figure 7. The welding conditions were: ER 309L electrode with a wire diameter $\phi = 1/32$ as filler metal, a Syncrowave 350Lx Miller welding machine; and welding current around 70A.

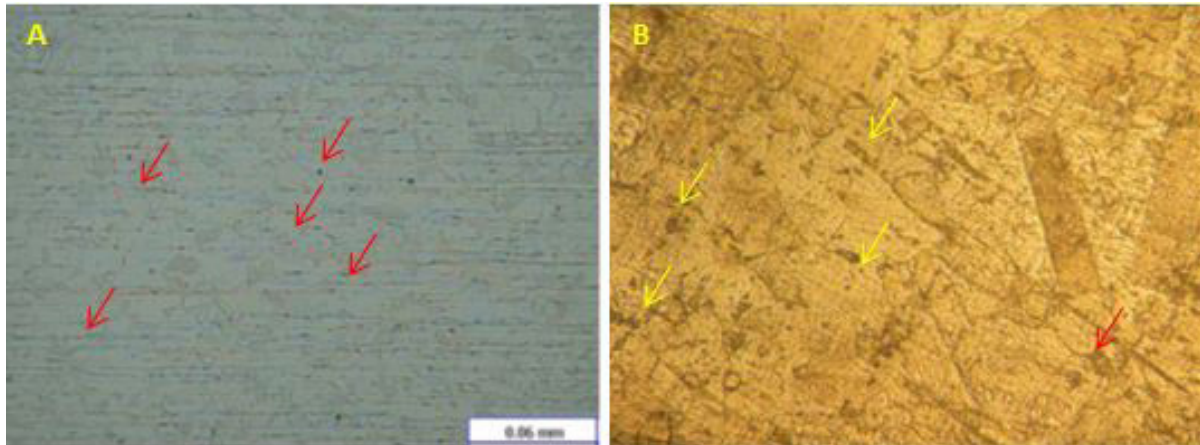
The microstructure of the base material “as delivery” was revealed applying in conventional metallography (Figure 8A) and in situ metallography (Figure 8B). The microstructure of the stainless steel AISI 304 showed a highly sensitized twinned structure, because there was evidence of chromium carbides precipitated along bands in the direction of cold rolling process. In both cases metallic carbides precipitates in the twinned grains area seen. These microconstituents indicated that the base material must be heat treated in order to dissolve the chromium carbides to prevent failures. Both microstructures showed the same characteristics even when each samples were observed in different planes and they were revealed by different etching methods. These facts indicated that in situ metallography can be applied to identify the metallurgical state of the base material.

Nevertheless, they are differences between the microstructures showed previously; for instance, no evidence of banding can be seen with the in situ metallography. This can be explained by the fact that the microstructure revealed though in situ metallography on the HAZ laid on the perpendicular plane to the thickness of the plate, which is the external surface of the material base. AISI 304 stainless steel with a microstructure that shows precipitated metallic carbides should not be welded because the heat input will make susceptible the material to corrosion. So then, after performing the solution heat treatment, the microstructure must consist on twinned grains with a low amount of metallic carbides, especially those related to TiC and MoC [3,4,8,10,11].

Figure 8. A - Microstructure at 200x shows the microstructure of the base material prepared by conventional metallography. B - Microstructure at 200x shows the microstructure of the base material prepared by in situ metallography.

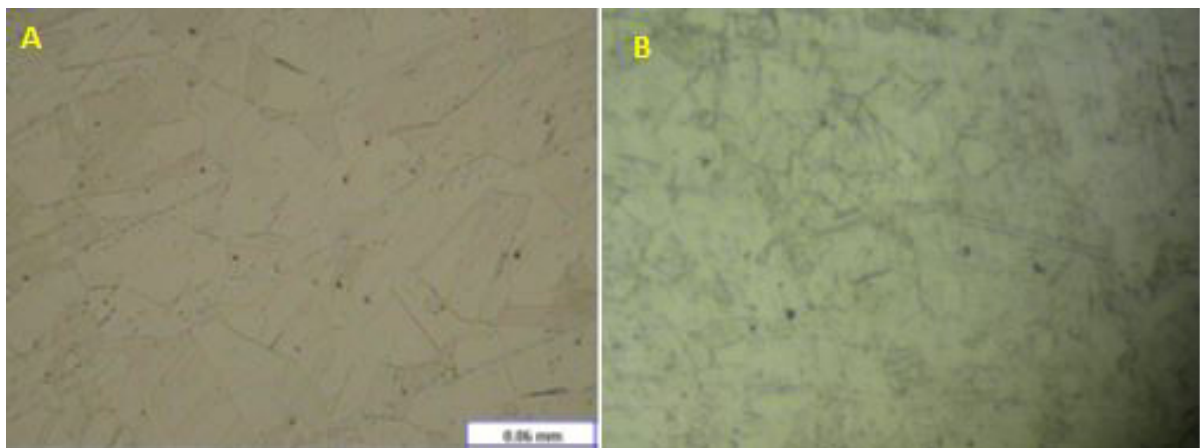
Figures 9A and 9B show the microstructures of the base material after heat treatment. In this case, both microstructures are comparable to each other and both of them showed qualitative evidence of a reduction in the amount of metallic carbides and grain growth, which indicates that solution heat treatment was successful and the risk of weld decay was reduced.

Figure 9. A - Microstructure at 200x of the base material subsequent to solution treatment carbides prepared by conventional metallographic. B - Microstructure at 200x revealed through in situ metallographic of the AISI 304 stainless steel after being subjected to a solution treatment of carbides.

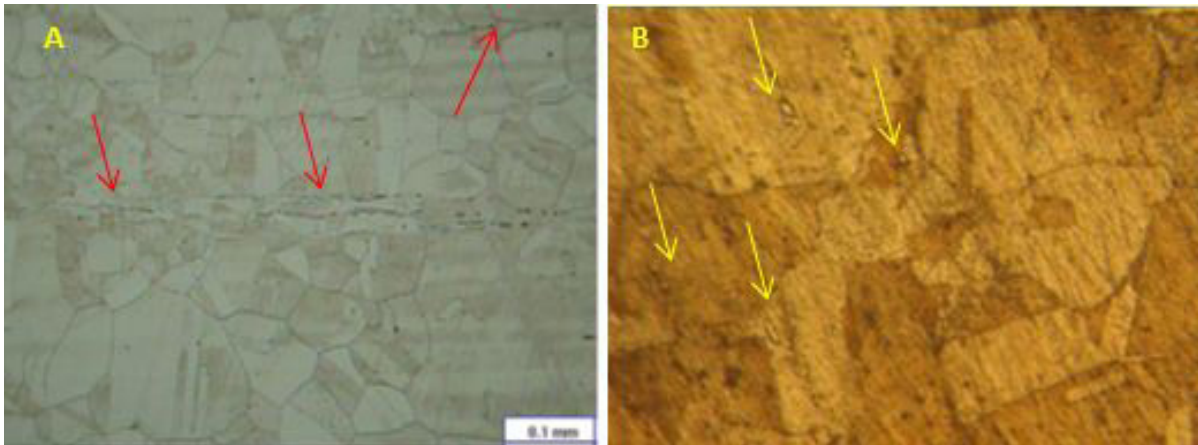
In Figures 10A and 10B, the microstructure in the HAZ of the one specimen after automatized welding is seen. Those micrographs evidences that both techniques, conventional metallography and in situ metallography, are able to show metallic carbides and sigma phase precipitated in the microstructure. However, conventional metallography is able to demonstrate that the sigma phase is mainly located in the middle of the specimen's thickness. This fact explains the reason of the low amount of sigma phase in the microstructure revealed though

Figure 10. A - Microstructure at 200x revealed through conventional metallography. B - Microstructure at 200x revealed through in situ metallography. Both microstructures show evidence of sigma phase and grain growth.

in situ metallography. In other words, the external surface of the specimen, where the in situ metallography was carried out, contains a lower amount of sigma phase.

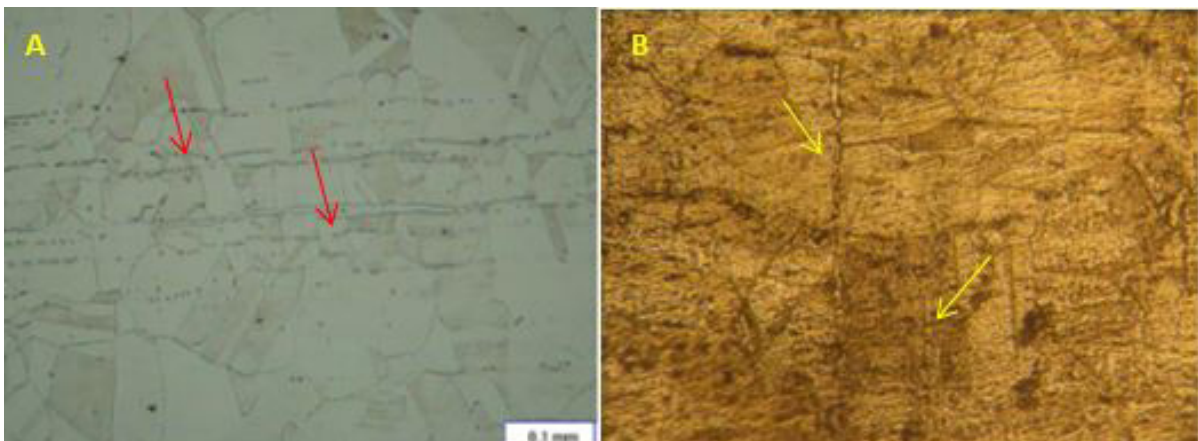
In Figures 11A and 11B, the microstructure in the HAZ of one of the specimens after welding repair is seen. The microstructure revealed through conventional metallography shows a higher amount of sigma phase than in the microstructure of the automatized welding. This fact indicated that the heat input of the welding repair increased the precipitation of this phase, which is detrimental for AISI 304 stainless steel.

In literature it has been probed that sigma phase caused sensitization of the passive layer, which induces corrosion in the material [3,8-10]. Moreover, this phase is brittle; so then, microstructures of this type stainless with sigma phase under cyclic loads will be susceptible to fatigue cracking. The fact that in situ metallography is capable to show the existence of sigma phase, grain growth, and precipitated metallic carbides probes that this technique can be applied for revealing metallurgical damage in welded stainless steel. This is especially important in case of welding repairs.
