## Geotechnical behavior of gravity dams built on sedimentary rocks: pore pressures and deformations analysis of Dona Francisca HPP foundation

Behavior of concrete gravity dam  
Sedimentary rocks foundation  
Pore pressure and deformation analysis  
Dona Francisca HPP case study

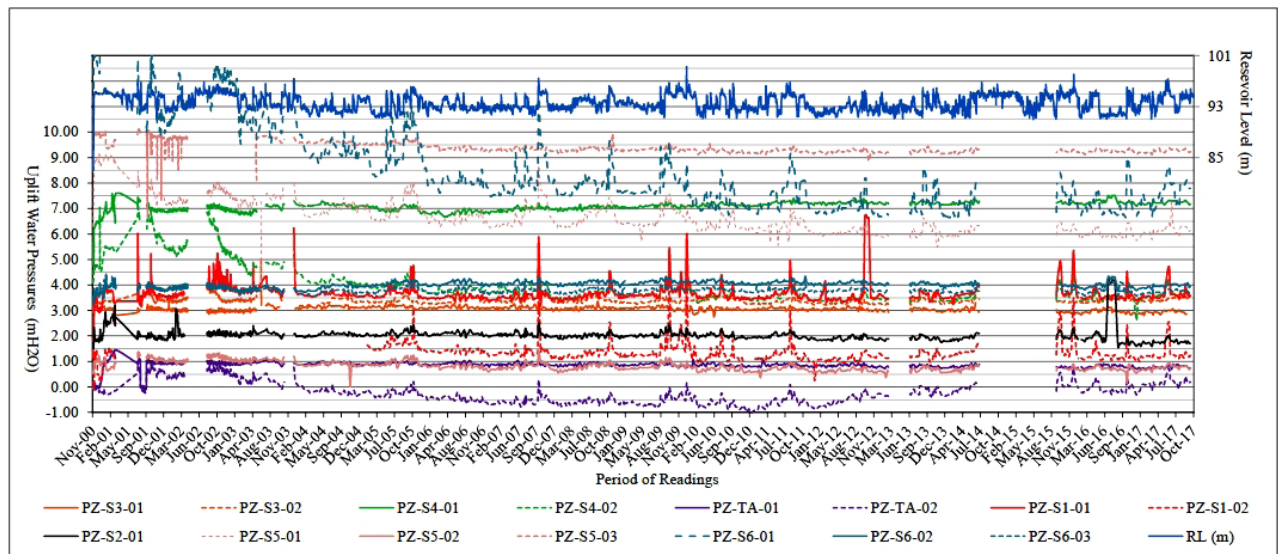
From the graph in Figure 8, it is highlighted that the highest pressures currently tend to be registered in *VWP*

Figure 8. Variation of uplift pressures in the inspection gallery *VWP*.

PZ-S5-03 and PZ-S6-03, both facing upstream, and it is also observed that under normal operating conditions there is an uplift pressures oscillation trend as a reservoir level upstream (RL) function. The uplift pressures observed in the stilling basin piezometers (Figure 9) present the same order of magnitude and increased until mid-2009. From then on, their records stabilized between 1.5 and 3.0 m H<sub>2</sub>O.

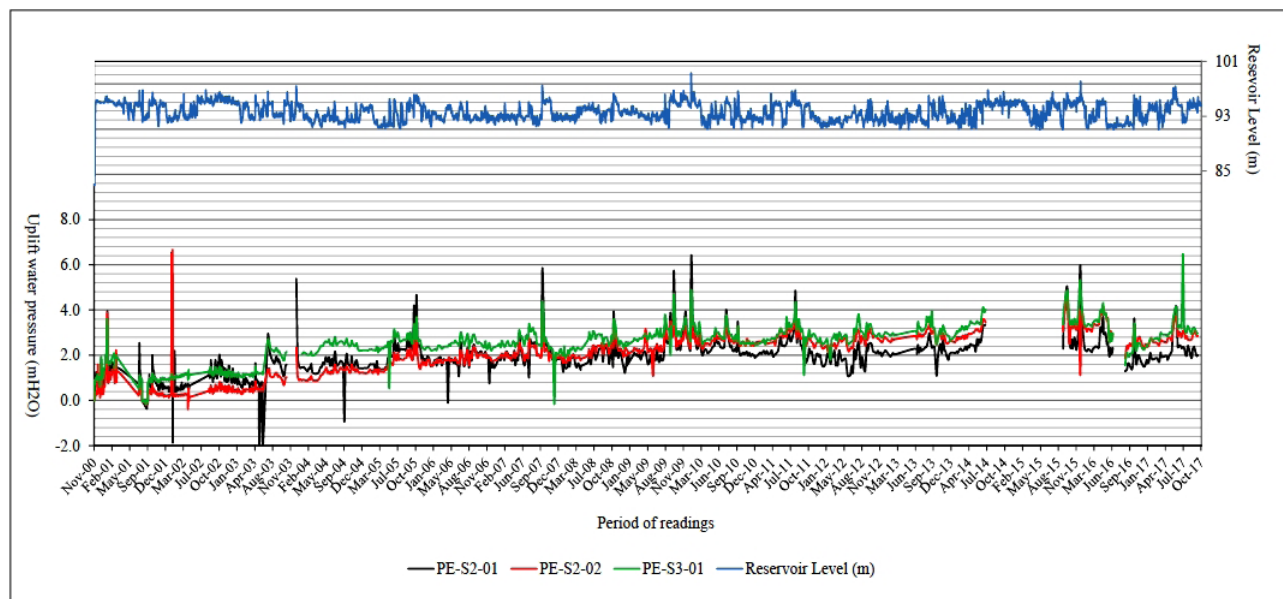
Figure 9. Variation of uplift pressures in the stilling basin *VWP*.

It is interesting to observe how quickly the system responds. In July 2016, during a maintenance procedure to carry out an inspection of the stilling basin, the pumping system of well N. 02 – located on the spillway – was shut down for a few days. The flows that discharged in well N.02 were

diverted to well N. 01. As a result, there was an increase in the water level inside well No. 2 and the uplift pressures in this region increased immediately after the pumps were turned off. On this occasion, several piezometers reached their historic maximums.

In the region of the stilling basin, the PE-S2-01, PE-S2-02 and PE-S3-01 *VWP* present uplift pressures in the same order of magnitude. Considering the trend of stability of these *VWP* readings, it is possible to infer that the uplift pressure conditions in the stilling basin region were always within the expected behavior, except when the well drainage pump No. 2 was turned off. Unfortunately, the control or limits values for these *VWP* were not estimated in design phase so that some comparison could be made with the database.

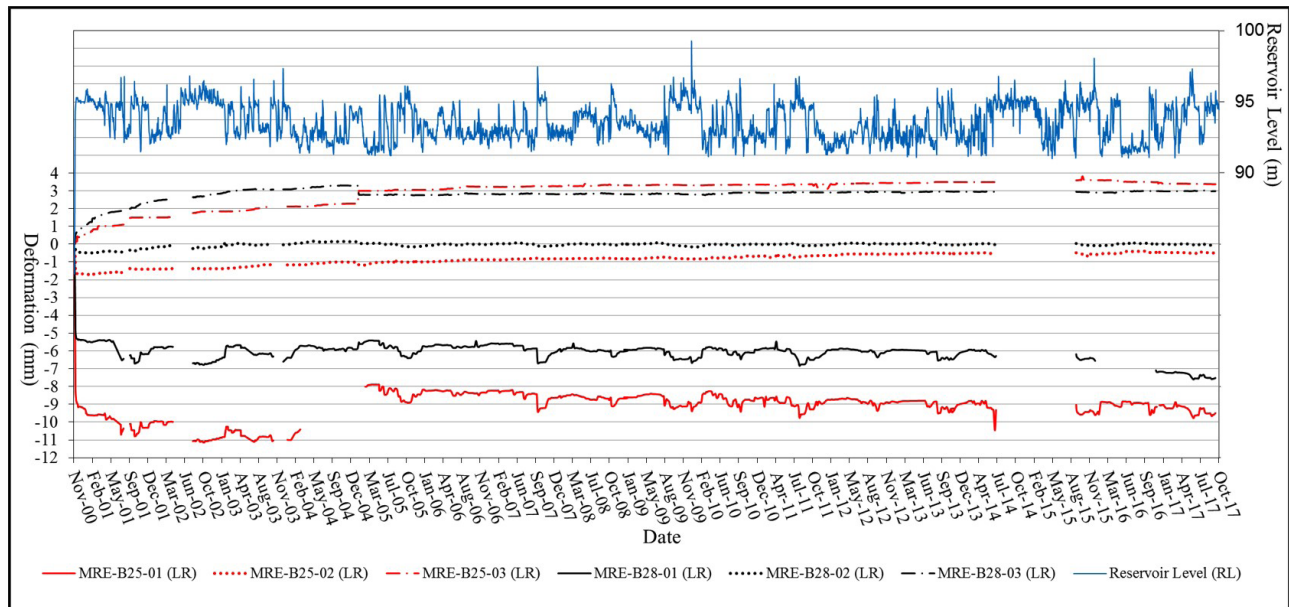
**Figure 10.** Total deformation recorded from the *MREs* long rods placed in the B25 and B28 blocks.

Analyzing the previous graphs from Figure 10 and Figure 11 and the data presented in Table 3, it is observed that the process of settlement of the rocky massif was more intense in the first 5 years of dam operation. From that period on, although the deformations continued to occur, mainly in the deeper layers of the foundation, it was observed that it took place in a lower rate. At the end of 17 years of

monitoring, it is possible to notice the tendency of a final stage of stabilization of the rocky massif. The experience reported by some authors – mainly regarding dams on basaltic massifs – shows that these long-term or slow deformations can occur in periods superior to 20 years after reservoir filling – such as the cases of Itaipu and São Simão – Brazilian dams presented in Silveira (2003).

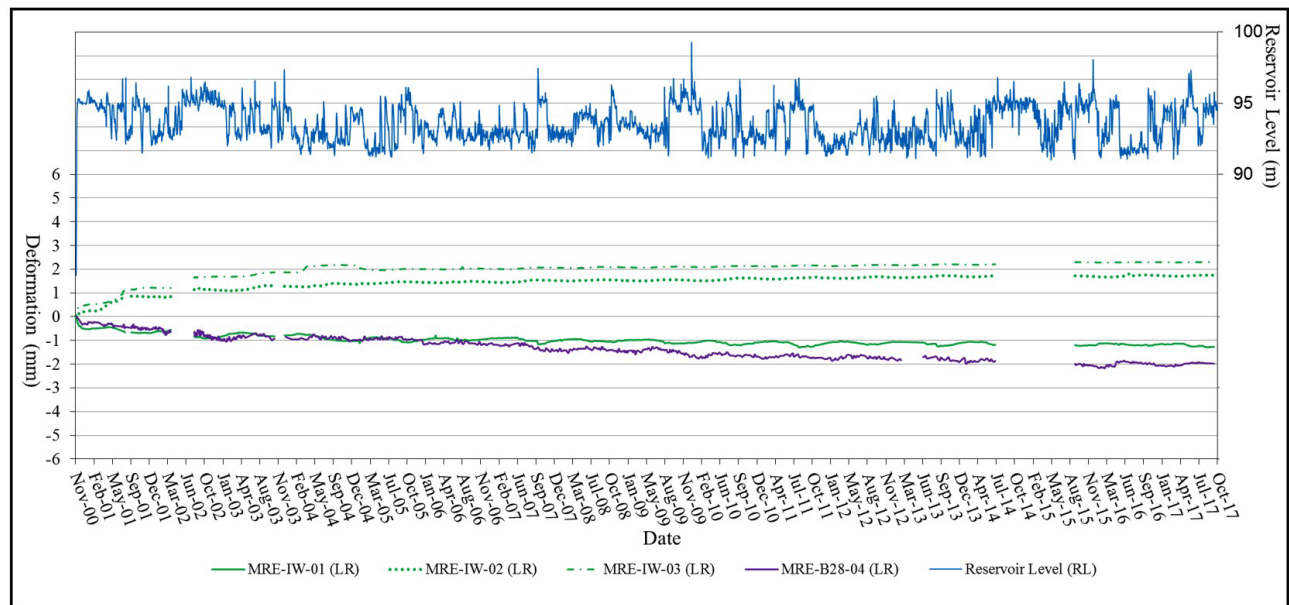
Through the analysis of deformation data of the foundation, acquired from the extensometers positioned in the *IW* block and shown in the graphs of Figure 11, it is possible to verify that the magnitudes of the records are lower to those found in the blocks of the spillway region (B25) and left abutment (B28). The reason for this behavior is that the foundation at the *IW* block region is composed of basaltic rocks which present lower deformability in comparison to the sedimentary rocks which are predominant in other

**Figure 11.** Total deformation recorded from the *MREs* long rods placed in the IW block.

regions of the dam. In general, the deformation data of the Dona Francisca dam foundation are consistent in terms of expected behavior.

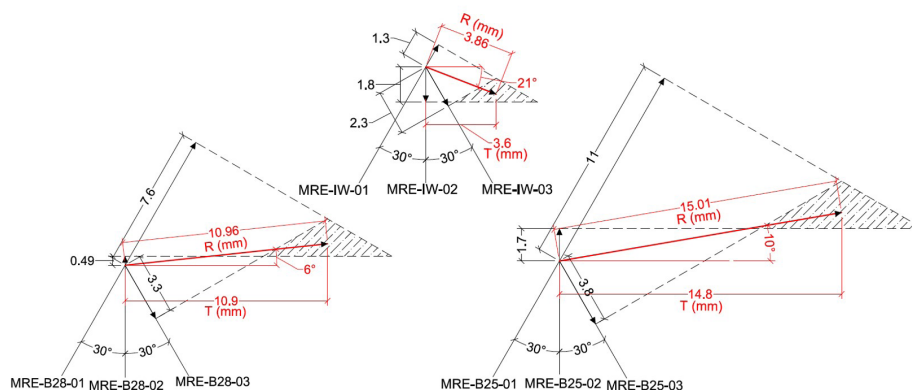
**Figure 12.** Resulting maximum deformation (*R*) and horizontal displacement (*T*) in the dam base.

The Figure 12 presents the vector calculations of the resulting maximum deformation (*R*) and horizontal displacement (*T*) of the Dona Francisca HPP dam base, from the maximum deformations recorded by the *MREs* rosettes installed in blocks IW, B28 and B25.

According to Silveira (2003), since the lower anchoring points of the extensometers are in an absolute reference, calculating a composition of the distension or compression recorded by the three *MREs* (long rods) results in a triangle and not a point. For the calculation of the resulting deformation, this same author recommends the determination of the geometric center of a triangle formed by the intersection of the three bisectors of the projected vectors. From the vector calculations presented, it is possible to estimate that the resultant deformations ( $R$ ) and the horizontal displacement ( $T$ ) at the dam base in the spillway region were of the order of 10.0 to 15.0 mm – higher than that one verified for the intake works region, whose value was approximately 4.0 mm.
