Judgement in geotechnical engineering practice

José António Mateus de Brito^{1#}

Lecture

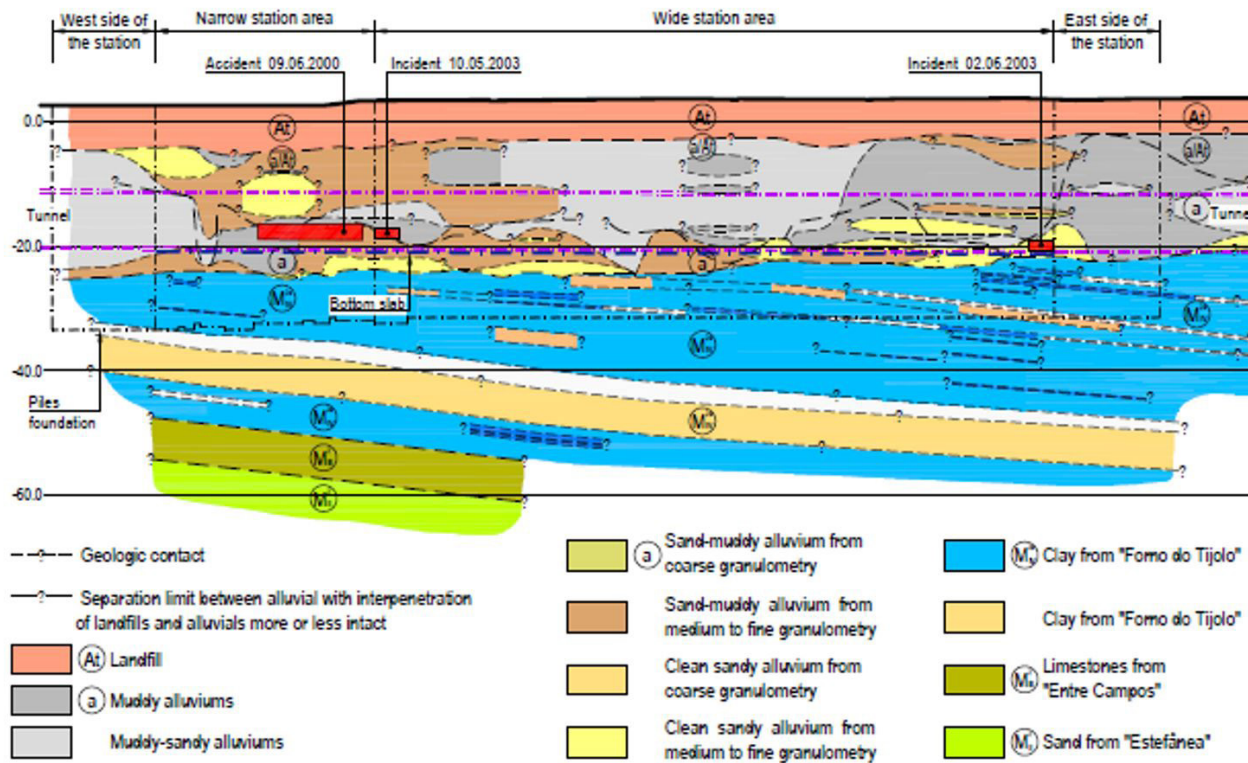
It can be seen in Figure 6 that around the zone of the tunnel accident and in incident areas of the station, there are soft clays and small layers of clean sands of medium to fine grain size.

Figure 6. Longitudinal geological profile corresponding to the north side of the tunnel and the station with the location of the tunnel accident and the station incidents (Brito & Fernandes, 2006a).

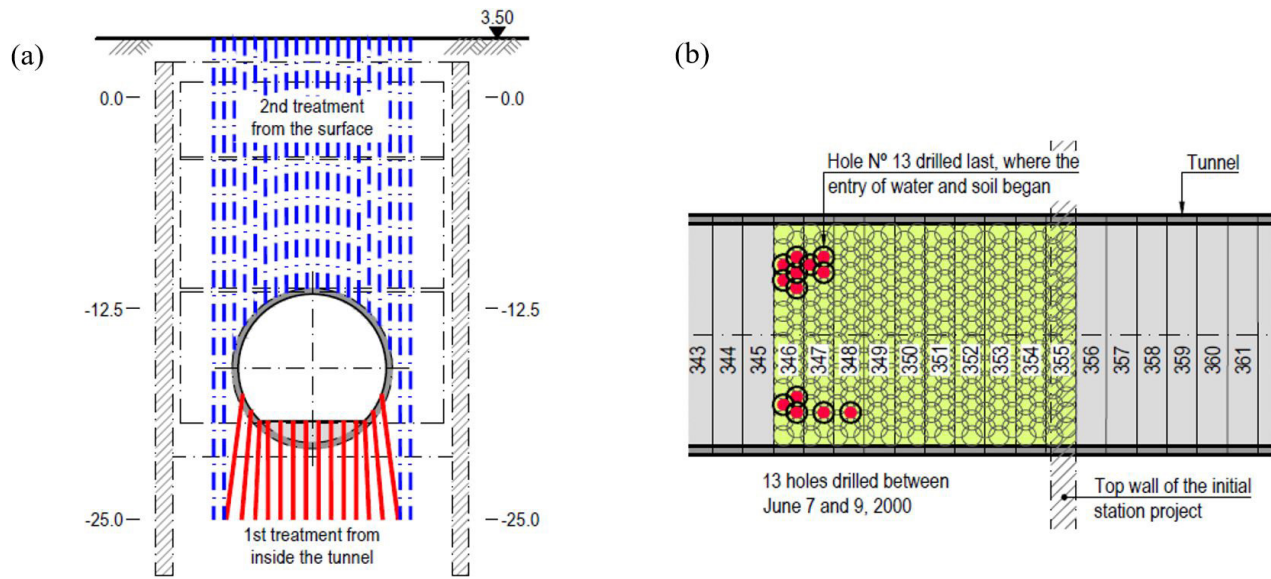
Initially 13 holes with 152 mm diameter were drilled to allow the subsequent execution of jet grouting, but water and soil entered the last hole drilled. Meanwhile, water and soil began to appear in another two holes, and the site was abandoned by the staff. In four hours, there were signs of structural damage and water entering through the lining joints of the tunnel. Simultaneously with the entry of water and soil, settlements and cracking occurred in front of the tower of the Finance Ministry building (Salgado, 2014).

Figure 7. (a) Execution phases of the jet grouting columns of the west portal; (b) Location plan of the columns to be executed from inside the tunnel and the holes executed before the incident occurred (adapted from Ferconsult, 2001).

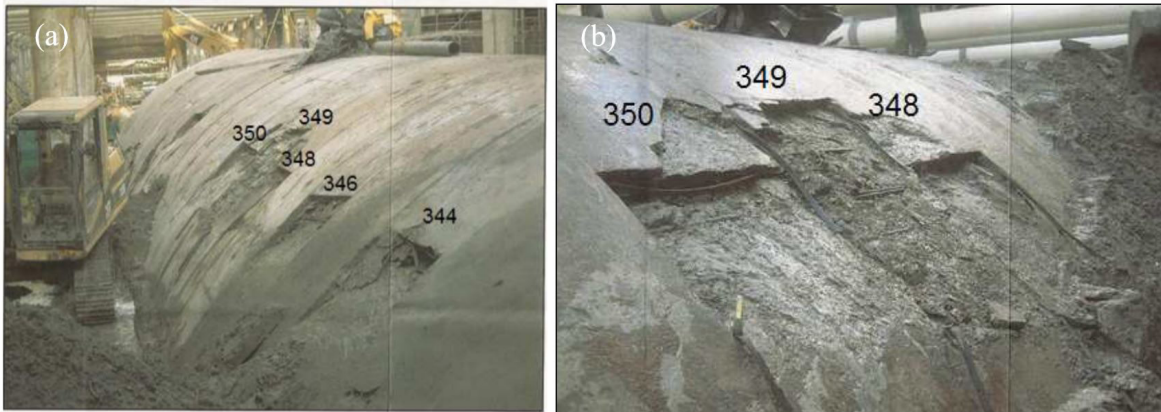
Figure 8. Views from the east and west sides of the lining segments 344 to 350 of the extrados of the north side of the tunnel (Salgado, 2014).

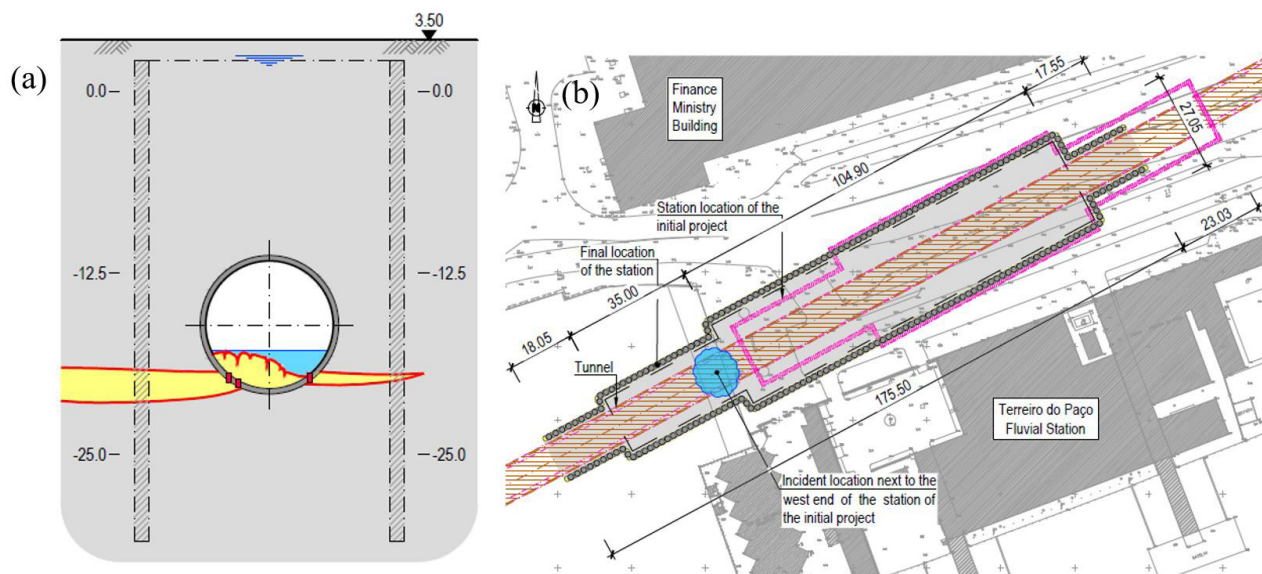
The cause of this accident was the inability of the sandy soils to resist the high hydraulic gradients occurred in some of the holes drilled in the tunnel, thus initiating a process of static liquefaction with the consequent entry of water and soil into the tunnel, as schematically represented in Figure 9 a.

Figure 9. (a) Schematic section of the water and soil entrance into the tunnel (Ferconsult, 2012); (b) Location of the stations of the initial and final project and the accident area (Ferconsult & Metropolitano de Lisboa, 2011).

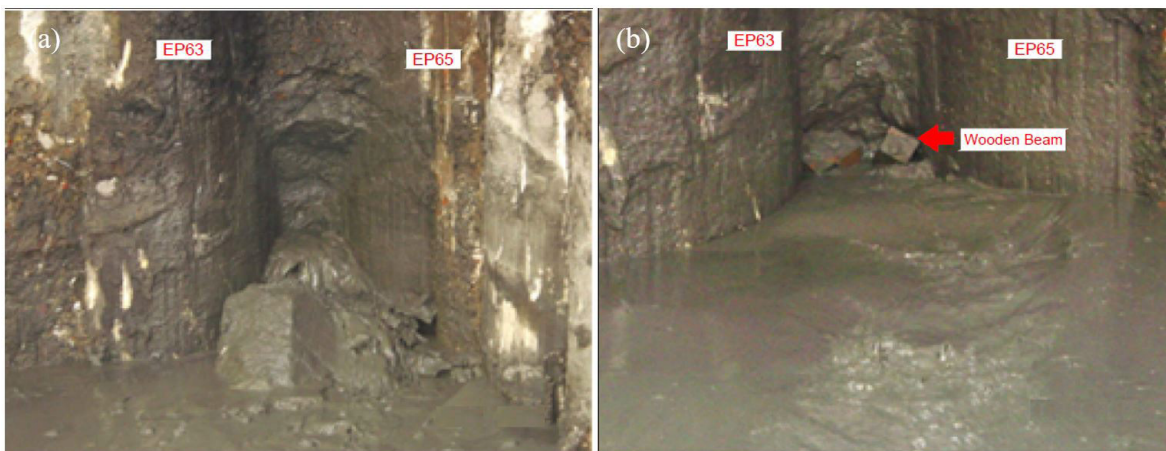
in the re-entrant corner on the north side coinciding with the axis 5. At that time, the base of the excavation was at the level of the working platform foreseen for the installation of the 5th level of struts (between about the levels -18.00 m and -19.00 m) and the water inlet and drag of material occurred at approximately the level -19.00 m. At that level, outside the area adjacent to the curtain, the soils were constituted by sandy-clay alluvial deposits with a slightly thick passage of clean sandy alluvial deposits over the Miocene substrate. As can be seen in Figure 21a and b, the entry of water and alluvial soil into the excavation occurred more significantly when the soil between the EP63 and EP65 primary piles was excavated. This terrain, during the excavation with the backhoe bucket and the progressive inflow of water from outside, collapsed by “blocks” of sandy-clay alluvial deposits, clearly showing the distance between those primary piles. Figure 21 a show the opening filled with alluvial deposits, and it is not possible to see the secondary corner pile (ES65), which, if it were in its correct position, would be visible. Figure 21b highlights this fact, since it was possible to insert a wooden beam to a certain depth (at least 0.50 m) beyond the visible soils face between piles.

- Settlements and cracks in the surface in the vicinity of north corner 5 in front of the tower of the Finance Ministry building; these settlements evolved rapidly and covered an area of about 500 m² with visible subsidence and radiating from the point of entry of water and material into the excavation; the settlements tended to stabilise quickly after the entry of water and alluvial soils was eliminated;
- The maximum settlement registered on the surface was 28 mm on a mark located 25 m from corner 5; a settlement of 5 mm was registered in the tower;
- Two piezometers, with the chambers in the alluvial sand layer at levels -18.50 m and -18.00 m, (at distances from the corner concerned of 8 m and 40 m, respectively) showed a drastic reduction in pressure of 12 m and 7 m respectively; the water pressures returned to normal values, when the entry of water started to be controlled;

Figure 21. (a) Initial phase of water inflow and dragging of sandy-muddy alluvial deposits in the north corner 5; (b) Most significant water inflow and alluvial deposits shortly after the start of the incident.

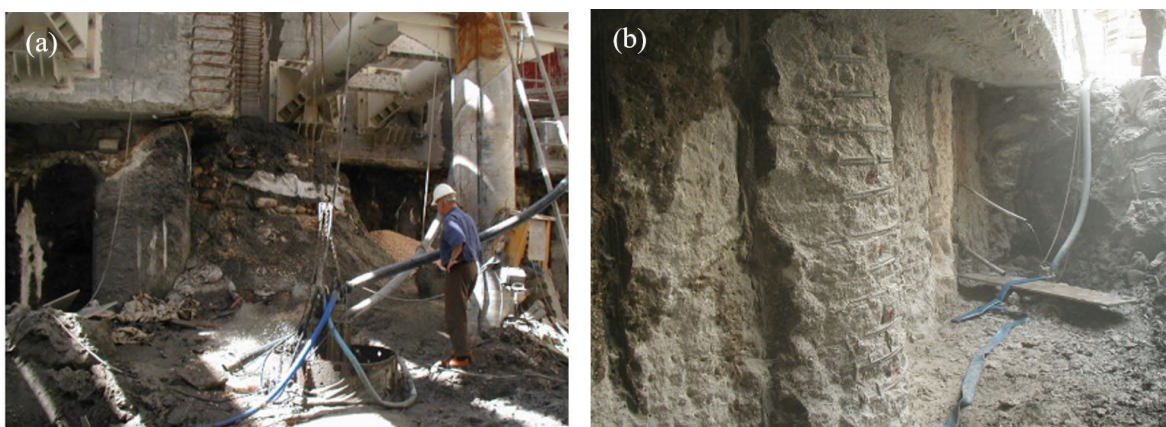
Figure 22. (a) Plug of sand bags, cement and concrete bags, about 3 m high; (b) Retaining piles from the narrow area on the north side between axes 3 and 5 after excavation up to the level -20.00 m, plug of sand bags and the underside of the lining wall at the level -18.20 m.

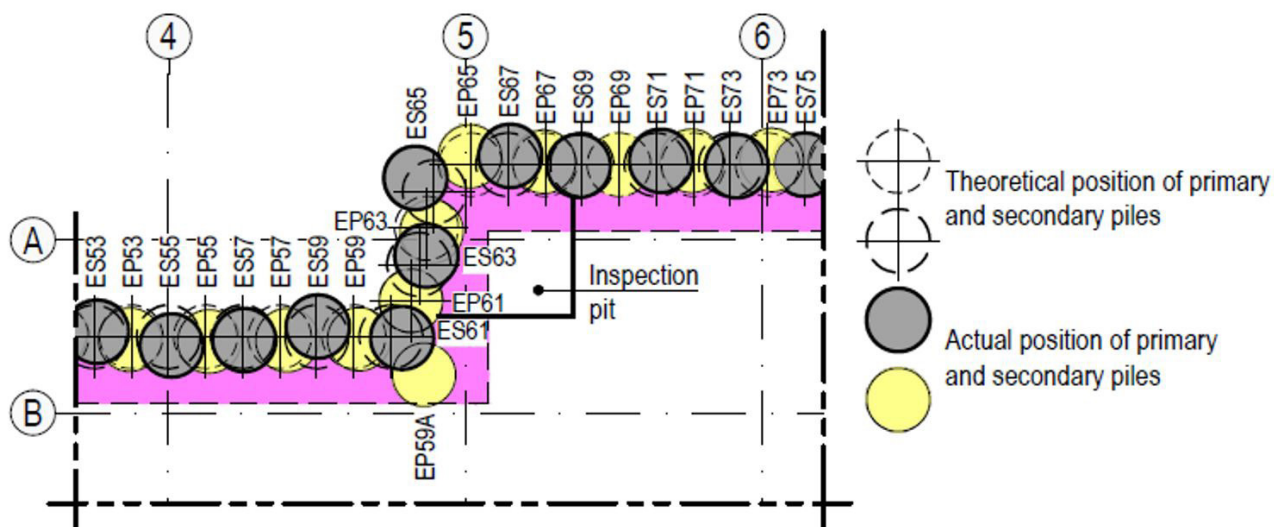
At the bottom of the shaft, one could see the inflow of water that was rising and being directed to the intake pipe. This water inflow was concentrated in the corner between the EP65 and ES65 piles. As Figure 23 shows, the area where the water inflow was observed corresponded exactly to the area of lack of overlap between the EP65 and ES65 piles.

The incident was caused by an opening in the piles curtain, in particular in the contact of the EP65 primary pile with the ES65 secondary pile, where the influx of water and alluvial soils was triggered when the excavation reached approximately the level -18.00 m. This opening was caused by a deviation of the axis of the ES65 pile, located at the

Figure 23. Plan at level -18:00 from survey of the piles position at north corner 5.

The survey of the position of the piles allowed to identify as a cause of the important inflows of water to excavation with transport of solid material, the deviations of the piles in relation to their theoretical verticality, deviations that reduced or even cancelled the overlaps between primary and secondary piles, in the body of the curtain, at the top of the Miocene or just below, especially at deeper levels of excavation. In fact, the analysis of these deviations showed that, in many cases, the specified vertical tolerance of 1/100 was substantially exceeded. These piles deviations were naturally more significant at lower levels, not guaranteeing a minimal overlap between primary and secondary piles. However, no inflow of water from the tip of the piles were detected inside the excavation perimeter, confirming very low permeability of the Miocene and its great resistance to “roofing” phenomena.

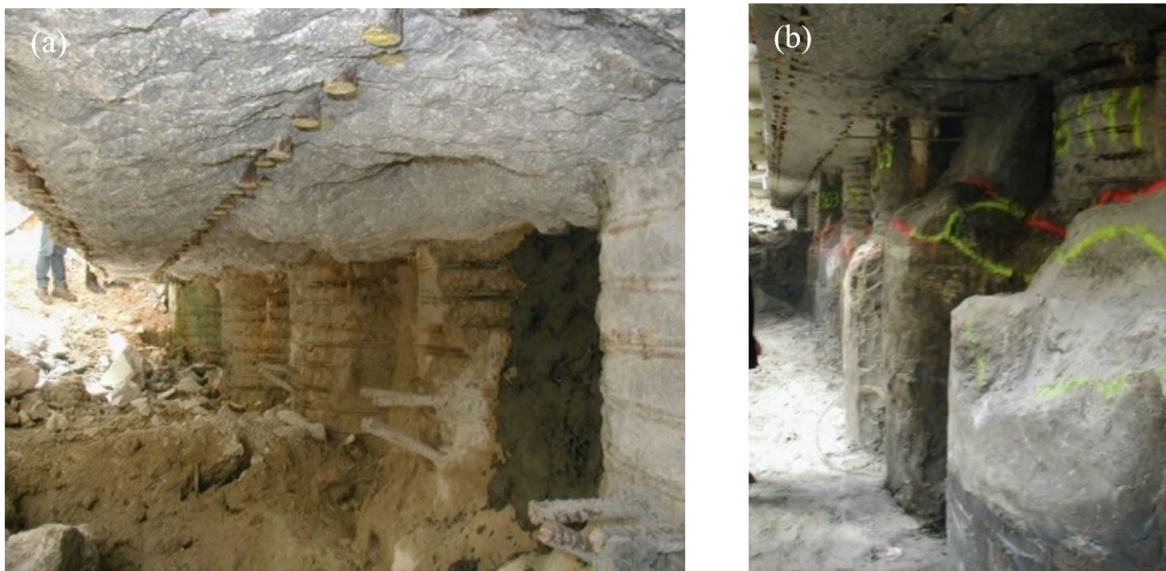
- Zones, more or less located, where some of the piles had slopes of about 1/50, resulting in a very reduced thickness of the primary piles (as they were removed with the execution of the secondary piles), so localized ruptures of primary piles could not be excluded; this situation resulted from the fact that the piles were inclined in the transversal direction of

As an example of the lack of verticality of the piles Figure 25 a is presented. This figure was obtained at the time of opening the inspection ditch for observation of the piles, before the general excavation for the execution of the bottom slab. It is observed the great deviation of the secondary piles in relation to the primary piles, well evidenced by the distance to the posterior line of reinforcement steel of the lining wall, conducting to a great concrete thickness of the lining wall. It should be noted that, if the execution of the piles had respected the specified tolerances, at the elevation at which the lining wall was located (-18.20 m), the maximum deviation from the vertical should be about 0.25 m in relation to the face back of the lining wall. As an example of the distance between primary and secondary piles, Figure 25 b is shown.

Figure 25. (a) Curtain piles at the level of the bottom slab; (b) Very significant spacing between primary bentonite-cement piles, in the foreground, and secondary reinforced concrete piles, in the background.

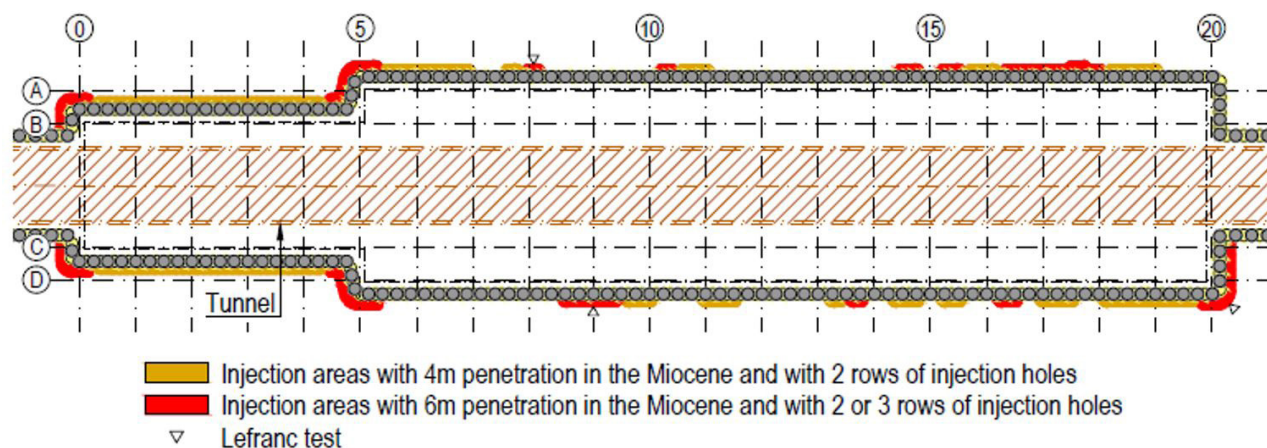
Figure 26. Location of the injected areas outside curtain (Brito & Fernandes, 2006a).

Depending on the situation assessed, two types of injection hole patterns were defined, with two and three rows of holes, in the locations shown in Figure 26 and 27. The injection length was defined in the upper zone with 2 m overlap with respect to the lining wall already made and in the lower zone with a penetration of 4 m or 6 m in the Miocene substrate due to the smaller or greater spacing of the piles (Figure 27 c).

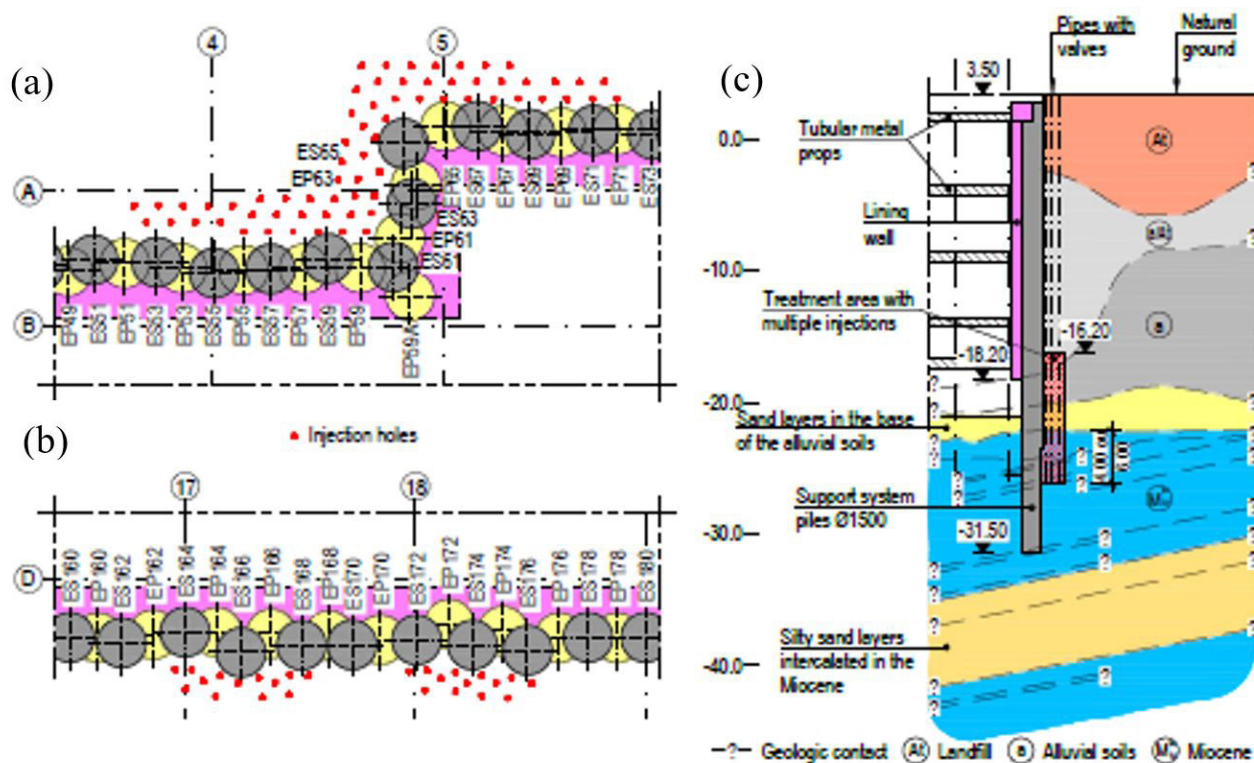
Figure 27. (a) Plan of injection holes in continuous meshes with two and three rows in the north wall in the vicinity of axis 5; (b) Plan of injection holes in meshes located with two rows in the south wall in the vicinity of axes 17 and 18; (c) Vertical cross section in the north corner 5 with indication of the injection holes with manchette tubes and the area treated with multiple injections (Brito & Fernandes, 2006a).

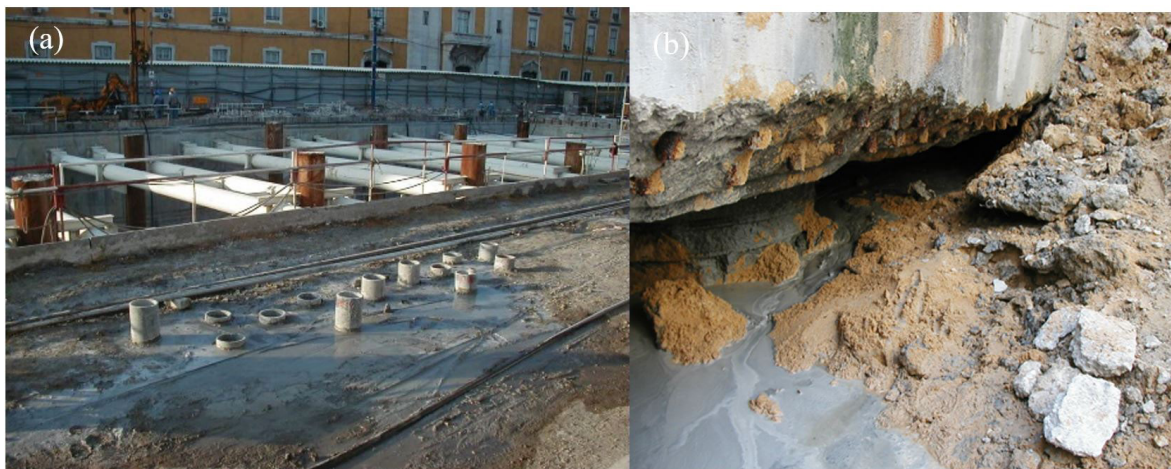
In Figure 28 a one of the 3-row mesh of injection holes can be seen. As shown in Figure 28 b, during the execution of the injections, some grouting entrances were registered inside the station through openings in the curtain.

Figure 28. (a) Implantation of three rows of injection holes in the south wall in the vicinity of axis 9; (b) Injection cement grout from the outside of the curtain affluent to the interior near the corner 5 south.
