Evaluation of environmental rehabilitation practices in bauxite mining at the plateau of Poços de Caldas

Abstract

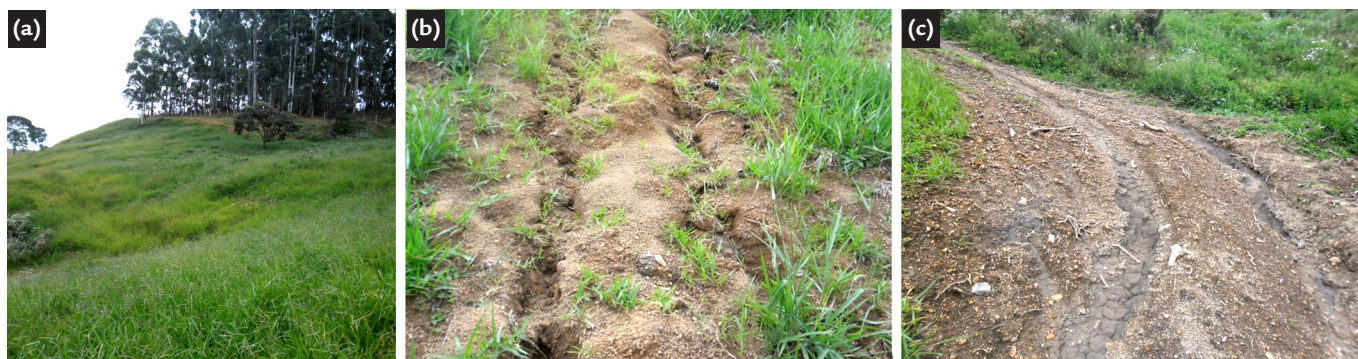
In Mine 1, it was observed that in many points, the level contours cause the water runoff to flow longitudinally through the mine, but as final systems to capture this water were not implemented, the water flows through the access roads of the mine, causing erosion and preventing vehicle traffic.

Failures were observed in the terracing practices, which resulted in erosion problems, alongside water runoff channels in the tree plantation area, rock block landslides and slope landslides at the main mine access road.

In general, the accompaniments found results already expected over the months. Figure 1 (a) presents a superficial way for the development of vegetation after 6 months of planting. In several places vegetation development occurred unequally (Figure 1 (b)). This fact is a consequence of the failures previously mentioned in the preparation and planting of the soil. Finally, Figure 1 (c) portrays erosion grooves resulting from erroneous procedures in the topographic reformation stage, in addition to a poor formation of the vegetation. This phenomenon was unleashed by improper ground terracing in this locality in the mine, so that the level curves were not able to control the longitudinal flow of the water, resulting in these erosive processes. This fact can lead to problems between the miner and the landowner because as the formation

Figure 1 – Superficial development of vegetation (a), poor vegetation formation (b) and erosion grooves at the main mine access (c).

I) Some different procedures could have been carried out in recontouring. In Mine 1, ground terracing was coherent, the level contours are at safe distances from each other, but as the flow of water occurred longitudinally through the mine, it would require gutters so that water would not flow over the roads, as well as sinks able of supporting the volume of water accumulated at the end of these gutters, which would avoid the erosive processes found in the access roads of the mine. Mine 2 was located in a very steep region. Since ground terracing into level contours was implemented far apart, there occurred irregular water flow along the ground, which may have withdrawn the nutrients from the reconfigured soil, and thus decreased the fertility of the soil for the development of seedlings. Another inadequate practice was in relation to the rock blocks, which should have been removed and allocated to the lower part of the terrain, but were not. Therefore, there were these blocks slid in several points of the mine, which may have caused the mortality of several seedlings;

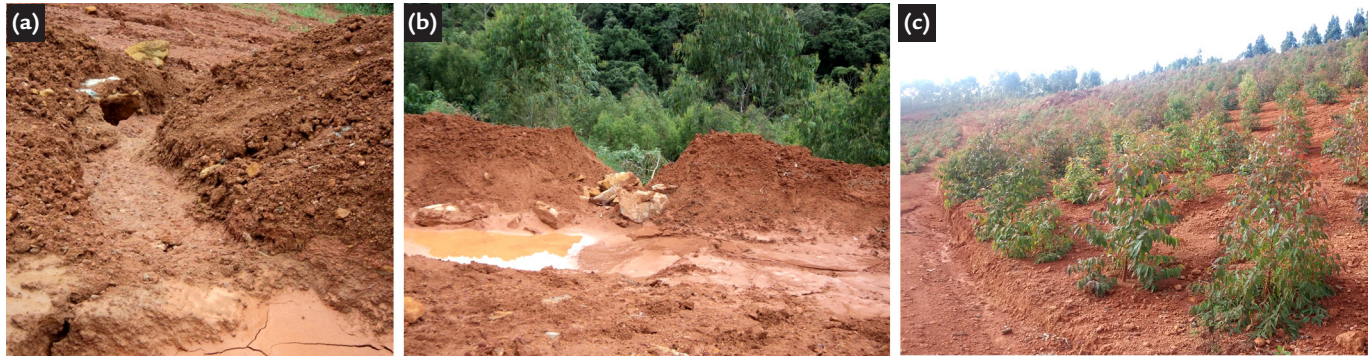
In the Mine 2, several erosive problems were detected since the planting phase. During January, there were irregular water flows in the plantation (Figure 2 (a)), accumulation of water in several points of the area and on the access roads, sliding of rock blocks (figure 2 (b)) and slides in the cut slope implemented for the delineation of access roads to the plantation. These problems are the result of an erroneous reformation of the terrain. The mine is characterized by an accentuated declivity, therefore ground terracing should have occurred based on safety measures to avoid rough outflow and water accumulation on the ground. This uneven flow of water along the terrain may have withdrawn the nutrients from the reformed soil, reducing soil fertility for seedling development. Another inadequate factor was in relation to the rocky blocks. Even though it was affirmed by the company representative that the tractor removed the larger blocks from the tops of the area, it was proven in practice that not all were removed, leading to landslides that may have killed several seedlings and could even have led to worse problems.

The only record of monitoring the development of vegetation occurred in December 2016 (Figure 2 (c)), eleven months after planting Eucalyptus. According to a company employee, the monitoring of the site was monthly, however no other photographic records occurred. After planting, the company had a contractual obligation to take care of the development of the culture for two years, whenever necessary carrying out interventions in the area, such as brushing, applying herbicide and insecticide. The owner of the rural

Figure 2 – Irregular water runoff in the plantation (a), rock block landslides (b) and the only record of monitoring the development of vegetation (c).

III) The accompaniments of Mine 1 led to what was already expected: unequal development of the *Brachiaria* pasture. Mine 2 has only a photographic record of monitoring the vegetation. It is recommended that monitoring reports on the rehabilitated areas be prepared, with regular monitoring and photographic collection of all dates.
