Analysis of strengthening procedures of reinforced concrete highway bridges: a brazilian case study

D. M. CARVALHO ^a

J. M. F. CALIXTO ^a

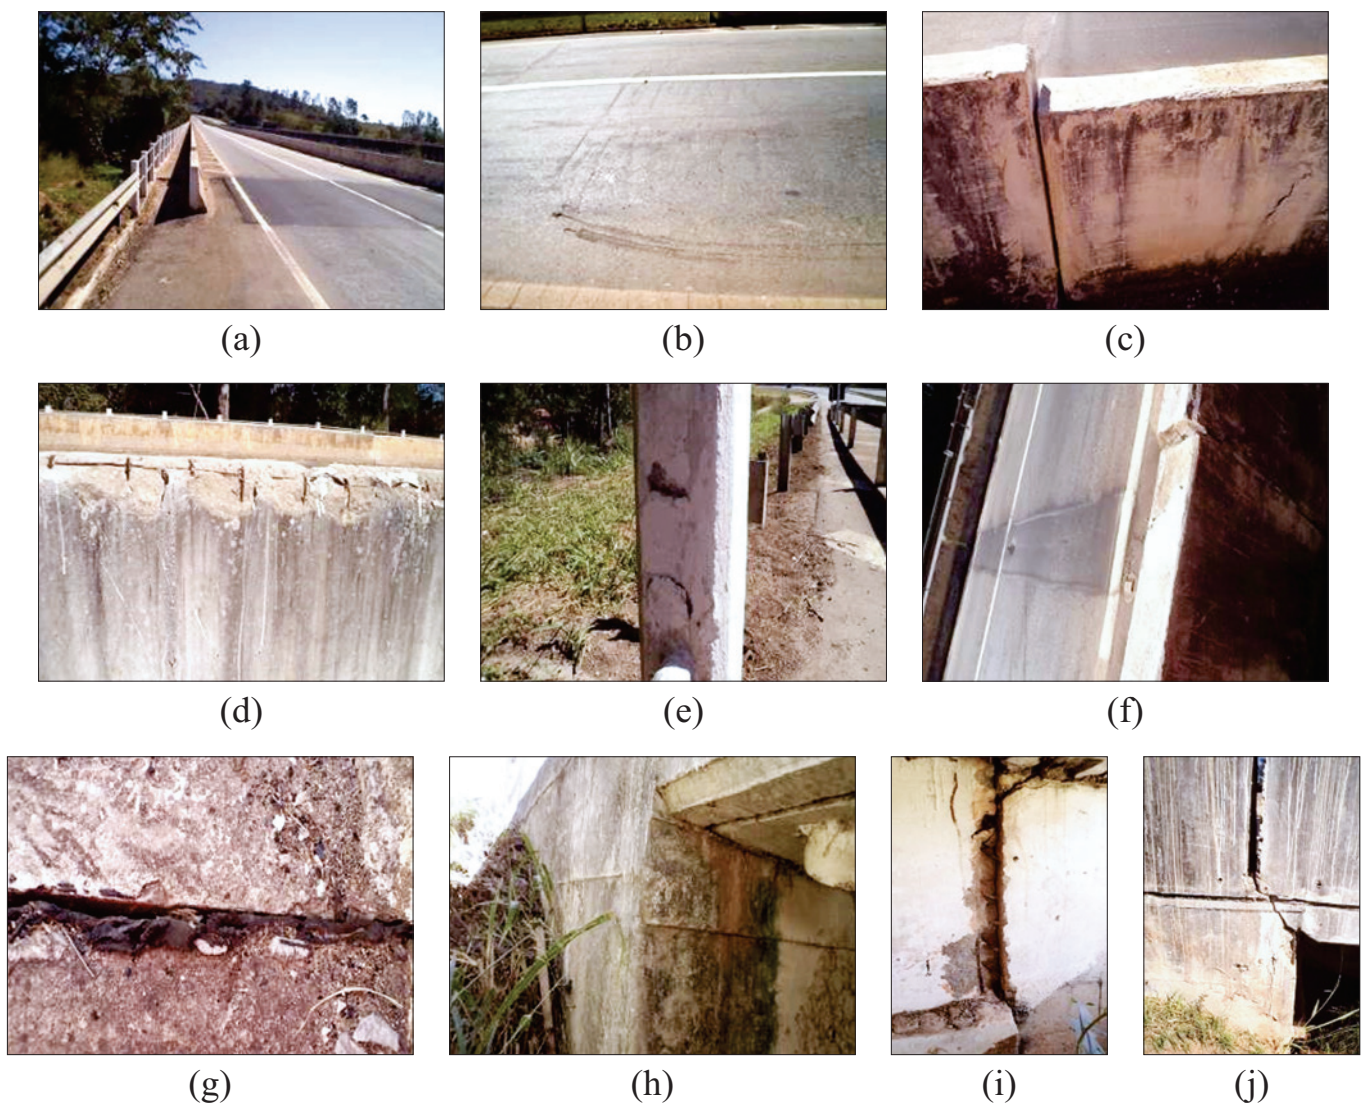
According to what had been reported in previous inspections, there is a lane narrowing on the bridge due to the existence of a pedestrian walkway on the place in which, according to the design, there should be the continuity of the shoulder. The pavement on the both bridge accesses shows only minor irregularities and a patch on the expansion joint was executed to correct a small step caused by a settlement. This settlement also caused a vertical misalignment of the safety barrier and sinking of the wings. This in turn led to crushing of the concrete and the exposition of the reinforcement on the left side of the bearing wall. On the right side, although the vertical displacement of the bearing wall had not occurred, it did not resist the weight of the wing, which caused cracking, the disintegration of the concrete and reinforcement exposure. The bearing walls also showed water infiltration points, most likely associated with drainage problems on the both sides of the bridge accesses. Several pathologies were identified in the safety barriers and guardrail, such as cracks, disintegration of the concrete, displacements, stains, and exposed and/or corroded reinforcements. The tests made with the pacometer indicated values of reinforcement covers on the barriers different from the design; this fact that can justify the early emergence of damages related to reinforcement corrosion. The expansion joints were obstructed by the asphalt coating, blocking the free

movement of the superstructure and consequently leading the accumulation of moisture and the deterioration of the sealing material. Moreover, there was accumulation of debris on the roller track close to the expansion joint. Figure 6 shows the conditions of the roller track, including the retaining structure, the drainage system and guardrails.

Conditions of the roller track. (a) Lane narrowing on the bridge and patch on the expansion joint, (b) Irregularities in the pavement on the access road, (c) Vertical misalignment of the New Jersey barrier, (d) Disintegration of the concrete and exposed reinforcement on the New Jersey barrier, (e) Reinforcement corrosion on the guardrail, (f) Expansion joint obstructed by the asphalt coating, (g) Deteriorated sealing material at the walkway, (h) Water infiltration points at the bearing wall; (i) Sinking of part of the bearing wall (left side), with crushing of the concrete and the exposition of the reinforcement, (j) Cracking, disintegration of the concrete and reinforcement exposure on the right side of the bearing wall

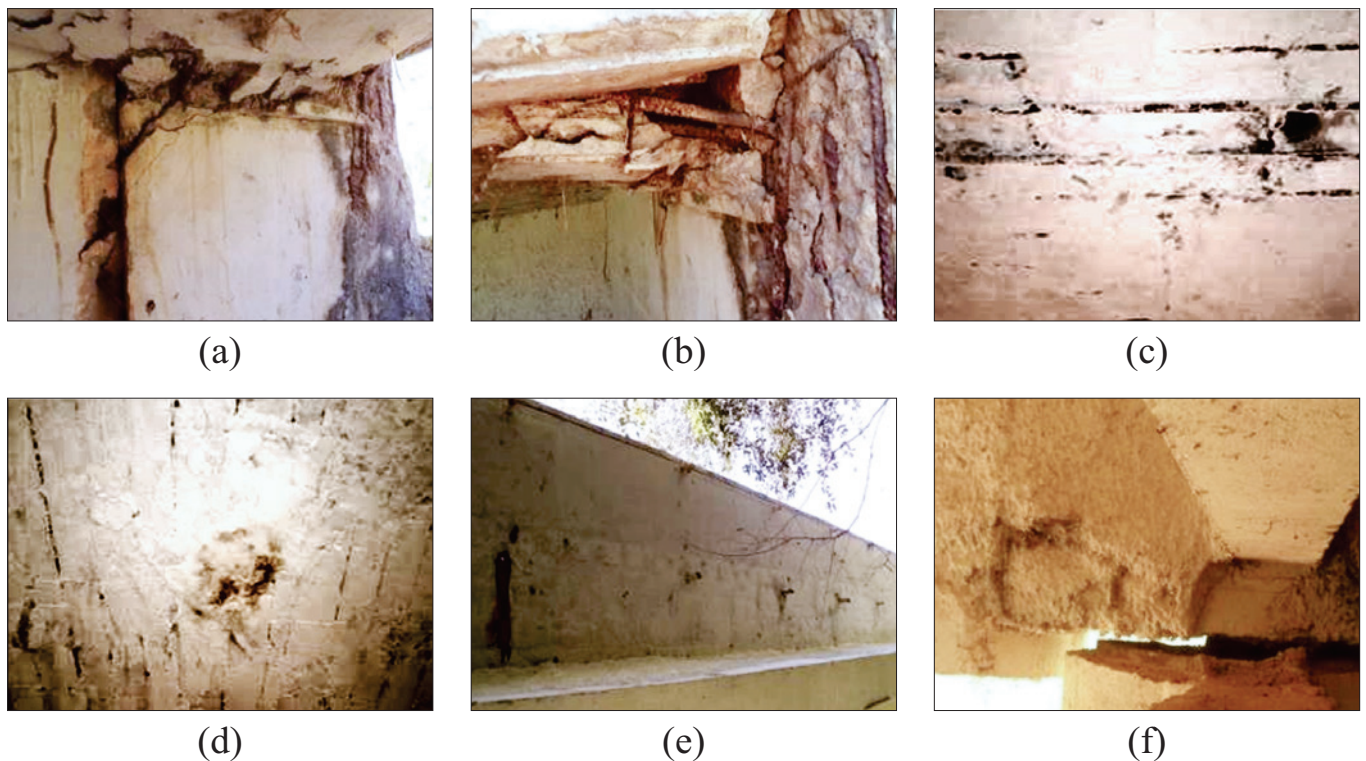
Figure 7

The main damage that was identified in the super-structure

was the concrete crushing of cantilever slab due to the settlement of the land fill which was not resisted by the bearing wall. There were also damages on the under surface of the slab related to failure in the drainage ducts and dripping pans that were poorly functioning, allowing water percolation through the slab on both cantilever sides. Infiltration stains in places that did not receive repair or strengthening interventions were also found. The presence of water on the under surface of the slab and the infiltrations may lead to leaching, concrete porosity increase and strength reduction which can make it more

Main damages identified in the superstructure. (a) Concrete rupture of the cantilever slab, (b) Detail of the bended slab with crushing of the concrete and reinforcement exposure, (c) Exposed reinforcement on the under surface of the slab, (d) Infiltration stains at the bottom surface of the slab (e) Damaged drainage ducts, allowing water percolation through the slab, (f) Localized concrete casting voids were noticed on the under surface of retrofitted main beams with exposed reinforcement

vulnerable (HELENE [7]). Localized concrete casting voids were noticed on the under surface of retrofitted main beams next to the support columns. The measurements made with the pacometer showed insufficient concrete cover on the transversal beams and the slab, including the retrofitted parts of these elements. These aspects are shown in Figure 7.

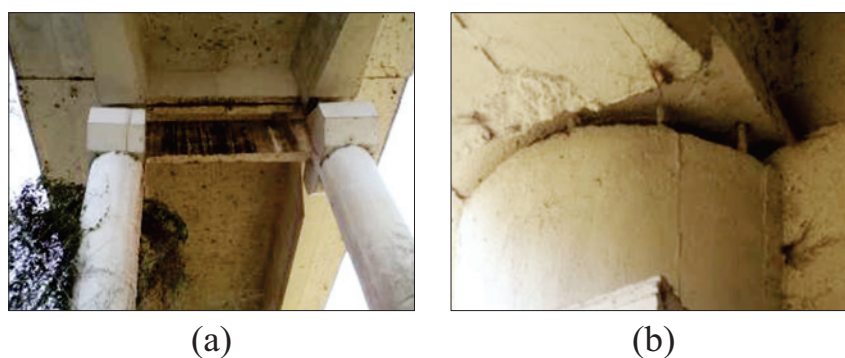
Figure 8

The mesostructure is in good condition of preservation. Only a few localized concrete casting voids in retrofitted columns have been identified; but they did not cause any type of structural deficiency. Signs of water infiltration in the sixth line of columns were noticed

Damages identified in the mesostructure. (a) Signs of water infiltration in the columns and transversal beam, due to failures in the sealing of the expansion joint (b) Exposed reinforcement in the column strengthening

due to failures in the sealing of the expansion joint. These damages are shown in Figure 8.

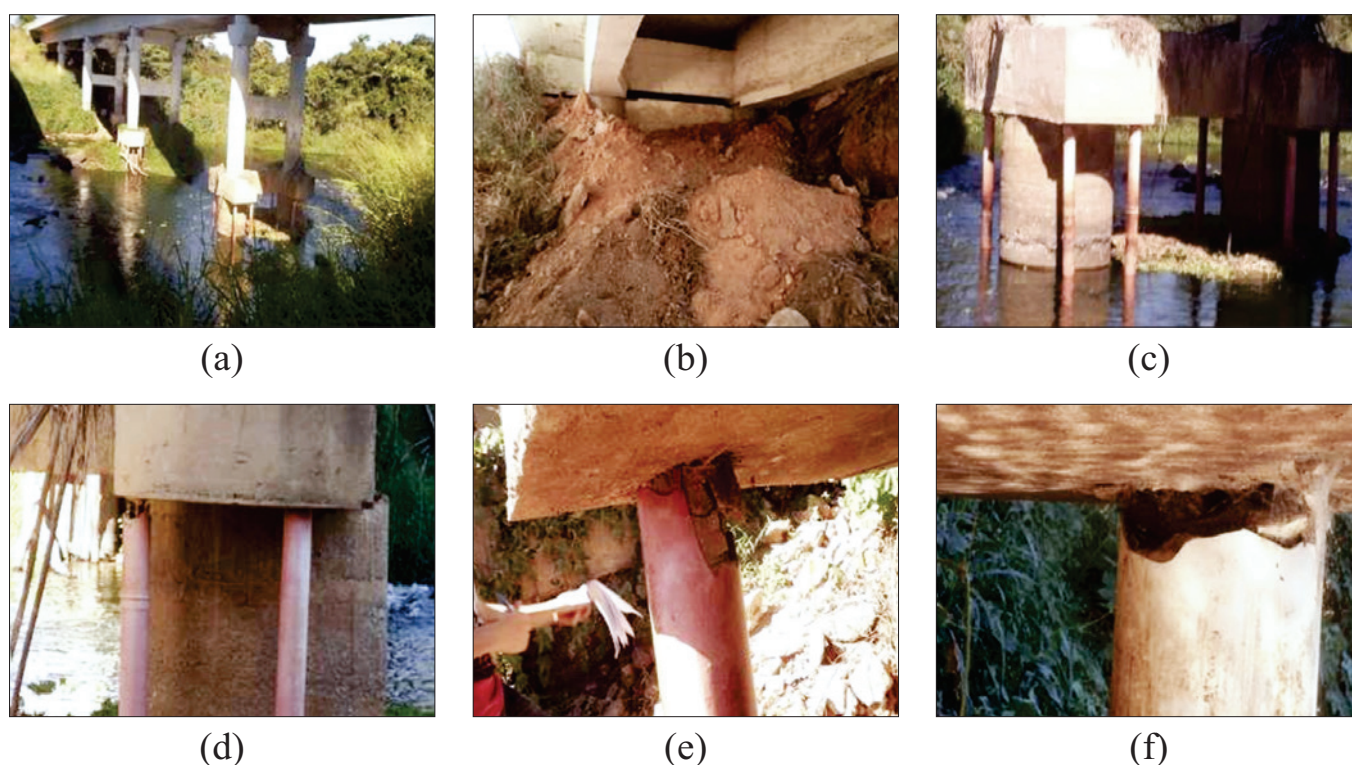
The most relevant identified anomalies in this bridge are in the new and strengthened elements of the foundation. The pile caps and part of the root-type piles were executed above water level, different from the design, which prescribed buried piles. This pile position compromises their durability and also reduces the contribution of lateral friction in increasing the load carrying capacity of the foundation. Major execution problems were visible at the top of the root type piles: significant reduction of their cross section dimensions due to the presence of concreting honeycombs or due to disintegration of concrete associated with the poor quality of the material. Failures in the bonding of the pile caps with the root-type piles prevent the strengthened elements to resist additional load and effectively contribute to the increase in the load carrying capacity of the foundation. Only the old caissons are bearing the bridge's increased load. There was no vegetation protection on the slopes which led to signs of erosion that needed correction to avoid the future occurrence of any kind of instability in the foundation or retaining structures of the roller track. Figure 9 illustrates these aspects.

Main problems related to infrastructure. (a) Exposed pile caps and part of the root-type piles, (b) Signs of erosion and lack of vegetation protection on the slope, (c) Damages at the top of the root-type piles, (d) Lack of concrete at the top of the pile in which the cap rests, (e) Disintegration of concrete at the top of the pile, (f) Concreting voids at the top of the pile

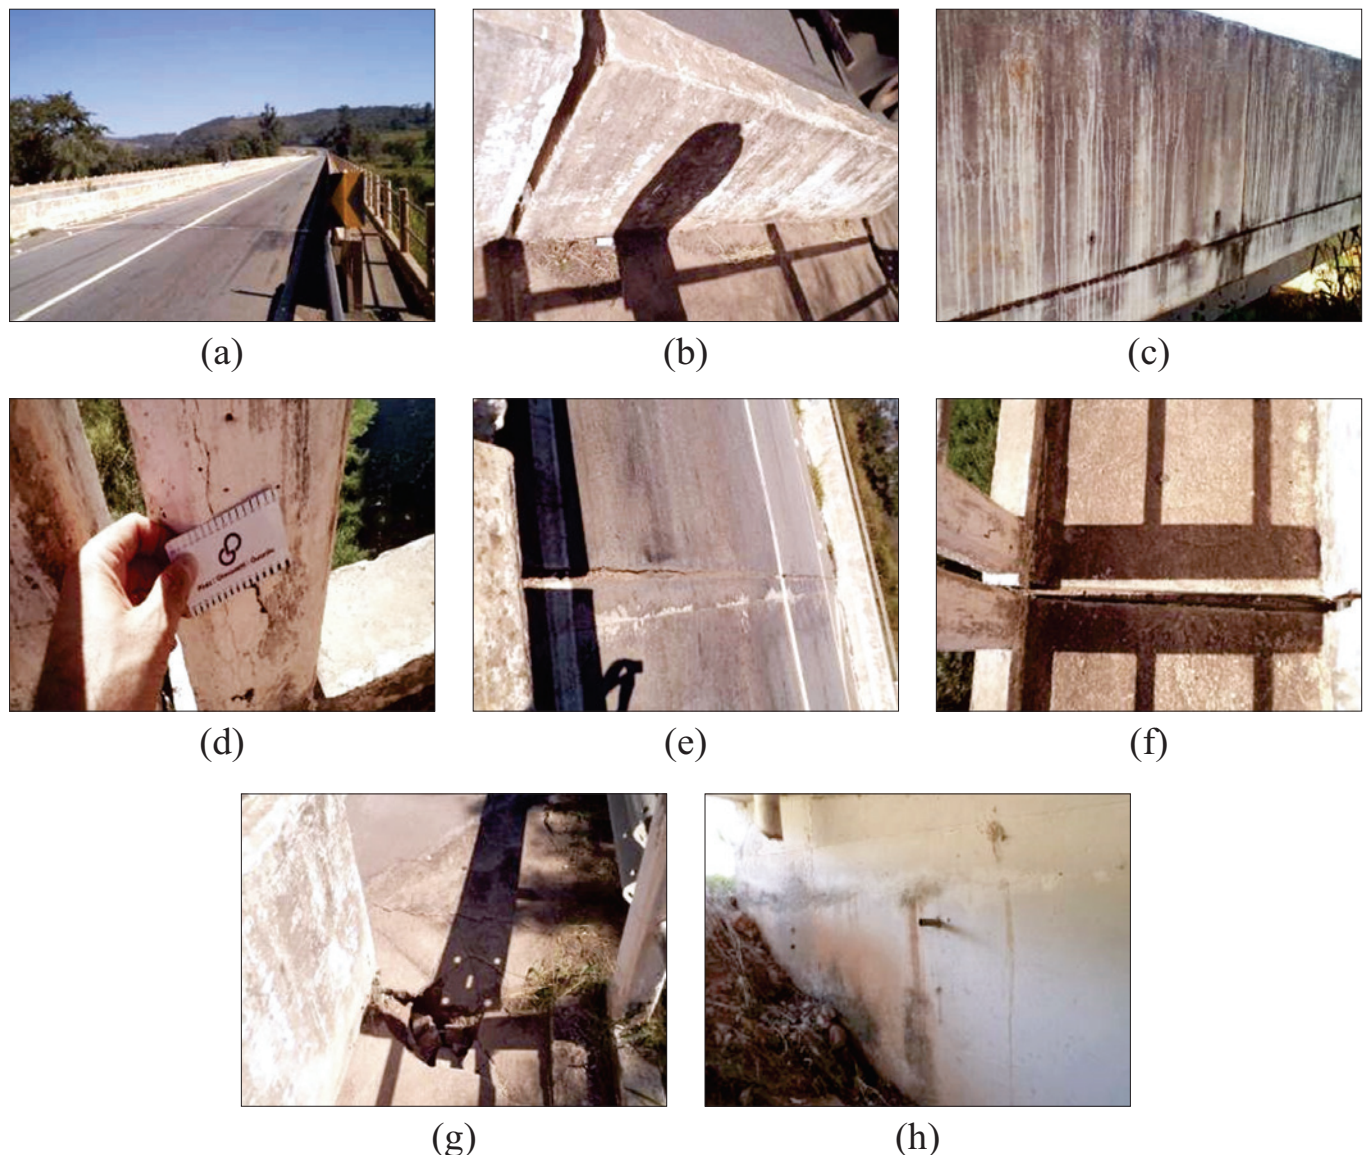
The new bridge presents lane narrowing for the same reasons as the old bridge. The pavement was in good conditions, having presented only a few deviations on the road accesses to the bridge. Settlement of the land fill of both accesses could also be observed, resulting in vertical misalignment of the safety barrier. Safety barriers and guardrail showed several pathologies most likely associated with the insufficient thickness of reinforcement cover. The expansion joints located at the ends of the bridge were completely obstructed by the asphalt coating. The joint located in the middle of the bridge, although unobstructed, also showed problems in the sealing due to deterioration of its filling material. There was a hole on the floor of the walkway caused by the settlement of the land fill at the exit of the bridge, which crushed the concrete on that part. The bearing walls presented water infiltration points most likely associated with malfunctioning of the drainage system. Figure 10 shows these conditions.

Conditions of the roller track. (a) Lane narrowing on the bridge, (b) Vertical misalignment of the New Jersey barrier, (c) Infiltration stains on the New Jersey barrier, (d) Cracking with opening of 0.4 mm in the guardrail due to reinforcement corrosion, (e) Expansion joint obstructed by the asphalt coating, (f) Deteriorated sealing material at the walkway, (g) Hole on the floor of the walkway, caused by the settlement of the land fill, (h) Water infiltration points on the bearing wall

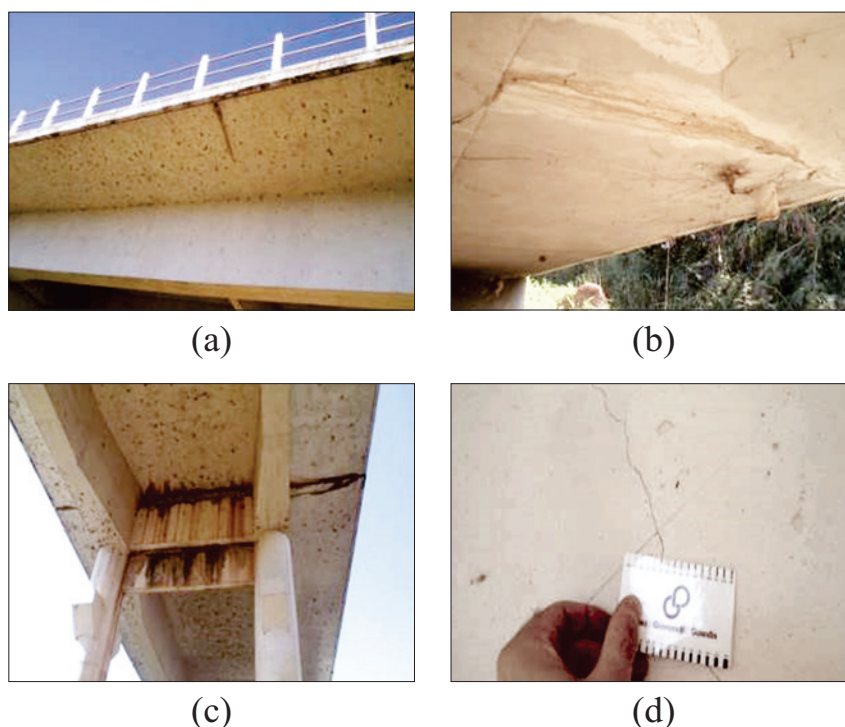
Figure 11

related to the drainage system, which was not efficient. There were some infiltration stains in the gaps of the slab and in one transversal beam caused by rupture of the sealing material in one of the expansion joints. Reinforcement was exposed on the top surface of the slab of the walkway. The main beams showed cracks on their lateral faces due to bending, but the openings were within acceptable levels according to norm NBR 6118 (ABNT [1]). The results of the pacometer tests showed insufficient concrete in the slab and in main and transversal beams. These aspects are illustrated in Figure 11.

Main damages identified in the superstructure. (a) Malfunctioning of the dripping pan, (b) Malfunctioning of drainage ducts and of the dripping pan, (c) Infiltration stains in the slab and in one transversal beam, caused by rupture in the sealing material in one of the expansion joints, (d) Cracking with a maximum opening of 0.3 mm at the lateral side of the main beams

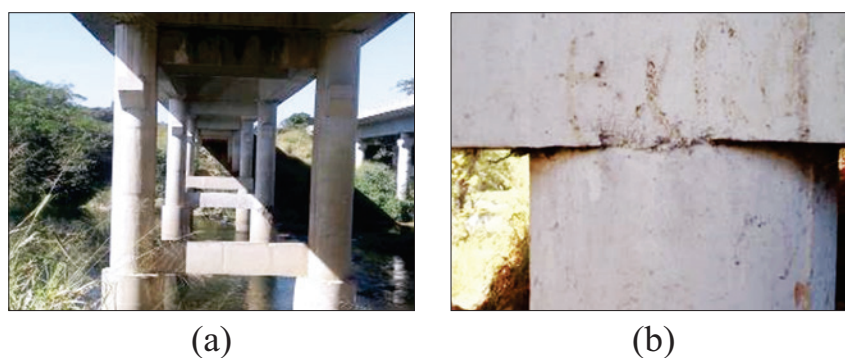
Figure 12

In general, the elements of the mesostructure were in good conditions. Some signs of infiltration caused by rupture of the sealing material were identified in the bracing beam that connects the columns located below the expansion joint (Figure 12 a). The supporting devices were obstructed by styrofoam and mortar residues compromising their optimal performance (Figure 12 b). Reinforcement cover was smaller than prescribed by design.

Main damages found in the mesostructure. (a) Infiltration stains on the bracing beam of the columns located below the expansion joint, (b) Presence of mortar residues around the support device

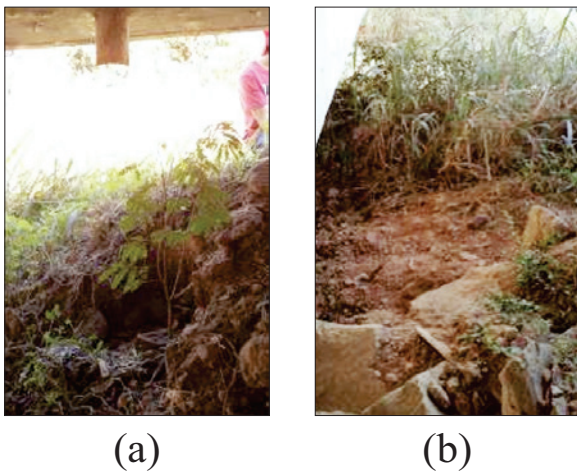
Despite its largest part not being visible, it is assumed that the infrastructure is in good state of preservation since there was no sign of consolidation or displacement of the foundation. Only the absence of vegetation protection on the slopes and some minor erosions caused by bad positioning of some drainage ducts that direct rain water to the exit of the land fill were observed (Figure 13).

Figure 13
Main damages identified in the infrastructure. (a) Minor erosion on the slope caused by bad positioning of drainage duct, (c) Another erosion on the slope

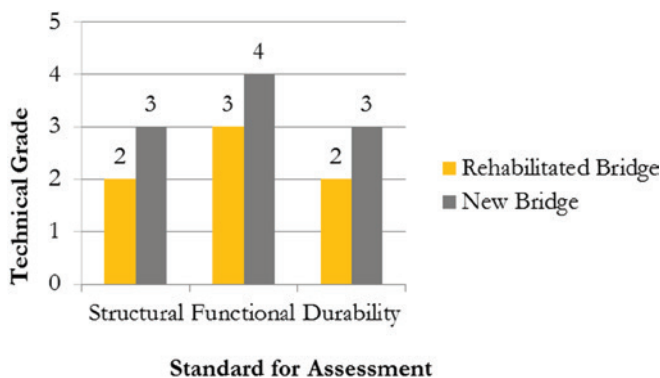
In general, the new bridge had a satisfactory performance: no significant damage that may affect the stability of the construction was detected. As for the rehabilitated bridge, its performance was subpar, with several damages or anomalies that may compromise not only its structural safety but also its long-term durability. Figure 14 shows a chart with the technical grades attributed to

The smaller technical grades of the rehabilitated bridge, related to structural and durability aspects, are due to deficient performance of the new and retrofitted concrete elements. The poor conditions of the rehabilitated bridge's safety barriers interfered on its technical grade according to the functionality behavior. The existence of cracks in the main beams and erosions located on the slopes of both bridge accesses were the most influential aspects in the evaluation of the new bridge. According to the results, correction of the anomalies that cause structural insufficiency and affect the long-term durability of the rehabilitated bridge should be the short term actions to be taken. The medium term actions correspond to the correction of problems that affect its functionality. For the new bridge, monitoring the cracks in the main beams of the new is recommended as a medium term measure; correction of the erosions on the slope may also be necessary.

Figure 14
Technical grades attributed to each bridge
