Main complications of hip arthroplasty: pictorial essay

Enge Júnior D, Castro AA, Fonseca EKUN, Baptista E, Padial MB, Rosemberg LA. Main complications of hip arthroplasty: pictorial essay. *Radiol Bras.* 2020 Jan/Fev;53(1):56–62.

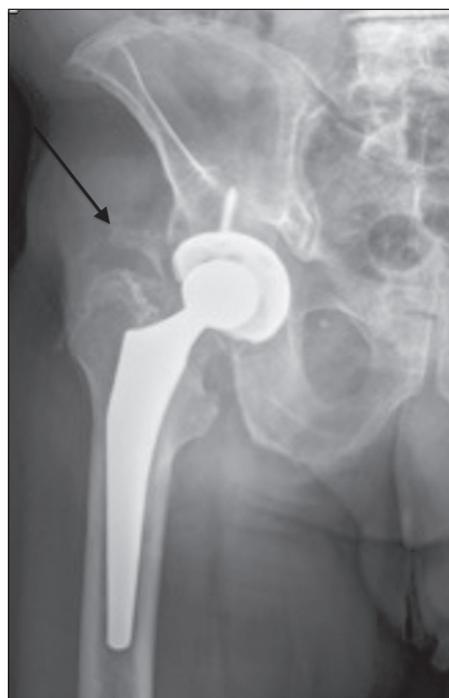
Figure 3. Total right hip arthroplasty in which the prosthesis had an acetabular component with screw fixation and an intramedullary femoral stem, with no signs of loosening or material failure. Grade II peritrochanteric heterotopic ossifications on the right (arrow).

Brooker et al.⁽³⁾ classified heterotopic ossification according to the findings on anteroposterior X-rays of the hip: grade 0 = no heterotopic ossification; grade I = one or two foci of heterotopic ossification < 1 cm (Figure 2); grade II = ossification or osteophytes occupying less than half the space between the femur and the pelvis (Figure 3); grade III = ossification or osteophytes occupying more than half of the space between the femur and the pelvis (Figure 4); and grade IV = ossification bridges between the pelvis and femur, indicative of hip ankylosis (Figure 5).

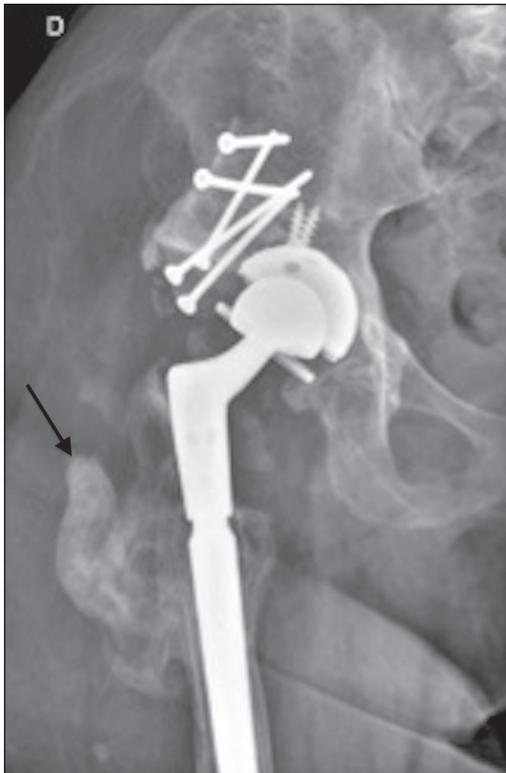
Figure 4. Anteroposterior X-ray of the right hip showing signs of total arthroplasty and bone grafting, with no signs of loosening. Grade III heterotopic ossification of soft tissue near the sites of surgical manipulation (arrow).

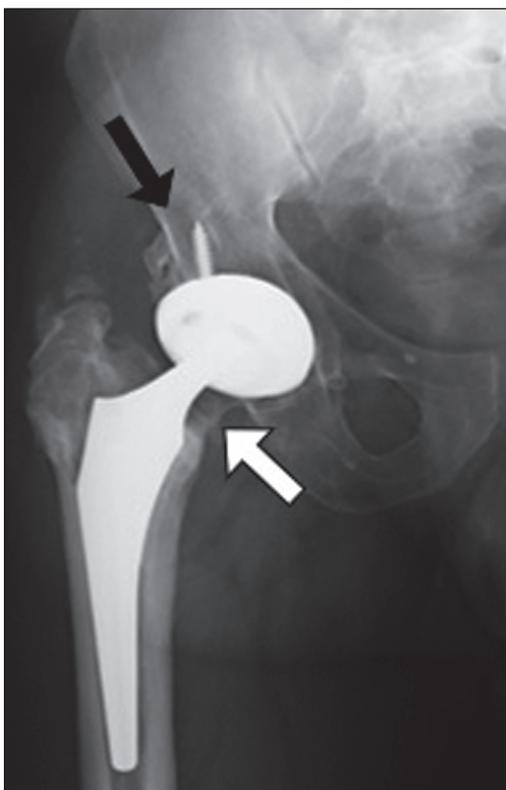
Figure 5. Anteroposterior X-ray of the right hip showing a total bipolar prosthesis and minor resorption (osteolysis—black arrow) of a screw in the acetabular component. Grade IV heterotopic ossification between the femur and the lower border of the acetabulum (white arrow). Cortical thickening without periosteal reaction (stress shielding) is also observed.

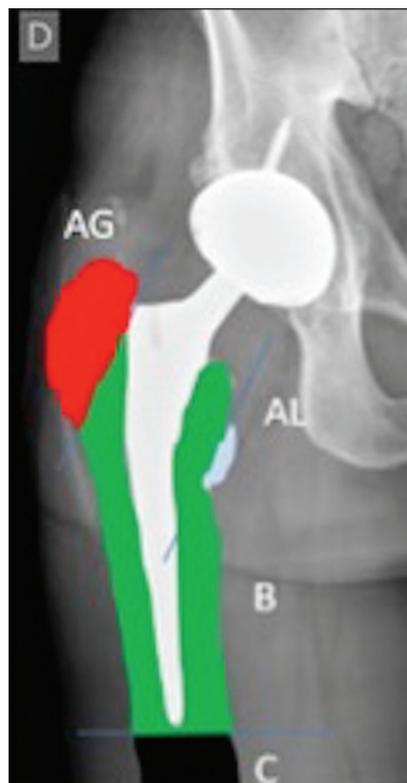
Figure 6. Vancouver classification for periprosthetic fractures.

According to the Vancouver classification, introduced by Duncan et al.⁽⁶⁾, which is based on the fracture location (Figure 6), the stability of the metal femoral stem, and the degree of bone loss in the proximal femur, periprosthetic fractures can be divided into three types: type A (peritrochanteric) fractures; type B fractures (those occurring around or just below the tip of the femoral stem); and type C fractures (those occurring well below the implant).

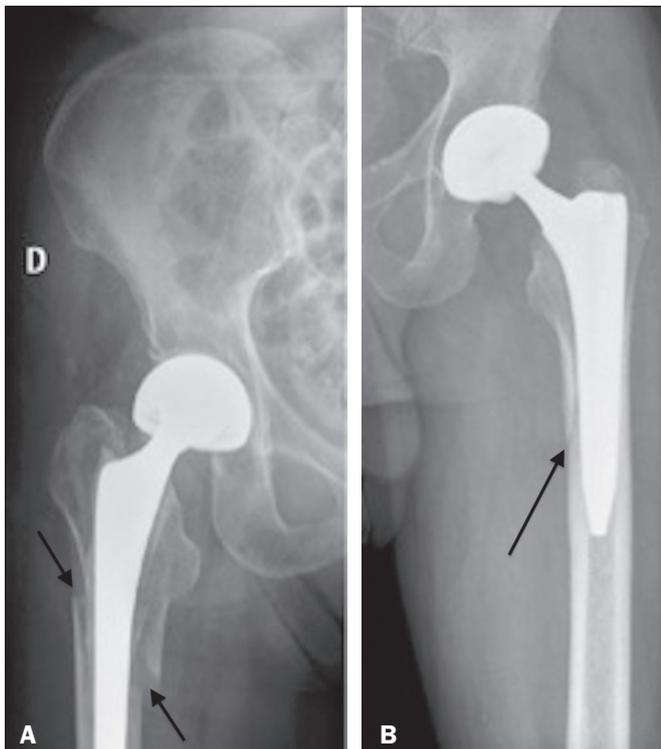
Figure 7. A: Anteroposterior X-ray of the right hip showing periprosthetic fracture (arrows) in the femoral component (Vancouver subtype B1). **B:** Anteroposterior X-ray of the left hip showing cortical fracture (arrow) at the medial margin of the femoral prosthetic component (Vancouver subtype B1).

The type A periprosthetic fractures are subdivided into the AG subtype (those of the greater trochanter) and the AL subtype (those of the lesser trochanter). The type B fractures are subdivided into the B1 subtype (stable stem; Figure 7), B2 subtype (loose stem; Figure 8), and B3 subtype (loose implant with substantial bone loss). The type C fractures have no subtypes.

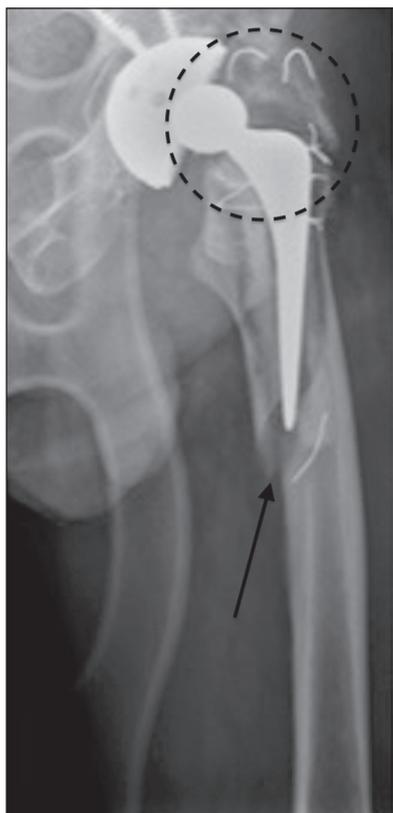
Figure 8. Anteroposterior X-ray of the left hip identifying periprosthetic fracture near the distal femoral stem (arrow), with signs of prosthesis instability (Vancouver subtype B2). Fracture of the greater trochanter with breaks in the metal bands (dotted circle).

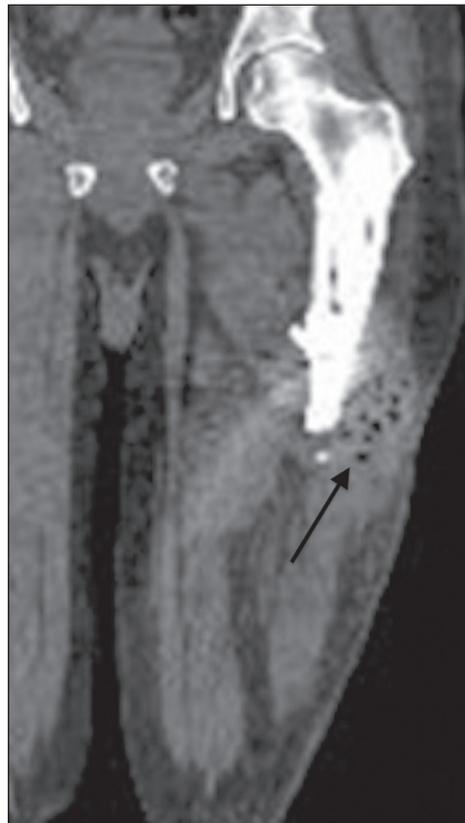
Figure 9. Coronal computed tomography scan of a patient with an infected left femoral prosthesis. Oval formation (arrow), measuring 9.1 × 2.3 cm, containing gas bubbles, located in the middle third of the left thigh, in contact with the femoral stem of the prosthesis, suggestive of abscess.

Foci of periprosthetic lucency that are greater than 2.0 mm or are expanding progressively are signs of abnormality. Making the differential diagnosis between septic and aseptic loosening/osteolysis can be challenging, especially if there are no previous X-rays available for comparative analysis. However, the presence of femoral periosteal reaction or rapidly progressive disease is indicative of septic loosening^(7,8). Joint effusion can also be indicative of infection⁽⁷⁾, as can periprosthetic fluid collections (Figure 9).

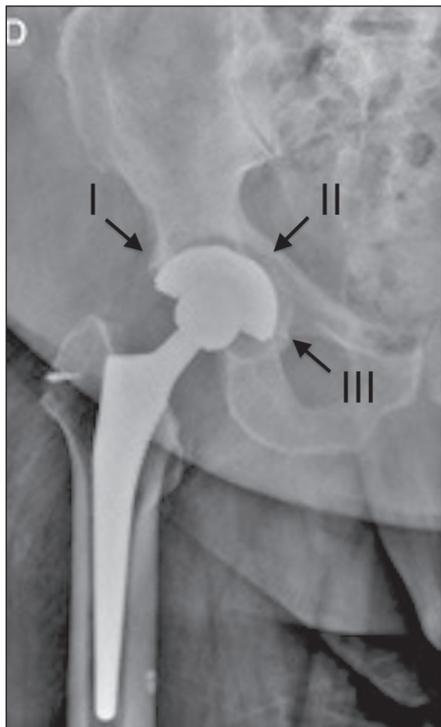
Figure 11. Anteroposterior X-ray of the right hip with osteolysis in zones I, II and III (arrows) of the right acetabular component.

The description of the location of the foci of lucency should adhere to the standard orthopedic nomenclature for the femoral and acetabular zones^(7,8). The regions around the acetabular component are divided into three equal zones—I, II, and III—from lateral to medial. As for the femoral zones, there are seven in the anteroposterior view and another seven in the lateral view. In the anteroposterior view, the first three run proximal to distal along the lateral aspect of the femoral stem, zone 4 is at the tip of the stem, and zones 5–7 run distal to proximal along the medial aspect of the prosthesis. In the lateral view, zones 8 to 14 follow the same pattern, starting in the anterior and proximal aspect of the stem (Figure 10). We present some practical examples of femoral and acetabular osteolysis (Figures 11, 12, and 13).

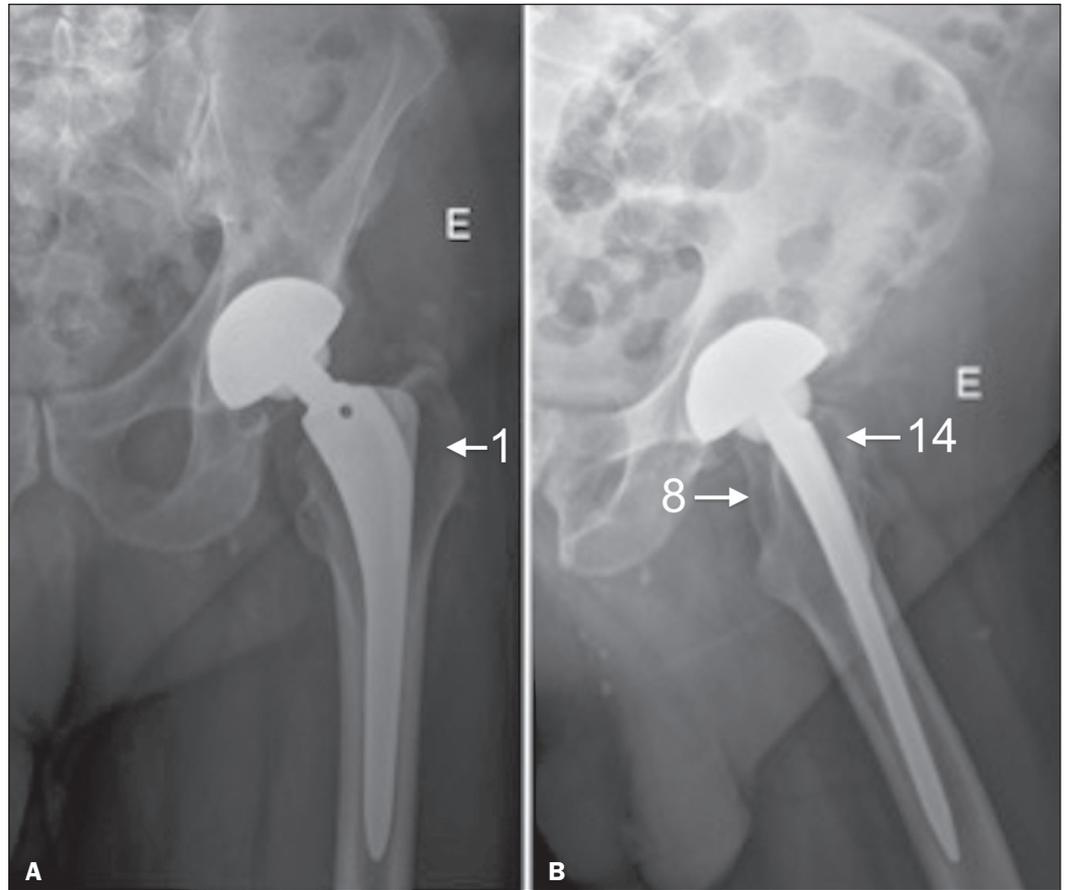
Figure 13. Anteroposterior and lateral X-rays of the left hip (A and B, respectively), showing osteolysis in femoral zones 1, 8, and 14 (arrows).

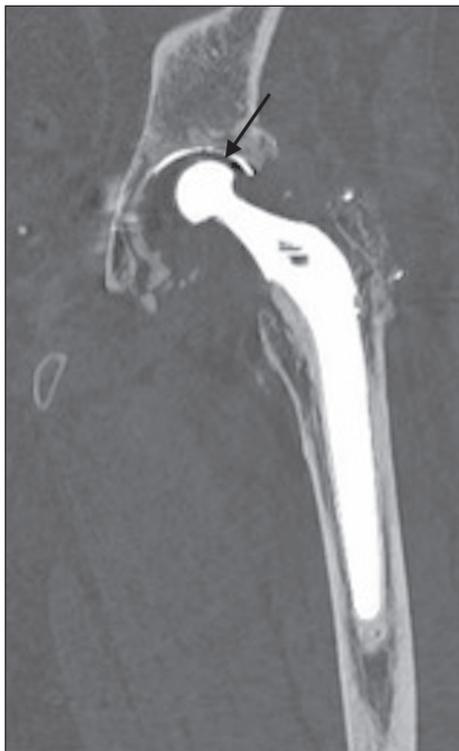
Figure 14. Computed tomography of the left hip in the coronal plane. Total left hip arthroplasty with reduction of the upper space, between the metallic head and acetabular components (arrow), indicating wear of the polyethylene lining.

Wear typically occurs in hip arthroplasty involving the use of a prosthesis with a polyethylene liner. As depicted

in Figures 14 and 15, the characteristic radiographic finding is asymmetrical positioning of the femoral head in the acetabular cup under load bearing⁽⁸⁾.

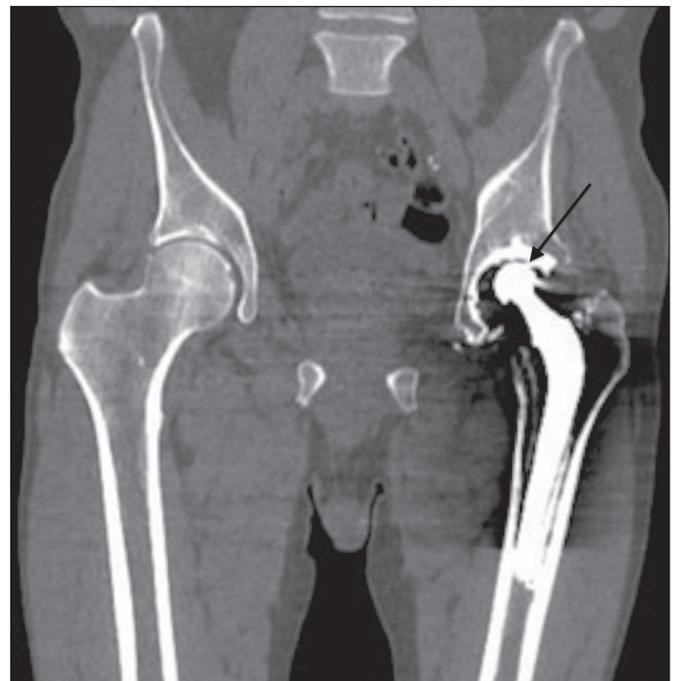
Figure 15. Coronal computed tomography scan showing a total left hip prosthesis, with asymmetry of the upper joint space, suggestive of wear of the polyethylene lining (arrow).

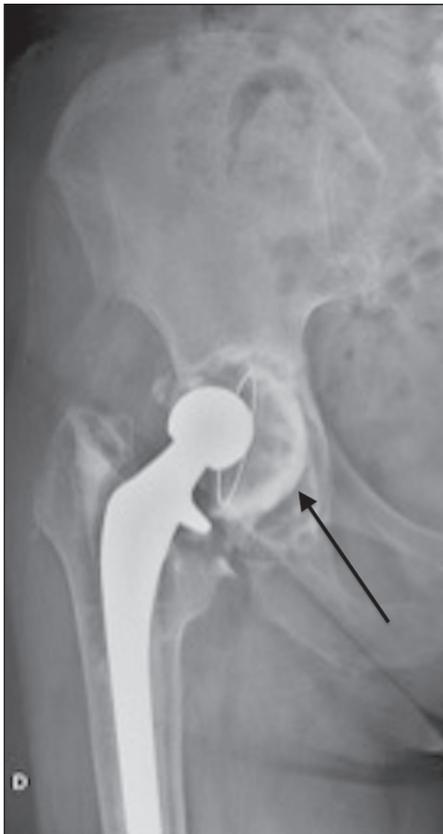
Figure 16. Anteroposterior X-ray of the right hip. Total right hip arthroplasty with vertical orientation and dislocation of the right acetabular component of the prosthesis (arrow).

months and more than five years after surgery, nontraumatic dislocation is usually due to laxity of the articular pseudocapsule and adjacent soft tissues, due to either immaturity (within the first three months) or lassitude (more than five years later). As can be seen in Figure 16, dislocation that occurs within the first three months or more than five years after surgery usually results from

poor positioning of its components, such as the acetabular component, which can become vertically orientated, anteverted, or retroverted⁽⁹⁾.

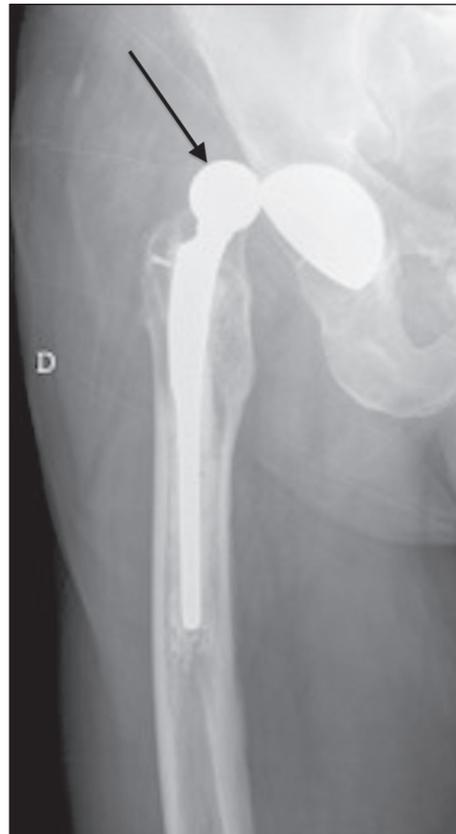
Figure 17. Anteroposterior X-ray of the right hip. Posterosuperior dislocation of the femoral component of right hip prosthesis (arrow), five years after the surgical procedure.

Early dislocations of prosthetic components are usually managed conservatively, whereas those occurring more than five years after arthroplasty usually require surgical management⁽¹⁰⁾, as depicted in Figure 17.
