Effect of Denture Surface Glazing on Denture Plaque Formation

Newton SESMA¹
Dalva Cruz LAGANÁ¹
Susana MORIMOTO²
Carlos GIL¹

¹Department of Prosthodontics, Faculty of Dentistry, University of São Paulo (FOUSP), São Paulo, SP, Brazil

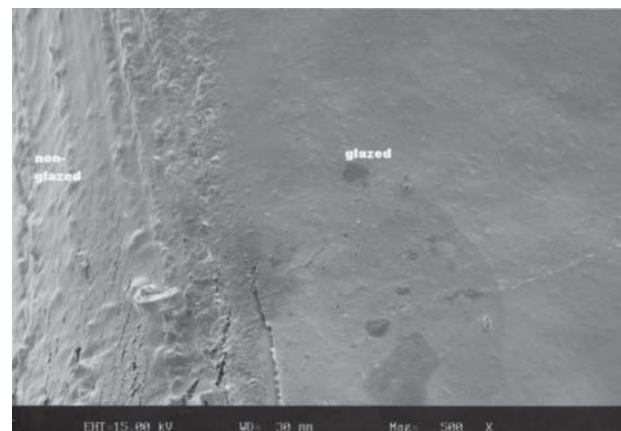
Figure 1. Boundary region between the glazed side and the non-glazed side, before denture insertion. Original magnification X500.

A layer of a light-cured glaze (Palaseal; Heraeus/Kulzer, Wehrheim, Germany) was applied to the right side of the dentures' fitting surface using a soft brush and light-cured (UNIXS; Heraeus/Kulzer) for 3 min. The left side was not coated with Palaseal (Fig. 1). The prostheses were then adjusted and installed.

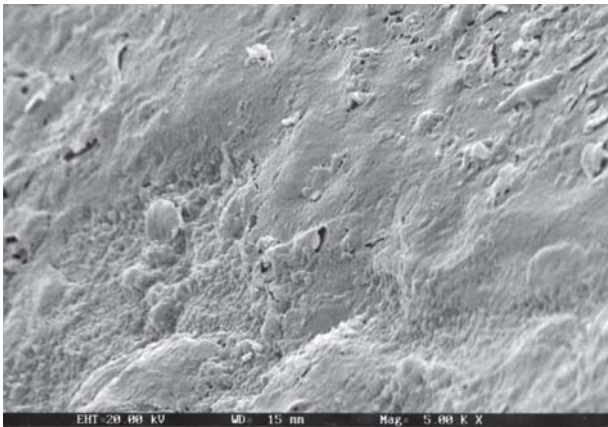
Figure 2. Glazed side (1 month). Denture plaque in an initial stage of colonization. Original magnification X5000.

At 1 month, biofilm characteristics and composition on glazed and non-glazed specimens differed in all patients. As a rule, the glazed resin surface appeared covered by a thin layer of bacterial plaque, with small number of microorganisms (Fig. 2), while the non-glazed surfaces showed dense plaque formation, rich in microorganisms (Fig. 3).

One month after denture installation, plaque deposited on the non-glazed side consisted of a thick layer, with microorganisms disposed in a compact arrangement and presence of cocci, bacilli and filamentous bacteria, characteristic of a mature plaque. On the other hand, bacterial plaque on the glazed side consisted of a thinner layer with predominance of cocci, which indicates recent colonization and suggests that, although glazing does not prevent plaque accumulation

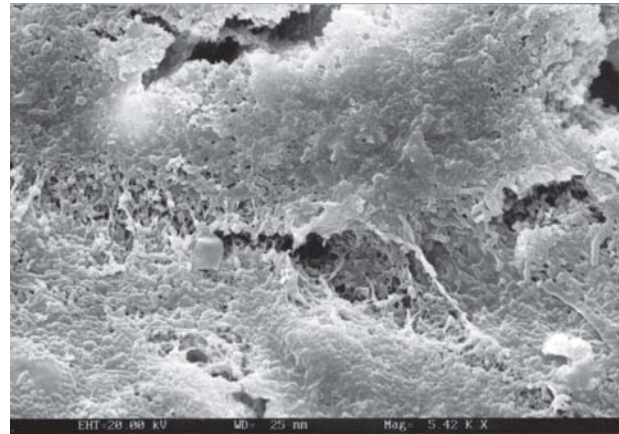
Figure 3. Non-glazed side (1 month). Intense colonization of the denture base's fitting surface by mature denture plaque. Original magnification X5000.

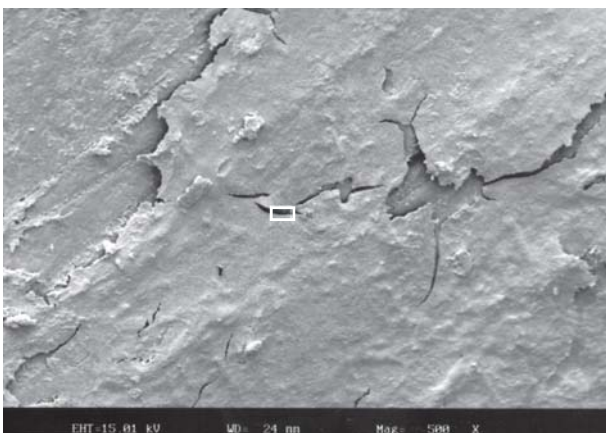
Figure 4. Glazed side (3 months). Glazed area with cracked appearance. The rectangle indicates a gap formed on the glaze layer. Original magnification X500.

smooth and imperfections were found in some regions. Figure 4 shows an area in which the glaze layer was apparently cracked. Similar appearance was observed in all fragments treated with Palaseal, at this evaluation period. The glaze cracks acted as microniches that favored bacterial plaque retention. Figure 5 shows intense bacterial proliferation in the vicinities of the cracked area.

At 3 months, SEM images revealed intense bacterial colonization in the regions where the glazed layer was cracked or partially detached. According to Taylor et al. (14), a small increase in surface roughness has a significant effect on microbial adherence because the microscopic niches on resin surface lodge and protect the entrapped microorganisms. The pioneering species are easily established and colonization readily takes place because of the interbacterial affinity and the difficult of removal.

In this study, glaze cracks may have occurred due to the rigidity that the glaze layer acquires after polymerization. Szabó et al. (15,16) have observed *in vitro* an increase of surface hardness and a decrease in the impact strength and transverse bending strength of resin surfaces coated with a surface glaze (Permalink; G.C. Dental Ind., Tokyo, Japan).

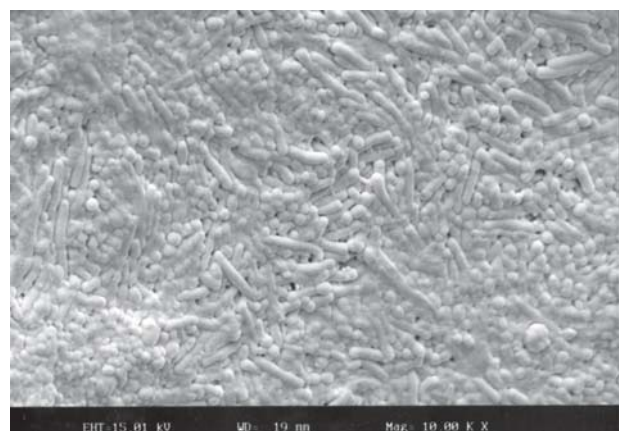
Figure 5. Glazed side (3 months). Greater magnification of the cracked area on Figure 4 (rectangle), showing bacterial outgrowth. Original magnification X10000.

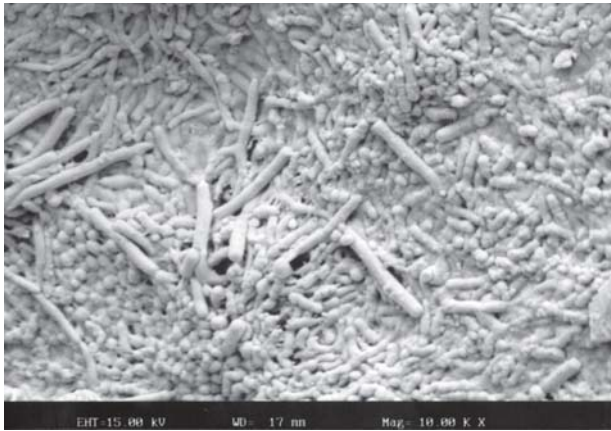
Figure 6. Non-glazed side (3 months). Dense plaque film. Original magnification X10000.

Generally, the non-glazed specimens presented a dense plaque film with characteristics of mature plaque (Fig. 6).
