# Influence of surface treatment and cyclic loading on the durability of repaired all-ceramic crowns

**O**bjective: This study investigated the durability of repaired all-ceramic crowns after cyclic loading. Material and methods: Eighty In-ceram zirconia crowns were fabricated to restore prepared maxillary premolars. Resin cement was used for cementation of crowns. Palatal cusps were removed to simulate fracture of veneering porcelain and divided into 4 groups (n = 20). Fracture site was treated before repair as follows: roughening with diamond bur, (DB); air abrasion using 50 µm Al<sub>2</sub>O<sub>3</sub>, (AA) and silica coating using Cojet system followed by silane application, (SC). Control group (CG) 20 specimens were left without fracture. Palatal cusps were repaired using composite resin. Specimens were stored in water bath at 37°C for one week. Ten specimens of each group were subjected to cyclic loading. Fracture load (N) was recorded for each specimen using a universal testing machine. Two-way analysis of variance (ANOVA) and Tukey honestly significant difference (HSD) test ( $\alpha=0.05$ ) were used for statistical analysis. Results: There was statistically significan

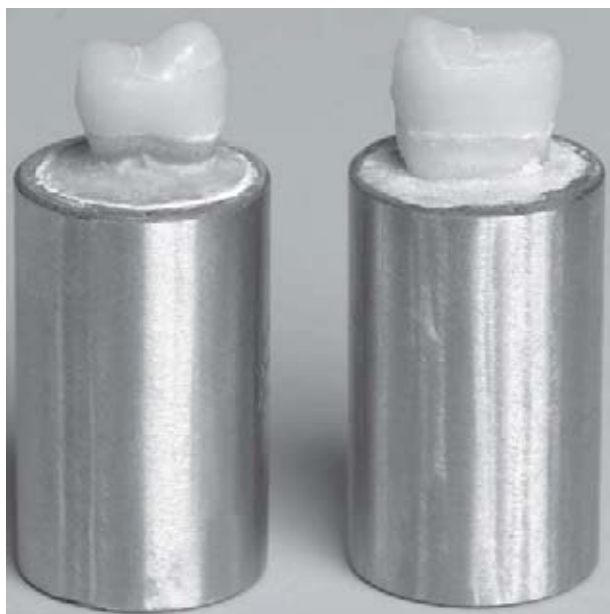
**Figure 1-** Fractured and repaired specimens

amounts of adhesive resin cement (Multilink automix, Ivoclar Vivadent) were extruded, mixed for 20 s and applied to the intaglio surfaces of crowns. Each crown was seated to its respective prepared tooth and kept under a static pressure of 40 N for 7 minutes in a loading apparatus<sup>7,14</sup>. The excess of luting cement at the margin was removed immediately. One hour after cementation, veneering porcelain of palatal cusps of sixty crowns were completely removed using porcelain finishing stone (# 6844.374-016, Komet Medical, Germany) to expose the In-ceram zirconia core to simulate fracture of veneering porcelain with core exposure<sup>11</sup> (Figure 1). The other 20 specimens left without palatal cusp fracture served as control group. Fractured specimens were divided into 3 groups (n=20) according to surface treatment of the fracture site before repair as follow; roughening with diamond bur, (DB), air borne particle abrasion with 50  $\mu\text{m}$   $\text{Al}_2\text{O}_3$ , at a pressure of 2.8 bars for 5 s at a distance of 10 mm (AA) and silica coating using Cojet system (3M ESPE, Seefeld, Germany) as follow: air borne particle abrasion with 30- $\mu\text{m}$   $\text{SiO}_2$  particles at a pressure of 2.8 bars for 20 s at a distance of 10 mm followed by silane application<sup>28</sup> (ESPE Sil, 3M ESPE), (SC). Five minutes were allowed to elapse for silane reaction<sup>28</sup>. Bonding agent (Visio Bond, 3M ESPE) was applied on the fracture site of all test groups

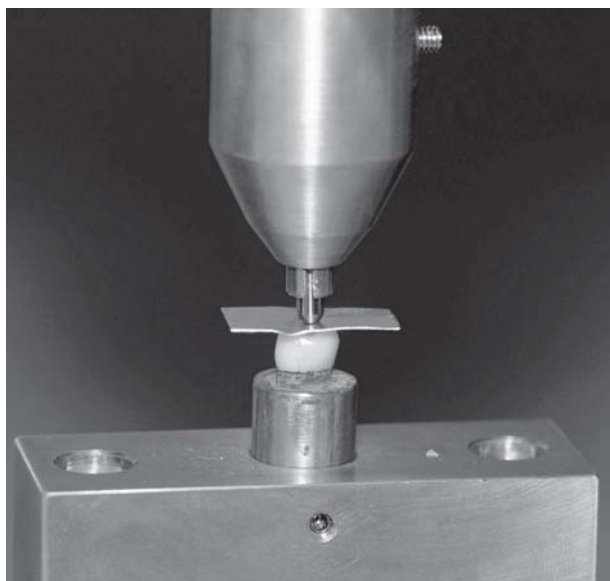
**Figure 2-** Applying the compressive load along the long axis of test and control specimens

repaired cusp, a 1 mm thin piece of polyethylene vacuum-forming foil (copyplast 1.0, Scheu-Dental, Iserlohn, Germany) was placed between the stainless steel bar and the crown (Figure 2). The compressive load required to cause fracture (N) was recorded for each specimen (Figure 3). Two-way analysis of variance (ANOVA) followed by serial one-way ANOVA with and without cyclic and Tukey's HSD test at significance level of .05

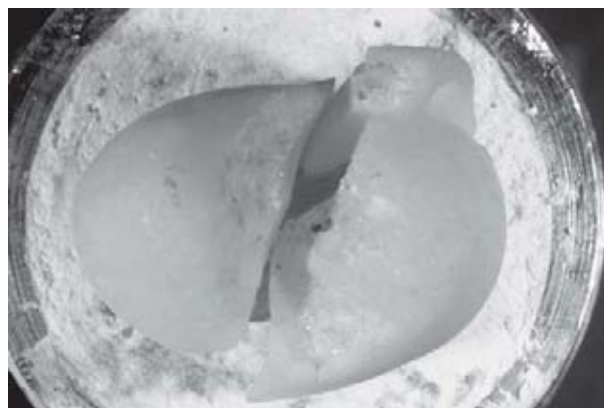
**Figure 3-** Fractured specimen after application of compressive load
