Some Observations on Wear and Damages in Cemented Carbide Tools

Keywords: Cemented carbide tools, milling, tool damage, thermal fatigue

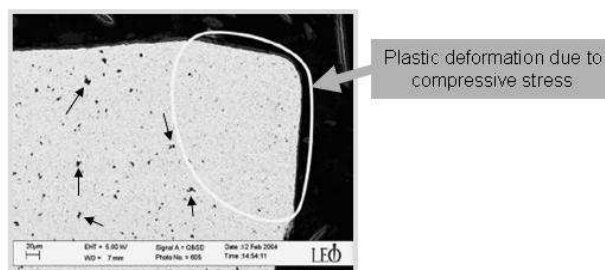
Figure 1. SEM micrograph of the deformed WC-TaC-Co cemented carbide. The image shows an overview of a cutting edge cross-section. The porosity (black spots, some pointed by arrows) seen in the bulk region is absent in the deformed region (Östberg *et al.*, 2006).

Figure 1 shows an example of plastic deformation under compressive stress obtained by Östberg *et al.* (2006). The cutting

edge of a WC-TaC-Co cemented carbide cutting tool after turning SS 2541 steel shows a strong evidence of plastic deformation. As can be seen the region of the cutting wedge affected by high compression stress during the cut presents absence of porosity, unlike the bulk region.

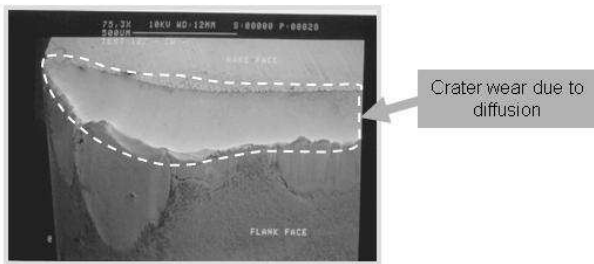
Figure 2. Rake face wear overview of an ISO K20 cemented carbide cutting tool after machining Ti-6Al-4V (Machado, 1990).

Figure 2 shows an ISO K20 uncoated cemented carbide cutting tool after machining Ti-6Al-4V alloy. It can be observed a crater wear on the rake face very close to the cutting edge. According to Machado and Wallbank (1990) this characteristic is peculiar when machining titanium alloys.

Crater wear on cemented carbide cutting tools is normally formed due to diffusion, where interchange of atoms occurs between rake face and chip root at the seizure zone, and it is strongly dependent of temperature, time and solubility of the involved elements (Machado, 1991).

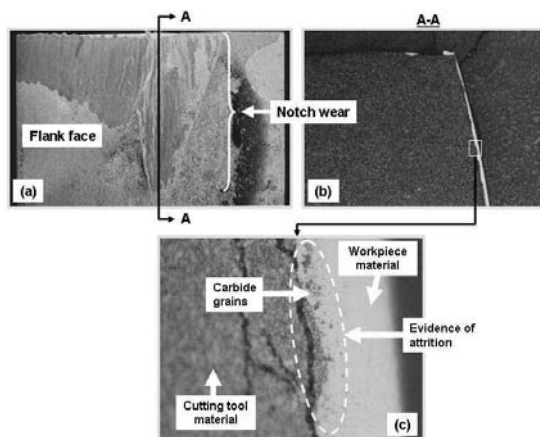
Figure 3. Sequence of pictures showing evidence of attrition wear on a notch wear region of an ISO K20 cemented carbide cutting tool after machining Inconel 901 (Machado, 1990).

A sequence of pictures in Fig. 3 shows evidences of attrition wear obtained by Machado (1990). In the specialized literature (Hutchings, 1992 and König and Klocke, 1997), attrition is frequently treated as adhesion. Who first introduced the term “attrition” was Edward Trent. This wear mechanism generally occurs under low cutting speeds, due to the irregular flow of chip material on the rake face and it is very common when built-up-edge (BUE) is present. Attrition consists basically in: (1) adhesion of workpiece material on the cutting tool surfaces; (2) breakaway of microscopic particles of the cutting tool material and (3) dragging of these particles on cutting tool surfaces, generally causing abrasion.

Figure 3(a) shows a typical notch wear on the flank face of an ISO K20 cemented carbide cutting tool after machining Inconel 901 with a layer of workpiece material adhered on this region. On section A-A [Fig. 3(b)] it is possible to observe a layer of workpiece material adhered during machining on the notch region of the flank face. Figure 3(c) shows a magnification of tool-adhered layer interface. It is observed a large crack running parallel to the flank face, which appeared during metallographic sample preparation. What is most important in this figure is the evidence of the carbide grains that were detached from the flank face of the cutting tool flowing within the work material layer (adhered layer). This is what Trent and Wright (2000) call attrition.

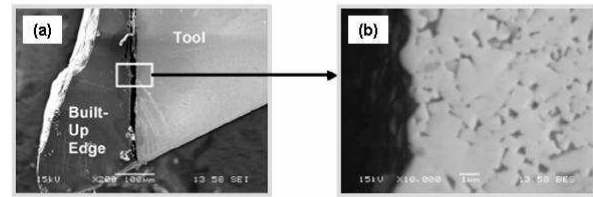
Figure 4. SEM images of a polished uncoated WC-Co cutting tool section after machining an aluminum alloy during 7min; $v_c=60\text{m/min}$ and $f=0.1\text{mm/rev}$. (List *et al.*, 2005).

Figure 4(a) shows a huge BUE formed after machining an aluminum alloy under low cutting speed obtained by List *et al.* (2005). According to the authors this condition is characterized by the combination of lowest temperatures and highest pressures at the tool-chip interface, which leads to adhesion by interlocking of the rake face asperities of the WC grains as showed in figure 4(b). In this situation, if the presence of BUE on the rake face is instable, it

can draw out small particles of the cutting tool causing attrition and consequently progressive wear of the cutting tool.

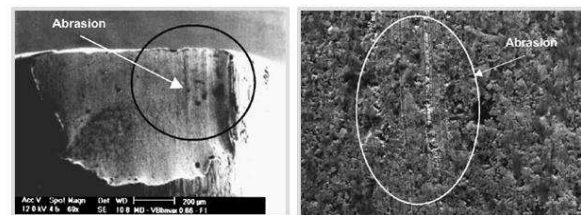
Figure 5. Evidence of abrasion on a cemented carbide tool (Corrêa *et al.*, 2005).

Figure 5 shows an example of abrasion wear on the flank face of a WC+Co cemented carbide cutting tool coated with TiCN+Al₂O₃+TiN after simultaneously boring two distinct materials. In this case, when machining bimetallic bearings composed by GH190 lamellar gray cast iron and Fe-C-Cu steel alloy (Corrêa *et al.*, 2005). It can be noticed the presence of some parallel grooves formed by flow of the workpiece material during machining. According to the authors abrasion occurred only when machining the bearing's half composed by GH190 gray cast iron.

Abrasion wear on cutting tools happens when tool material is removed or dislocated by hard particles that can be loose, between chip and rake face, or emerging from workpiece material and/or from cutting tool material (Machado and da Silva, 2004).

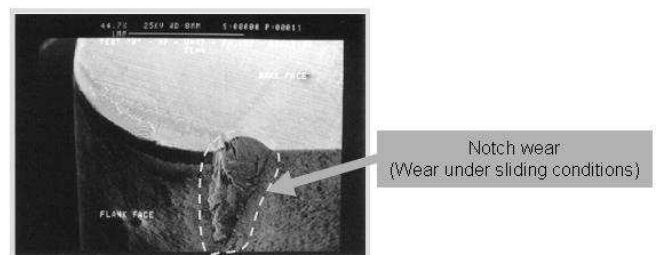
Figure 6. Notch wear observed on the flank face of an ISO K20 cemented carbide cutting tool after machining of Inconel 901 (Machado, 1990).

Figure 6 shows an example of a notch wear occurred on flank face of a K20 cemented carbide cutting tool after machining Inconel 901 (Machado, 1990). It can be seen evidences of attrition in the notch. Notch wear is a type of wear and not properly a mechanism of wear. However, there is no consensus in the literature explaining the mechanism that causes this type of wear (Machado and da Silva, 2004).

Notch wear occurs mainly when machining materials with poor thermal properties such as nickel alloys, titanium, cobalt and stainless steel and it can develop either on the flank face and on the rake face of a cutting tool. According to Trent and Wright (2000), this type of wear generally occurs in regions where sliding condition persists and involves abrasion and attrition and suffers strong influence of the atmosphere, mainly due to the amount of oxygen.

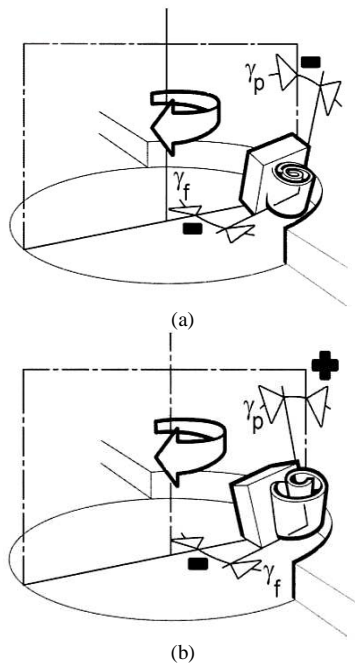
Figure 7. Tool geometries recommended when milling hard materials: (a) negative tool geometry and (b) positive-negative tool geometry (Anonymous, 1994).

When milling hard materials, or in the presence of intense mechanical impacts during machining, a double negative tool geometry [negative axial (γ_p) and radial (γ_f) rake angles] is recommended, although a positive-negative tool geometry [positive axial (γ_p) and negative radial (γ_f) rake angles] can also perform well. With these tool geometries, the cutting wedges possess higher strength to cope with the adversities of inherent mechanical shocks (Anonymous, 1994). These angles are illustrated in Fig. 7.

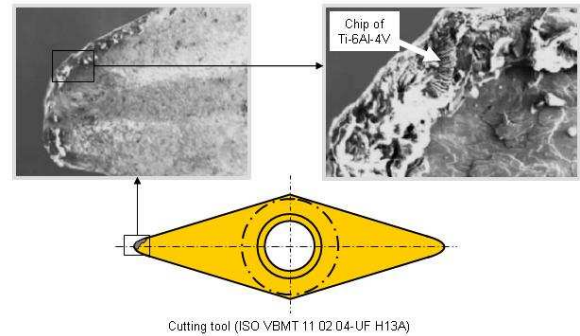
Figure 8. Adhesion of Ti-6Al-4V on cutting edge of the cemented carbide after turning (adapted from Ribeiro *et al.*, 2003).

Kabaldin (1980), the chips of some work materials, such as titanium and stainless steel, tend to stick and gall onto the tool's rake faces just before the tool teeth exit the workpiece, where they get stuck during the idle moments in a milling cutter revolution. When the tool's teeth reenter the workpiece upon resumption of the cutting cycle, the chips can cause edge chipping in the tools. Figure 8 shows a phenomenon like this when turning Ti-6Al-4V with cemented carbide. It can be observed the strong adhesion of the chip and workpiece materials on the cutting edge.

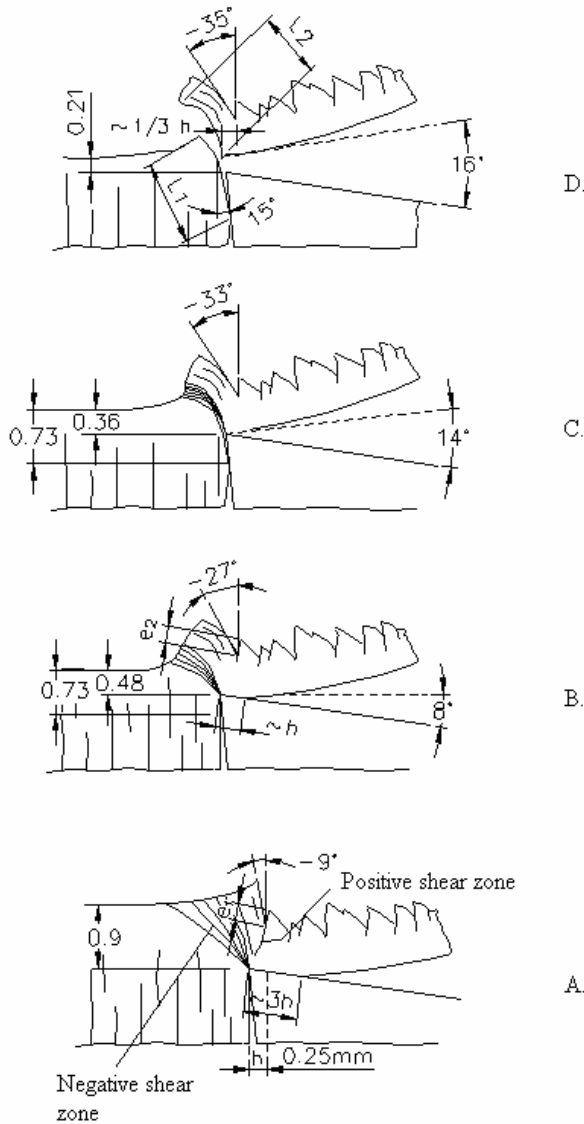
Figure 9. Sequence of the phenomenon of foot forming according to Pekelharing (1978).

According to Pekelharing (1978), excessive tool chipping can also occur when the tool's teeth are exiting the workpiece. This author observed the behavior of the primary shear plane that rotates and becomes negative as the tool exits the workpiece. The ultimate result of this process is the formation of what the author called *foot forming*, because the chip thus formed resembles a human foot. The negative shear resulting from the primary shear plane rotation causes the chip velocity to become negative, producing tensile stress on the rake face of the tool tip, which, in turn, is responsible for ploughing off small quantities of material from the tool's surface, causing fracture or chipping. Figure 9, illustrates the *foot forming* phenomenon.

- a) In diagram A of Fig. 9, the tool edge is about 0.9mm from emerging out of the trailing edge of the workpiece. The negative shear begins here, although the positive shear zone is still visible. The foot follows the direction of the negative shear and a rotation of the plane with an angle of -9° is visible. The chip rests in a chip-tool contact length of approximately $3h$ with null rotation.

- b) In diagram B, the tool edge is only 0.48mm from the trailing edge of the workpiece. The negative primary shear plane shrinks, now with even greater rotation, showing an angle of -27° with the chip showing a slight rotation of 8° , as well. The chip-tool contact length is reduced to approximately $1h$. Note, also, that the shear at the positive shear plane has expired, working only as a connection between the foot and the rigid part of the chip, or "the leg". A crack may begin to develop at the lower end of the negative shear plane.

- c) In diagram C, the tool edge is now 0.36mm from the trailing edge of the workpiece. The negative shear plane becomes thinner, curving even further towards the left. Now the inclination angle of this plane is -33° and the chip has rotated to an angle of 14° . The crack in this shear plane has increased at this stage.

- d) In diagram D of Fig. 9, the tool edge has still 0.21mm to traverse before emerging from the trailing edge of the

workpiece, while the foot and leg are already free of the workpiece. This situation occurs because the crack has progressed throughout the entire negative shear plane. At this moment, the angle of this plane is -35° and the chip-tool contact length is only approximately $1/3h$, with the chip rotating at an angle of 16° .

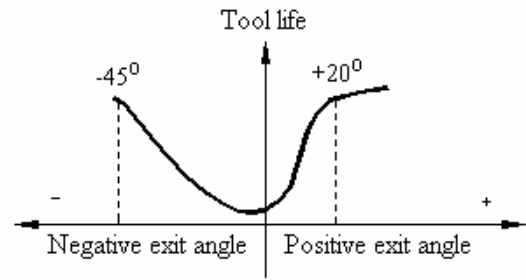
Figure 10. Safe tool exit angles (Anonymous, 1994).

The negative shear caused by the rotation of the primary shear plane promotes a negative chip velocity, briefly producing tensile stress along the chip-tool contact length. This process happens very quickly, so that the tool, which a moment earlier was undergoing a highly compressive stress, is now under tensile stress. This change can cause breakage of the tool tip if it is not sufficiently tough. This type of failure can be prevented by chamfering the trailing edge of the workpiece or by establishing a tool exit angle, ϵ , of more than 20° or less than -45° , as illustrated in Fig. 10. With these cutting geometries, the undeformed chip thickness is small enough to prevent tool damage.

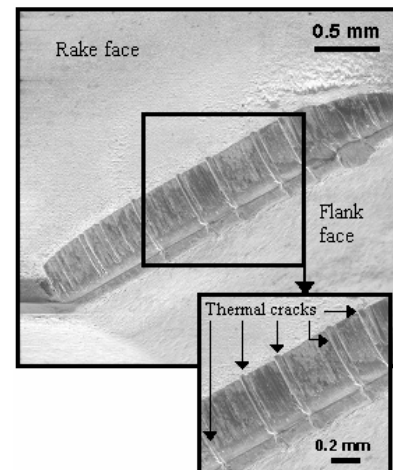
Figure 11. Thermal cracks in a cemented carbide tool (Melo, 2001).

Thermal fatigue in cemented carbide tools occurs frequently in interrupted cutting such as milling operations. Thermal fatigue in cutting tools is evidenced by the development of cracks running along the rake and flank faces perpendicularly to the cutting edge, as illustrated in Fig. 11.

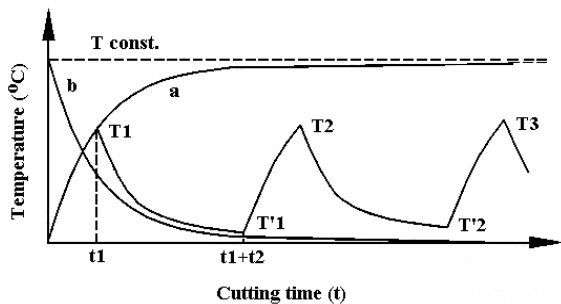
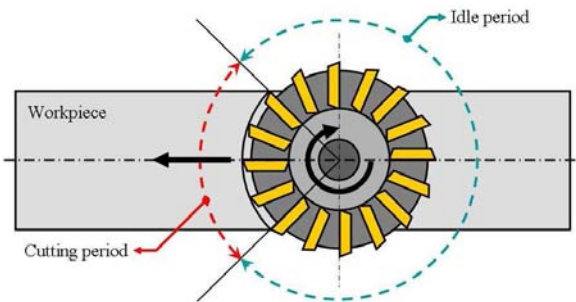
Figure 12. Cyclical variation of the cutting temperature in an interrupted cutting process (adapted from Palmai, 1987).

Trent and Wright (2000) explain that these cracks are promoted by the cyclic expansion and contraction of surface layers of cutting tools when they are cyclically heated and cooled during cutting processes. Figure 12 depicts the thermal cycle that a tool experiences during continuous and interrupted cutting. Curve **a** represents the heat that builds up in continuous cutting, in which the temperature tends to stabilize at a certain value. In practice, this value increases with wear. Curve **b** represents the continuous cooling of the tool from the cutting temperature down to room temperature.

In an interrupted cutting process such as milling, during the cutting time, t_1 , the tool heats to a given temperature, T_1 . The idle

period starts at that point and lasts for a given time, t_2 , during which the tool cools, reaching temperature T'_1 at the end of time $t_1 + t_2$. At that point, the tool resumes cutting and the cycle is repeated in each revolution of the milling tool.

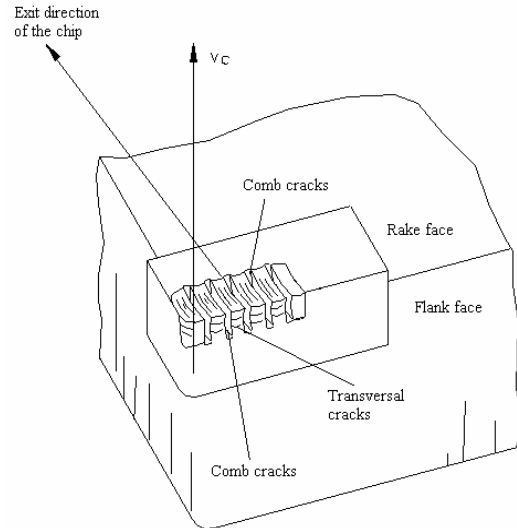
Figure 14. Comb cracks (Ferraresi, 1977).

These temperature fluctuations are more common in interrupted cutting, but they can also occur in response to frequently irregular access of cutting fluid at the chip/tool interface in continuous cutting, caused, for example, by the formation of a nest of swarf. After a certain number of cycles, thermal cracks appear on the tool surface (see Fig.11), subsequently transforming into comb cracks, as shown schematically in Fig. 14, if the cut continues.

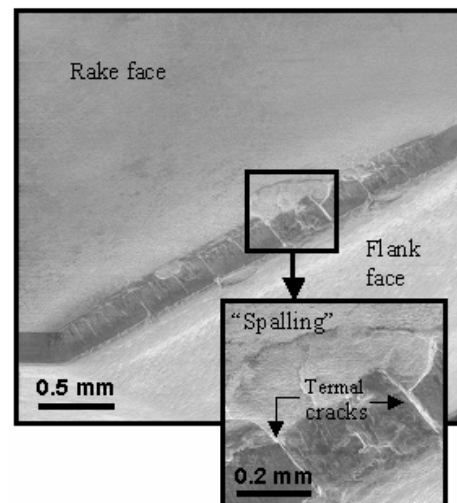
Figure 15. Cutting edge of a P25 uncoated cemented carbide after face milling a 1000mm long steel bar ($v_c=240\text{m/min}$; $f_z=0.15\text{mm/tooth}$; $doc=2.0\text{mm}$) (Melo, 2001).

Variations in temperature ($\Delta T = T_1 - T'_1$) cause variations in stress on the tool surface, and are therefore a determining factor of cracking. Thermal cracks normally initiate at the hottest point of the chip/tool interface (about 0.1 to 0.3mm from the cutting edge) and propagate towards the cutting edge and the flank surface. These thermal cracks therefore run perpendicularly to the cutting edge. They may occasionally encounter mechanical cracks running parallel to the cutting edge, which can lead to chipping and/or spalling at the tool surface, drastically reducing the tool’s life. Figure 15 illustrates this phenomenon.

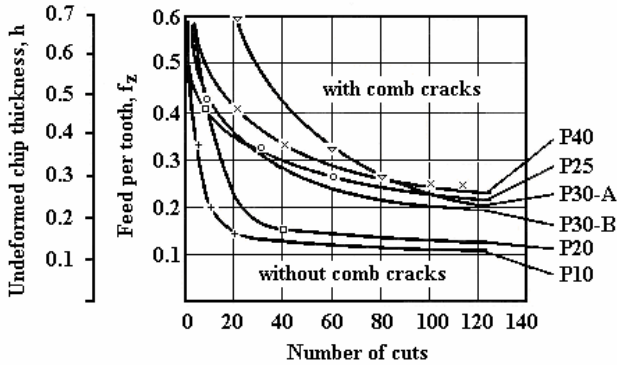
Figure 16. Ultimate thermal crack curves for face milling AISI 1045 steel with various grades of cemented carbide tools; $v_c=148\text{m/min}$; $\text{doc}=5\text{mm}$, after Lehwald (1963), cited by Ferraresi (1977).

Ferraresi (1977) presented thermal crack results obtained by Lehwald (1963) after testing P10, P20, P25, P30 and P40 grade cemented carbide tools in the face milling of AISI 1045 steel. Figure 16 shows the ultimate thermal crack curves for each tool grade as a function of the feed per tooth and the number of cuts (number of milling cutter tool revolutions).

As can be seen, the number of cuts required for the first crack to appear decrease as the feed per tooth increases. Such diagrams are particularly useful for adjusting cutting parameters when machining a certain tool/workpiece pair, because they enable one to select a feed per tooth ratio that precludes thermal cracking. Figure 16 also shows that P10 and P20 tool grades are less resistant to thermal crack formation.

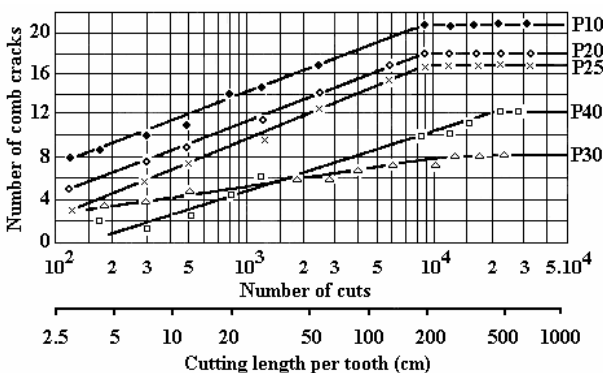
Figure 17. Number of thermal cracks versus number of cuts for several cemented carbide tool grades; work material: AISI 1045 steel; $v_c=170\text{m/min}$; $f_z \times \text{doc}=0.25 \times 5\text{mm}^2$, after Lehwald (1963), cited by Ferraresi (1977).

The number of thermal cracks generated on a tool surface is limited (Ekemar *et al.*, 1970), and was dubbed “thermal crack limit number” by Ferraresi (1977). Figure 17 presents the behavior of various cemented carbide tool grades after tests conducted by Lehwald (1963) and also reported by Ferraresi (1977). The graph in Fig. 17 shows the number of thermal cracks as a function of the number of cuts (number of milling cutter revolutions). The number of thermal cracks begins by growing exponentially, after which it stabilizes at the limit number. The greater the toughness the lower the thermal crack limit number.

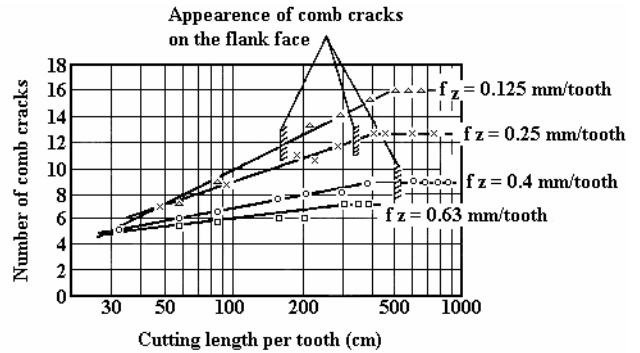
Figure 18. Number of thermal cracks along the cutting length per tooth after face milling AISI 1045 steel with P25 cemented carbide for several feed rates per tooth; $v_c=170\text{m/min}$; $\text{doc}=5\text{mm}$, after Lehwald (1963), cited by Ferraresi (1977).

Figure 18 shows how the feed per tooth affects the thermal crack limit number, according to Lehwald (1963). Note that a higher feed per tooth ratio leads to a lower thermal crack limit number. The

author explains that higher average cutting temperatures develop at higher feed rates or higher undeformed chip thickness than at lower feed rates. The result is a lower percentage reduction in tool temperature during the idle period, which leads to a reduction in the number of thermal cracks. These findings, however, disagree with those of Bhatia *et al.* (1979), who observed an increase in ΔT when the feed rate was increased during interrupted cutting.

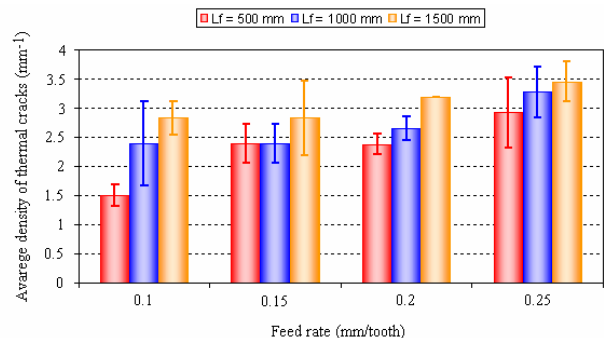
Figure 19. Average density of thermal cracks (number of thermal cracks/cutting edge active length) as a function of the feed rate for uncoated P25 cemented carbide tools after machining AISI 1045 steel through 500, 1000, and 1500mm of cutting length; $v_c=240\text{m/min}$; $\text{doc}=2.0\text{mm}$ (Melo, 2001).

Melo (2001) also found a slight increase in the number of thermal cracks at higher feed rates, corroborating Bhatia *et al.*'s findings, as shown in Fig 19. This is particularly evident when increasing the feed per tooth from 0.10mm to 0.15mm for a 500mm cutting length and from 0.20mm to 0.25mm for a 1000mm cutting length.

Melo (2001) explains that thermal stresses generated at the cutting edges of the tools are more severe when higher feed rates are used due to the increase of the temperature ΔT . An explanation for cases where an increase in feed rate did not conspicuously increase the number of thermal cracks is that an increase in the feed rate increases ΔT (Bhatia *et al.*, 1979) but also reduces the number of thermo-mechanical cycles (number of idle and cutting periods) for the same cutting length, thus reducing the risk of thermal cracking. Thus, the system must be evaluated considering both these effects. When they are evenly balanced, the density of thermal cracks remains practically unchanged, but when an increase in ΔT prevails, the density of thermal cracks increases.

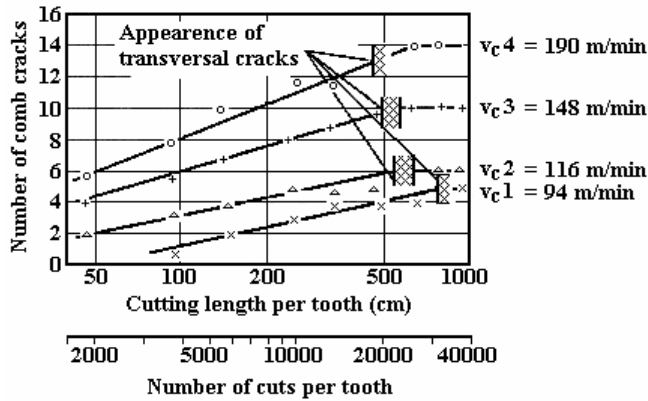
Figure 20. Influence of the cutting speed on the thermal cracks formed during milling of AISI 1045 steel with P25 cemented carbide tools, $f_z=0.25\text{mm/tooth}$; $\text{doc}=5\text{mm}$, after Lehewald (1963), cited by Ferraresi (1977).

As for the influence of the cutting speed, Lehwald's results showed that the higher this parameter the higher the thermal crack

limit number, as shown in Fig. 20. This is entirely congruous with Melo's findings shown in Fig. 21.

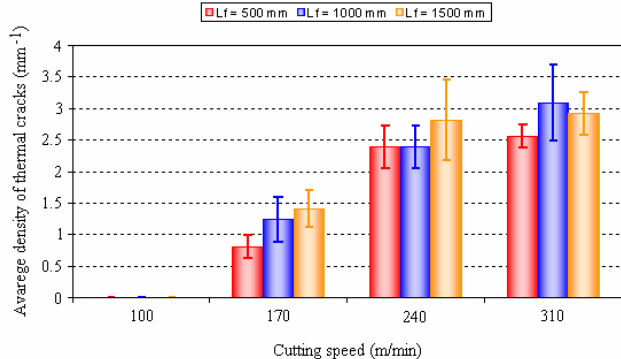
Figure 21. Average density of thermal cracks (number of thermal cracks/cutting edge active length) as a function of the cutting speed for uncoated P25 cemented carbide tools after milling AISI 1045 steel through 500, 1000, and 1500mm of cutting length; $f_z=0.15\text{ mm/tooth}$; $\text{doc}=2.0\text{ mm}$ (Melo, 2001).

This figure shows that even after the third pass (cutting length of 1500mm), a cutting speed of 100m/min was unable to produce sufficiently high temperature variations (ΔT) to cause thermal cracking. Another fact that may corroborate the absence of thermal cracking at this cutting speed is the number of thermo-mechanical cycles, which may not suffice to promote the thermal fatigue necessary to cause cracking. Possibly, with additional passes, the cracks might begin to nucleate and propagate on the tool faces. However, this possibility would have to be confirmed through further tests.

Increasing the cutting speed to 170m/min, 240m/min and 310m/min clearly also increases the density of thermal cracks, although the change from 240 to 310m/min is statistically inaccurate because there is overlapping of standard deviations. Probably at such high cutting speeds, the thermal crack limit number of Lehewald (1963) is reached earlier, and the number seems to vary only slightly, which may explain these results.

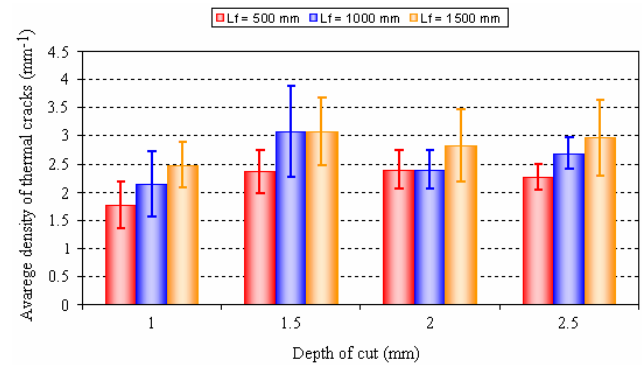
Figure 22. Average density of thermal cracks (number of thermal cracks/cutting edge active length) as a function of the axial cutting depth for uncoated P25 cemented carbide tools after face milling AISI 1045 steel through 500, 1000, and 1500mm of cutting length; $f_z=0.15\text{mm/tooth}$; $v_c=240\text{m/min}$ (Melo, 2001).

The influence of the axial depth of cut was also studied by Melo (2001), whose results are illustrated in Fig. 22.

Only slight variations in the average thermal crack density were visible within the range of depths of cut investigated (1.0 to 2.5 mm). The author attributes this result to the fact that a small depth of cut requires low cutting power, since the cutting area is small.

Consequently, the temperature developed during the cutting period is low and is also distributed in a smaller area of the tool. In contrast, large depths of cut require high cutting power, generating large quantities of heat and developing high cutting temperatures, which are distributed in a larger tool area. Practical results of these two situations indicate that only slight differences in tool temperatures occur during cutting periods. The temperature during the idle period can be similarly analyzed. With small depths of cut, an equally small area of the tool exchanges heat with the ambient air, while high depths of cut cause a larger area of the tool to exchange heat with the air. Thus, it is reasonable to assume that the difference between the maximum and minimum temperatures during each cutting cycle will not vary significantly with changes in the depth of cut. As a result, there will be no significant alterations in the thermal stresses and, hence, in the densities of thermal cracks resulting from variation in the depth of cut.

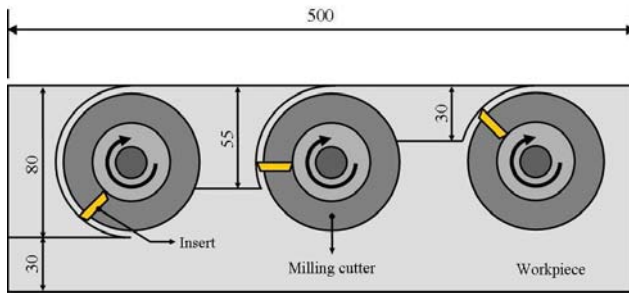
Figure 23. Relative positions of the milling cutter for cutting at a radial cutting depth of 30, 55 and 80 mm (Melo, 2001).

Another important parameter, which strongly influences the formation of thermal cracks is the radial cutting depth, or the cutting width, a_c . Melo (2001) investigated this variable as well, using three different a_c values (30, 55 and 80mm), as shown in Fig. 23.

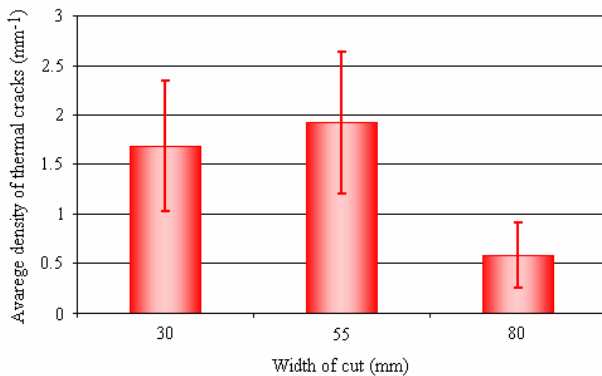
Figure 24. Average density of thermal cracks (number of thermal cracks/cutting edge active length) as a function of the radial cutting depth for uncoated P40 cemented carbide tools after face milling AISI 1045 steel through 500mm of cutting length; $d_{oc}=2.0\text{mm}$; $f_z=0.15\text{mm/tooth}$; $v_c=240\text{m/min}$ (Melo, 2001).

Figure 24 shows the results obtained. There is no significant variation between the number of thermal cracks formed at radial cutting depth of 30 and of 55mm. However, when a radial cutting depth of 80mm was used, the number of thermal cracks dropped considerably. Again, the behavior of temperature variation ΔT is responsible for this result. Increasing the radial cutting depth also causes the cutting time to increase and the idle time in a cycle, or in a milling cutter's rotation, to decrease. This will lead to a reduction in the ΔT and in the number of thermal cracks. This behavior had already been reported by Zorev in 1963.

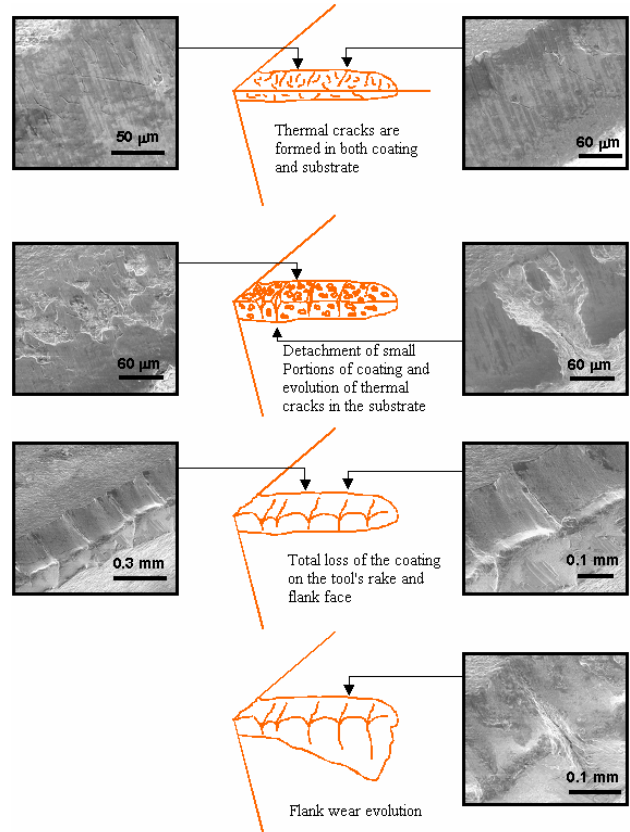
Figure 25. Different stages of thermal crack formation and wear evolution of ISO P45-coated tools during face milling of AISI 1045 steel with flood application of a cutting fluid (Melo, 2001).

The cutting fluid is another agent that strongly influences the process of thermal crack formation. The use of a cutting fluid in milling processes may be highly detrimental to the tool's life, depending on the cutting parameters, tool material and the type of damage involved. In the presence of thermal cracks, the cutting fluid will accelerate their nucleation process and reduce the tool's life regardless of the type of cutting fluid used (Vieira *et al.*, 2001). In his investigation, Melo (2001) also took into account the application of cutting fluids. He demonstrated that using a flood of cutting fluid during the milling process caused the thermal crack tool damage to rapidly trash the tool, while cutting without fluid, in the dry mode, delayed the formation of thermal cracks and prolonged the tool's life. Figure 25 contains a sequence of photos showing the rapid evolution of wear on an ISO P45 cemented carbide tool coated with TiN + TiCN during the face milling of an AISI 1045 steel with the flood application of a cutting fluid. As can be seen, the cutting fluid accelerates the formation of thermal cracks in both coating and substrate, exposing the tool to other negative effects of the milling process and rapidly ending its useful life. This figure depicts the following stages:

- i) Formation of multiple cracks in the coating and several in the substrate;
- ii) The cracks formed in the coating join, causing partial detachment of the coating and exposing small regions of the substrate, leading to the development of a comb crack formation pattern;
- iii) Total loss of the coating on the tool's rake face;
- iv) Evolution of flank wear.

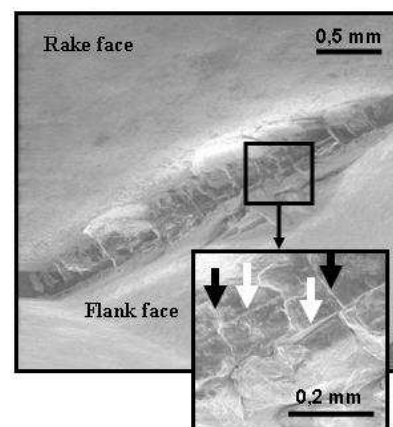
Figure 26. Cutting edge of a P25 uncoated cemented carbide after wet face milling a 1000 mm long steel bar ($v_c=310\text{m/min}$; $f_z=0.15\text{mm/tooth}$; $d_{oc}=2.0\text{mm}$) (Melo, 2001).

During interrupted cutting as in milling, other cracks of mechanical origin, besides thermal cracks that run perpendicular to the cutting edge, may appear and run parallel to the cutting edge. These are cracks developed by mechanical fatigue in the way already explained. Figure 26 shows an example of mechanical cracks (white arrows) and thermal cracks (black arrows) running on an ISO P25 cemented carbide tool's surface. Many of them will appear transversally at the ridges formed on a tool with comb cracks.

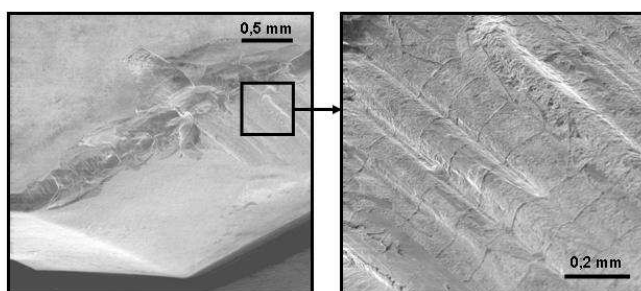
Figure 27. Detail of mechanical cracks developed on the flank face parallel to the cutting edge of an uncoated ISO P25 cemented carbide tool after milling AISI 1045 steel (Melo, 2001).

These transversal cracks are attributed to fluctuations in the mechanical loads acting on the cutting wedge, which is common in such interrupted processes. Constant shear loading and unloading on the rake and flank surfaces of the tools at every rotation of the tool causes mechanical fatigue and nucleation of cracks running transversally to the chip flow on the tool's rake face parallel to the cutting edge. If the tool/workpiece contact area is large enough due to flank wear, a tribological situation similar to that of the rake face will occur, and mechanical fatigue will also occur on the tool's flank face, as indicated in Fig. 27.
