Surface modification of a granite building stone in central Rio de Janeiro

JOSÉ A. BAPTISTA-NETO^{1,3}, BERNARD J. SMITH², JOHN J. McALLISTER²
MARIA AUGUSTA M. SILVA³ and FABIO S. CASTANHEIRA¹

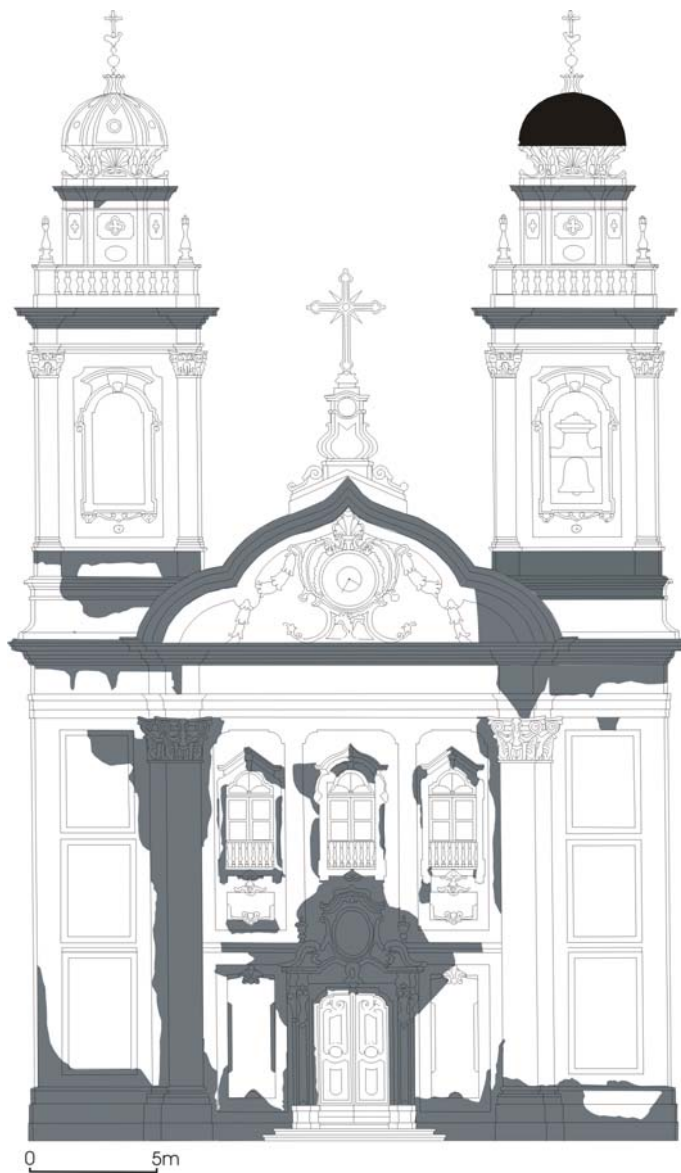
Fig. 2 – Distribution of black crust on the church of Ordem Terceira de Nossa Senhora do Monte do Carmo façade.

To highlight the degree of stone weathering in the church façade, those areas most affected by black crusts and weathering were mapped (Figure 2). Black crusts occur over most of the façade, but are more concentrated in areas sheltered from direct rain-wash, and those close to street level where granular disintegration, blistering and contour scaling of stonework were observed (Figure 3).

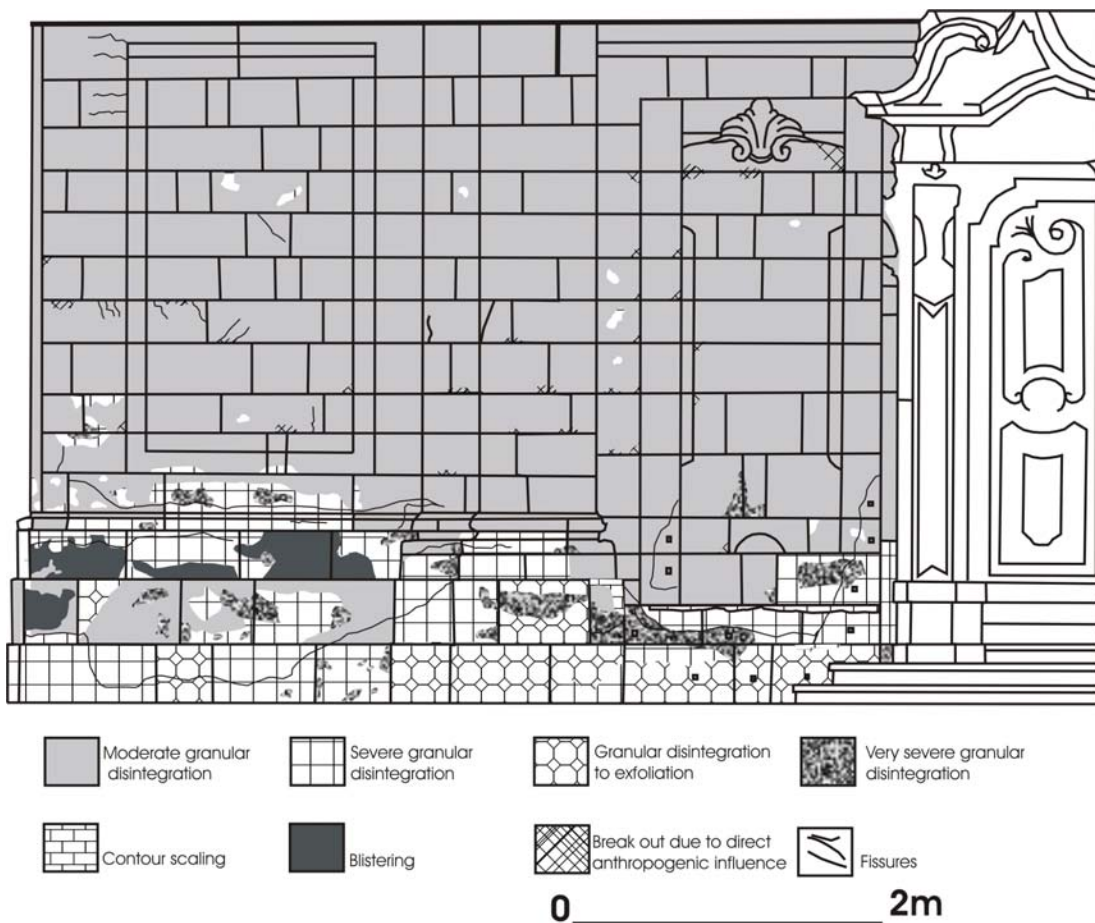
Fig. 3 – Examples of the weathering forms mapped on the façade of the church.

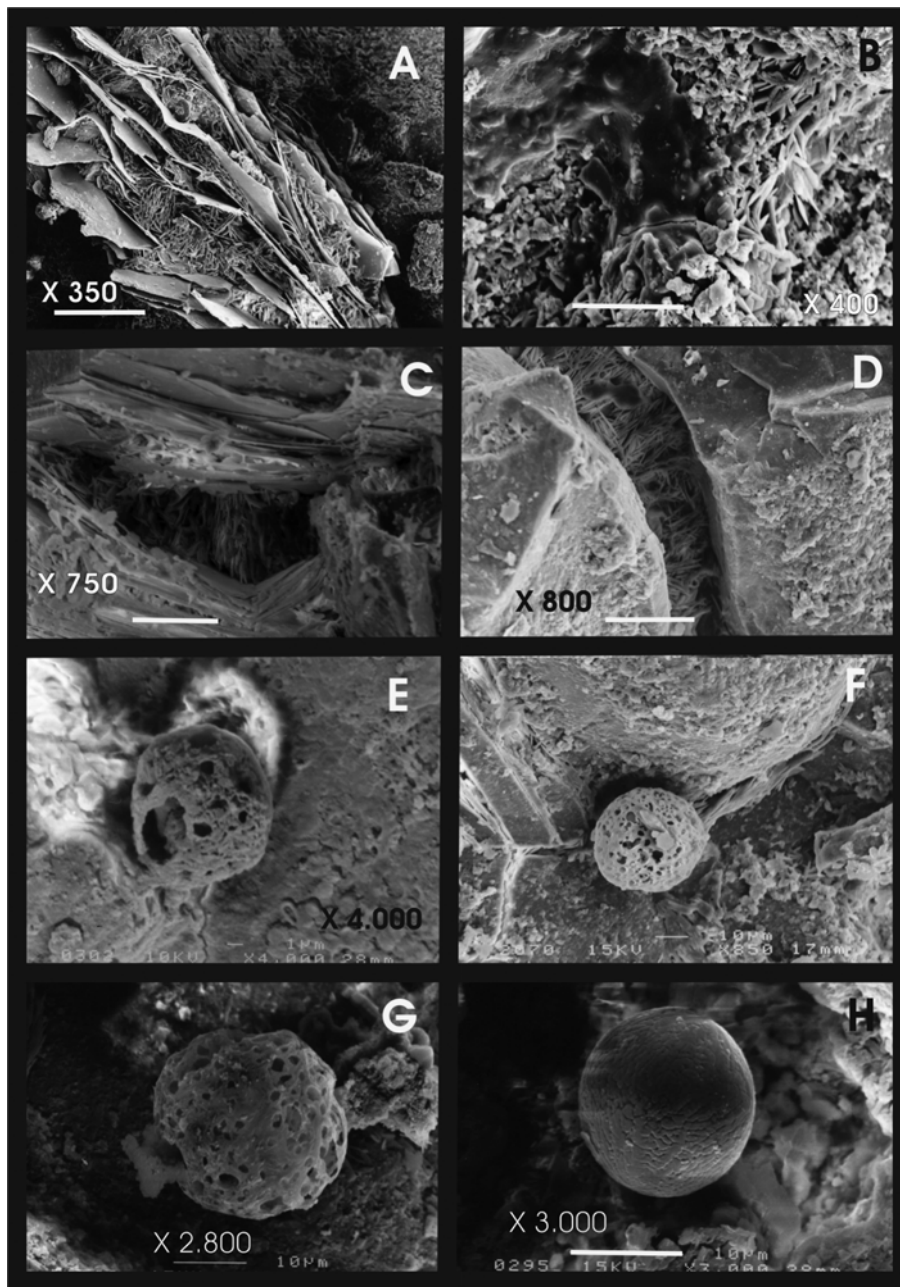
Fig. 4 – SEM micrographs of black crusts showing (A and B) needle-like crystals of gypsum accumulated in the inter- and intracrystalline fractures of quartz and feldspar crystals and bridge gaps between open cleavage planes in micas causing deformation and breaking (C and D), rounded fly ash particles from combustion of oil-based fuels (E, F, G and H).

SEM analyses of the black crusts showed high concentrations of gypsum, which occur as a needle-like crystals plus a lower concentration of halite. Gypsum crystals have accumulated in the inter- and intra-crystalline fractures of quartz and feldspar crystals and bridge gaps between open cleavage planes in micas causing deformation and breaking (Figure 4a, b, c and d). Gypsum (CaSO₄.2H₂O) crystallise in the monoclinic system. The external morphology of gypsum varies considerably depending on temperature and impurities in the water, but commonly it appears as prismatic, twinned, or as clusters and crusts. One well known variety appears as blades with curved faces (Figures 4A,

B, C and D) or lenticular forms comprised of two curved faces, the most famous of this type being the desert rose (Schreiber 1988). According to Neill and Smith (1996) micas are the main avenues of entry for agents of decay, since once their structure has been deformed, they can either form potential fluid pathways into the rock substrate, or undergo volumetric change to induce mechanical decay.

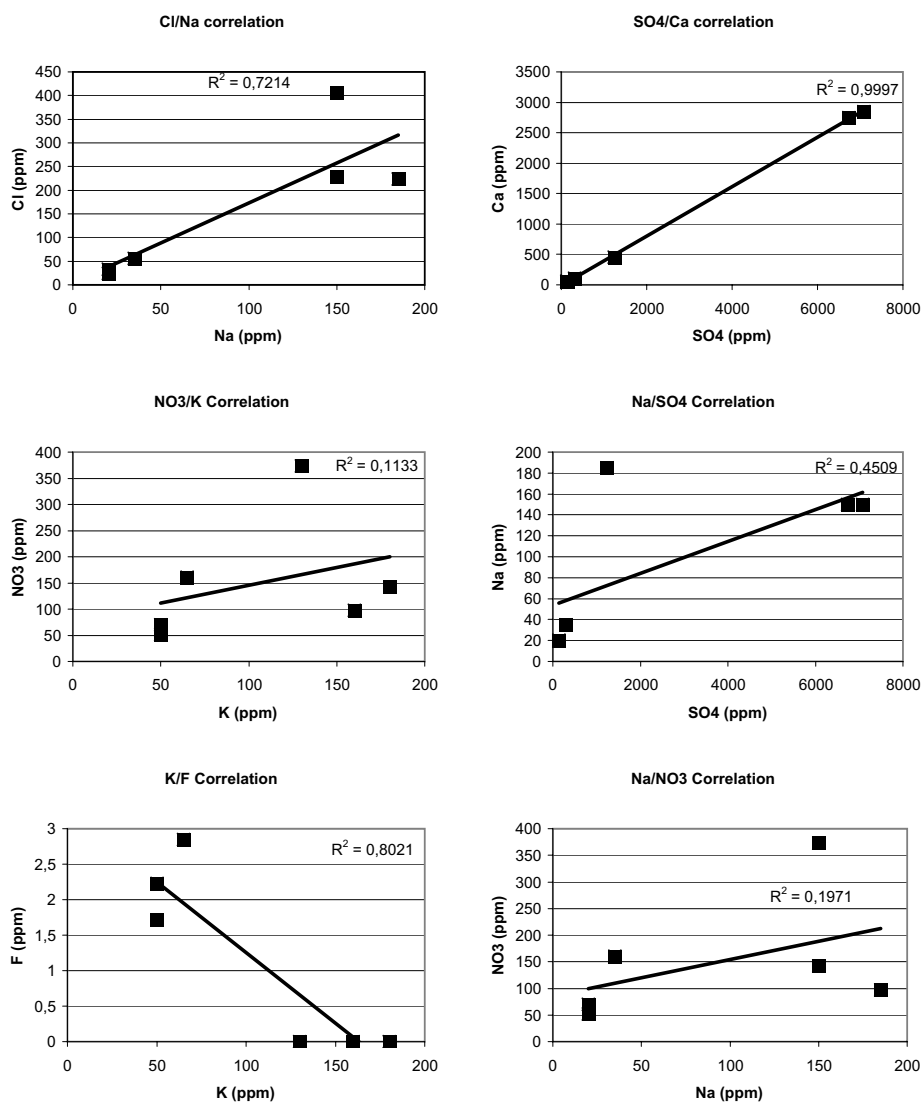
Fig. 5 – Correlation between some chemical elements.

Results for IC and AAS analyses presented in Table I highlights the high concentrations of the Ca, Na, Cl and SO_4 in the samples. A significant correlation between Ca and SO_4 is shown in Figure 5 and demonstrates the importance of gypsum formation and how it contributes to weathering on the church façade. The presence of gypsum was previously confirmed by a preliminary study of the church by Smith and Magee (1990), who used X-ray diffraction to identify multiple peaks for the mineral. Sodium and chloride are also present but do not correlate as well as Ca and SO_4 and may suggest that that salt (NaCl) weathering plays a lesser role in the weathering process, there are, also more correlation between the elements, which suggest different salts, and it will be better examined in the future research. Previous studies on precipitation chemistry in the metropolitan area of Rio de Janeiro (Mello 2001) demonstrated how precipitation was greatly affected by marine aerosols, as indicated by their high Cl^- and Na^+ concentrations. However, according to Moropoulou et al. (1998) only one third of the Cl originates from marine spray and the remainder originates from anthropogenic sources. In this study area, Ca and K are primarily of Terrestrial origin; such as soil dust, vegetation exudates and biomass burning and on this church another important source of Ca is from the mortar used for building (Smith et al. 2004). Sulphate and NO_3 are released to the atmosphere mainly by human activities, especially as a result of

fossil fuel combustion (Fassina 1991). Significant correlations between SO_4 and Ca, and to a lesser extent Na and Cl, and K, F may show the importance of atmospheric deposition (wet and Dry) rather than to material lost by the stone. Normally NaCl concentration is strongly influenced by marine aerosols and the high concentration of CaSO_4 can be explained by the presence of gypsum ($\text{CaSO}_4 \cdot 2\text{H}_2\text{O}$) observed by SEM (Figure 4). Zn, Cu, Pb, Cr, Ni and Mn concentrations in the black crusts come from urban pollution produced within the city itself by industrial combustion processes, road traffic and the wearing down of mechanical parts (Bolbély-Kiss et al. 1999, Silk et al. 1986).
