Experimental study of solid RC slabs strengthened on the upper surface

Análise experimental de lajes de CA reforçadas pela face superior

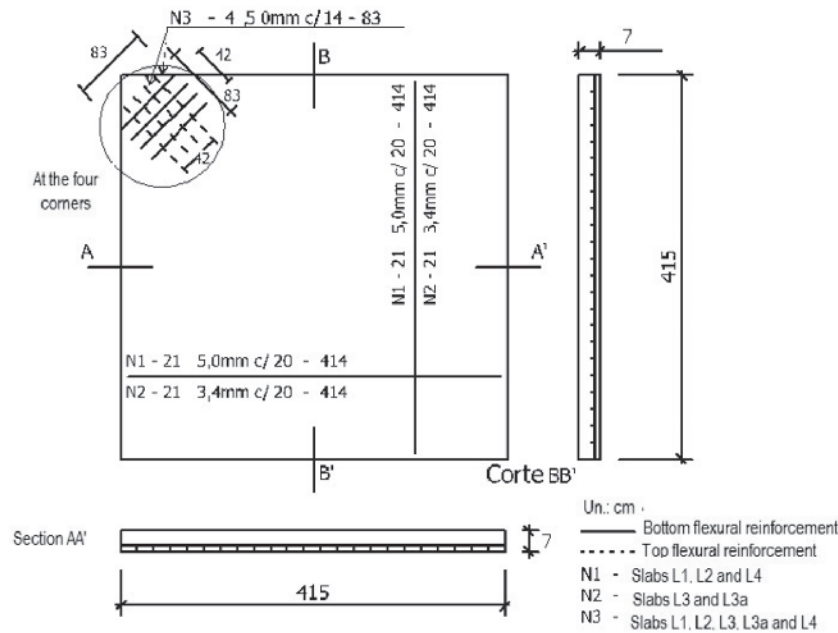
Figure 1
Details of the reinforcement in the slabs

all reinforced slabs, which were renamed L2R, L3aR and L4R. Table 1 shows the test schedule and the main variables in the tested models, whereas Figure 1 presents the nominal dimensions and details of the reinforcement in the slabs.

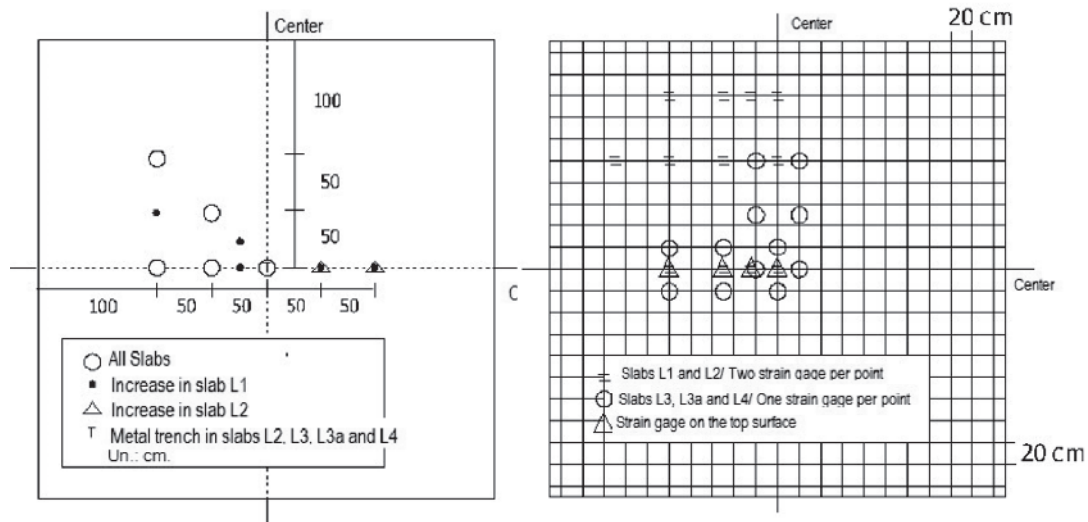
Figure 2 Position of the deflectometers and electrical strain gages fixed in the flexural reinforcement and on the concrete surface of the slabs

Mechanical analogical deflectometers were the instruments used in tests conducted to measure vertical deflections, whereas electrical resistance strain gages were used to measure steel and concrete deformations. A metal strip was positioned at the center of the slab (lower surface) in all tests, except for slab L1, in order to measure the approximate central deflection in the fracture after the mechanical deflectometers were removed. At least five Mitutoyo deflectometers, at precision 0.01 mm, were positioned on the low-

er surface of each slab. The deflections were measured in a single quadrant by positioning the devices on the central axis and in the diagonal of the slabs for symmetry purposes. Kiowa KLM PA 06 250BA 120L electric strain gages were also attached to the main flexural reinforcement, at 12 different points, of each slab. Two diametrically opposed strain gages per point were used in the lower and upper sides of the reinforcement in slabs L1 and L2. A single strain gage per point was used in the other slabs; it was fixed in the lower side of the reinforcement. Kiowa “KLM PA 06 201BA 120L” electrical strain gages were attached to four points on the concrete surface, and on the upper surface of all slabs, in order to measure the deformations. Figure 2 shows the position of the deflectometers and electrical strain gages fixed in the flexural reinforcement and on the concrete surface of the slabs.

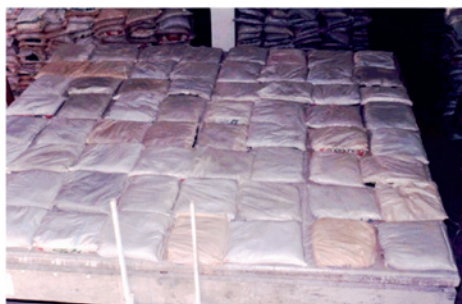
Figure 3 The bag placement sequence and slab with a load of 1,0 kN/m²

divided in 16 squares measuring 1m². Each loading stage occupied a quadrant of these squares. The bag placement sequence followed the previously established positioning instruction: bags placed from the center towards the edges, as shown Figure 3. The bags only touched each other inside each of the 16 squares in order to avoid the "bow effect". Figure 4 shows the picture of the full load on slab L4R (after strengthening), with 12 layers and 4 stacks in each square did not touching the stacks in the neighboring squares.

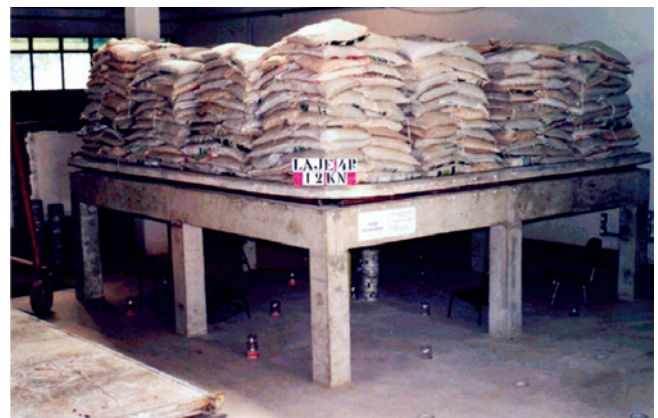
Figure 4 Slab L4R loaded of 12,0 kN/m²

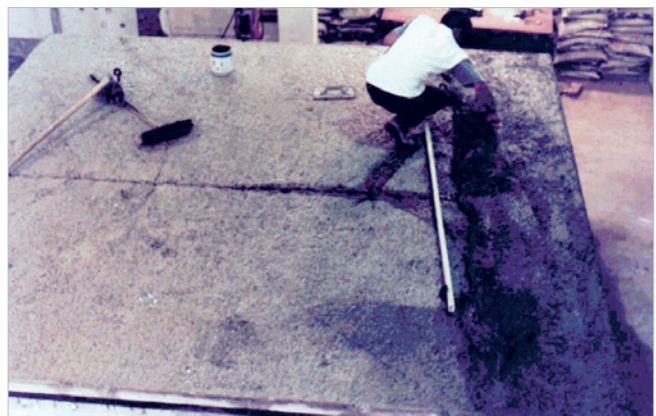
**Figure 5**

The manual chipping on the upper surface and the spreading of the strengthen layer

The strengthening was equally prepared for reinforced slabs L2R, L3aR and L4R. Firstly, a manual chipping was applied to their upper surface, with the aid of a pointer and a hammer, in order to create a rough surface without cement slurry. The chipped surface was washed with water by using a high-pressure pump to remove all loose powder and sand. A hydraulic jack was used to return the slabs to their original flat shape at the beginning of the tests. This operation was controlled through a stretched line fixed on the upper surface of the slab, in the center of the slab sides, and leveled through optical level (NA K1 - WILD). The strengthening procedure lied on applying a high-performance concrete layer, of varying thickness (2.0 cm in the edges and 4.0 cm in the center), to the upper

surface of the slab. Figure 5 shows pictures of The manual chipping on the upper surface and the spreading of the strengthen layer.

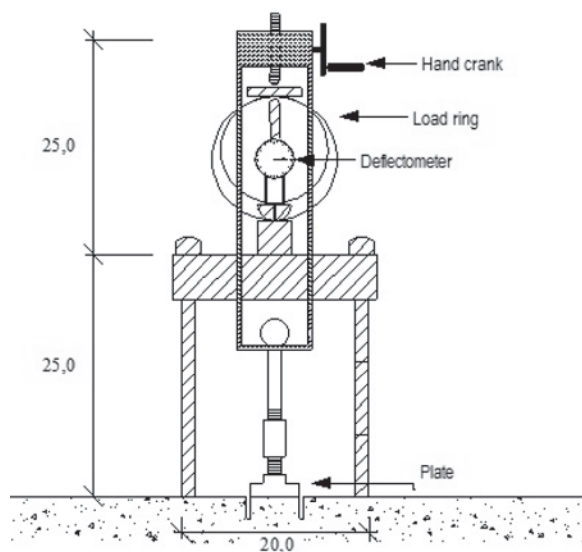
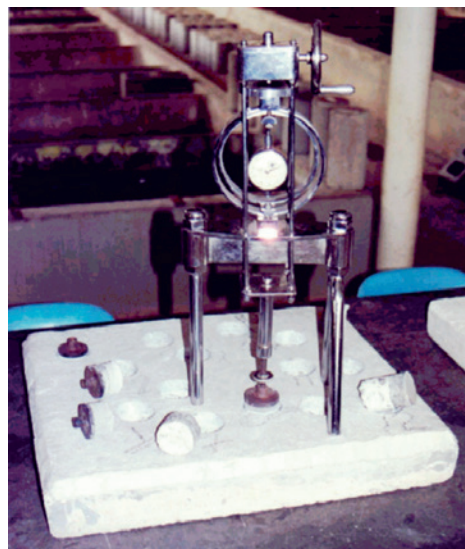
Figure 6
Arrangement of pull-off test (unit: cm)

A metal pull head plate was glued onto the specimens after they were cleaned and dried in order to distribute the applied tension. The tests were performed after the glue got hard - overall, one day after the metallic plate was glued. The pulling force was applied by using a mechanical analogical device; the force was increased by activating a crank using a fine-threaded screw, which compressed the double dynamometric ring. In turn, the ring reacted on the metallic plate glued to the strenghted layer (Figure 6). The mean test duration was 5 minutes.

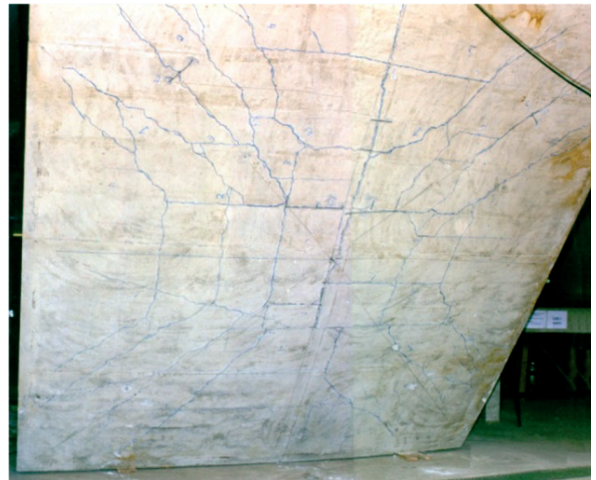
Figure 7
 Scheme of cracks pattern of slab L1 and cracks of slab L2R after failure

The first cracks visually observed in slabs L1 and L2 happened under loads 2.50 kN/m² and 2.25 kN/m², respectively. The first cracks were observed in slabs L3, L3a (with low reinforcement rate) and L4 (with low concrete compressive strength) when they were subjected to loads 1.25 kN/m² (L3) and 1.0 kN/m² (L3a and L4). The first cracks appeared in the central region towards the edges. Four (4) areas with failure lines passing through the center towards the

edges were clearly defined in advanced loading stages. Figure 7 shows the slab L1 cracking scheme and a picture of the crack on the lower surface of slab L2R.

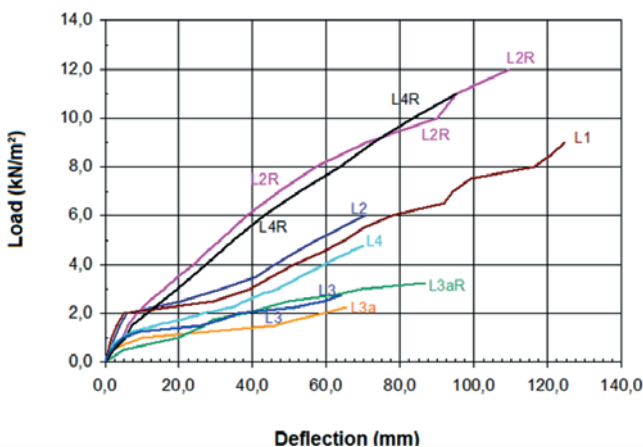
Figure 8
 Load deflection curves (all slabs)

Figure 8 shows the graph of load x central deflection in all slabs. All the slabs showed increased deflections due to increased load. Slab L1 (effective height 7.1 cm) showed the largest central deflection among all slabs; it reached 12.5 cm for the failure load 9.25 kN/m². The central deflection values of non-reinforced slabs ranged from 6.5 cm (L3a, d = 6.0 cm) to 7.5 cm (L2, d = 6.3 cm), at stop loads 2.25 kN/m² and 6.50 kN/m², respectively, except for slab L3. Slab L3, which failed at 3.0 kN/m², showed 6.4 cm central deflection at load 2.75 kN/m². Reinforced slabs L2R (d = 10.3 cm) and L4R (d = 10.0 cm) failed at 11.0 cm and 9.5 cm vertical deflections, respectively, whereas slab L3aR (d = 10.5 cm) failed at 6.9 cm deflection. It was possible seeing that the slabs showing reinforcement deficiency (L3 and L3a) and the reinforced slab (L3aR) presented the largest deflections at the lowest loads. A second group, which comprised slabs L1,

L2 (without strengthening and concrete deficiencies) and L4 (with concrete deficiency), showed deflections in the same order of magnitude, and with intermediate values, when they were compared to other slabs subjected to the same loads. The third group comprised reinforced slabs L2R and L4R, which showed similar behavior and presented the smallest deflections at loads higher than 2.0 kN/m². These smallest deflections took place due to the increased useful height deriving from concrete reinforcing layer application. Slab L3aR, which also received reinforcing layer similar to that of L2R and L4R, did not present the same deflection profile, probably because it was manufactured with flexural reinforcement deficiency.

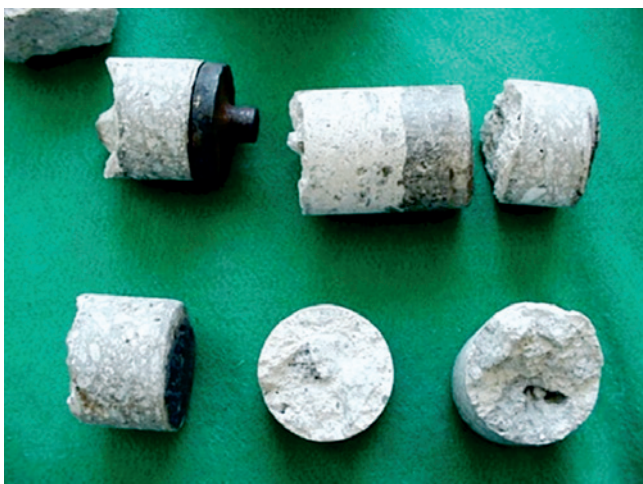
Figure 11
Failed specimens

failure surface concomitantly involving part of the old-new concrete interface and the new concrete surface. Figure 11 shows a picture of the failed specimens and indicates the failure modes.

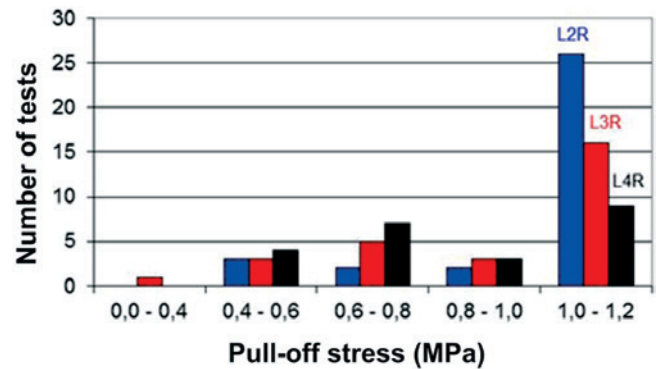
Figure 12

Histogram variation results of the pullout test slabs L2R, L3aR e L4R

in slab L4R. Although slab results indicated broader limits, there was significant concentration of values in the range between 1.0 MPa and 1.1 MPa (Figure 12).
