Localized failure analysis in a large reinforced concrete wall theater

Marcos Alves da Silva^a Luiz Carlos de Almeida^a Leandro Mouta Trautwein^a ^aUniversidade Estadual de Campinas – UNICAMP, Departamento de Estruturas, Campinas, São Paulo, Brasil

Figure 1. Reinforced concrete building with a localized failure.

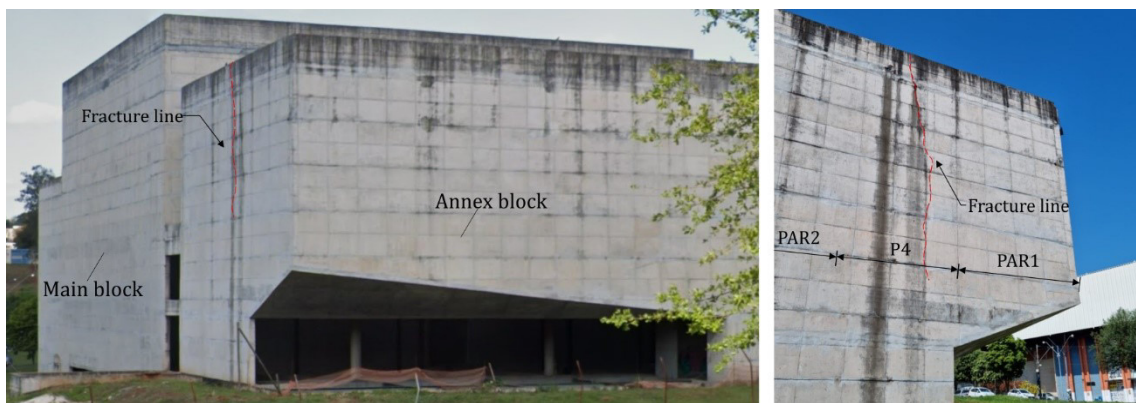
The case study presented in this work has the objective of portraying the partial failure found in a large-scale reinforced concrete building (Figure 1), under construction at the Universidade Estadual de Campinas (UNICAMP), to examine its cause and compose an accurate diagnosis. To detect the pathologies, technical visits were carried out, followed by a detailed study of the structural project, *in-situ* tests, and computational simulations through the Finite Element Method (FEM)

The building, located inside the UNICAMP campus, is an under-construction reinforced concrete building meant to be a theater, comprising two modules: the theater (main block) and the entrance building (annex block) offering access to the theater, made up of three floors, basement, mezzanine, and general top floor, inside a total area of 5669 m² (Figure 1).

A technical survey report was carried out on the construction site, due to a localized fracture followed by reinforcement rupture (see Figure 1). Among several pathological manifestations found in the building, this fracture required significant attention because it compromises structural safety. Other pathologies sources were discussed by Almeida et al. [3] and adopted rehabilitation techniques by Silva et al. [4] and Franoso et al. [5].

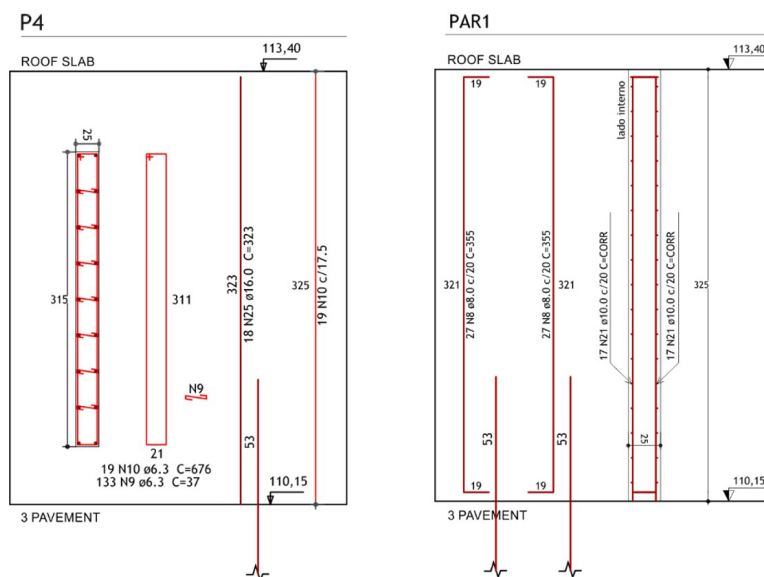
Figure 3. Reinforcement detail of the elements.

Figures 2 and 3 reproduce excerpts obtained from the executive project of the structural wall P4 and the cantilever wall PAR1. These elements create a single plane on the annex block front, where the rupture was localized within the P4 boundary. It can be noted in Figure 3a that the P4 structural drawing is a typical column reinforcement detail, with 16mm longitudinal rebars, 6.3mm stirrups and cross-ties. This could indicate that the designer adopted column elements in the structural model. The PAR1 structural drawing shown in Figure 3b is a typical structural wall reinforcement detail, using a double-layered mesh shape, composed of 8mm vertical and 10mm horizontal steel rebars. However, PAR1 structural drawings presented no information regarding how or if the horizontal rebars should be anchored within the P4. This fact increased the suspicion that the cantilevered-wall equilibrium was being held only by the 6.3mm stirrups. Thus, *in-situ* tests could support this hypothesis by revealing the horizontal anchoring length of PAR1 rebars.

(a) Horizontal cross-section view

(b) Profile view

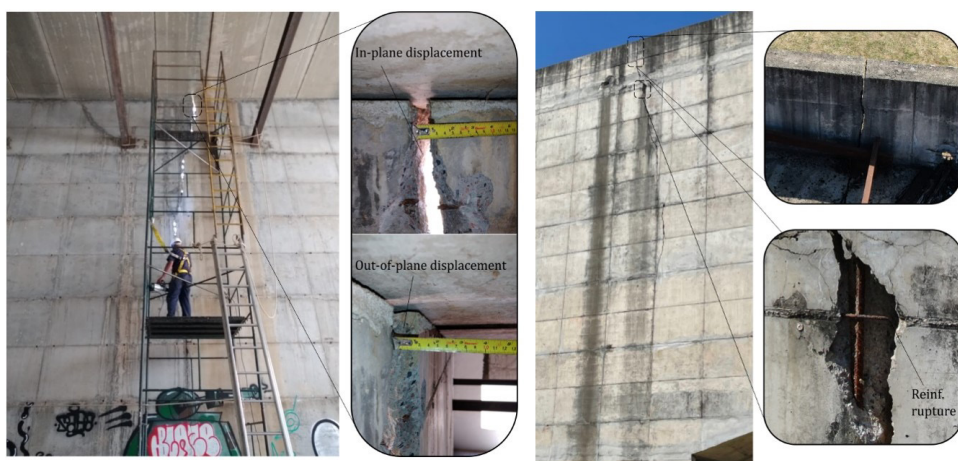
Figure 4. Fracture details on the P4.

Different pathologies origins have been identified, arising from construction defects and misconceptions in the structural design [3]. In the photos of Figure 4, both the internal and external faces of the P4 structural wall were presented, where can be observed the extension and opening of the crack. In terms of crack opening, 25 mm in-plane and 28 mm out-of-plane displacements (see Figure 4a) were measured. As a result, some stirrups near the top of the wall ruptured due to the excessive deformation (see Figure 4b).

(a) Internal face of P4.

(b) External face of P4

The simulation presented a deformed shape that was compatible with the real structure as can be seen in Figures 12 and 13. It is clear by comparison of the deformed and undeformed shape that the PAR1 wall behaved similarly to a cantilevered member, with a -1.7mm deflection in the model. Besides this vertical displacement, a rotational movement revealed by the slab crack pattern appeared at the top of the intersecting walls, causing an out-of-plane displacement in parts of PAR1 and PAR36. In this situation, PAR1 moved inwards whereas PAR36 moved outwards the building. As a consequence, the fracture line at the wall developed a mixed crack mode (mode I and II) that was also observed *in-situ* (see Figure 4a).

- Rehabilitation proposals involved the application of carbon-fibers reinforced polymers (CFRP) externally bonded to P4 and PAR1; however, this procedure would require specialized labor to first prepare the structure to then apply the CFPR, in heights up to 10m. Another solution would be to eliminate the free span by including a new column, which seems to be a viable solution despite the architectural impact.

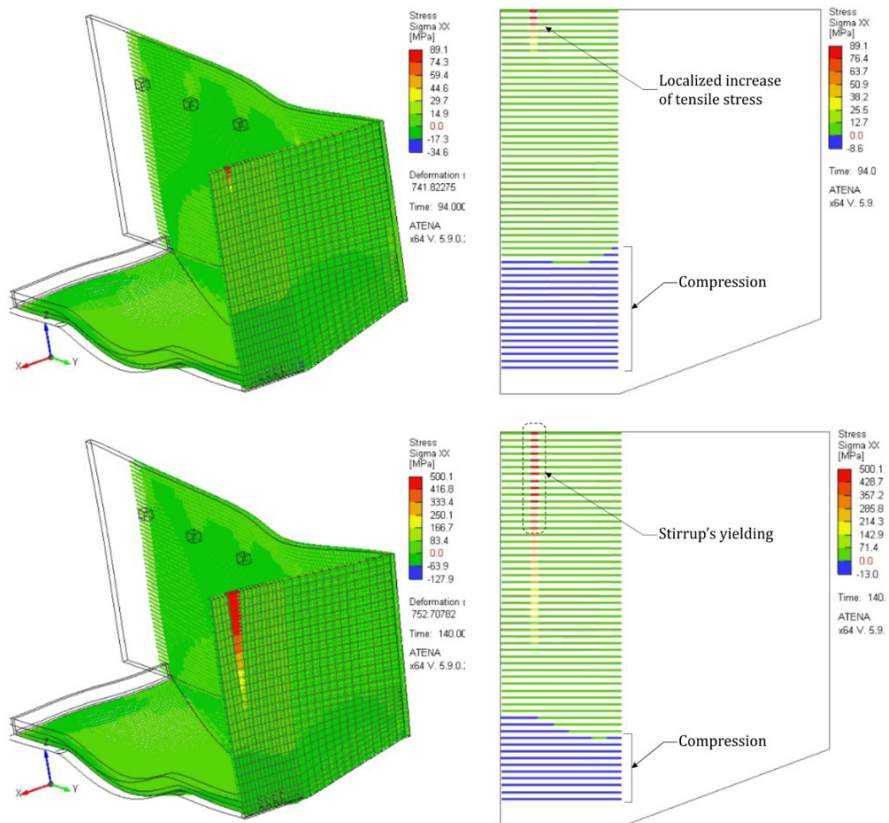
Figure 16. Reinforcement yielding in the P4 structural wall.

Figure 16 shows the reinforcement stresses. As can be noted, some horizontal bars were compressed at the bottom, while the rest were tensioned at the top. The cross-section's neutral axis dislocated downwards as the load increased in a typical flexural behavior.
