Epoxy putty external skeletal fixation in a tibiotarsal fracture of a wild choroy parakeet (*Enicognathus leptorhynchus*)

J. I. Arias¹, C. Beato¹, A. Espinoza²

¹Faculty of Veterinary and Animal Sciences, University of Chile – Santiago, Chile

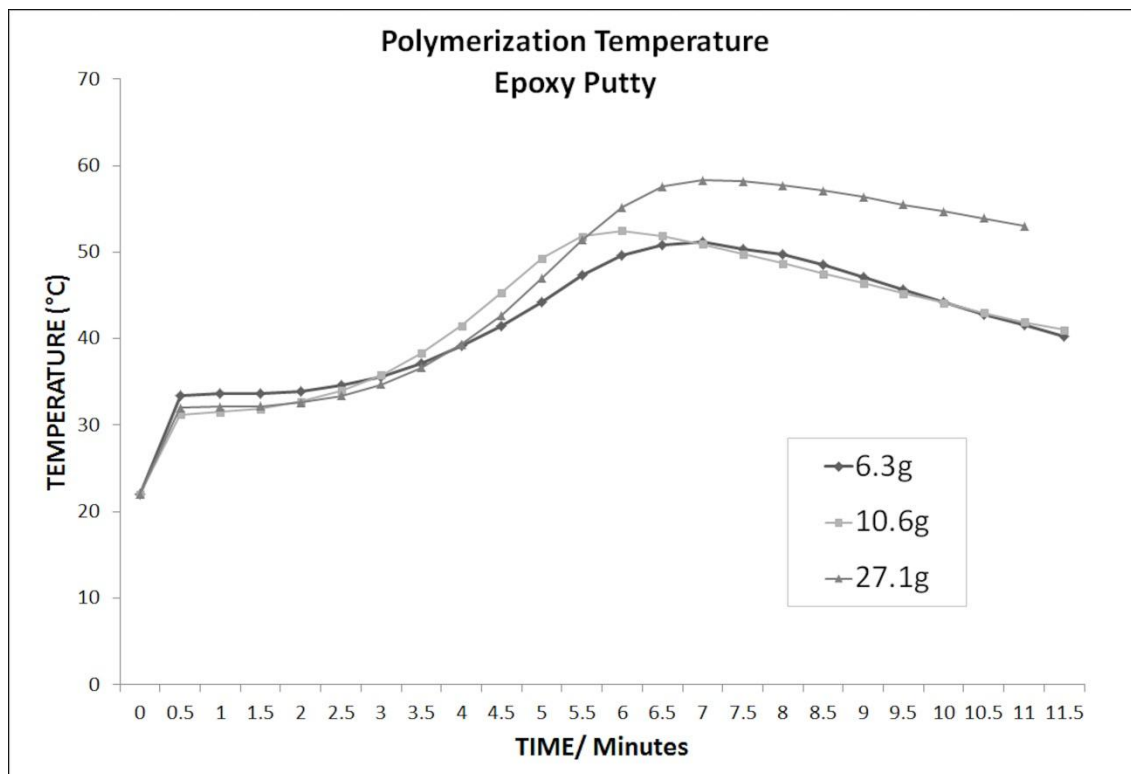
Figure 1. Temperature curve of polymerization of the epoxy putty Poxilina® (Akapol S.A., Argentina).

accuracy of $\pm 0.4^{\circ}\text{C}$, was introduced radially until approximately the center of the sphere was reached. Temperature was recorded every 30 seconds for 12 minutes. The temperature of the pieces reached a peak of $50\text{-}60^{\circ}\text{C}$, where the

highest peak corresponds to the highest amount of material. When approximately 6g of putty was assessed, the peak temperature reached only 51°C . This peak changed to 58°C when 4 times more epoxy was mixed and assessed (Figure 1).

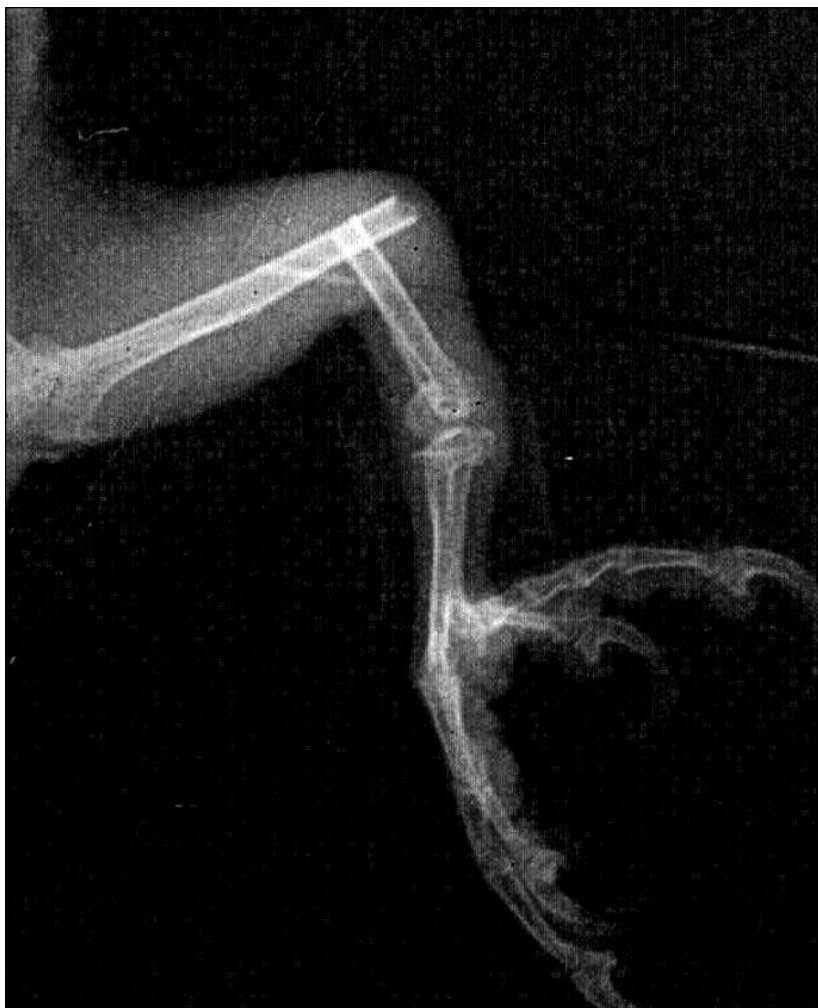
Figure 2. Parakeet. Radiographic medio-lateral examination of the left tibiotarsal bone. The view confirms a closed, complete, non-comminuted transverse fracture of the distal diaphysis of the left tibiotarsal bone.

Digital radiographic (Uno®, Cuatro Veterinary USA, 3760 Rocky Mountain Ave Loveland, CO 80538 USA), examination from ventro-dorsal and medio-lateral views confirmed a closed, complete, non-comminuted transverse fracture of the distal diaphysis of the left tibiotarsal bone (Figure 2).

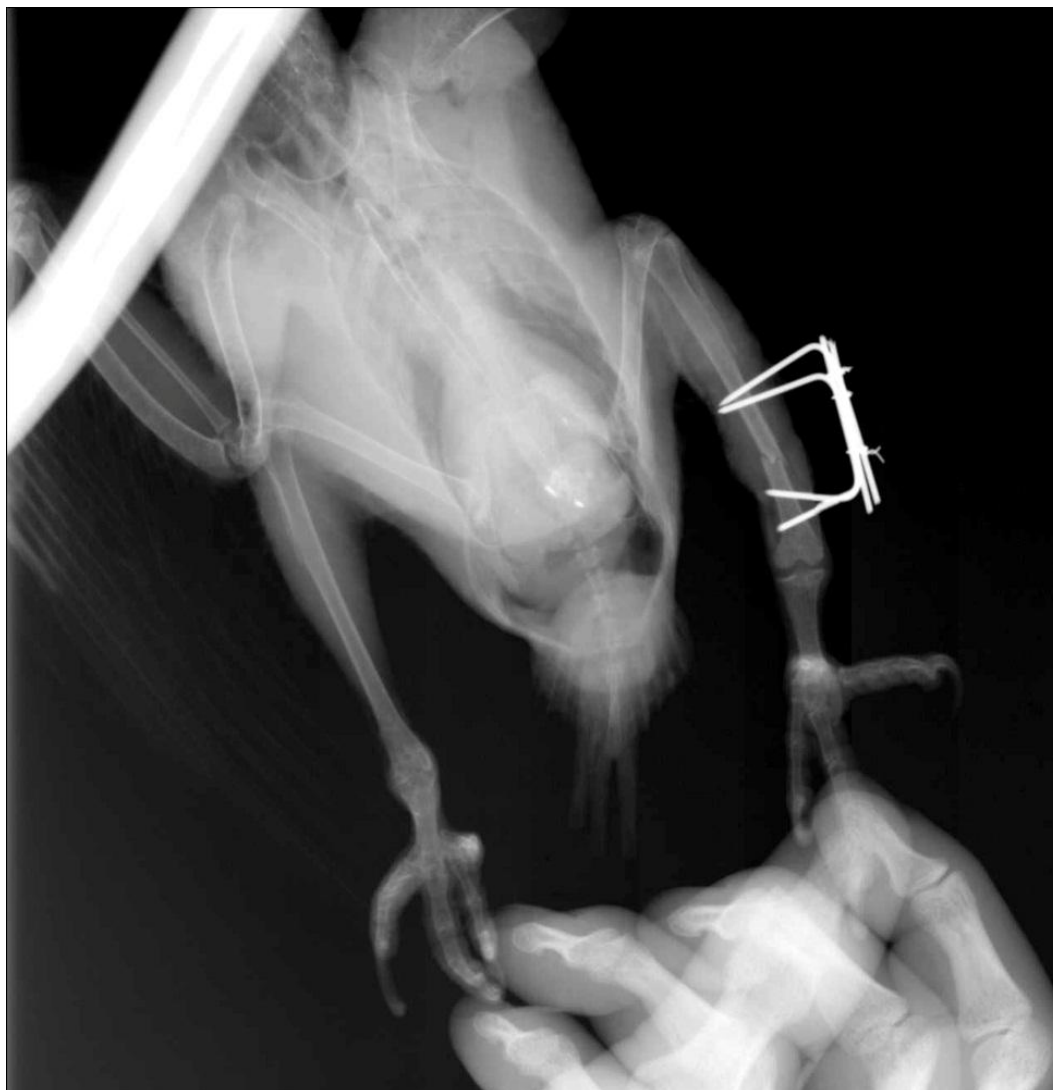
Figure 3. Parakeet. Radiographs showing bone alignment before applying the epoxy putty.

Epoxy putty was used to fabricate a custom-made connecting bar. Before applying the epoxy

putty, bone alignment was assessed with digital X-rays (Figure 3).

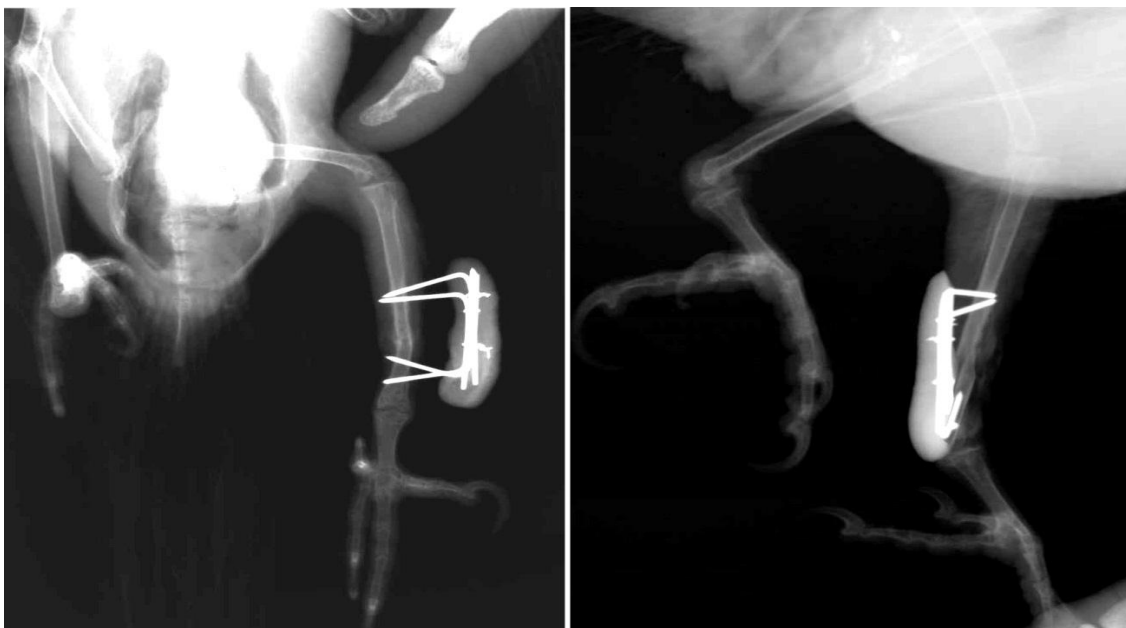
Figure 4. Parakeet. Ventro-dorsal (left) and medio-lateral (right) radiographic views taken 4 weeks of cage rest after surgery showing an initial callus with osseous union.

After 4 weeks of cage rest, a new set of digital radiographs was taken in ventro-dorsal and medio-lateral views. To achieve this with minimal stress inhalatory anesthesia was again induced in a chamber. At this point a callus was present with osseous union evident. Fixation was

not removed because it was decided that more primary callus bone density was needed (Figure 4).

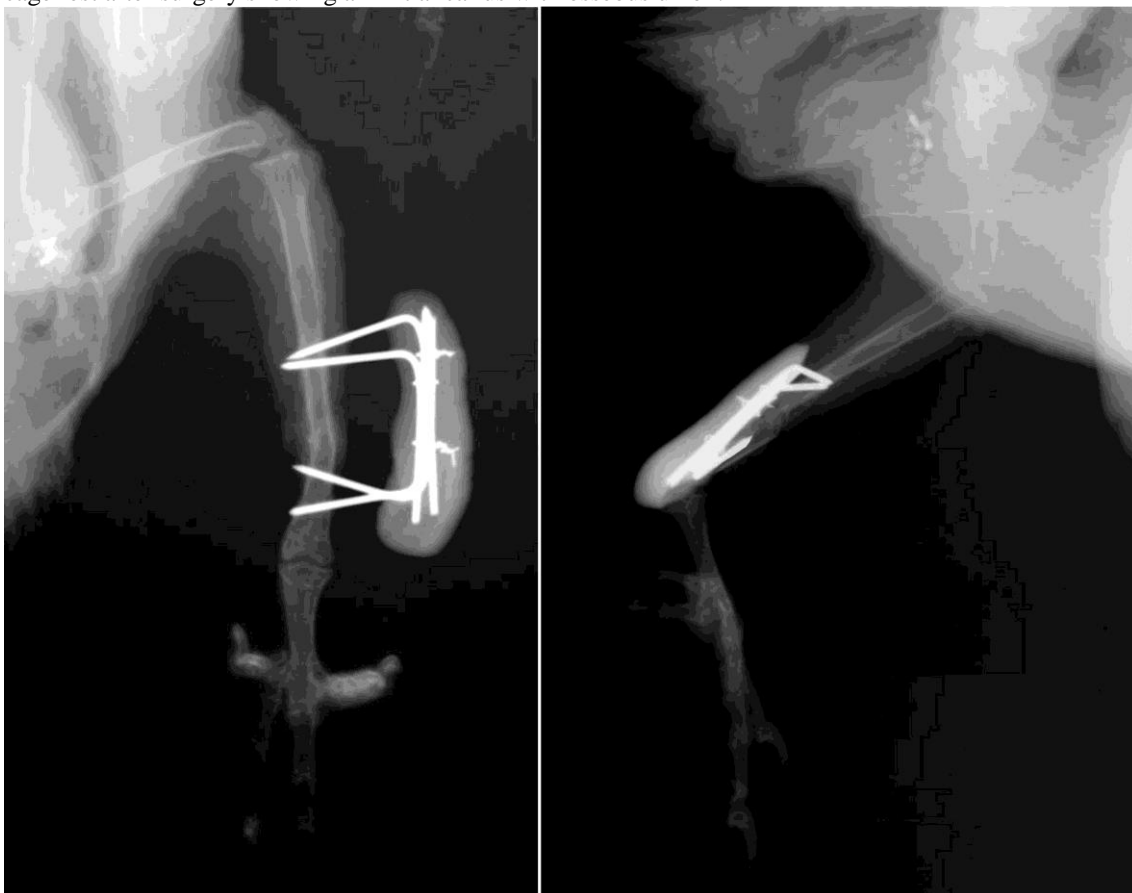
Figure 5. Parakeet. Ventro-dorsal (left) and medio-lateral (right) radiographic views taken 6 weeks after surgery with cage rest, showing a mature and well organized callus.

In light of these results 2 more weeks of recovery were advised to complete the stability of the primary bone callus. At 6 weeks after surgery the bird was anesthetized again with the same procedure, digital X-rays were taken and analyzed (Figure 5). With this result a decision was made to remove the external fixators. Clinically, after anesthesia recovery, the bird had full use of the limb.
