The influence of cement type and admixture on life span of reinforced concrete utility poles subjected to the high salinity environment of Northeastern Brazil, studied by corrosion potential testing

A. Joukoski^{1,2}, K. F. Portella², O. Baron², C. M. Garcia², G. R. Vergés^{1,2}, A. Sales², J. F. de Paula³

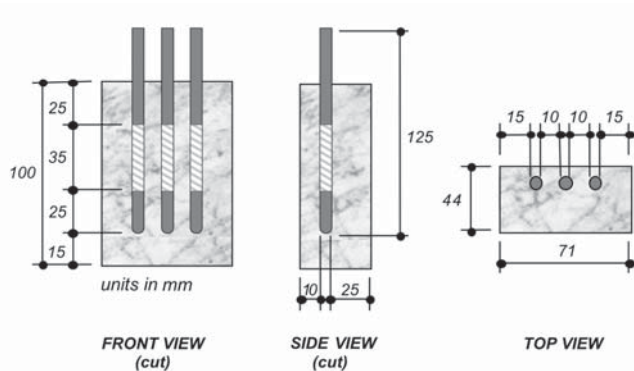
Figure 1: Prismatic specimen sketch.

- prismatic reinforced concrete specimens: 71 mm large, 100 mm high and 44 mm thick. The concrete cover thickness (25 mm) was selected due to the usual thickness of Brazilian light poles. The reinforcement of the prismatic specimens consisted of three bars of class CA-50 steel (carbon-steel, with 500 MPa of tensile strength), 6.3 mm in diameter and 125 mm long. Both extremities of each bar were protected by a tar-based, corrosion-protective coating, resulting in only a central steel-exposed region of the bar with about 35 mm of length. In Fig. 1 are shown more details about the prismatic specimen.

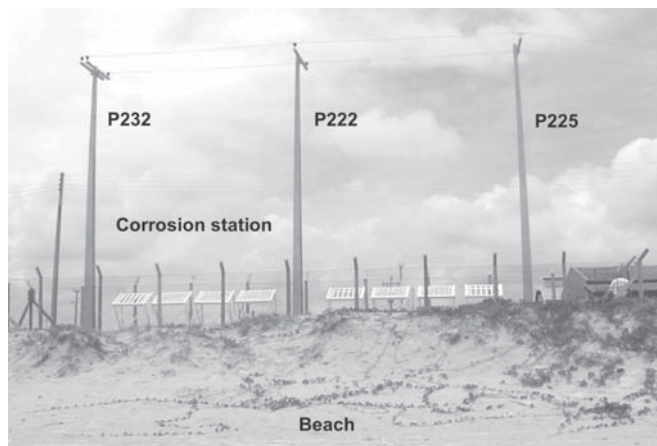
Figure 2: View of the corrosion station at Caueira Beach (Itaporanga d'Ajuda district), Sergipe State, Northeastern Brazil.

A marine environment corrosion site, shown in Fig. 2, was built at Caueira Beach, in Itaporanga D'Ajuda, a district near Aracaju. The corrosion station is located approximately at the coordinates $37^\circ 40' \text{ W}$ and $10^\circ 09' \text{ S}$, and about 2 m above the high tide line of the Atlantic Ocean. In this place, average annual temperature is 26.7°C and annual pluviometry is of about 1400 mm.

The sample containing silica fume admixture (CP222SF) presented the best result, as shown in the same Fig. 4. This admixture reduced to a minimum the expansive reaction verified in the other concrete mixtures. These data were decisive in selecting the mix design of the cast P222 light pole, tested at Caueira Beach corrosion station (Fig. 2).

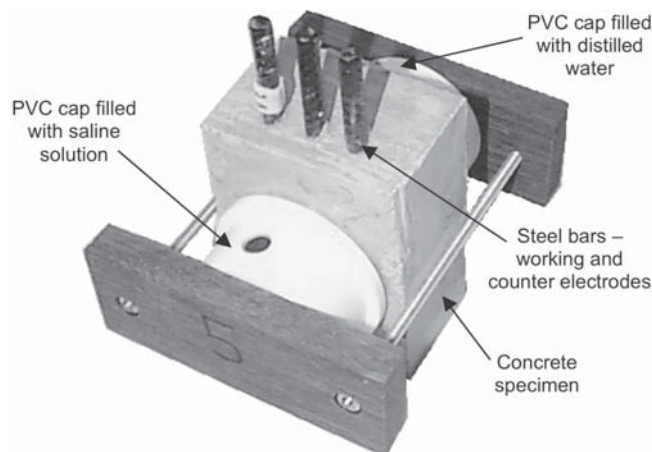
Figure 3: Aging cell photograph.

After 28 days of curing, the aging process of prismatic specimens by the NaCl solution started, as well as the EIS testing, which results to be presented [8]. Aging cells, consisting of two PVC piping caps, were fastened to each specimen, as shown in Fig. 3.

The container at the side of the 25 mm concrete cover was filled with the saline solution, whereas the other was filled with distilled water. This configuration was designed in order to simulate the regular conditions which actual light poles

installed along the coast are subjected to, i.e., the salt-water splashing on one side, and the rain water washing on the other. These different NaCl concentrations also induced chloride ion migration through the concrete thickness of the samples.

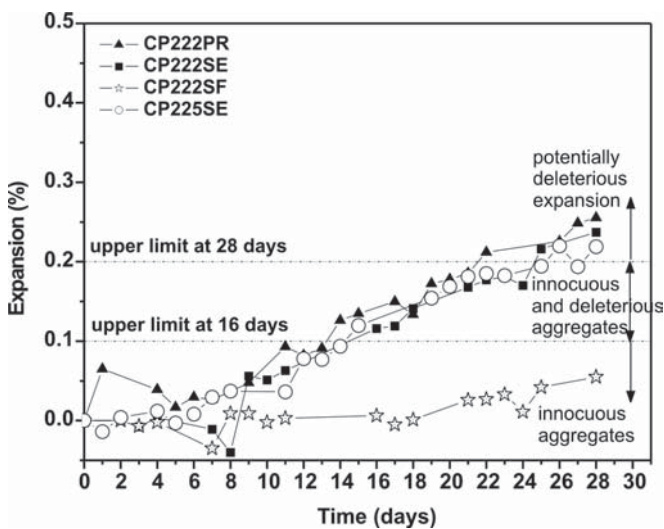
Figure 4: Potential alkali reactivity of CP222PR, CP222SE, CP222SF and CP225SE mortar-bars.

The alkali concentration of both cement types, the chemical phases and the microstructure of coarse aggregates could be responsible for the potentially deleterious expansion presented by the mortar samples. In Fig. 4 the curves of expansion are plotted against aging time of samples CP222PR, CP222SE, CP222SF, and CP225SE. All mortar-bars showed expansions beyond the recommended limits at 16 days specified by ASTM C 1260-94 standardization [10]. To confirm these results the tests were carried out until 30 days, and all samples expanded more than the recommended limits, as shown in the plot of Fig. 4.

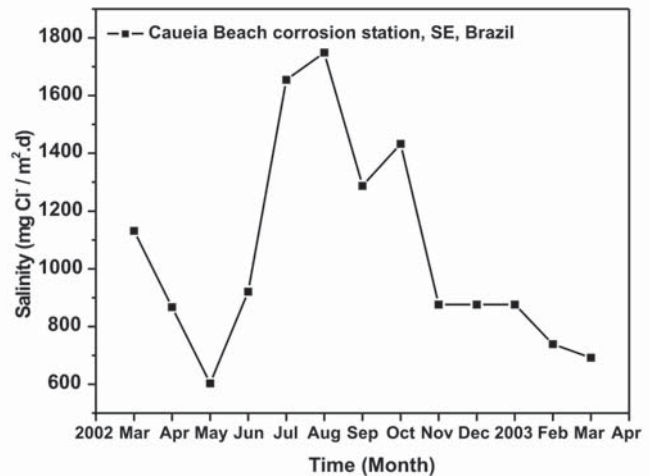
Figure 5: Atmospheric salinity, measured at Caueira Beach, from March 2002 to March 2003.

Salinity data obtained at the Caueira Beach corrosion station, from March 2002 to March 2003, are shown in Fig. 5.

The mean chloride value presented of (1087 ± 394) $\text{mg}/\text{m}^2.\text{day}$ is higher than the maximum results obtained by Pintos et al [15] in ten Brazilian corrosion sites, which were about 360 $\text{mg}/\text{m}^2.\text{day}$. In the paper, the chloride deposition rate was obtained from Fortaleza, Ceará State, also in Northeastern Brazil's coastal zone. Silva, Portella, Dalledone and D'Alkaine [16] presented the results of chloride deposition rate measured in a corrosion station located at Pontal do Sul Beach, Paraná State, in the South of Brazil, during two years, from January 1987 to January 1989. The salinity rate varies from, approximately, 20 $\text{mg}/\text{m}^2.\text{day}$ in the winter to 120 $\text{mg}/\text{m}^2.\text{day}$ in the summer. These maximum values are about a tenth of the results obtained in the Caueira Beach corrosion station. Due to these results, location is classified as marine environment [17]. Based on the studies of Pintos [15] and Morcillo [17] about atmospheric corrosion of steel, a corrosion rate three

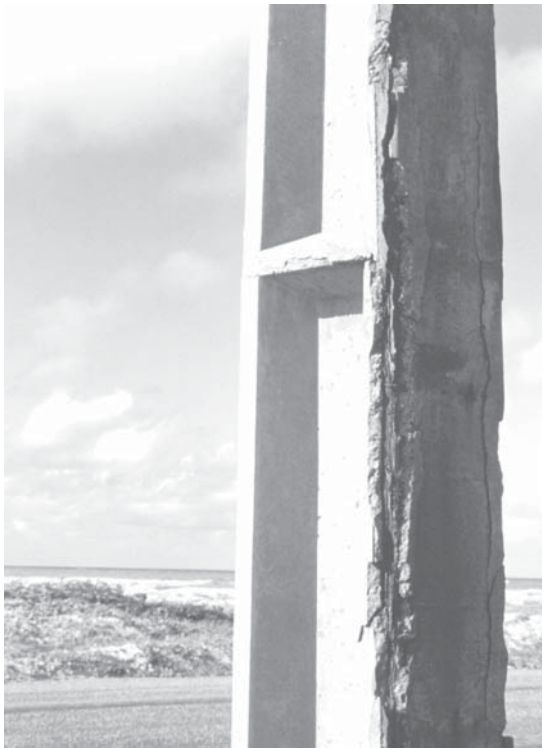
Figure 6: Concrete utility pole presenting chloride corrosion attack, at Aracaju.

Another particularity observed at surroundings of Caueira Beach is the intensity of the corrosive attack in the steel reinforcement and in the concrete cover of light poles. The pole surface at back seaside presented more serious damages than the side facing the seashore, which is probably due to the predominance of sea-to-coast (southeastern) wind. The prevailing wind keeps the sea-facing concrete dry, while the other face is subjected to longer periods of wetness and salinity. Allied to this is the local average daily temperature of up to 25°C (in 2002). This fact can be observed in Fig. 6, which shows a damaged six-year utility pole.

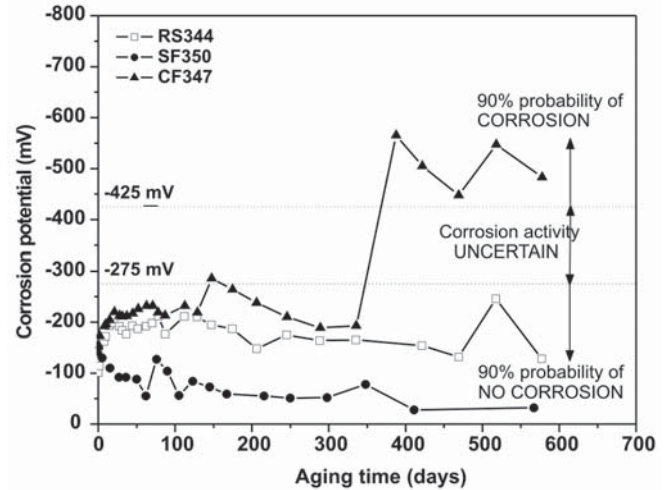
Figure 7: Corrosion potential versus laboratory aging time of RS344, SF350 and CF347 concrete samples.

The plots presented in Fig. 7 show the corrosion potentials versus time of three reinforced concrete samples subjected to aging by a 3.4% NaCl aqueous solution at laboratory environment.

The influence of cement type in RS344 sample and of silica fume admixture in SF350 was easily observed. As noted in the plots, the reinforcement steel bars didn't present substantial changing in the electric potential, within the testing period, by the imposed chloride aging. For these two samples, the potential values remained in the region where there is 90% probability of no corrosion, that is below the minimum corrosion potential line (-275 mV).

The CF347 sample presented the highest corrosion potential for steel rebar, which values attained the zone of 90% probability of corrosion, i.e., above the high corrosion potential line (-425 mV), after about one year of aging. SEM images and EDS analysis revealed high chloride concentration in most fracture surface, as well as the presence of alkali gel and crystals into cracks and pores, as shown in Fig. 9.

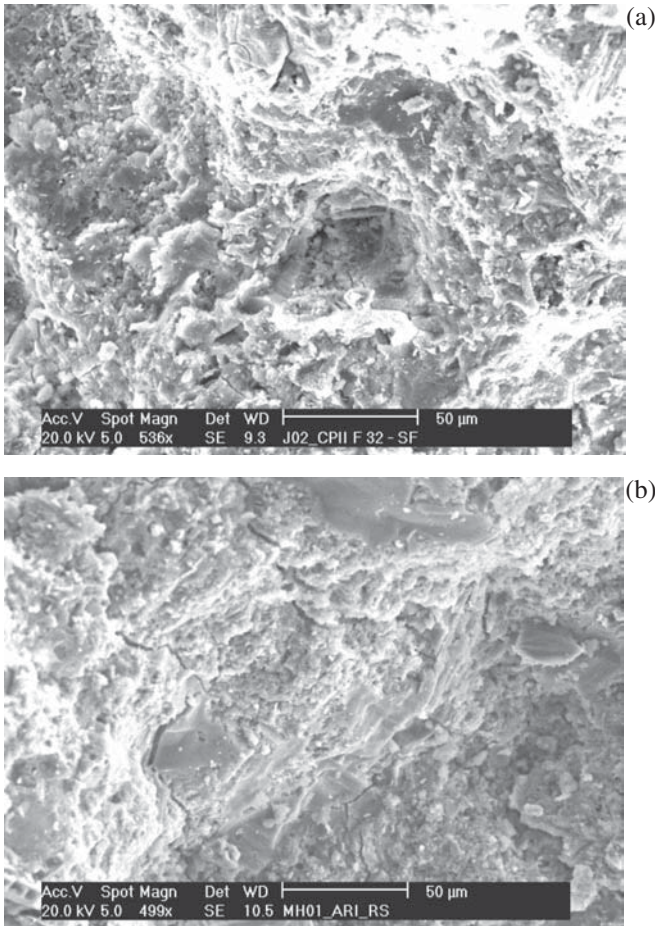
Figure 8: Scanning electron microscope images from fracture surfaces of RS344 and SF350 concrete samples.
 [Figura 8: Imagens obtidas por microscópio eletrônico de varredura das superfícies de fratura das amostras de concreto RS344 e SF350.]

In Fig. 8 are shown the two fracture surfaces of SF350 and RS344 samples, respectively, viewed by scanning electron microscopy (SEM). Cracks are visible on the surface of sample made with high-early-strength cement, but no particular micrographic image was detected. Microanalysis by X-ray energy dispersive system (EDS) revealed low level chloride concentration in all parts of the assayed samples, as well as CSH elemental chemical compounds. In opposite to the results presented by Glass and Buenfeld [19], the good performance of RS344 sample in corrosion potential testing may be attributed to the concrete compactness, since the authors concluded that sulfur resistant Portland cement (SRPC) has a low level binding of chloride.

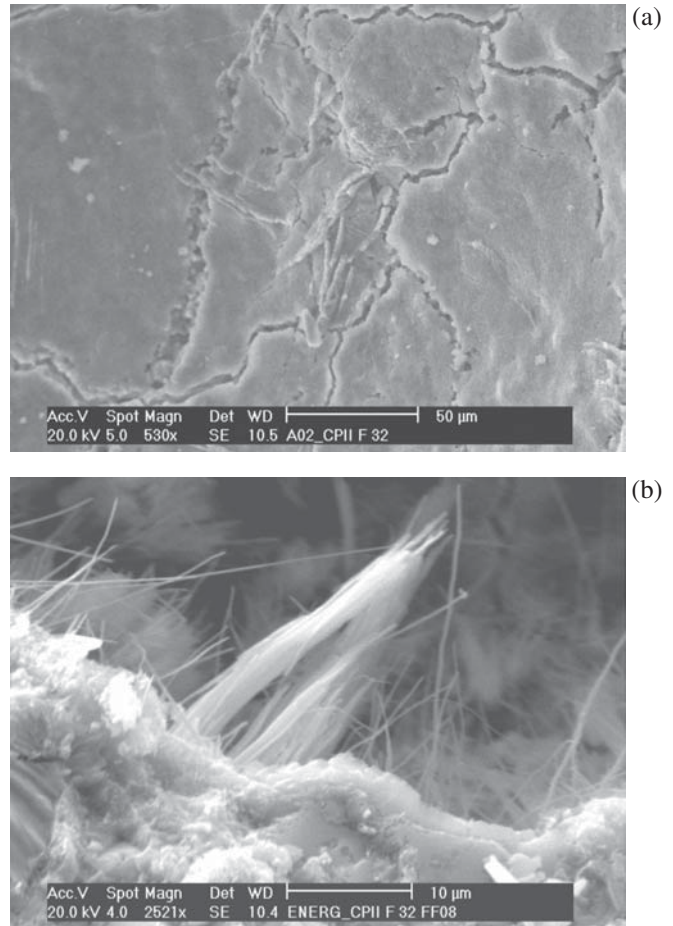
Figure 9: Scanning electron microscope images from fracture surfaces of CF347 concrete sample.
 [Figura 9: Imagens obtidas por microscópio eletrônico de varredura da superfície de fratura da amostra de concreto CF347.]

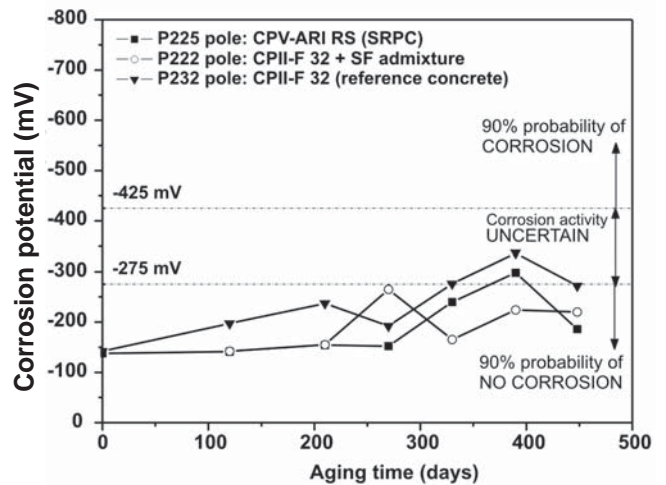
Figure 10: Corrosion potential of the lights poles submitted to the natural aging for 18 months in Caueira Beach corrosion station.
 [Figura 10: Potencial de corrosão dos postes submetidos a envelhecimento natural por 18 meses na estação de corrosão da Praia da Caueira.]

The corrosion potential results of the utility poles made with these same mixtures and submitted to natural aging at Caueira Beach corrosion station are presented in Fig. 10.

The corrosion potential results of all light poles remained within the zone of 90% probability of no corrosion, during the testing period. However, the corrosion potential results of the reference utility pole (P232), seems to present the same tendency of CF347 sample – with supposed similar mixture proportion, cement type, cement content and water/cement ratio – that is passing to the zone of uncertain corrosion activity. A photograph of the surface of this reference pole is presented in Fig. 11, where it can be seen a color alteration of concrete, iron smudges and superficial cracks along the longitudinal steel reinforcement surroundings. Apparent corrosion of a transversal reinforcing bar can also be seen.

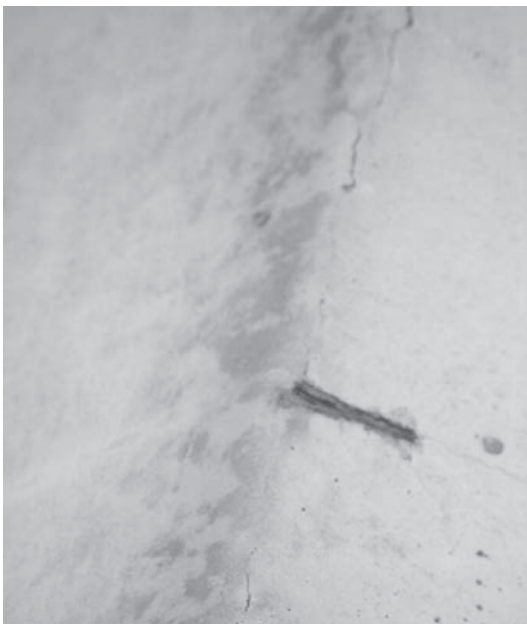
Figure 11: P232 utility pole presenting color alteration on the concrete surface, at rebar direction (iron smudges), superficial cracks and corrosion of steel reinforcement.

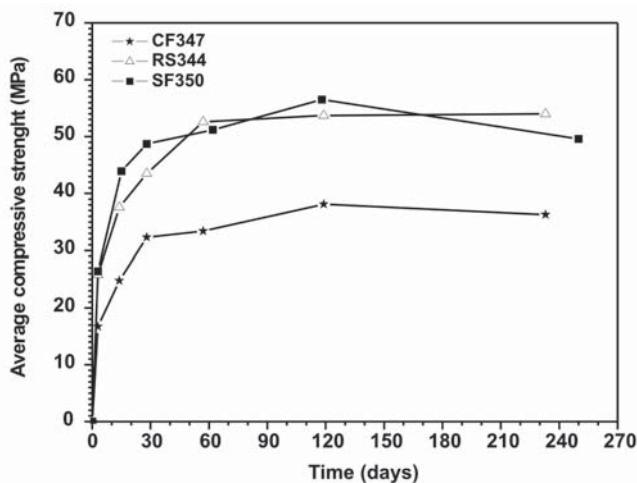
Figure 12: Compressive strength of cylindrical concrete specimens.

The mixtures containing silica fume and CPV-ARI RS cement presented higher compressive strengths than the mix made with CII-F 32 cement and no admixture. Within the period of immersion in a 3.4% NaCl solution, a tendency of decreasing strengths was noticed for all three mixtures, as shown in Fig. 12.
