ERRATA JOURNAL OF APPLIED ORAL SCIENCE - v.13, n.1, 2005

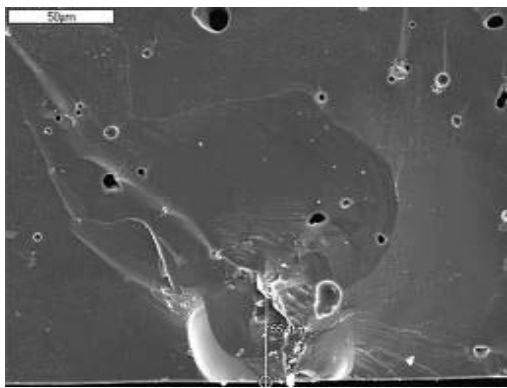
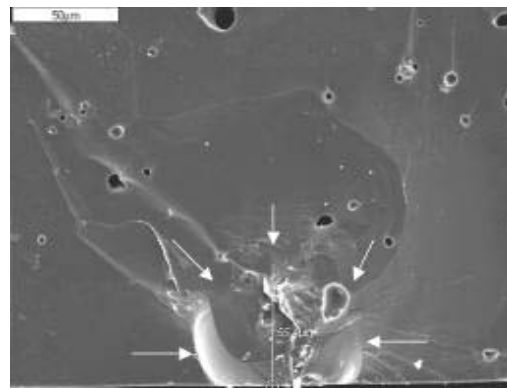
<p data-bbox="400 1198 909 1366">FIGURE 5 – SEM micrograph of ceramic fracture surface showing a critical flaw (crack) outlined by white arrows. Fracture surface of a amorphous glass (IPS Empress2 body, Ivocalr AG, Schaan, Liechtenstein; note the tailed fracture markings (top right) pointing toward the crack origin; measured line represents the semiminor axis a= 55µm (500x). From Della Bona, et al. ²⁰, 2004</p>

<p data-bbox="935 1198 1444 1366">FIGURE 5 – SEM micrograph of ceramic fracture surface showing a critical flaw (crack) outlined by white arrows. Fracture surface of a amorphous glass (IPS Empress2 body, Ivoclar AG, Schaan, Liechtenstein; note the tailed fracture markings (top right) pointing toward the crack origin; measured line represents the semiminor axis a= 55µm (500x). From Della Bona, et al. ²⁰, 2004</p>
5	Figure 6

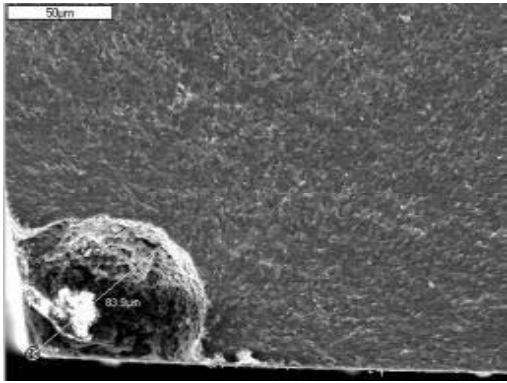
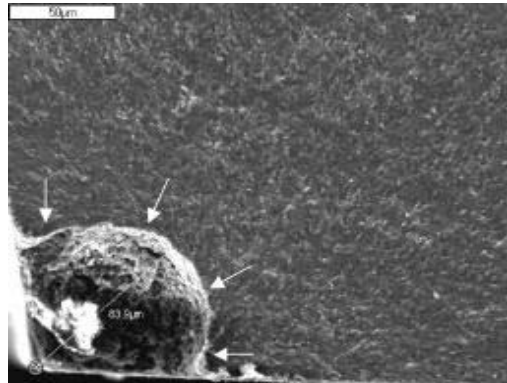
<p data-bbox="400 1803 909 1948">Figure 6 - SEM micrograph of ceramic fracture surface showing a critical flaw (crack) located at the corner of the specimen (outlined by white arrows). Fracture surface of a leucite-based ceramic (IPS Empress, Ivoclar AG, Schaan, Liechtenstein); line from flaw corner, c+84 µm (500x). From Della Bona, et al. ²⁰, 2004.</p>

<p data-bbox="935 1803 1444 1948">Figure 6 - SEM micrograph of ceramic fracture surface showing a critical flaw (crack) located at the corner of the specimen (outlined by white arrows). Fracture surface of a leucite-based ceramic (IPS Empress, Ivoclar AG, Schaan, Liechtenstein); line from flaw corner, c+84 µm (500x). From Della Bona, et al. ²⁰, 2004.</p>
