# CERAMIC RESTORATION REPAIR: REPORT OF TWO CASES

Thus, dental professionals should use techniques that produce acceptable, simplified, low cost and quick repair of such restorations. This paper presents two cases of feldspathic ceramic repair using composite resin, with and without the fractured ceramic fragment, in a single clinical session without the need for laboratorial assistance, allowing for an esthetic and functional rehabilitation.

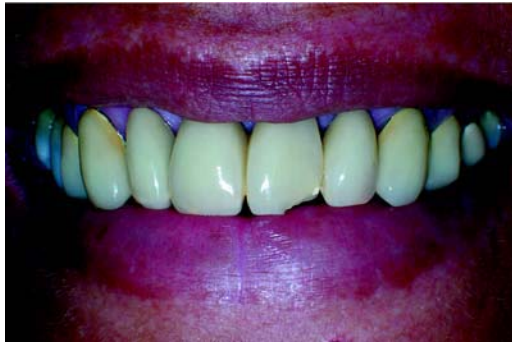
A 45-year old female patient with a 9-unit metal-ceramic fixed partial denture presented with a fracture delamination of the buccal and part of the incisal surface of the maxillary left central incisor distal angle without the ceramic fragment (Figure 1). After treatment proposal, the patient refused denture replacement due to the high procedural cost. In addition, the prosthesis had a good aspect with satisfactory marginal adaptation around the abutments and good periodontal health. Thus, ceramic repair with composite resin was selected as the treatment of choice.

**FIGURE 1-** Initial aspect of the case with a fracture in the distal angle of the maxillary left central incisor. No ceramic fragment was available

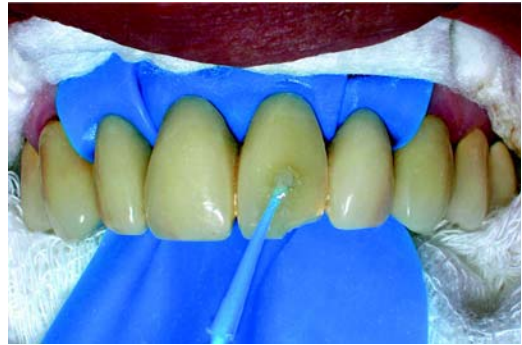
**FIGURE 5-** Application of the adhesive system

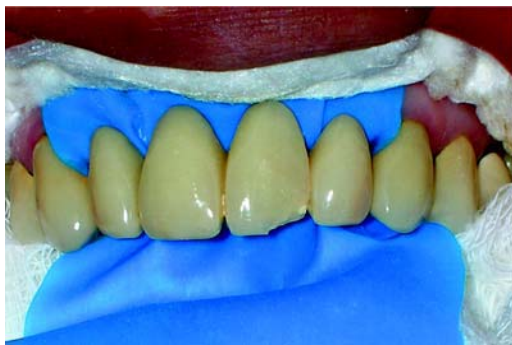
The ceramic color (A2 shade) was selected using the Vita Classical shade guide (VITA Zahnfabrik, Bad Säckingen, Germany). For control of the oral cavity humidity and patient protection, an alternative field isolation was obtained with the aid of a rubber dam (Madeitex Ltda, São José dos Campos, SP, Brazil), cottons, gauzes and a lip expander (Lip Expand; Indusbello, Londrina, PR, Brazil) (Figure 2). Acid etching was performed with the application of 10% hydrofluoric acid (Porcelain conditioner; Dentsply Ind e Com. Ltda, Petrópolis, RJ, Brazil) for 2 min on the feldspathic ceramic surface (Figure 3). The gel excess was removed with moist gauze to avoid spreading of the product into the patient's mouth, followed by water rinsing for 30 s and drying with an air stream and absorbent paper. Special care was carried out at this step to avoid accidental exposure of soft tissues to the hydrofluoric acid due to the inherent risks of this product.

**FIGURE 2-** Isolation and protection of the patient's mouth with rubber dam, cottons, gauzes and a lip expander.

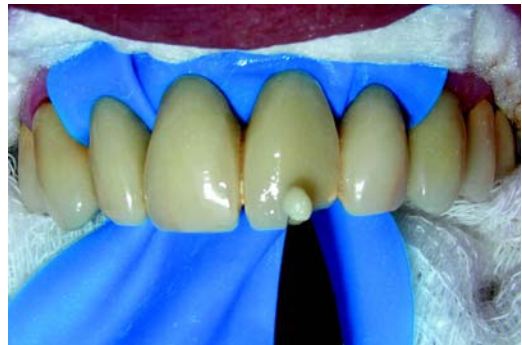
**FIGURE 6-** Composite resin insertion over the fractured angle

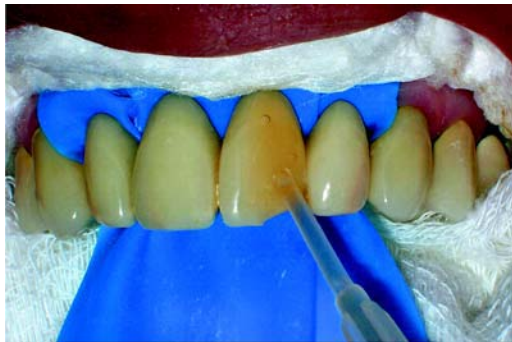
**FIGURE 3-** Ceramic etching with 10% hydrofluoric acid

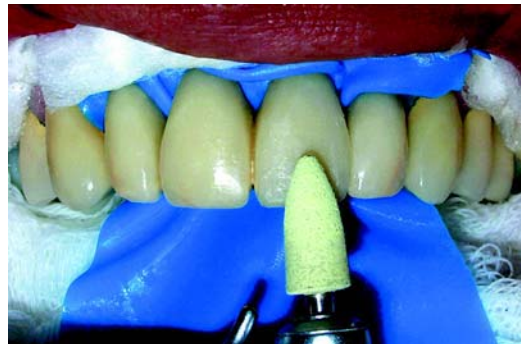
After light curing the composite resin, finishing was performed with abrasive silicone polishing tips (Optimize, TDV Dental, Pomedore, SC, Brazil) (Figure 7). After removing the rubber dam isolation, an occlusal evaluation

**FIGURE 7-** Finishing of the restoration

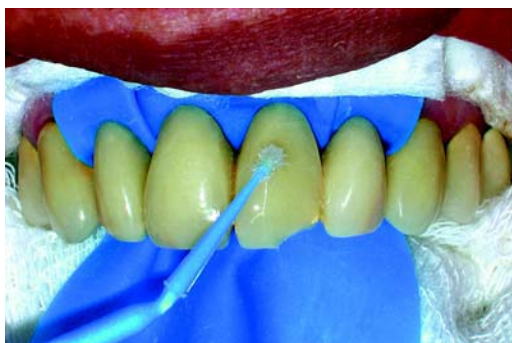
One-bottle silane coupling agent (Silano, Angelus, Londrina, PR, Brazil) was applied over the etched region for 1 min (Figure 4) followed by the application of the Scotchbond Multipurpose adhesive phase only (3M/ESPE, St. Paul, MN, USA) in the silanized area (Figure 5). The adhesive layer was light cured with a LED curing unit (Radii-E; SDI, Victoria, Australia). A microhybrid composite resin (4 Seasons; Ivoclar Vivadent, Liechtenstein, Germany) was inserted incrementally with a thin A2 dentin layer, followed by A2 enamel and translucent resin layer to repair the fractured angle (Figure 6).

**FIGURE 4-** Application of the silane coupling agent

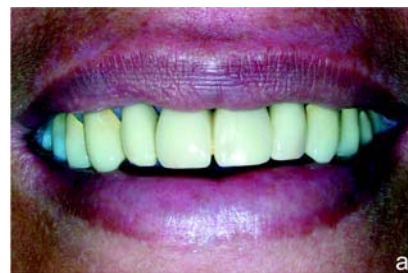
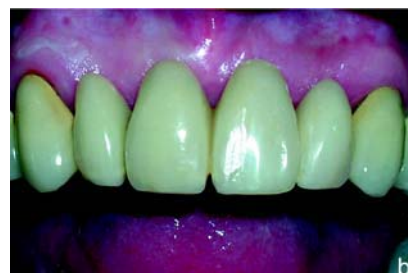
was performed to check for any contacts in maximum habitual intercuspation of the anterior teeth and during protrusion movement. The anterior contacts during anterior guidance were distributed to avoid overloading the restored tooth. The occlusal interferences during excursive movements were removed to allow for free mandibular movement<sup>16</sup>. After 24 h, polishing and burnishing were done with silicon tips and felt discs (Felt wheels, TDV Dental) and polishing paste (7026; KG Sorensen, Barueri, SP, Brazil) to create a natural appearance of the repaired ceramic (Figure 8).

**FIGURE 8-** Final aspect of the ceramic repair (a and b)

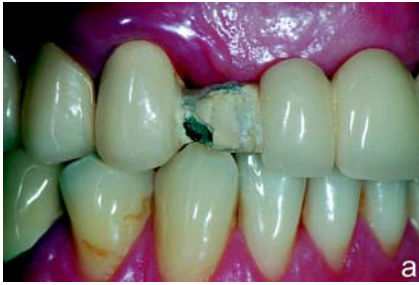
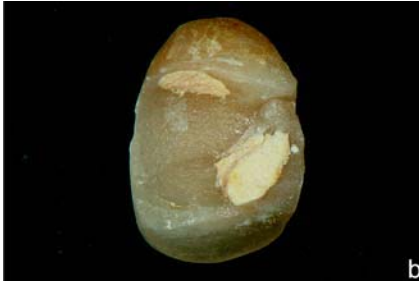
A 55-year old female patient with a 14-unit metal-ceramic fixed partial denture presented with a dislodgement of the ceramic portion from the metallic structure in the maxillary right canine, probably due to the fatigue of the ceramic structure overloaded during the excursive movements (Figure 9). The patient kept the ceramic fragment. As previously described in Case 1, the replacement of an extensive fixed prosthesis is an expensive treatment, mainly in cases of single-element fracture, and so ceramic repair with composite resin is a viable solution.

**FIGURE 9-** Initial aspect of the case with a dislodgement of the ceramic portion from the metallic structure in the maxillary right canine (a). View of the ceramic fragment (b)

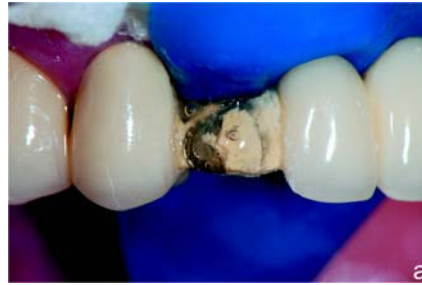
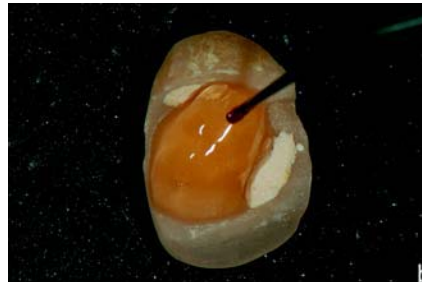
The shade of the microhybrid composite selected in this case was B2 dentin (4Season; Ivoclar Vivadent). A rubber dam (Madeitex Ltda) was placed between the abutments to protect the patient and to prevent the contamination of the surface with saliva. Acid etching (Porcelain conditioner; Dentsply) was performed on the ceramic fragment and on the prosthesis structure in the patient's mouth for 2 min (Figure 10). Conditioner excess was removed with moist gauze and the region was rinsed with a water spray for 30 s followed by air drying. Thereafter, the rubber dam was removed due to the difficulty in obtaining a correct positioning of the ceramic fragment, and the area was protected with gauze and cottons rolls.

**FIGURE 10-** Etching of the prosthesis (a) and ceramic fragment (b) with 10% hydrofluoric acid

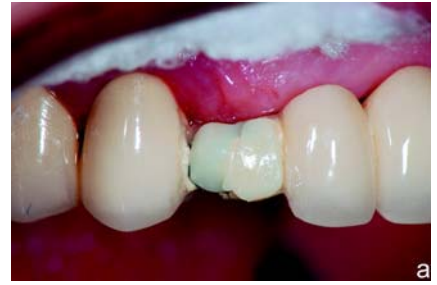
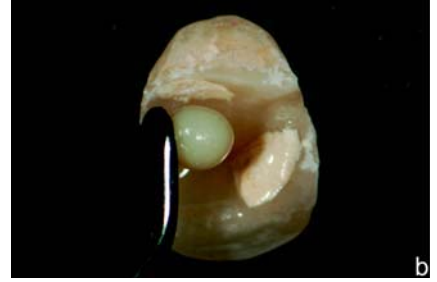
**FIGURE 11-** Composite resin insertion on the prosthesis (a) and ceramic fragment (b)

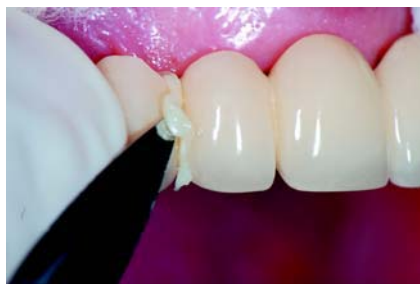
The union was promoted with a silane agent (Silano, Ângelus), applied in the fragment and in the prosthesis for 1 min followed by the application of the Scotchbond Multipurpose adhesive phase (3M/ESPE) on the silanized area. The activation was carried by a LED curing unit (Radii-E; SDI). The composite resin was inserted in the two ceramic separated parts (Figure 11). The fragment was taken into position and pressed against the prosthesis. Composite excess was removed and light activation was performed (Figure 12).

**FIGURE 12-** Fragment in position pressed against the prosthesis and composite excess removal

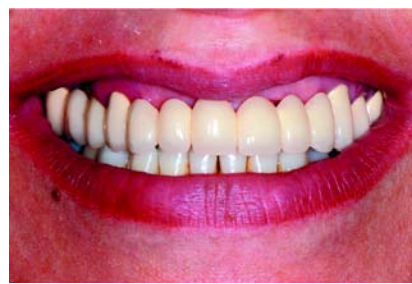
Subsequently, the excursive movements were checked, reproducing the anterior and canine guidances to achieve a harmonic distribution of the occlusal contacts, eliminating overload of the restored denture and providing free mandibular movements without damaging contacts<sup>17</sup>. Prosthesis repair was finished, reestablishing esthetics and function to the patient (Figure 13).

**FIGURE 13-** Final aspect of the ceramic repair
