The Challenges of Rehabilitating the Hercilio Luz Suspension Bridge

The Hercilio Luz suspension bridge, built in 1926, has been out of service since 1991 due to high corrosion levels and structural element impairment. A complete rehabilitation project was developed which included the replacement of the impaired items and foundation strengthening. For this, an auxiliary structure was employed to support the central span during the rehabilitation process. A carefully studied load transfer process, where the central span loading is transferred from the eye-bar towards the auxiliary structure will be performed. For this purpose, a synchronized jacking sequence will be used, which was predefined by means of numerical model analysis. All structural elements had their designs evaluated and some geometric changes were implemented. This paper presents all the methodology developed in the rehabilitation project of Hercilio Luz bridge, as well as the development stages up to the present date.

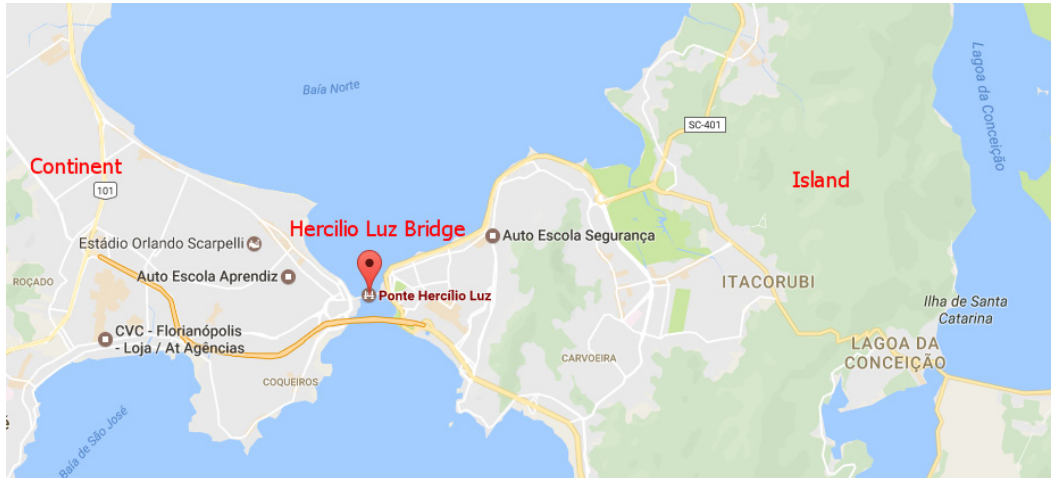
Figure 1: Hercílio Luz bridge location (www.googlemaps.com.br).

The Hercilio Luz suspension bridge construction began on November 14th, 1922 and was opened to traffic on May 13th, 1926. The bridge built over the Atlantic Ocean connects the continent to the island (Fig. 1). Initially, it was conceived to support a road, an electric railway and the city of Flo-

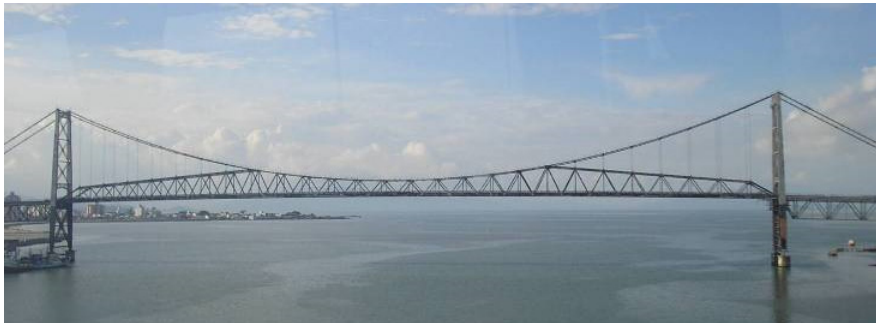
Figure 2: Main span of the Hercílio Luz Bridge (339.5 meters long).

Florianópolis water supply. The bridge is 819.5 m long and its length is composed of: 259 m of island overpass, 339.5 m of main span (Fig. 2) and 221.0 m of continent overpass. The main span makes the Hercílio Luz Bridge one of the largest in the world and one of the last possessing eye-bars incorporated to a truss.

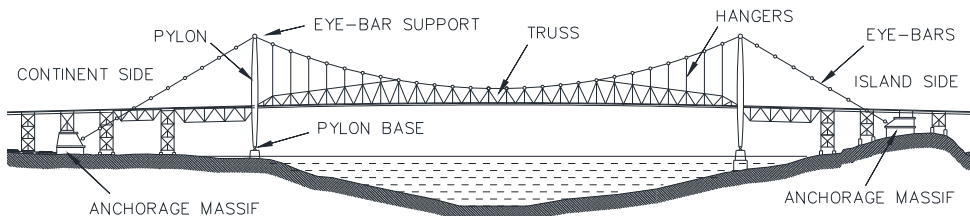
Figure 3: Main elements of the Hercilio Luz bridge.

Figure 3 presents the main elements that compose the bridge. The steel structure has the approximated weight of five thousand tons. The foundations and pillars were built with 14.250 m^3 of concrete. The metallic pylons are 75 m high above sea level and the main span is 32 m high above sea level.

The main span is composed by a truss whose maximal height is reached at one quarter of the span, where the bending moment is maximal. In the truss central part, between one quarter and three quarters of the span, the eye-bars are incorporated to the truss, where they work as an upper chord. Outside the span's central region, the truss upper chord is connected to the eye-bars through vertical hangers (Steinman, 1922).

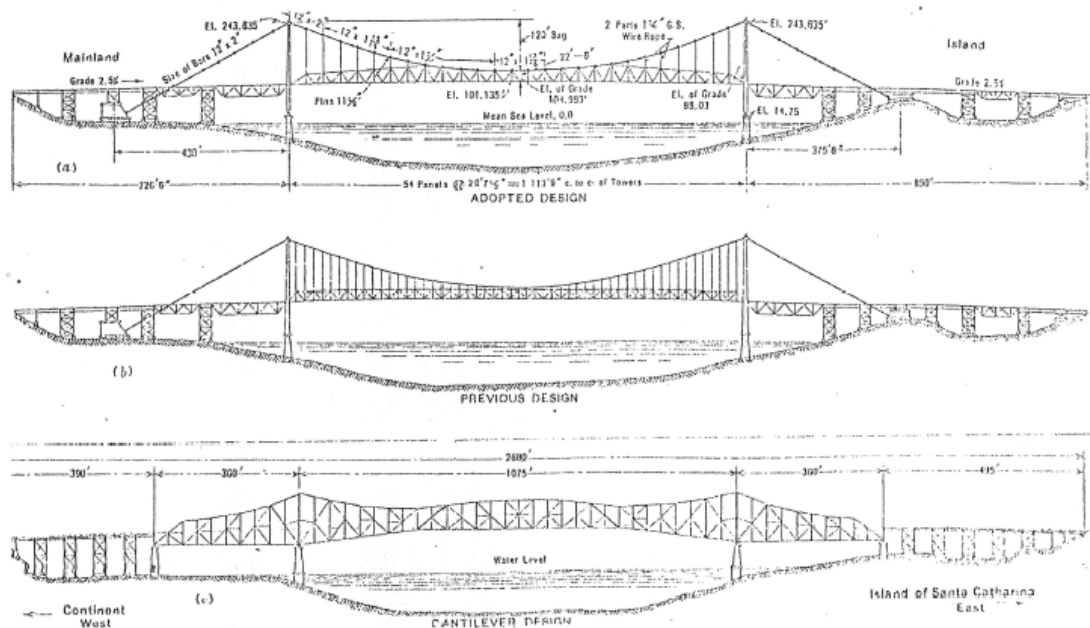
Figure 4: Structural solutions evaluated by the original designers (Steinman, 1926).

The bridge original design was conceived in the 1920s by the American engineers H. D. Robinson and D. B. Steinman. The steel structure was manufactured in the United States and assembled in Brazil by the company American Bridge. Figure 4 shows the three different structural solutions evaluated: a suspension bridge with incorporated eye-bars (the retained solution, judged as the most cost-effective solution at the time), a standard suspension bridge and a truss bridge.

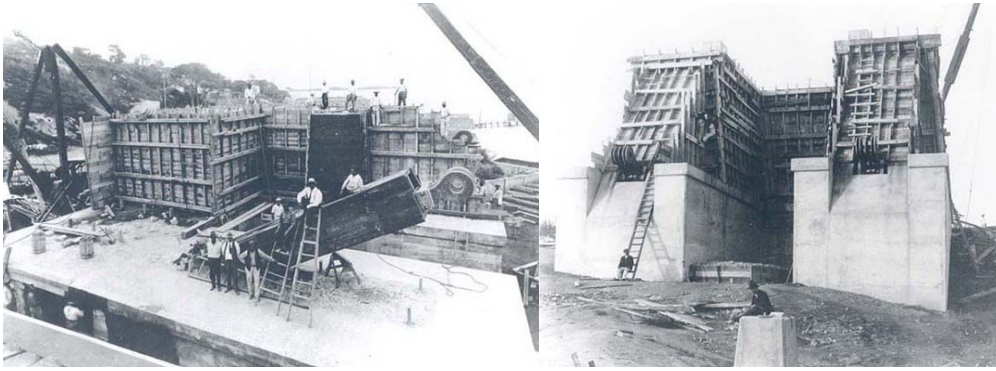
Figure 5: Anchorage massifs building (Steinman, 1926).

Figure 5 shows the anchorage massifs building, where it is possible to observe the concrete forms and the anchorage of eye-bars inside the massif.

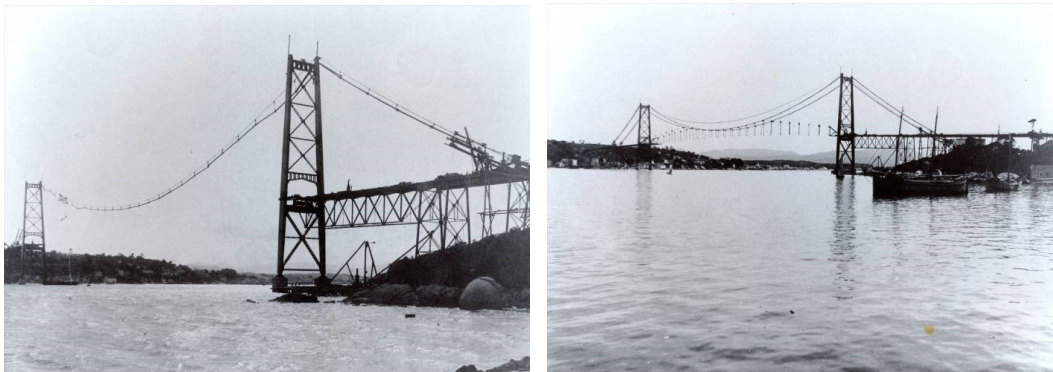
Figure 6: Main span assembly pictures (a) The pylon and the employment of auxiliary cables
(b) Truss isolated elements assembly (Steinman, 1926).

After the foundations were finished, the structural assembly of the access spans was performed. Figure 6 (a) shows the beginning of the main span assembly with the pylon assembly and the employment of auxiliary cables. After the eye-bar assembly, the truss elements are individually assembled (Fig. 6(b)) until the complete closing of the plane trusses (Fig. 7).

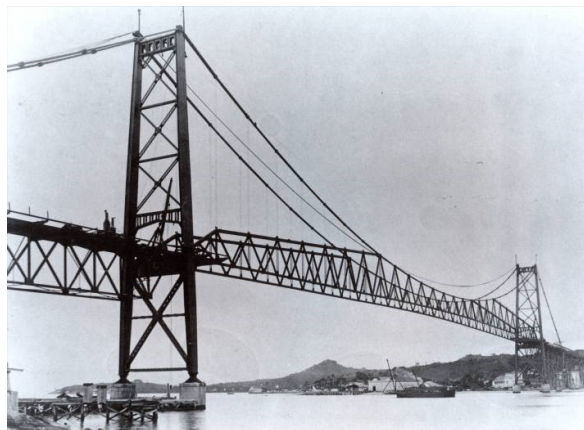
Figure 7: Plane trusses assembly (Steinman, 1926).

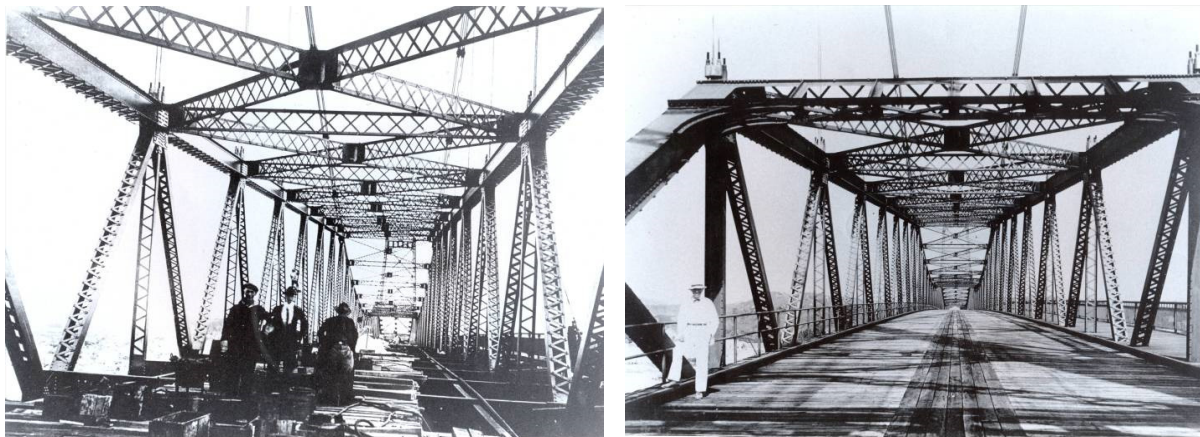
Figure 8: Deck photos (a) Support metallic elements assembly (b) Complete main span deck (Steinman, 1926).

After the plane trusses closure, the eye-bars are the only truss element at work. They are the only elements loaded due to the chosen operational assembly sequence. The other truss elements are in service only after the assembly of transverse elements (bracing elements and diaphragms) and bridge deck. Figure 8(a) presents the assembly of the metallic elements that support the bridge deck. Figure 8(b) presents the finished wood deck.

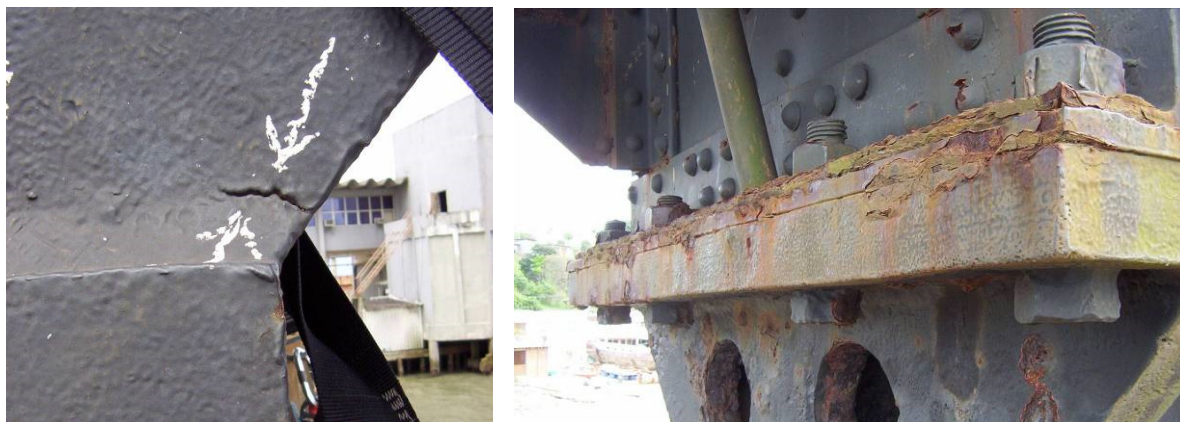
Figure 9: Fissures and the high corrosion level at the pylon base.

The last visual inspections were made between 2009 and 2013. Figure 9 presents the fissures and the high corrosion level at the pylon base. The high corrosion state of the steel deck is presented in Figure 10.

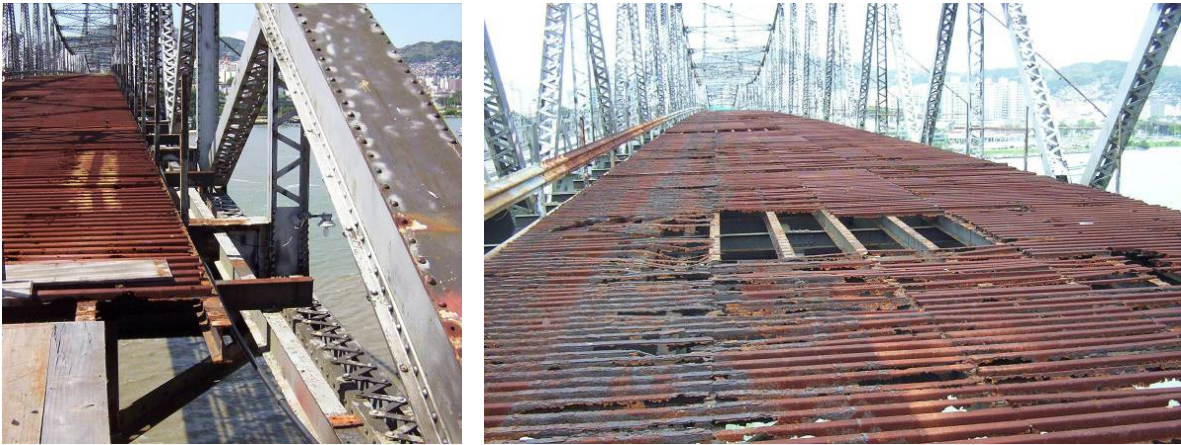
Figure 10: The high corrosion state of the steel deck.

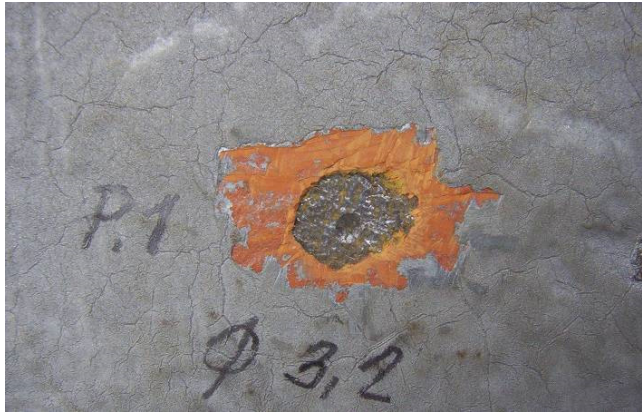
Figure 11: Hardness test in main structural elements.

Due to the fact that the original project is very old, there were no records of the composition of the steel employed in the construction. In order to characterize the kinds of steel present in the structure, hardness tests were performed in the main structural elements, such as pylons, eye-bars and truss elements (Fig. 11). The yield limits of the materials were defined based on the characterization results, in accordance with ASTM standard (ASTM E140-05e1, 2005).

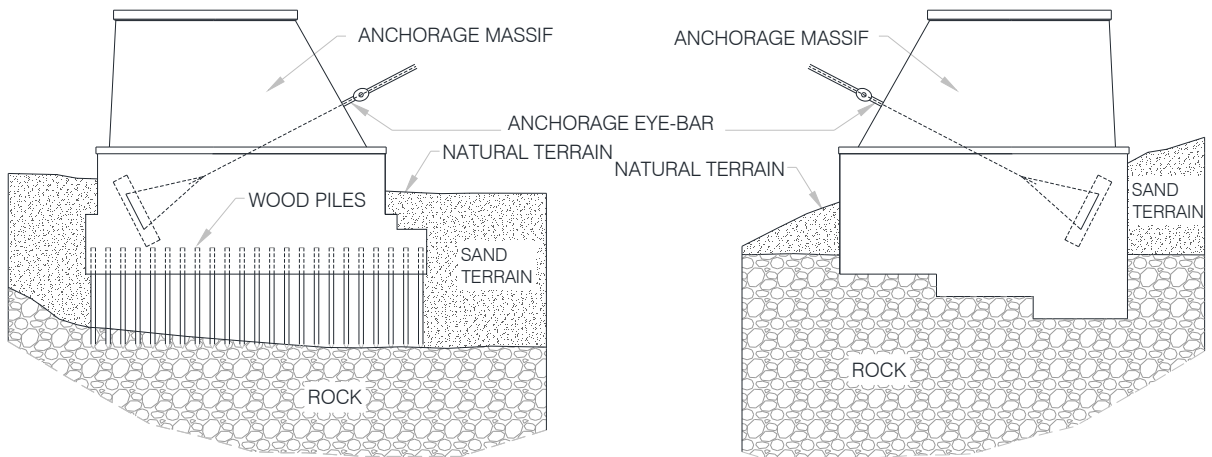
Figure 12: Anchorage massifs.

During inspections, surface wear was found in the concrete structures. Furthermore, it was found that the blocks and anchorage massifs were made of Cyclopean concrete. The original foundation project indicates that one of the anchorage massifs is set directly over the rock and the other over wood piles (Fig. 12). The wood piles are inaccessible. Therefore, it was not possible to verify their state of preservation and the structural integrity of the wood piles, due to age, cannot be guaranteed.

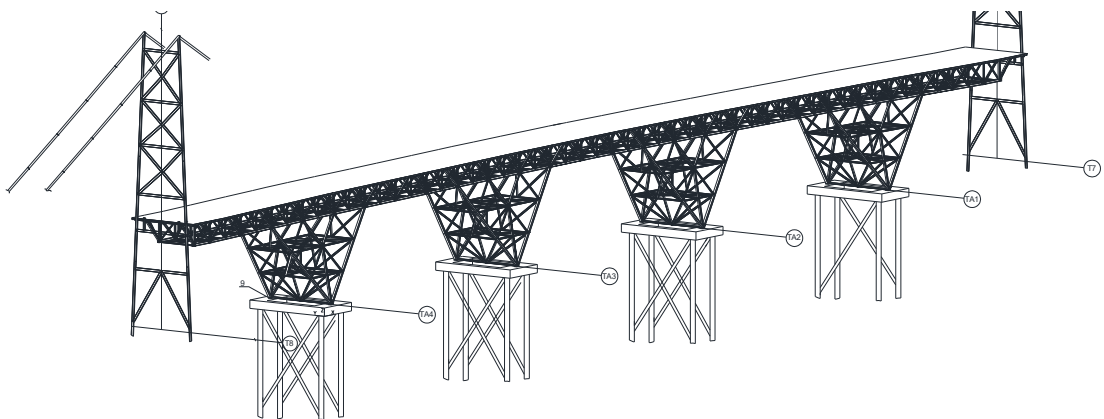
Figure 13: Inferior auxiliary structure supporting the main span.

A state of minimal structure loading should be reached so that the steel elements replacement and foundation retrofit may take place. For that purpose, a solution where the main span is supported by an auxiliary structure was designed. This approach makes the rehabilitation process safe, once the main span is completely supported by the auxiliary structure. This structure is composed by a space truss with four bases, supported by independent foundations (Fig. 13).

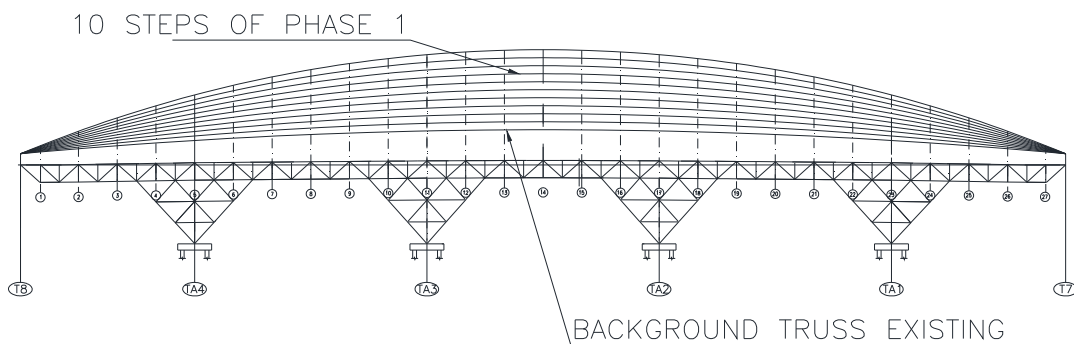
Figure 14: Load transfer Phase 1 steps.

- Phase 1: Jacking of 54 points in a parabolic form, with upward displacements, aiming to reach zero loading condition to the truss external eye-bars. After phase 1 is completed, just the external eye-bars can be disconnected from the truss. Even with the disconnected truss structure, there will be a residual tension load in the internal eye-bars (superior chords of the truss) due to the erection order of the bridge. In disassembly, the structural system of the truss does not enable the relieve of the tension efforts existent in its superior chords (composed by eye-bars). As can be seen in Figure 3b, the eye-bars are subject to tension loads before the assembly of the truss has been completed, due to the self weight of the elements. A total upward displacement of 550 mm must be considered in the middle span in order to annul the tension load in external eye-bars. The displacement will be made in 10 steps of 55 mm each (Fig. 14).

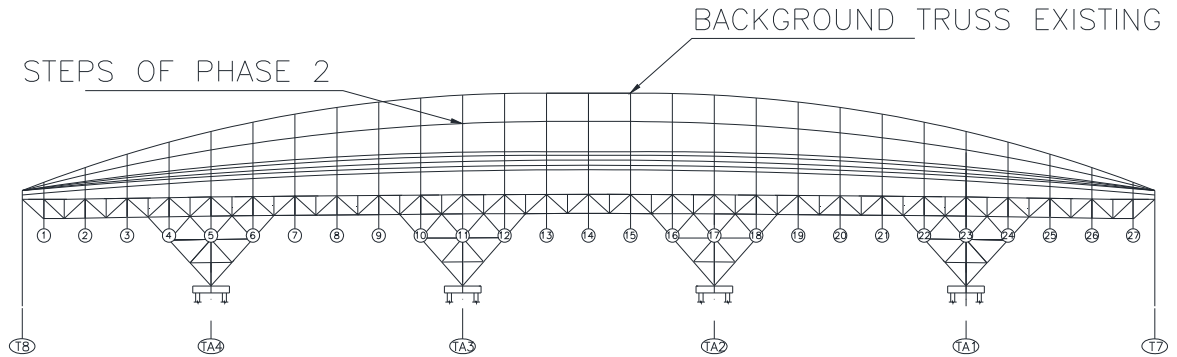
Figure 15: Load transfer Phase 2 steps.

- Phase 2: After disconnecting the truss from the external eye-bars, the 54 points must be jacked in a parabolic form, through downward displacements, aiming to reach compression loading at the truss superior chord. These imposed displacements are applied through six steps – Fig. 15 – and their values vary from 330 mm (first step) to 30 mm (last step) in the middle span. At each step, the added compression load will annul the residual tension load in the eye-bar symmetrical pairs, from the extremity towards the center, and the elements can be sequentially removed.

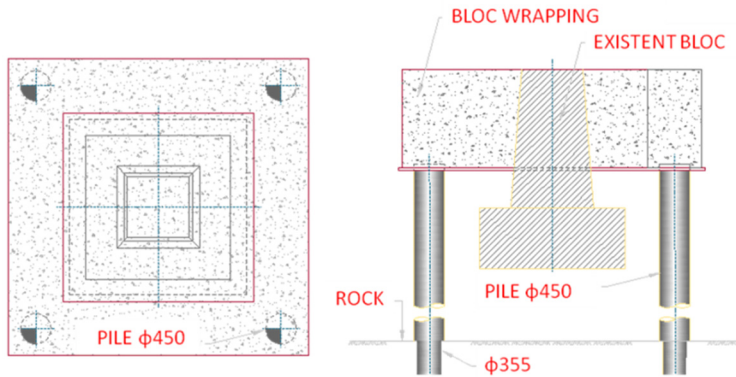
Figure 16: Typical reinforcement of the Bridge's access span bases.

The access span foundations were originally designed as rock supported concrete blocks. Since it is not possible to verify the real condition of the block support, a block reinforcement project was developed. The blocks will be expanded by being wrapped by a new bigger block that will be supported by 450 mm diameter concrete piles (Fig. 16).

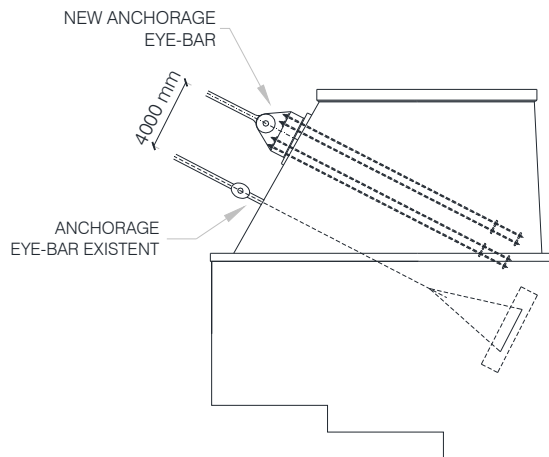
Figure 17: New position of anchorage eye-bars in the massif set over the rock.

The anchorage massif, which is set over the rock, will be used and only its surface repaired, while the anchorage massif set over wood piles will be demolished and integrally rebuilt with the original geometric shape. Figure 17 shows the position of the new anchorage eye-bars in the massif set over the rock.

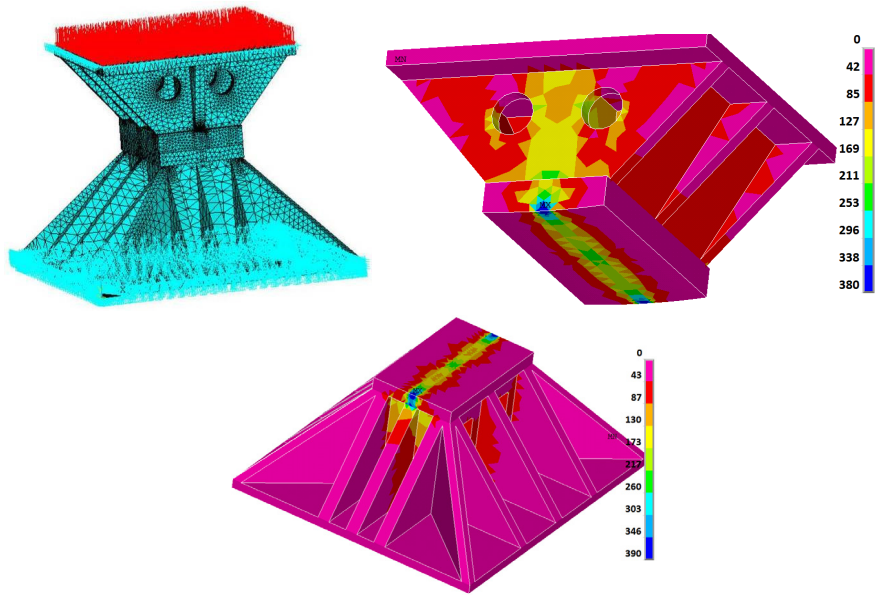
Figure 18: Numerical model and von Mises stress distribution at pylons bases [MPa].

The Hercilio Luz Bridge steel structures were the most affected by the time effect. The bridge deck, initially composed by steel beams covered by wood plates, will be replaced by an orthotropic steel deck. All the elements with complex geometries had their resistance evaluated based on FEM models. The cast parts, such as the pylon base and the eye-bar supports will be replaced by new cast parts. Figure 18 presents the stress diagram at the pylon base. Figures 19 and 20 present the stress diagrams of the eye-bar support and the eye-bar anchorage on the massif, respectively.

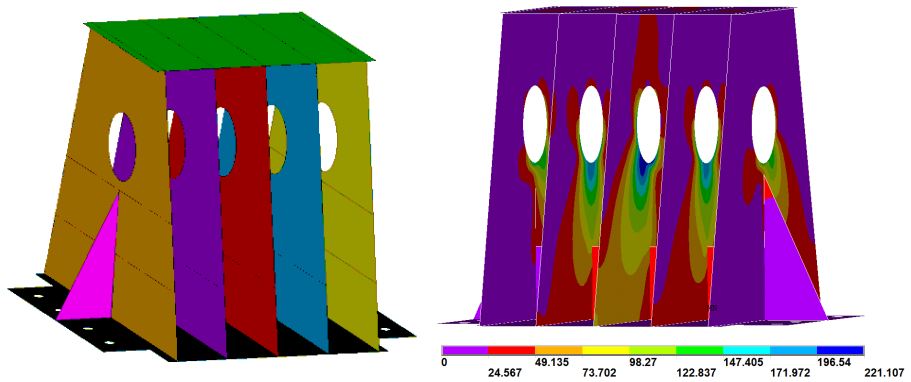
Figure 19: Eye-bar support numerical model and von Mises stress distribution [MPa].

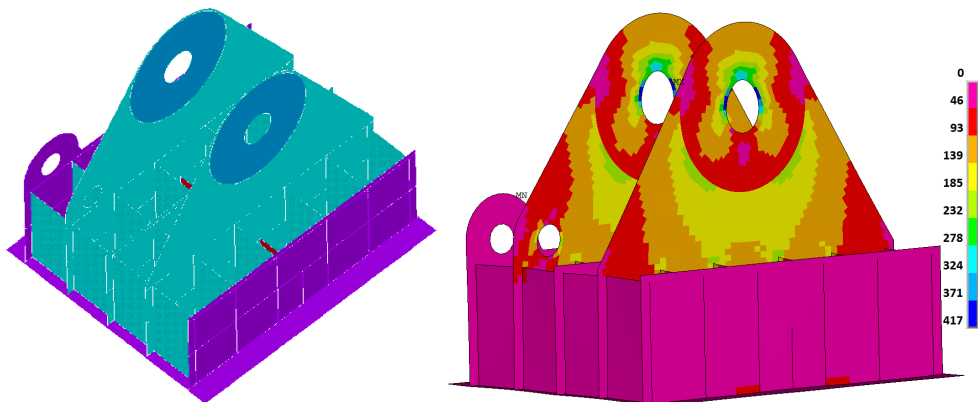
Figure 20: Eye-bar anchorage numerical model and von Mises stress distribution [MPa].

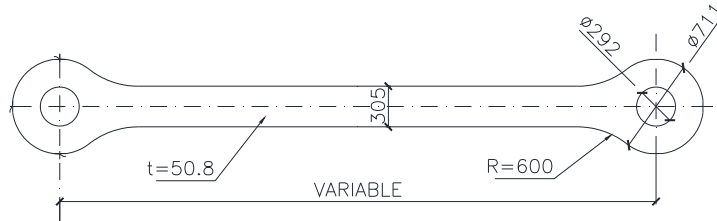
Figure 21: Geometry adopted for the whole eye-bar [mm].

The eye-bars will be replaced by new machined bars, made by high resistance steel with yield limit equal to 980 MPa. Some changes in the eye-bar geometry were analyzed, but the original design with circular hole was maintained. Figure 21 presents the geometry for the whole eye-bar, which total length is equal to, approximately, 15000 mm.

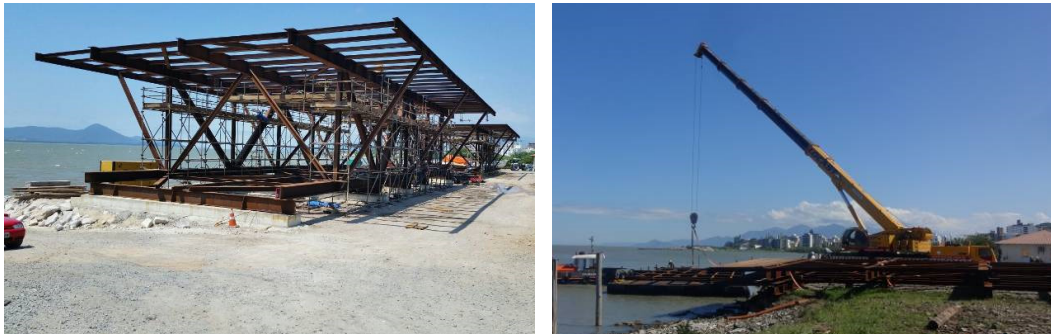
Figure 22: (a) Structure pre-assembly on site (b) Structure transportation by floating devices.

Currently (01/06/2016), the inferior auxiliary truss assembly has been concluded. The load transfer process is predicted to be initiated in August, 2017. After this stage is completed, the load transfer process will be initiated. Once the load transfer process completed, the proper rehabilitation work will start. Retrofitting and replacement of damaged steel elements, foundations strengthening and reverse load transfer will be performed. Figures 22 to 24 present the auxiliary structure assembly in several stages.

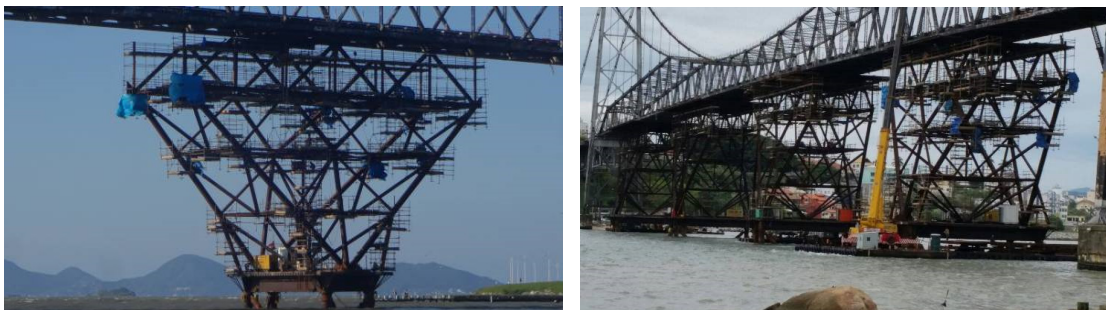
Figure 23: Auxiliary structure tower assembly.

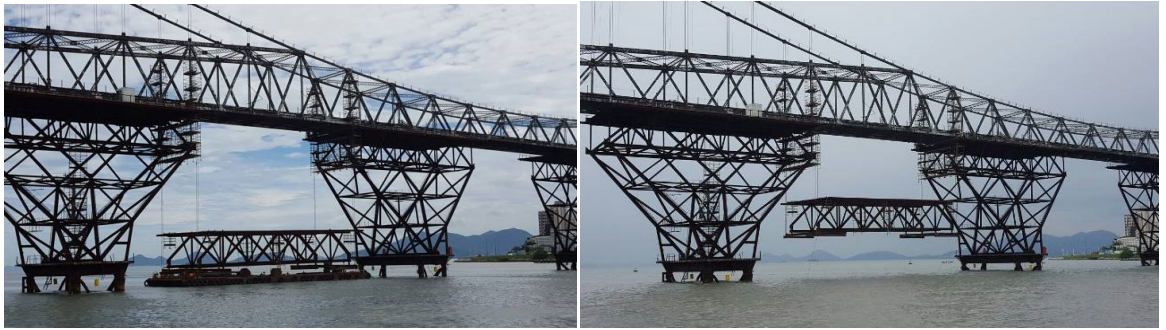
Figure 24: Transportation and hoisting of an auxiliary structure truss part.
