# Seismic Upgrading of Exterior Reinforced Concrete Frame with Small Column and Joint Area Using Externally Attached Steel Column

## Abstract

beam-column joint, seismic strengthening, small column frame

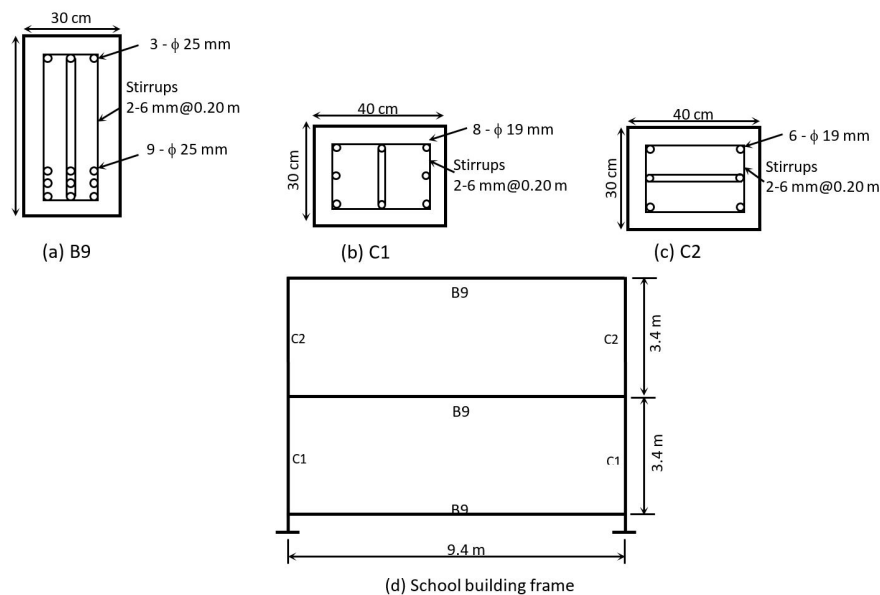
Many school buildings in Thailand are low-rise, single span type, as seen in Figure 1. The height is 2-4 stories and typical span is 9.4 meter. For the only gravity load design, the building frame is composed of small columns (30x40 cm rectangular section) connected with deep beams (30x80 cm rectangular section). This makes the designed frame behaving as the strong beam-weak column under a strong earthquake. Seismic vulnerability of the school building was studied and the strengthening using the concrete infilled steel tube in haunch zones was proposed Hansapinyo et al. (2018). The studies indicated the very low seismic capacity due to the joint and column weakness. Hence, seismic strengthening requirement was concluded in the studies.

**Figure 1:** (a) Beam section, (b) and (c) Column Sections, (d) School building frame (Hansapinyo et al., 2012)

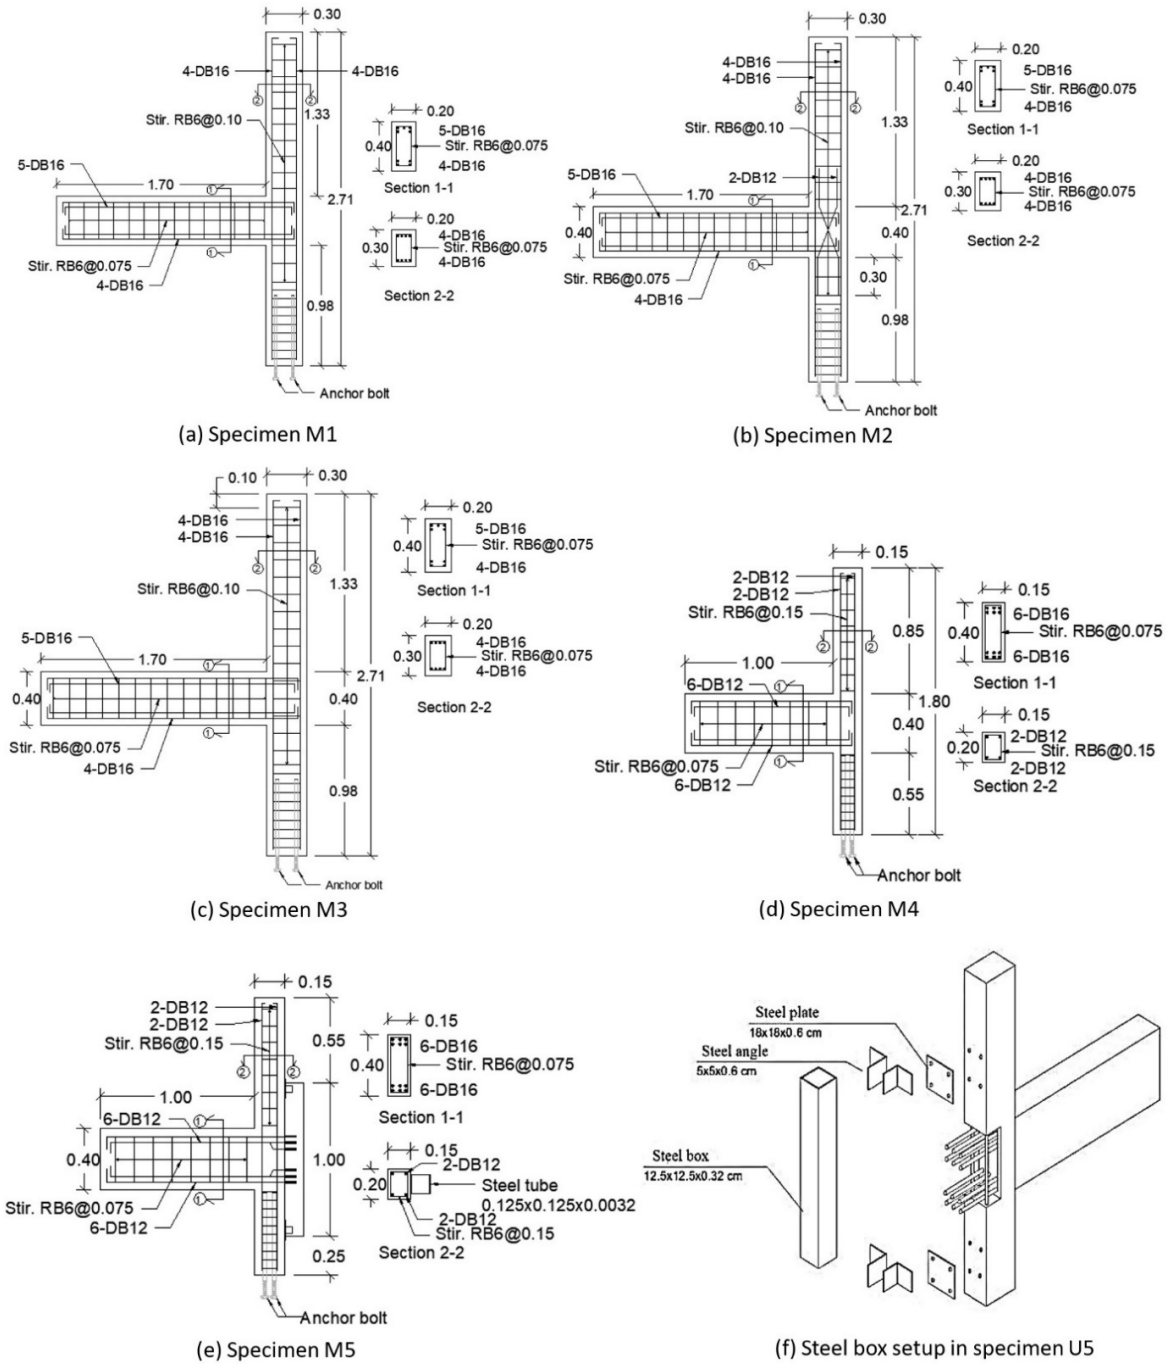
The first group of specimens comprising of M1-M3 were designed for the joint shear critical to obtain the effect of the different joint detailing. As shown in Figure 2, there was no hoop reinforcement in the joint area for M1 specimen. Three stirrups were provided for M2 specimen and diagonal rebars were arranged for M3 specimen. However, the contribution of the reinforcement is ignored for the determination of the joint shear strength based on chapter 21.7.4 of ACI318 (ACI, 20008), as seen in equation (1), where  $f'_c$  and  $A_j$  are respectively the concrete compressive strength and the effective cross-sectional area within a joint in a plane parallel to plane of reinforcement resisting shear in the joint. For M4 specimen, the exterior joint had no shear reinforcement resemble with M1 specimen but the column size was smaller. The reinforcement and dimensions of M4 specimen were designed considering strength scaling based on the capacity of the school building frame, as shown in Figure 1. The calculated ultimate story shear was 13.10 kN, as shown in Table 2, with the joint failure mode. For specimen U5, 12.5x12.5x0.32 cm hollowed steel box column was externally attached to the column to increase the column and shear capacity. As shown in Figure 2(f), to attach the steel box into the exterior existing column, two steel plates were attached to the column at the two ends using four drilled bolts. Then, the column was welded to the steel plate. At the beam-column joint, the covering concrete of the hook bar was removed and the hooks of the longitudinal reinforcement were straightened out and welded to the attached steel box. The required strength of the steel box was determined based on the capacity design philosophy. As shown in Figure 3, the capacity for different failure modes are first determined (Steps 1-3) and then calculate the ultimate story shear for the different modes (Step 4). Next, aiming at altering failure to the flexural damage in the beam, the required more strength upgrade for each mode is estimated based on the exiting flexural capacity of the beam. For upgraded specimen U5, the calculated story shear is 33.60 kN, as shown in Table 2, with the failure mode is altered to the shear failure in the column at the section next to the end of the attached steel box. It is noted that, to achieve the alteration of the failure to the beam flexure, the beam shear capacity, column shear and joint shear must be upgraded to a capacity higher than the beam bending capacity by using a larger size of the steel box and extended through the column length.

Figure 2: beam-column joint reinforcement detail

There were 5 test specimens as shown in Figure 2. The first four specimens were exterior reinforced concrete frame designed to be failed by the joint shear failure. Their nomenclature starts by “M” letter. The other one specimen was the upgraded exterior reinforced concrete frame. The nomenclature starts by “U” letter. The test specimens were planar beam-column subassemblies representing a portion of the building frame at the exterior joint between column and beams. The cyclic force was applied so that the distribution of the bending moment and shear force in the specimens were the same as for the whole building frame under lateral cyclic loading (Ketiyot & Hansapinyo, 2018). Specimens M1, M2, and M3 were a group of similar test specimens. The only difference was the reinforcement at the joint. The upgraded specimen U5 using attached steel column had sectional dimension and reinforcement similar to M4 specimen. The steel column was a 12.5x12.5 cm square steel box with a thickness of 3.2 mm. Longitudinal reinforcement was SD40 deformed bar either DB12 or DB16 with the nominal diameter of 12 mm and 16 mm, respectively. The stirrup was SR24 round bar either RB6 or RB9 with the nominal diameter of 6 mm and 9 mm, respectively. The tensile test results of the steels are shown in Table 1. At the cast date, concrete cylinders were sampled and tested for the compressive strength at the same date of the frame test. The concrete compressive strengths of the specimens are shown in Table 2.

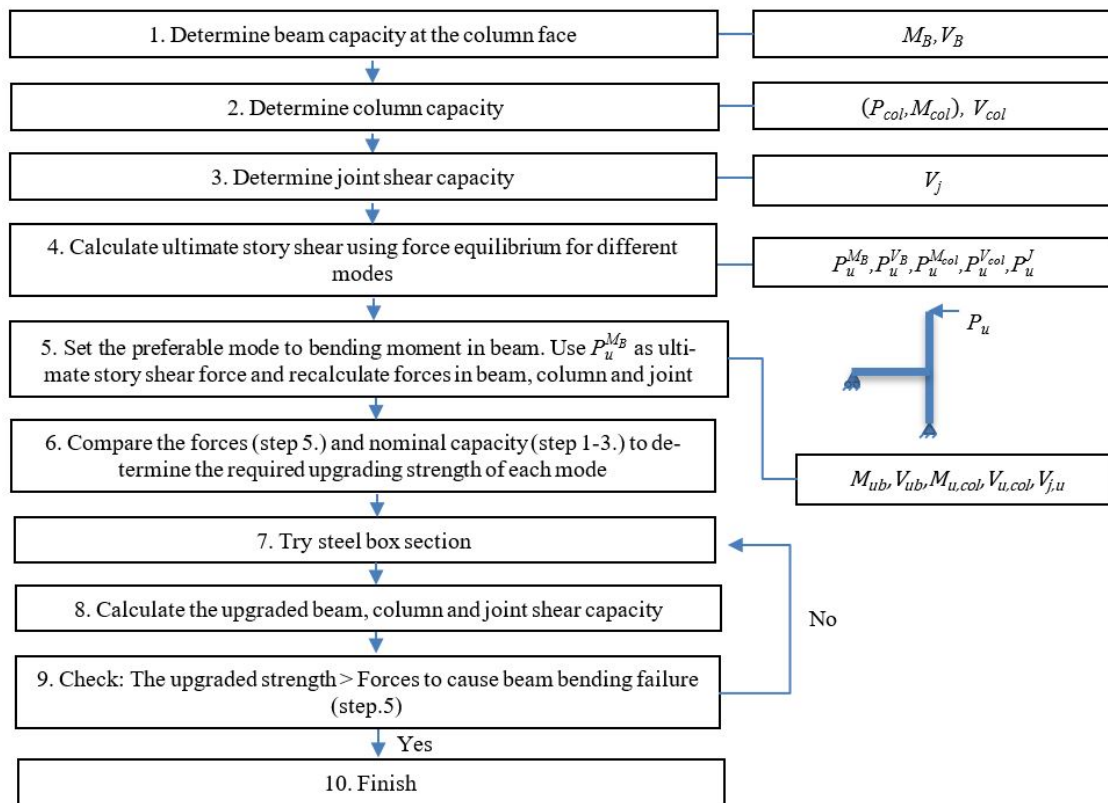
**Figure 3:** Determination of the steel box section

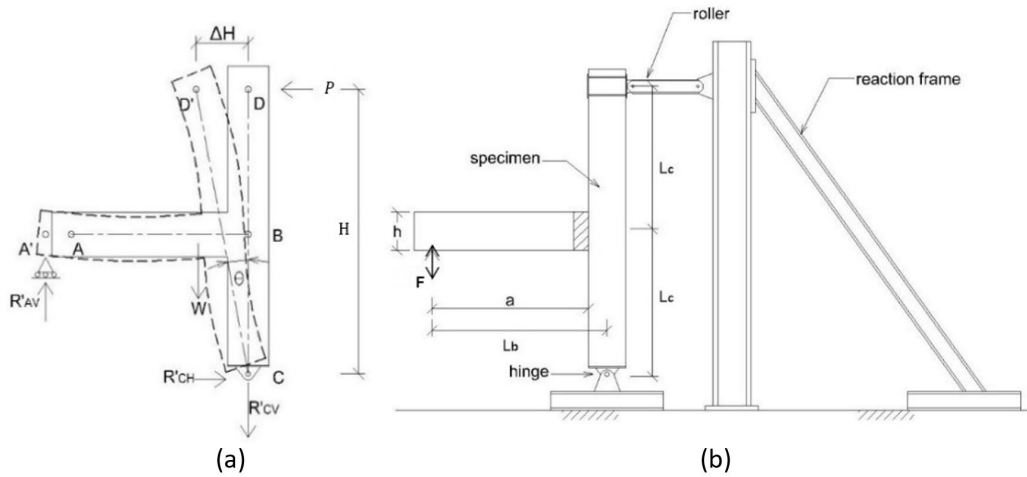
To simulate the earthquake loading during the test, ACIT 1.1-01 (ACI Innovation Task Group 1 and Collaborators, 2001) structural testing was adopted. As shown in Figure 4(a), a subframe of the exterior beam-column joint is subjected to the lateral cyclic force  $P$  at the column top end leading to the deformation represented by the dash line. The drift ratio defined as the angle change of the column ( $\theta$ ) is adopted as the loading increment. For the lateral deflection at the column tip  $\Delta H$  and the column height  $H$ , the drift ratio is determined as  $\Delta H/H$ .

In this study, however, vertically cyclic loading was applied at the beam end under the drift ratio control (Figure 5), as shown in Figure 4(b). Hinge supports were arranged at the top and bottom of the columns. Hence, based on the frame deformation configuration, the lateral displacement controlled at the column end ( $\Delta H$  in Figure 4(b)) was converted to the vertical displacement at the beam end for the loading increment. In addition, the applied lateral load ( $P$  in Figure 4(a)) was obtained considering the force equilibrium of the test frame system with the applied force ( $F$  in Figure 4(b)), as seen in equation (2). It is noted that there was no compressive load applied at the column of the specimens as the low-rise building is subjected to a small magnitude of the axial load. In addition, the strength of the beam-column joint is less compared with the column having a certain amount of compressive load leading to a conservation study for the joint strengthening.

Figure 4: Experimental setup (a) after apply load (b) Installation of test specimens and test force

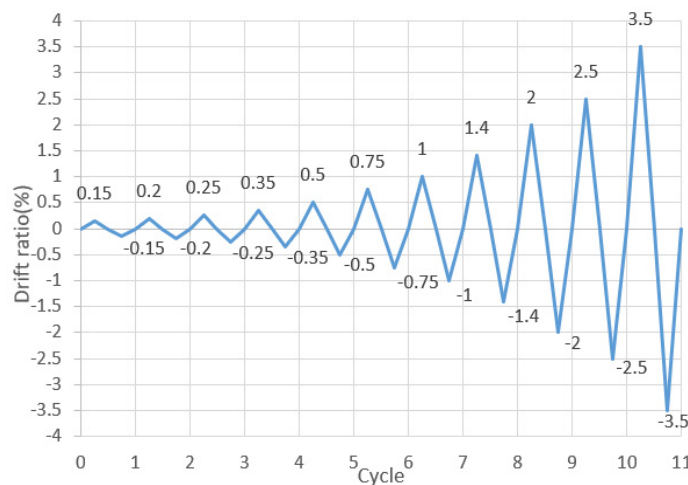
Figure 5: Drift ratio incremental loading

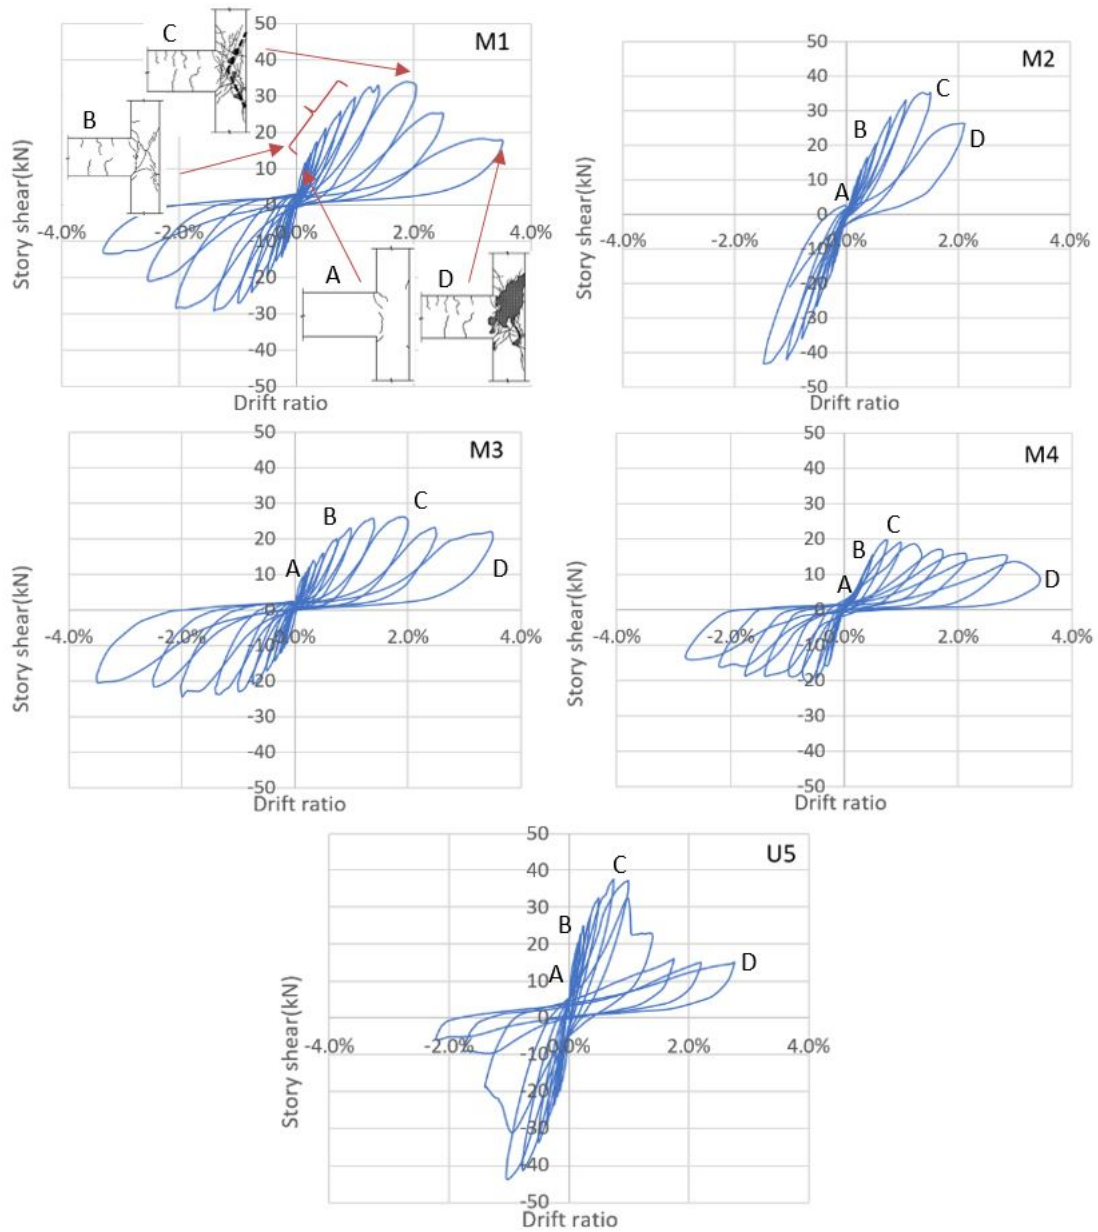
The relationship between the story shear ( $P$ ) and the drift ratio ( $\theta$ ) of the specimens are shown in Figure 6. The cracking and the hysteresis behavior of all specimens were similar. For the sake of the explanation, the cracking propagation of M1 specimen is shown with the hysteresis curve (the first graph of Figure 6). At the early loading with the drift ratio less than 0.2%, the stiffness was maintained constant. Then, the first flexural crack at the beam end near the column face was occurred leading to the reduction of the stiffness (Point "A"). With the increase of the drift ratio, the flexural crack was lengthened and widened. New flexural cracks in the beam were generated at sections far from the column face. Diagonal cracks in the beam-column joint also were found. However, for M4 and U5 specimens, there were only a few cracks in the beam. After the occurrence of the diagonal cracks in the beam-column joint, the further increased of the drift ratio increased the damage at the joint area, deteriorated the stiffness. The area under the relationship was decreased and the pinching effect was obviously demonstrated (Loading range "B"). The peak story shears were obtained at about the drift ratio of 1.4% with the formation of the wedge formed crack at the joint (Point "C"). With the further increase of the drift ration, the generated cracks were widened and concrete spalling was observed (Point "D"). For U5 specimen, shear crack at the bottom column was found at the section next to the externally attached steel box. Figure 7 shows the crack pattern of U5 specimen. Figure 8 shows the crack development of all specimens. Hence, as the failure mode was brittle, the energy dissipation capacity of the specimens was quite limited. The failure mode of M1-M4 specimens was the beam-column joint failure. However, it is noted that M2 specimen test was stopped accidentally at the post peak loading due to the improperly loading alignment.

Figure 6: The relationships between story shear – drift ratio

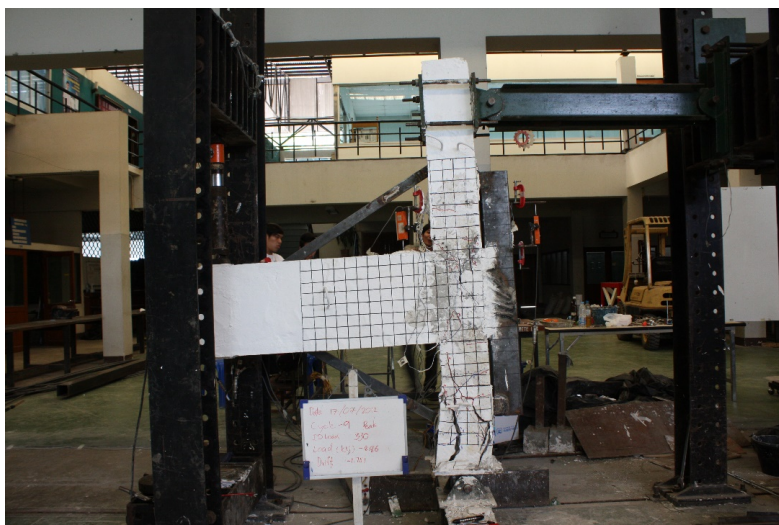
Figure 7: Failure of U5 specimen

- Considering M4 specimen with the very small column compared with the connecting beam, the column was failed at a very low story shear. As the joint area is also very small, the column failure was immediately followed by the joint shear failure. There were no damages in the connecting beam. Hence, the externally attached steel column the exterior was introduced in U5 specimen. The result of the installation increased the story shear from 18.6 kN of M4 specimen to 37.5 kN of U5 specimen which is 2.02 times higher. However, the ductility is needed to be improved as the failure of U5 specimen was the column failure.

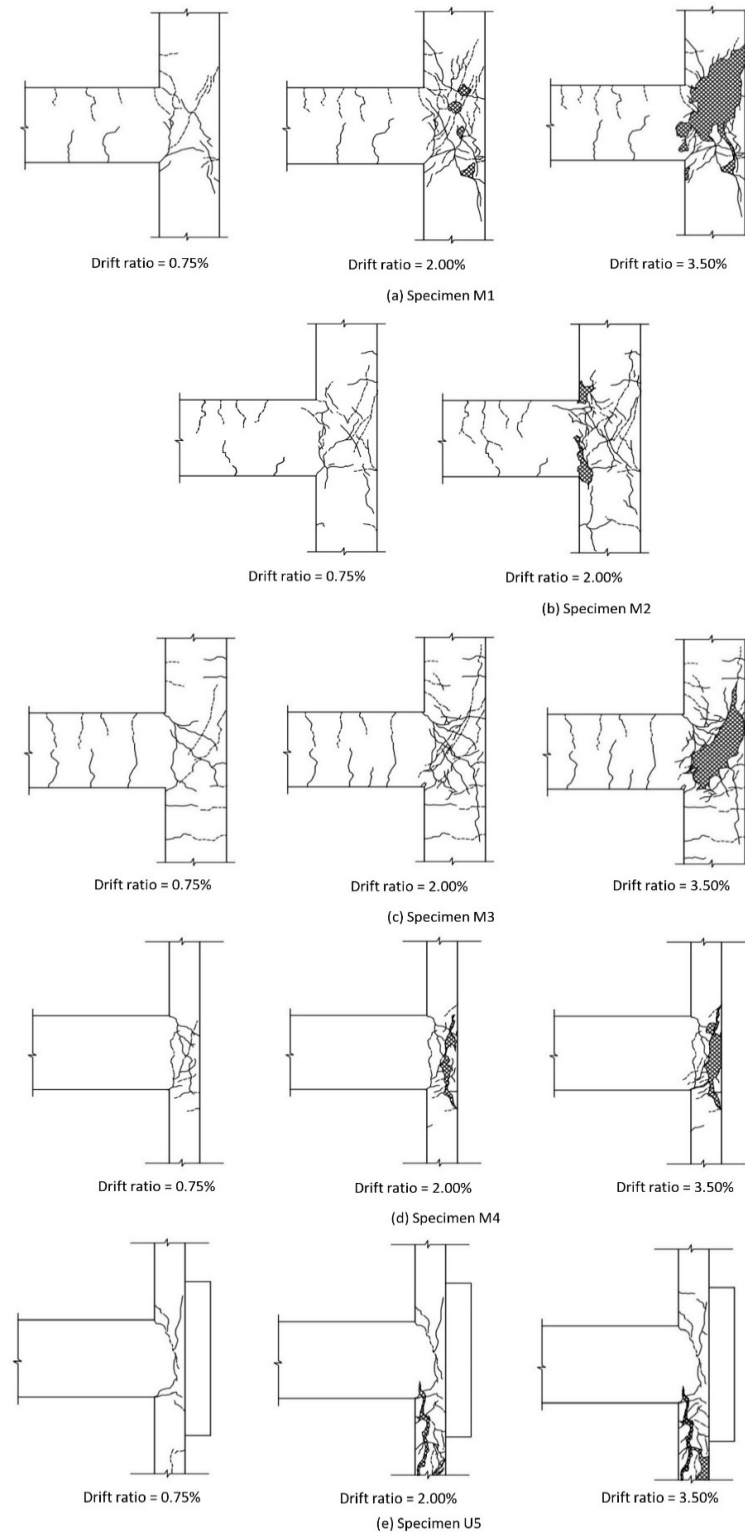
**Figure 8:** Crack propagation

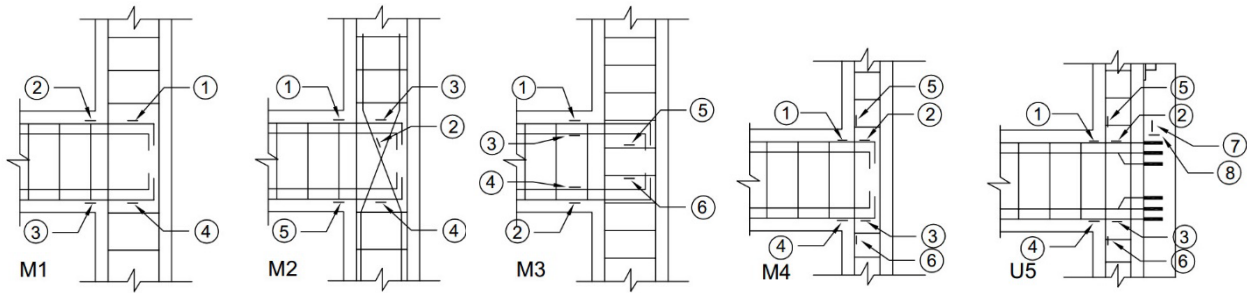
Strain gauges were attached to the reinforcement at the expected critical sections as shown in Figure 9. Some strain values obtained during the tests are shown in Figure 10. The strains in the longitudinal beam reinforcement at the column face are smaller than the yield strains shown in Table 1. The strain the joint shear reinforcement (M3-STG6) is also small. Hence, the contribution of the shear reinforcement to resist the joint shear force is negligible.

Figure 9: Strain gauge positions

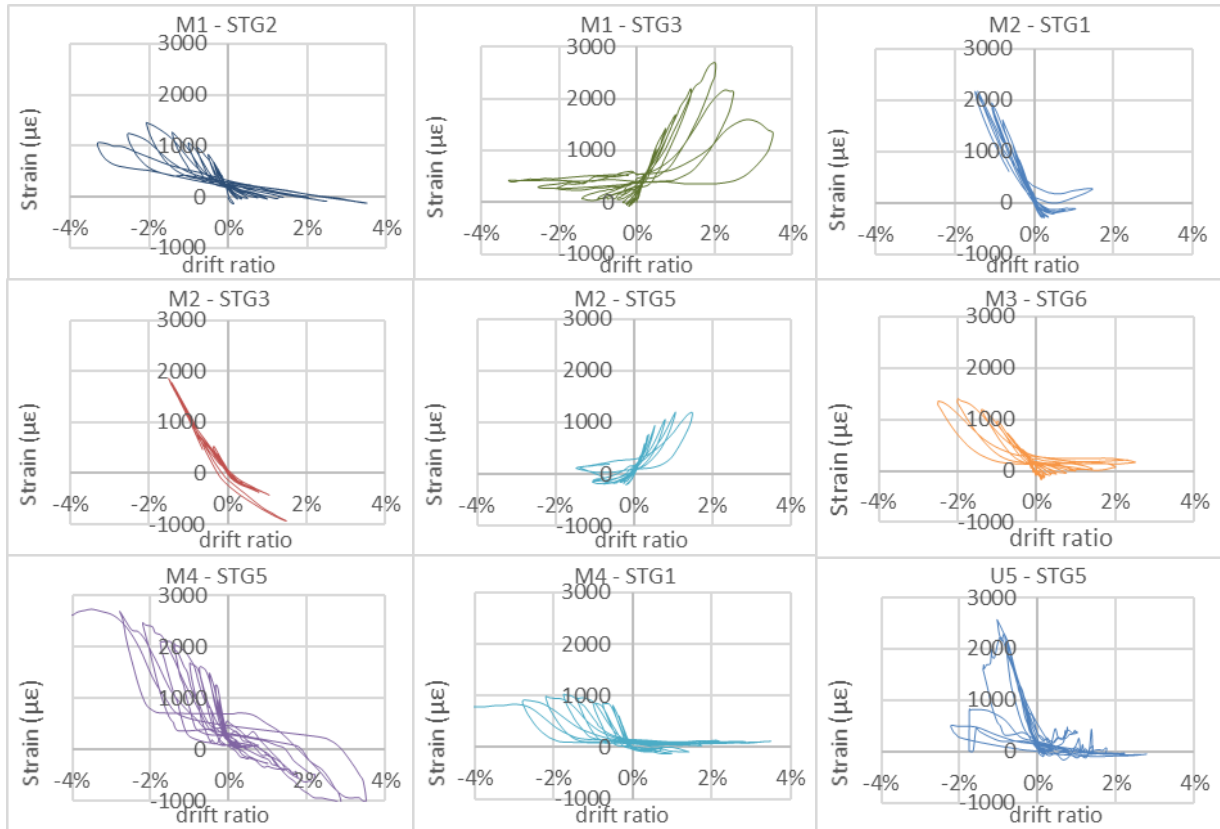
Figure 10: Strain in the reinforcement

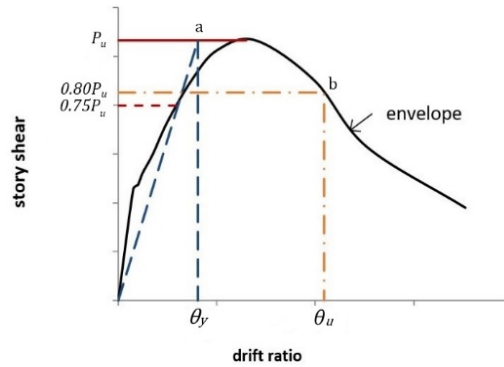
Based on the research of Legeron & Paultre (2000), the yield drift ratio and the ultimate drift ratio can be defined, as shown in Figure 11. First, the 0.75 of the ultimate story shear ( $0.75 P_u$ ) is determined and a line from the origin to the  $0.75 P_u$  story shear to meet the ultimate story shear at point “a” is drawn. Then, the yield drift ratio can be defined corresponding to the point “a”. For the ultimate drift ratio, it is defined as the drift ratio at the after peak story shear of  $0.80 P_u$  (point “b”). The envelop curves of the specimens are shown in Figure 12. Considering the smaller loading capacity

Figure 11: Determination of ductility (Legeron & Paultre, 2000)

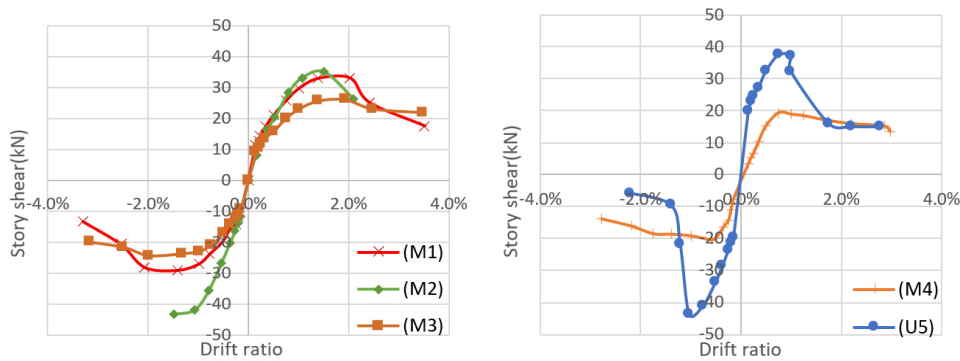
between the push and pull sides, the story shear capacities of the specimens are shown in Table 3. The story shear of M1, M2 and M3 specimens were 29.0 kN, 35.0 kN and 24.4 kN., respectively. For M4 specimen, the story shear capacity was only 18.6 kN. The upgraded U5 specimen possessed the story shear capacity of 37.5 kN which is 2.02 times of the strength of M4 specimen. The comparison ratio of the ultimate story shear between the test and calculation are in the range of 0.64-1.42. The calculation is overestimated for the first group of specimens (M1-M3) and underestimated for the small column specimens (M5 and U5). The smaller ductility of the push and pull sides are shown in Table 3. As all the specimens were failed by the brittle failure modes, the ductility of the specimens is quite small values (2.02-4.54).

Figure 12: Envelop curve of specimens M1 - U5
