## Biodeterioration of Coastal Concrete Structures by *Macro algae - Chaetomorpha antennina*

Puducherry is a coastal region in India where the growth of *Chaetomorpha antennina* is very abundant on all marine concrete structures. Though the detrimental effect of this *Macro algae Chaetomorpha antennina* is secondary, its effect has to be ascertained. To know its effect, M20 grade concrete cubes were cast and kept in the coastal area where there is abundant growth of *Chaetomorpha antennina* and also laboratory simulation has been carried out. The basic mechanism by which *Chaetomorpha antennina* deteriorates concrete structures has been highlighted and also the detrimental effect on the algal grown concrete surface were ascertained using SEM, EDX and XRD. The result showed that there is sustainable effect by the marine algae on the concrete surface.

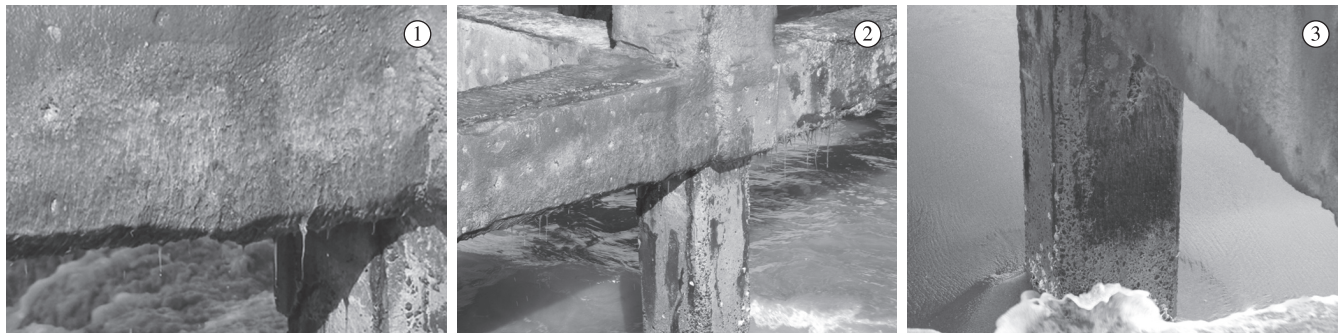
Figure 1, 2 and 3. Growth of marine seaweed on structural components.

Puducherry is an Indian coastal region on the Bay of Bengal. There are many marine structures located in the coastal area. These structures deteriorate due to the macro flora Figure 1, 2 and 3 present in the sea water<sup>3,4,5,6,7</sup>. Though a secondary deterioration process, there is significant detrimental effect due to this macro flora<sup>9,14,15</sup>. The ambient condition prevailing in the coastal area helps the growth of *Chaetomorpha antennina* round the year. The growth of *Chaetomorpha antennina* on concrete structure in Puducherry region is found almost on all the structures. This study aims to ascertain the effect of marine chlorophyceae *Chaetomorpha antennina* on concrete structure. For this, concrete cubes were immersed in the coastal area

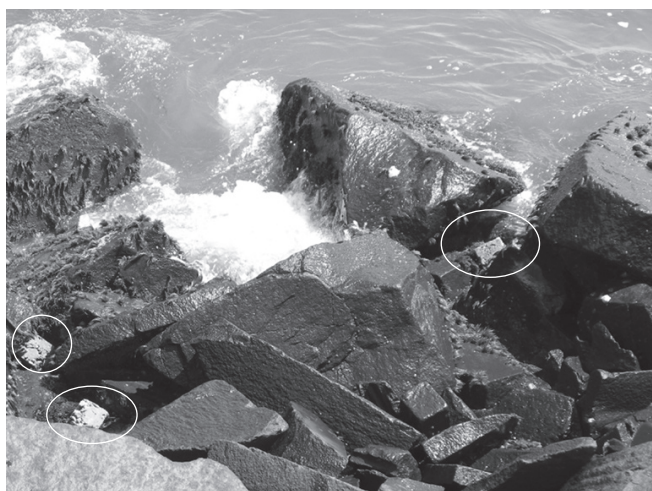
Figure 4. shows the natural culture of the marine algae *Chaetomorpha antennina* on concrete cube.

- a) To culture *Chaetomorpha antennina* naturally, several concrete cubes were kept in the coastal area where there was abundant growth of *Chaetomorpha antennina* (Figure 4);
- b) Concrete cubes were allowed to cure in ordinary water; and
- c) Laboratory simulation was carried out to culture the *Macro algae* on the concrete cube. For the simulation, Humidity oven was used (Figures 5 and 6). The details of the oven are as follows:

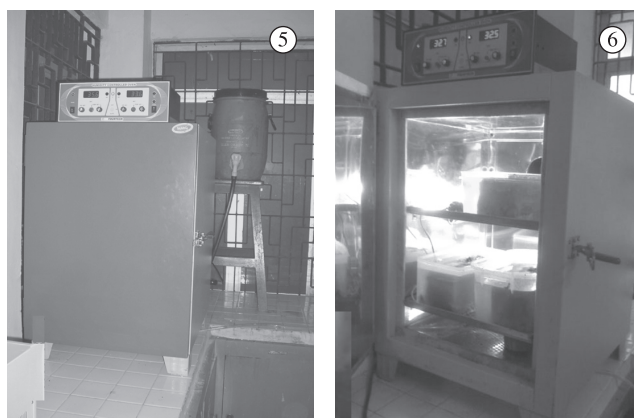
Figure 5 and 6. shows the Laboratory culture of the marine algae *Chaetomorpha antennina* on concrete cube.

The ambient condition maintained in the chamber is as follows. Samples were incubated under lighting conditions of 2000 lx, 12 h/day with a "daylight" with white fluorescent lamp. The temperature was maintained at 30 °C. The relative humidity was maintained as 90%<sup>3</sup>.

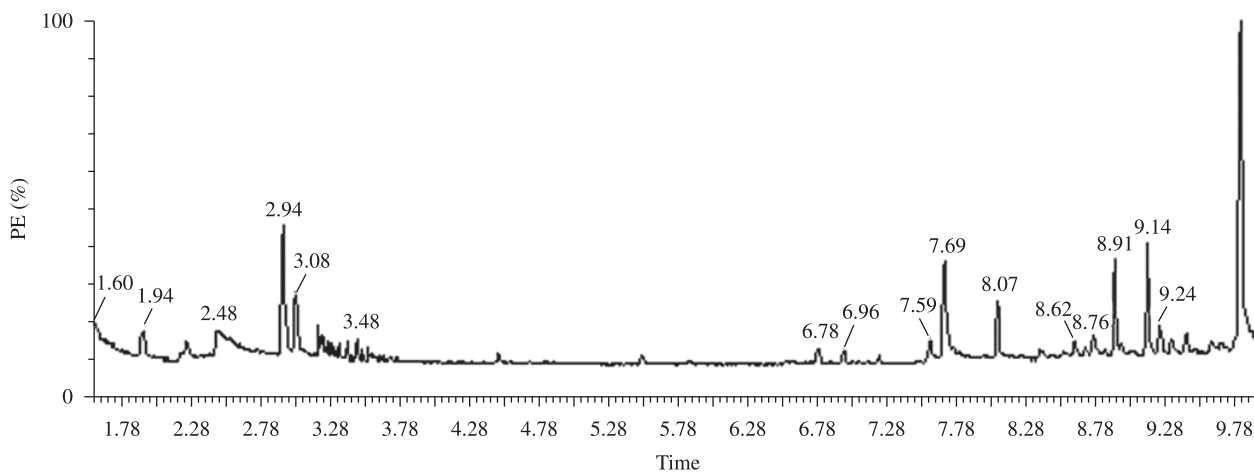
Figure 7. GC-MS of fatty acid fractions subjected to methylation obtained from *Chaetomorpha antennina*.

- Esterification  
All the fatty acid fractions obtained were subjected to methylation and 1.5 -2.0 mL ethereal diazomethane was added to the fatty acid mixture. The reaction mixture was left in the fuming chamber at room temperature, over night until dissolved. The aliquots were then directly injected to a Hewlett Packard®

gas chromatograph – mass spectrophotometer (GC-MS) with 11/73 DEC computer system (Figure 7); and

- The methanolic extract of *Chaetomorpha antennina* revealed the presence of three saturated and six unsaturated fatty acids. The details are as show in Table 1.

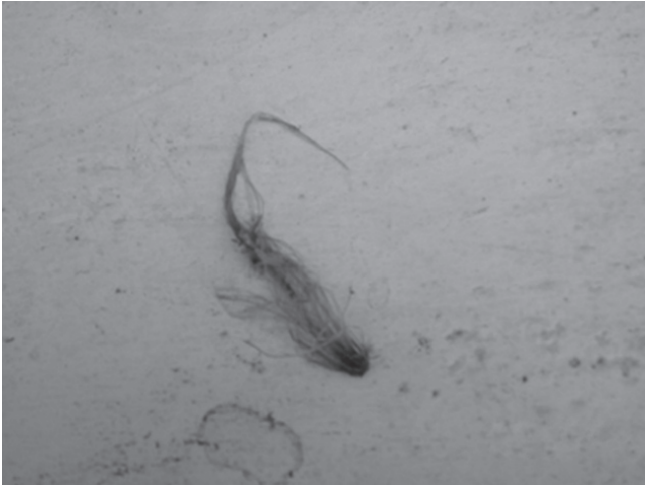
**Figure 8.** *Chaetomorpha antennina* species.

The species collected by scarping from the surface of concrete was identified as *Chaetomorpha antennina* (Figure 8).

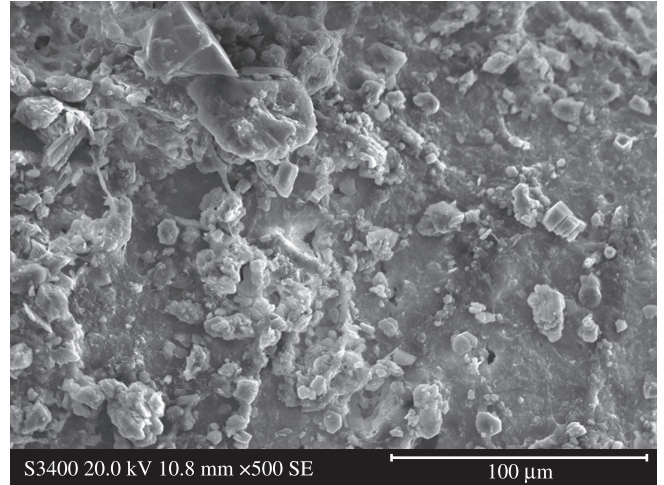
**Figure 11.** SEM of *Chaetomorpha antennina* attached concrete surface in laboratory condition (magnification: x5000).

SEM Figures 9, 10, 11, and EDAX results depicted in the Table 2, 3 and 4 and EDAX Figures 12, 13, and 14 elucidate that the base material has been modified. In the case of concrete cubes cured in ordinary water (control concrete) the silica level is 10.37% atom while calcium level is 9.18% atom. The EDAX results of the algal affected concrete shows that the calcium level has tremendously increased to 46.06% atom while silica level had decreased to 1.29% atom<sup>7,15</sup>. While in the case of simulated condition, calcium level had tremendously increased to 44.01% atom while silica level had increased to 4.23% atom. This proves that the calcium level in the algal affected concrete surface in natural and laboratory condition has increased tremendously. This high level of calcium is due to dissolution of calcium in concrete by organic acid produced by marine *chlorophyceae Chaetomorpha antennina* and precipitation of the organic salt upon dehydration. This is an indication of the alteration of the base material.

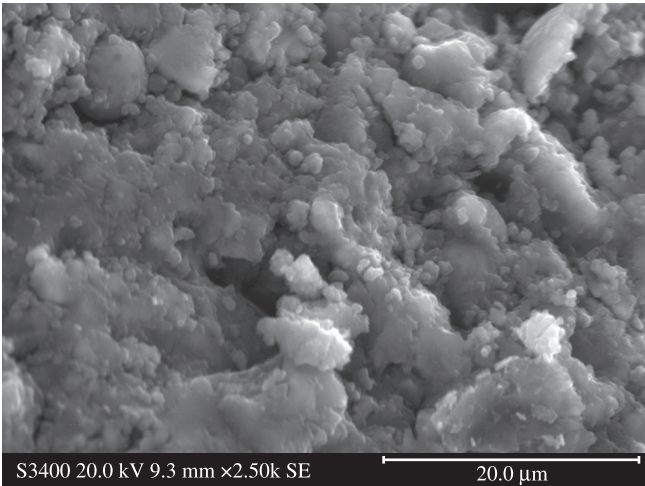
**Figure 9.** SEM of concrete specimen immersed in ordinary water (magnification: x2500) - (control concrete).

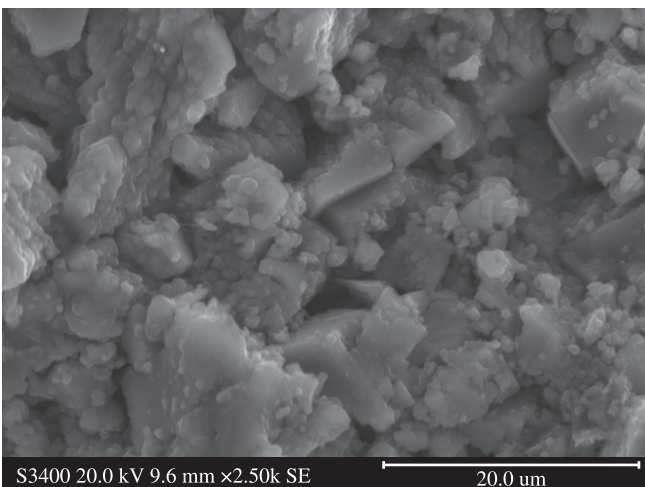
**Figure 10.** SEM of *Chaetomorpha antennina* attached concrete surface in natural condition (magnification: x2500).

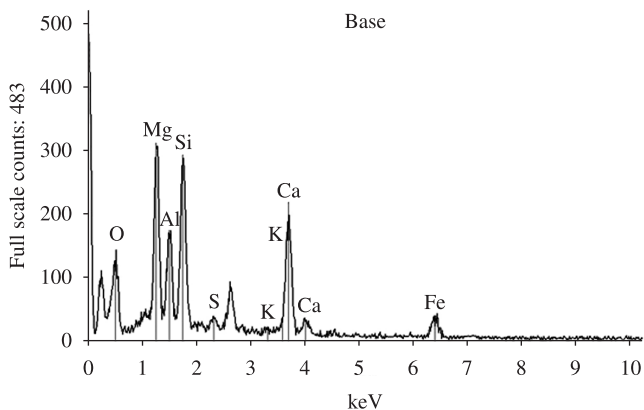
**Figure 12.** EDAX of concrete specimen immersed in ordinary water (control concrete).

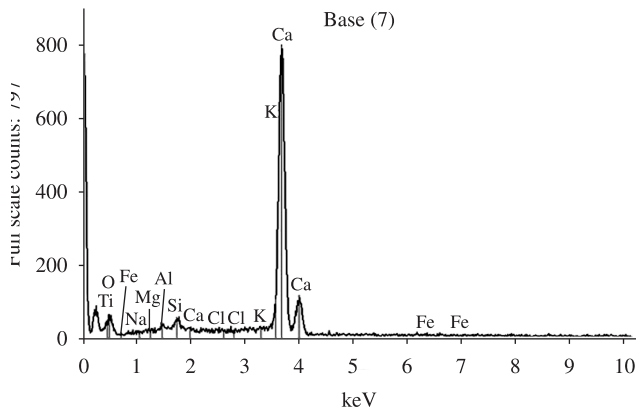
**Figure 13.** EDAX of *Chaetomorpha antennina* attached concrete surface in natural condition.

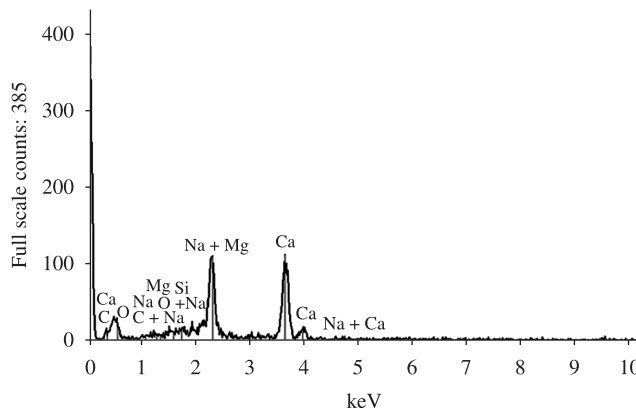
**Figure 14.** EDAX of *Chaetomorpha antennina* attached concrete surface in laboratory condition.

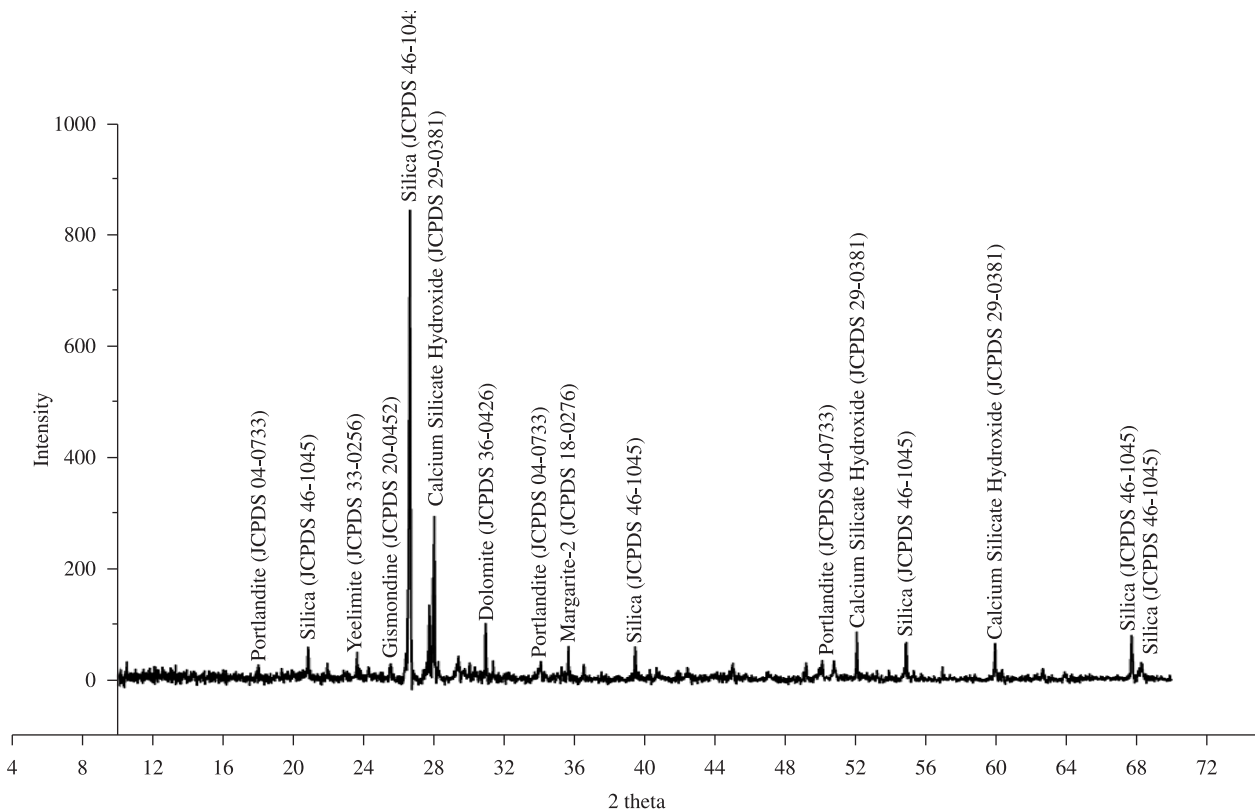
**Figure 15.** XRD of concrete specimen immersed in ordinary water (Control concrete).

Figure 15 shows the mineralogical analysis of concrete by XRD. The following are the crystals present in concrete specimen immersed in ordinary water Portlandite ( $\text{Ca}(\text{OH})_2$ ), Silica, Yeelite

( $\text{Ca}_3\text{Al}_6\text{O}_{12} \cdot \text{CaSO}_4$ ), Gismondine ( $\text{CaAl}_2\text{Si}_2\text{O}_8 \cdot 4\text{H}_2\text{O}$ ), Dolomite ( $\text{CaMg}(\text{CO}_3)_2$ ), Margarite-2 ( $\text{CaAl}_2(\text{Si}_2\text{Al}_2)\text{O}_{10}(\text{OH})_2$ ), Calcium Silicate Hydroxide ( $\text{Ca}_4\text{H}_2\text{O}_{15.5}\text{Si}_3$ ). The intensity of Portlandite is 34 at  $18^\circ$ ,  $34^\circ$ ,  $50^\circ$  while silica has a maximum intensity of 846 at  $26^\circ$  and Calcium Silicate Hydroxide has a intensity of 294 at  $28^\circ$ .

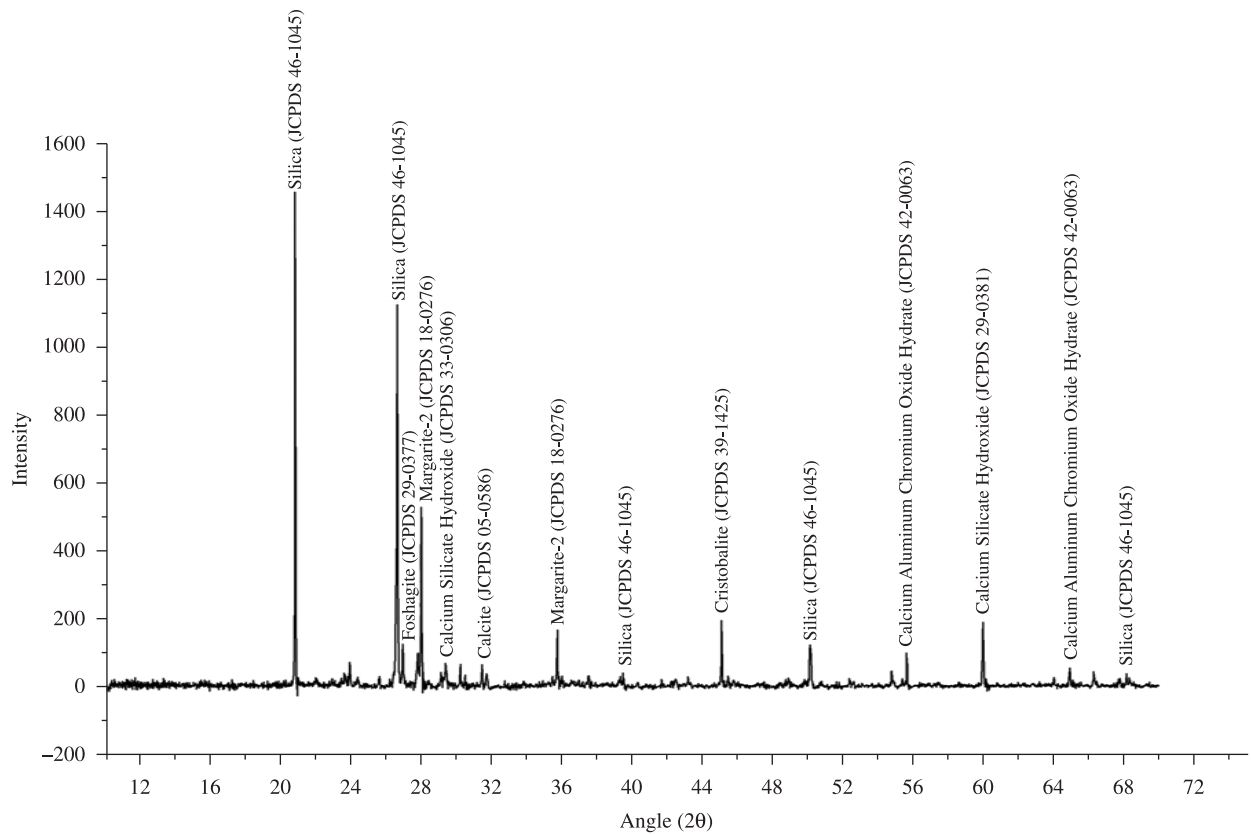
Figure 16. XRD of *Chaetomorpha antennina* attached concrete surface in natural condition.

Figure 16 shows XRD pattern for algal attached concrete in natural condition. Compounds like Foshagite ( $\text{Ca}_4\text{H}_2\text{O}_{11}\text{Si}_3$ ), Calcium Silicate Hydrate ( $\text{Ca}_{1.5}\text{SiO}_{3.5} \cdot x\text{H}_2\text{O}$ ), Calcite ( $\text{CaCO}_3$ ), and Cristobalite ( $\text{SiO}_2$ ), Calcium Aluminum Chromium Oxide Hydrate are present here which are absent in the concrete specimen immersed in ordinary water (Control Concrete). Apart from this, it is noticed that the Silica intensity (1452) is very high at  $21^\circ$  compared to  $26^\circ$  which is 1119 only. Similarly the intensity of Calcium Silicate Hydroxide at  $60^\circ$  is  $64^\circ$  in control concrete while it is 187 here. Compounds like Yeelimite, Gismondine and Portlandite are completely absent here. The absence of Portlandite (i.e. Calcium Hydroxide) shows that the alga has utilized it for its metabolic activity<sup>1,2</sup>.

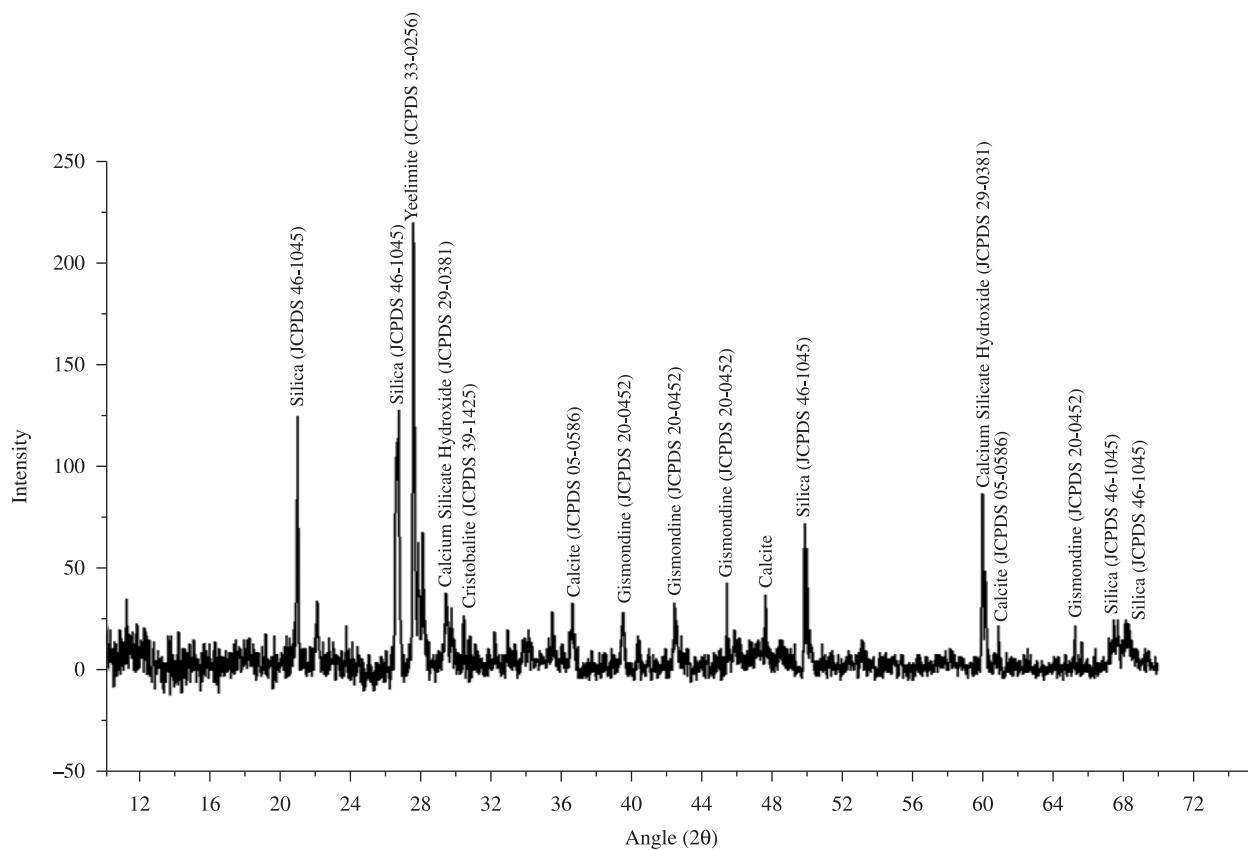
Figure 17. XRD of *Chaetomorpha antennina* attached concrete surface in laboratory condition.

Figure 17 shows the XRD pattern for algae attached concrete in simulated condition. It is notified that the intensity of Yeelimite is very high (218) while there are two Silica peaks at  $20^\circ$  and  $26^\circ$  with more or less equal intensity of 126. The intensity of Calcium Silicate Hydroxide at  $60^\circ$  is  $64^\circ$  in control concrete while it is 87 here. Apart from this new compounds like Cristobalite and Calcite are present here which is not notified in control concrete. Three peaks are noticeable for portlandite in control concrete which is totally absent in this case. Similarly Margarite-2 is not noticeable here. This shows that algae have utilized the calcium hydroxide for its metabolic activity<sup>1,2</sup>.
