Use of Bovine Pericardium and Sutureless Biological Glue in Left Ventricular Rupture After Mitral Valve Replacement, Five Years of Follow-up

Abstract

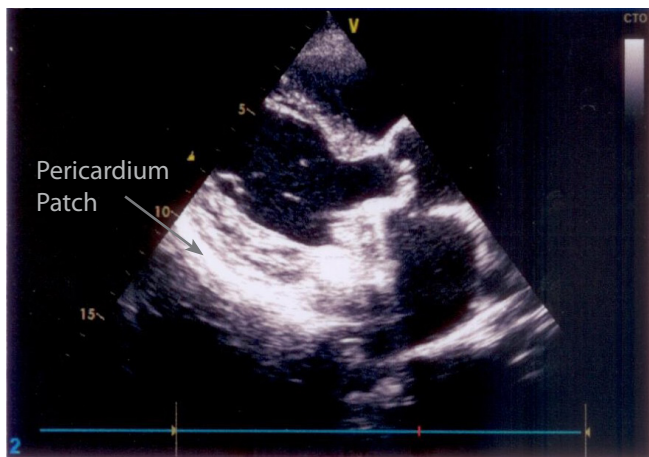
Fig. 1 – Fixed bovine pericardium patch.

was opted for an alternative strategy for bleeding correction: a flap of bovine pericardium was immediately fixed with N-butyl-2 cyanoacrylate and methacryloxysulfolane (Glubran®) over the area of bleeding, filling the retrocardiac space with absorbable gelatin sponge (Gelfoam®) for compression, without the use of sutures (Figure 1). With these measures and the control of blood pressure (mean arterial pressure maintained between 50 and 60 mmHg), bleeding was contained.
