Early Intraprosthetic Dislocation of Total Hip Arthroplasty with Double Mobility Implant: Case Report

Rev Bras Ortop 2024;59(3):475–478.

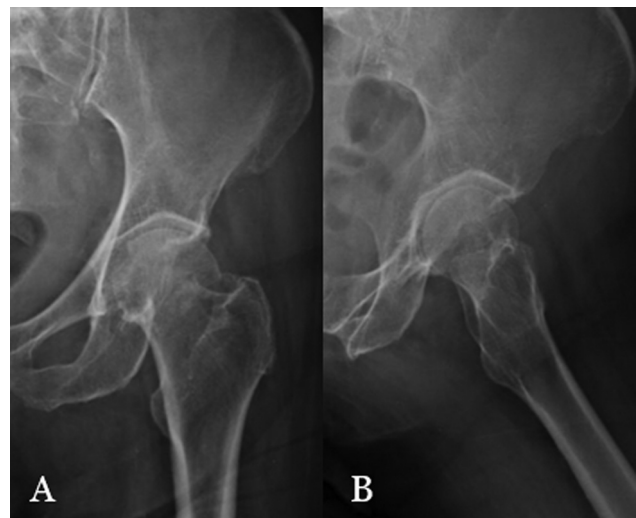
Fig. 1 Fracture of the neck of the left femur impacted in valgus, in AP (A) and profile (B).

The radiographic examination revealed the diagnosis of fracture of the neck of the left femur, AO 31B1.1 (► Fig. 1a-b).

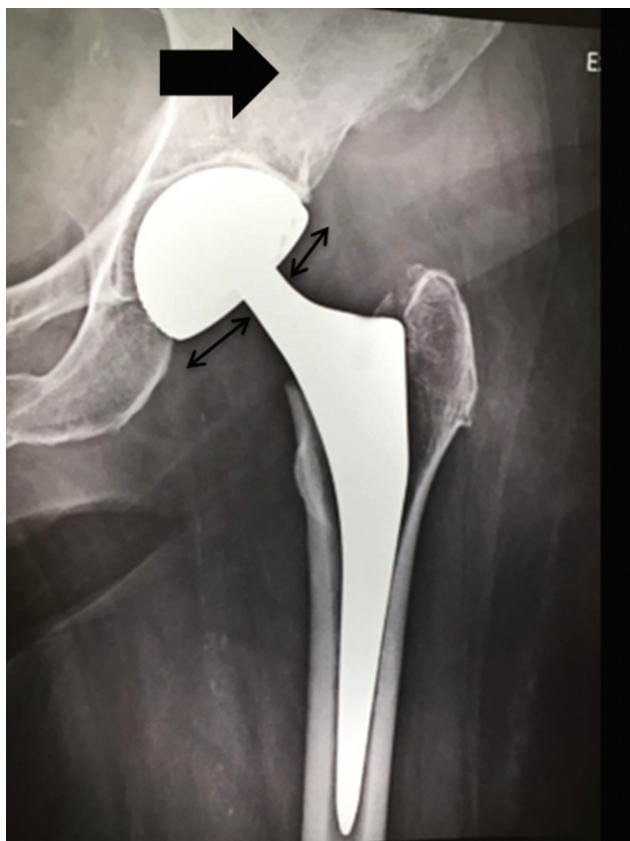
Fig. 4 X-ray 7 days after reduction. The larger arrow shows the "bubble sign", the polyethylene displaced in the soft parts. The smaller arrows show the eccentricity of the metal head in the acetabular dome.

condition, without functional limitation, complaining only of crackling in the posterior region of the left hip. Radiographs after reduction show congruence between the femoral head and the acetabular dome, but femoral head eccentricity is observed in the acetabular metallic dome (→**Fig. 4**). A superolateral circular opacity (bubble sign) is also observed. Computed tomography (CT) reveals a polyethylene component in the posterosuperior aspect of the hip (→**Fig. 5**).

In our case, the patient presented complications after a single attempt at closed reduction, in which the maneuver strength resulted in intraprosthesis displacement of the polyethylene. This complication occurs when the polyethylene coating fits into the edge of the acetabular component, and the

subsequent traction of the limb results in the dissociation of the metal head from the polyethylene coating, similar to a "bottle opener" effect, and polyethylene can migrate out of the acetabulum.
