## Case report

# Traumatic dissociation of the tibial insert with patellar tendon rupture after high-flex posterior-stabilized Genesis II total knee arthroplasty<sup>☆</sup>

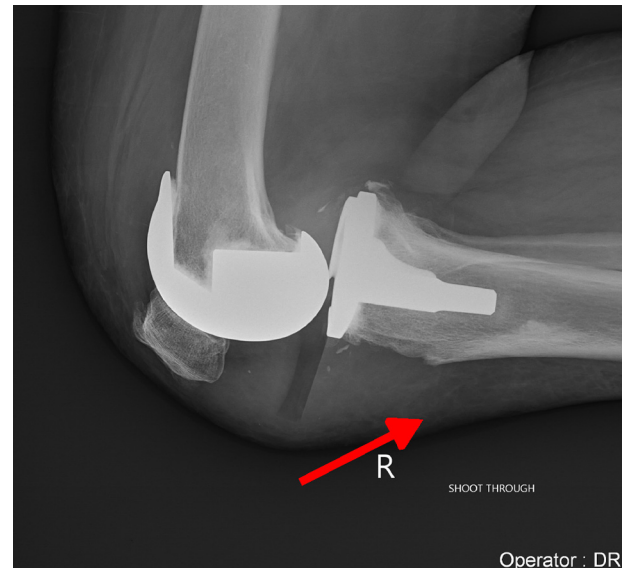
**Fig. 1 – Lateral radiograph showing anterior displacement of dissociated polyethylene insert from tibial base plate.**

dissociation of the insert from the tibial base plate without loosening of the femoral or tibial component (Fig. 1). A medial parapatellar arthrotomy was undertaken using the previous skin incision. A mid-substance patellar tendon rupture with complete dissociation of the polyethylene insert from the tibial base plate with anterior displacement was found (Fig. 2). Retrieved insert showed compression damage

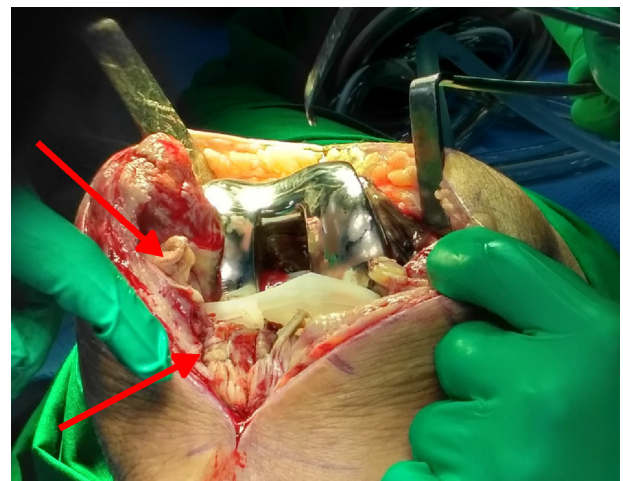
**Fig. 2 – Intraoperative image showing mid-substance patellar tendon rupture (arrows pointing at both the ends) with anterior displacement of insert.**

A direct repair of the mid-substance patellar tendon rupture was done which was further augmented with a harvested hamstring tendon graft. Same incision was used to harvest semitendinosus tendon. Intra-operative sample sent for culture were negative. Walker assisted full weight bearing ambulation with knee brace was started on 1st post-operative day. The range of flexion was increased to 60° at 2 weeks and to 90° at four weeks. At six weeks, knee brace was discontinued and an active extension was started.

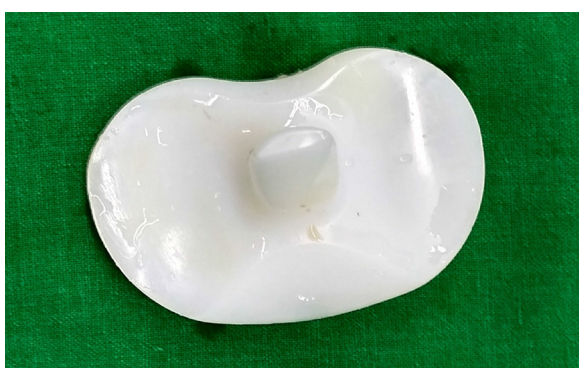
**Fig. 4 – Image of the superior surface showing lack of any deformation on the articulating side, including the post.**

more on the posteromedial than on the posterolateral side of the non-articulating surface of the insert (Fig. 3). There was no damage/deformation seen on the articulating/superior surface or the post of the insert (Fig. 4). The intraoperative evaluation showed well-fixed components with no rotational malalignment. No osseous or soft tissue impingement was evident and flexion-extension gap balancing was also adequate. Since the tibial base plate demonstrated no loosening with an intact locking mechanism, a new conventional posterior stabilized 9 mm polyethylene insert was slid into the tibial base plate regaining a range of motion of 0–125. Medial and lateral sides were checked for proper engagement of dovetails.
