FRACTURE OF THE TIBIAL COMPONENT IN TOTAL KNEE ARTHROPLASTY: REPORT ON TWO CASES

ABSTRACT

The authors report the rare occurrence of two cases of fracture of the tibial component in total knee arthroplasty. They review the literature and discuss the main

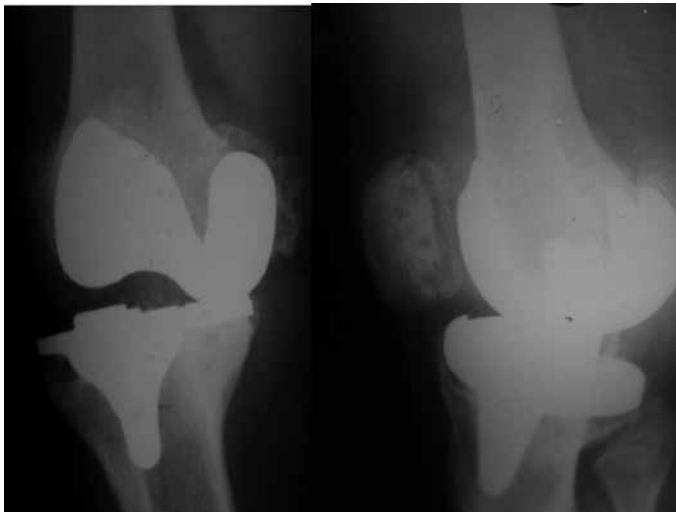
fracture in the tibial component (Figure 1). TKA revision surgery was indicated, and this was performed in August 2009 (Figures 2 and 3). During the immediate postoperative period, we observed pain relief and functional improvement of the knee.

Figure 1- Preoperative radiograph of case 1.

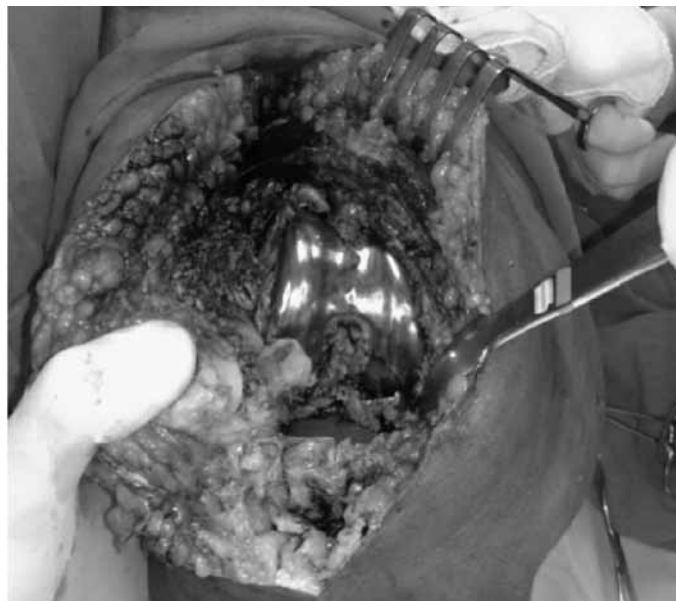
Figure 2 – Intraoperative view of case 1.

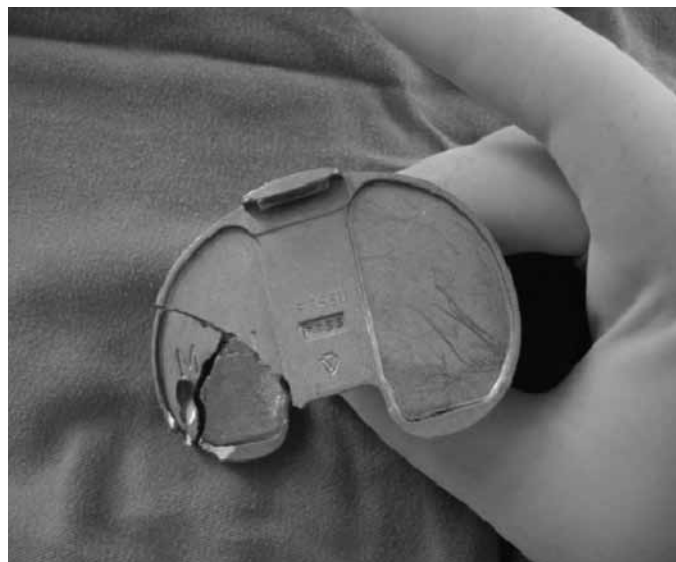
Figure 3- Fracture of the tibial component of case 1.

In our view, the two implants in our sample remained in varus knee positioning because of inadequate ligament balance. Because of this, greater weight was borne on the medial compartment of the knee, thus facilitating fracturing of the implant. Luring et al⁽⁷⁾ corroborated our thinking and reported that misalignment of the implant creates osteolysis and generates cyclic overload on the prosthesis used. Swarts et al⁽⁸⁾ considered that correct alignment was the main factor in TKA success. Rousseau et al⁽⁹⁾ observed that early failure in TKA (excluding cases of infection) was re-

The two implants used in our study were of the same model made in the United States (Howmedica®). Flivik et al⁽¹⁰⁾ and Maruyama et al⁽¹¹⁾ concluded from their studies that inappropriate design was the main factor involved in fracturing of the tibial component. In our study, the prosthesis used was of modern design, and what drew our attention was the similar fracture location in the two implants.

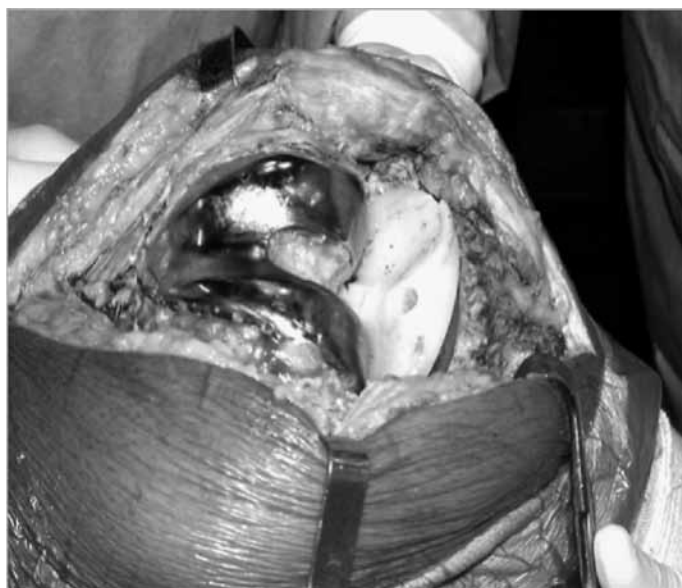
Figure 5 – Intraoperative view of case 2.
