## Evaluation of reinforced concrete structural durability in the post-occupation phase – A case study in Novo Hamburgo/RS

Thus, this study aims to evaluate the building durability of a post-occupation phase designed to meet the higher level established in the Brazilian Performance Standard NBR 15575 (ABNT, 2013).

A residential building located in Novo Hamburgo, RS, Brazil inaugurated in June 2016 was analyzed. Built on a site of 3,074.12 m<sup>2</sup>, the vertical multi-family condominium has a total area of 17,993.63 m<sup>2</sup> with 26 floors divided into: 3 basements, a ground floor, a mezzanine, 16 typical floors, 04 duplex floors and a rooftop.

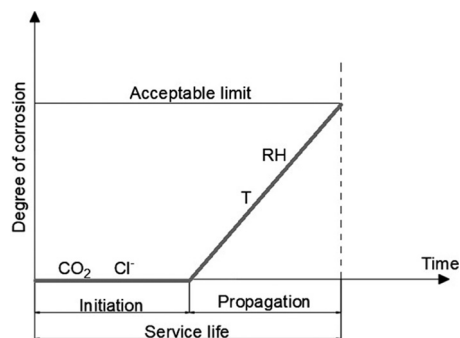
The end of service life of a reinforced concrete structure is set to the end of the period of initiation and the beginning of critical propagation mechanism as shown in Fig. 1 (Tuuti, 1982).

Figure 1 The sequence of initiation and propagation in reinforced concrete (Tuuti, 1982).

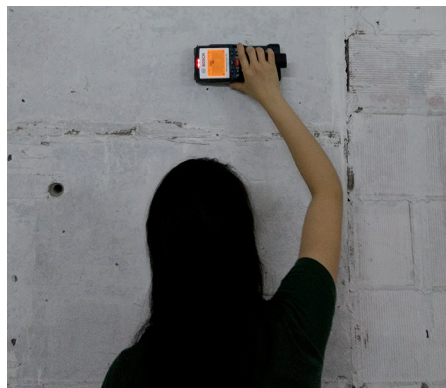
chine room with the same characteristics of the structural system was chosen. With the pacometer (Fig. 2), which has the function of detecting the position and diameter of the metallic reinforcement, as well as the thickness of concrete covering on the reinforcement (Mehta and Monteiro, 2014), it was possible to detect the reinforcements of the column analyzed. The technical specifications of the equipment used in the study can be seen in Table 2.

Figure 2  
Placement of the pacometer on the column to detect the reinforcement.

After conducting the tests, analyses were made. The measurements made with the pacometer indicated that the reinforce-

ment cover was in accordance with the covering specified in the project, i.e. 30 mm. For the concrete surface hardness, the measure-

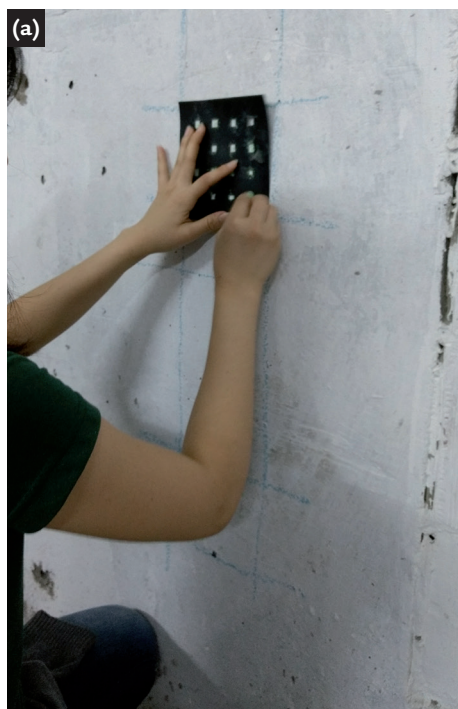
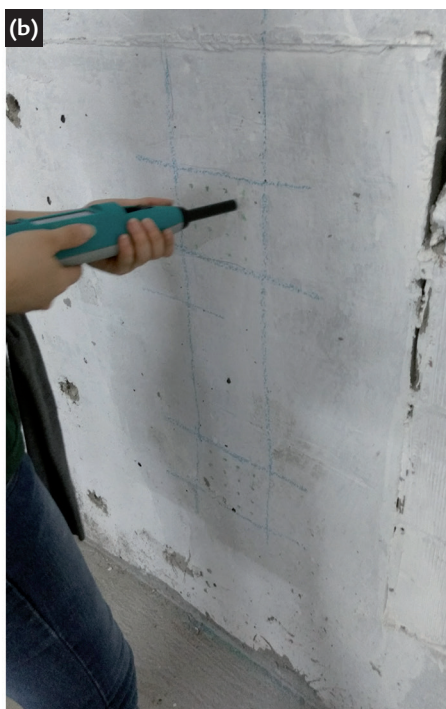
with a Schmidt hammer, a concrete surface hardness test was performed (Fig. 3).

Figure 3  
Surface hardness test:  
(a) marking the points with the test gauge  
(b) placement of the Schmidt hammer.

A total of 16 measurement points were marked using a test gauge, according to the requirements of NBR 7584 (ABNT, 2012). The technical specifications of the Schmidt hammer used in the study can be seen in Table 3.

ments performed with the Schmidt hammer indicated that the average values were close to 50 MPa, as indicated in Table 4.

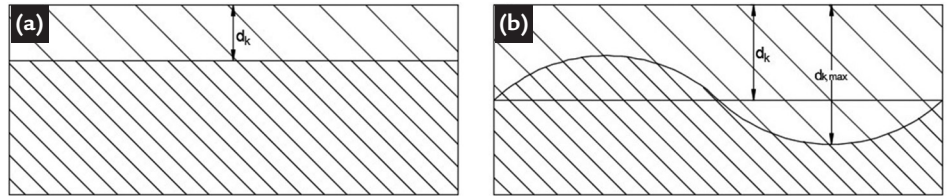
According to report CPC 18 (RILEM, 1988), a preliminary analysis on specimens at a mean carbonation depth (dk) of 5 mm is recommended. This value refers to the variation in specimens as

Figure 4  
Average carbonation depth representation: (a) mean carbonation depth and (b) maximum carbonation depth (RILEM, 1988).

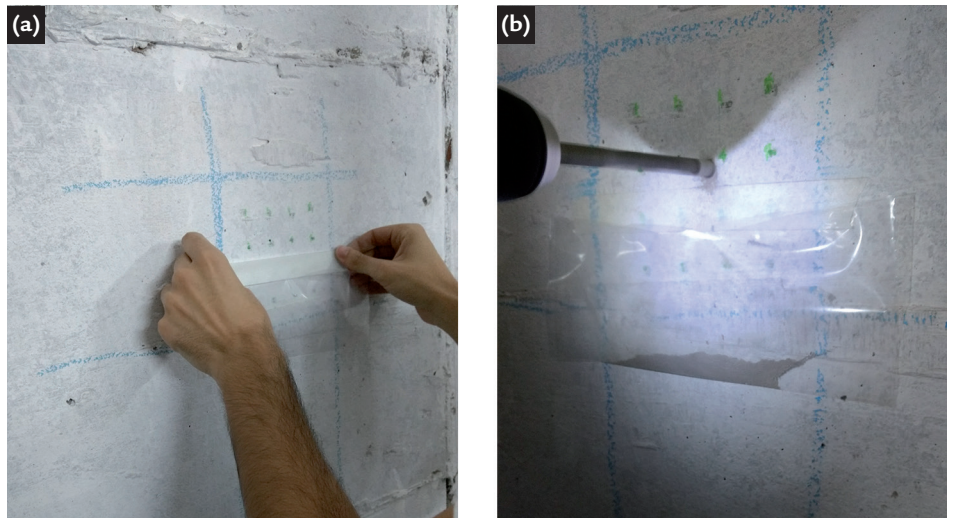
shown in Fig. 4. In this study, the analyses were performed on the collected dust at an initial depth of 5mm, and a drill was used to drill the holes. A collector was placed below the drilling point for the deposition of the concrete dust and a phenolphthalein solution was sprayed as shown in Fig. 5.

Figure 5  
Collection of the concrete powder for the carbonation test: (a) preparation of the sample collector bag and (b) extraction of the sample.

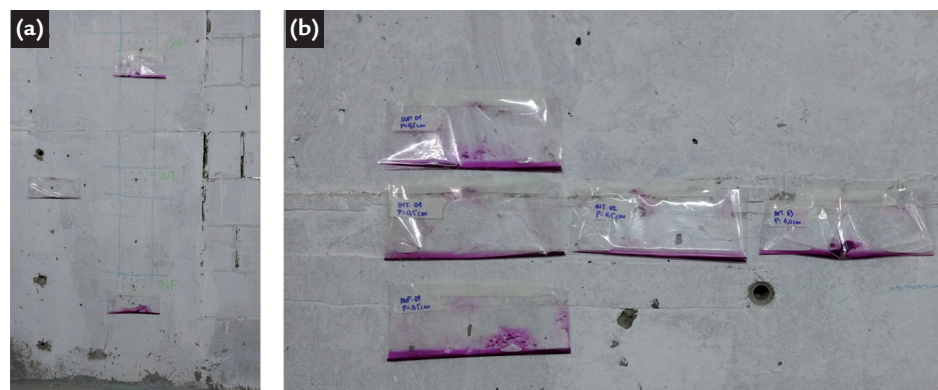
On the top floor, the column was tested inside the machine room and without coating, being exposed to gases and moisture. The samples collected in the low and high heights of the column indicated that the concrete was not carbonated to a depth of 5 mm, in accordance with the pinkish color ac-

In the intermediate height sample, there was no color change in the first seconds after the sprinkling of phenolphthalein. However, after about 30 seconds, the sample presented the pink coloration characteristic of no carbonation. The

procedure was repeated in the same region of the column to the same depth. The second sample confirmed the result, with the same reaction time. To validate the test, we made a third hole with a 10mm depth. The reaction occurred instantly, validating that the concrete was not carbonated, as shown in Fig. 6.

Figure 6  
Machine room  
column samples: (a) 5mm depth samples and (b) all collected samples.

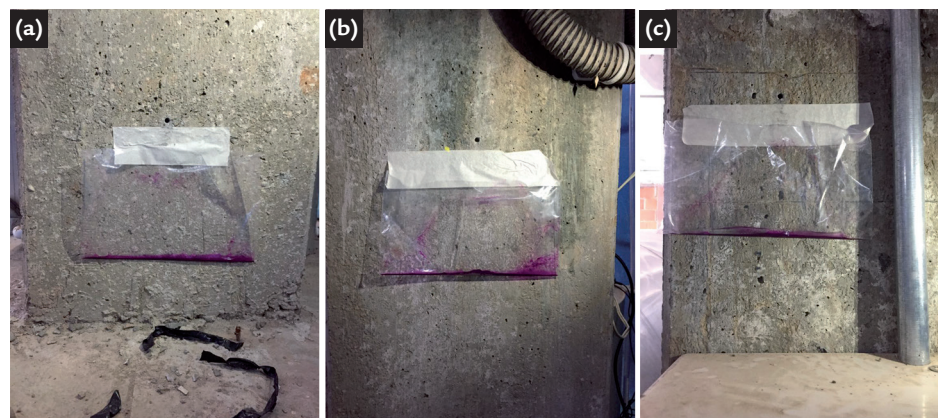
The tests on the column of the treatment station showed similar results to tests in the machine room. Although in

the basement, the column was in similar conditions indoors and without covering. Samples were collected at three heights,

low, intermediate and high (Fig. 7). All samples indicated that the concrete was not carbonated at a 5 mm depth.

Figure 7  
Column samples of the treatment station.

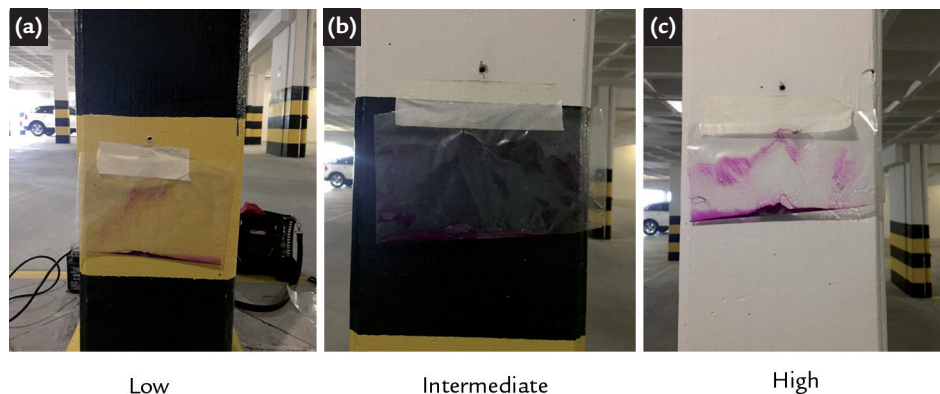
The third column located in the parking lot, as well as the previous ones, has been tested for three heights Fig. 8). In this case, the structure was covered with epoxy paint that provides protec-

tion and waterproofing, avoiding the accumulation of moisture and gases in the concrete pores. At the 5mm depth, the three samples showed no carbonation. Although the column environment is

a parking lot susceptible to high levels of carbon dioxide in the air, the results indicate that the cover protection avoids the carbonation process as well as degradation of the system.

Figure 8  
Column samples of the parking lot.

It is important to prevent carbonation through coatings and paintings that

waterproof the surface and prevent the penetration of moisture and harmful gases and chlorides. This is to avoid the loss of reinforcement protection and its subsequent corrosion. The performance over the service life of the building depends on the decisions and actions taken from the stage of design and construction, as well as during use and occupation stage. As the concrete is a material that undergoes change in its properties over the years, it is important to monitor it. The quality of concrete and reinforcement can be verified even after the implementation phase.
