A survey of the mechanical properties of concrete for structural purposes prepared on construction sites

Um estudo das propriedades mecânicas do concreto para fins estruturais preparado em canteiros de obras

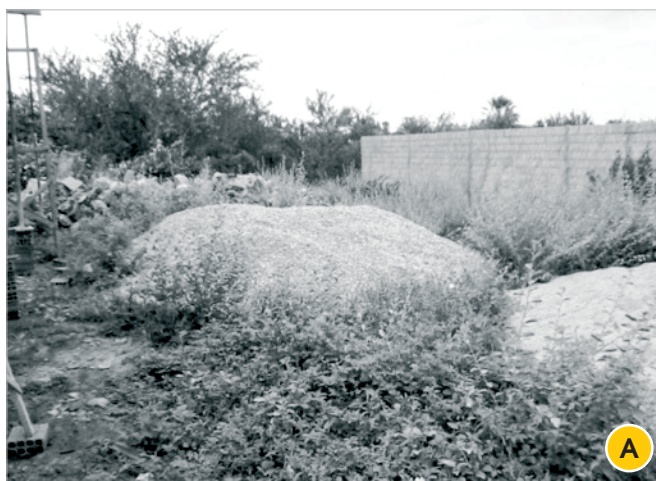
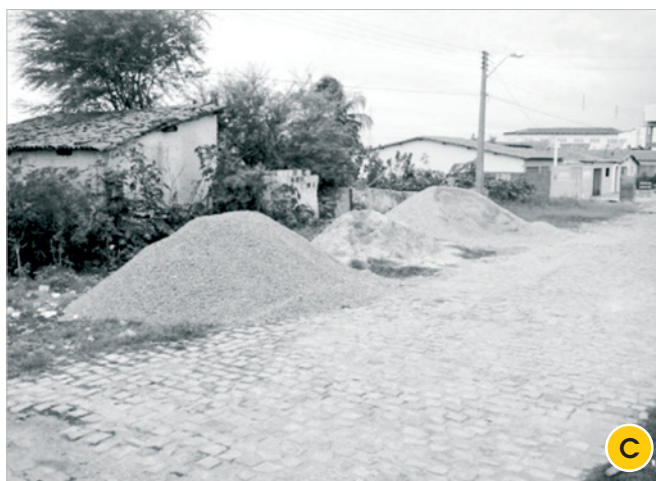
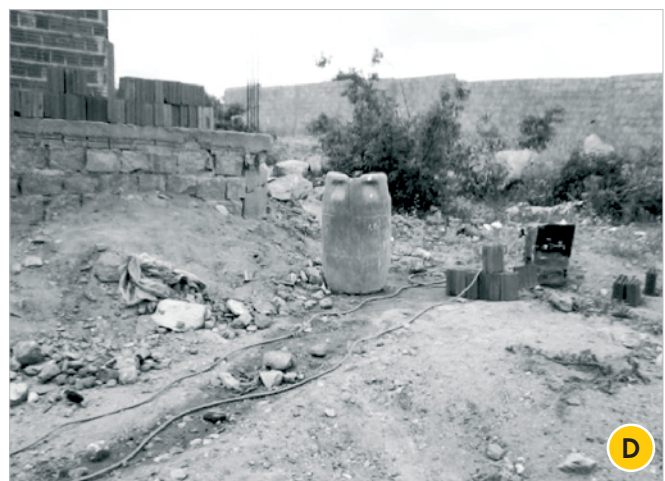
Figure 2 – Provision of materials: a) and c) willing materials through the vegetation, b) Deposit for cement storage, d) barrel used to store water

[5], being vulnerable to contamination, as shown in Figures [2] and [3]. Generally, the cement was placed in deposits in the sites or in the neighborhood.

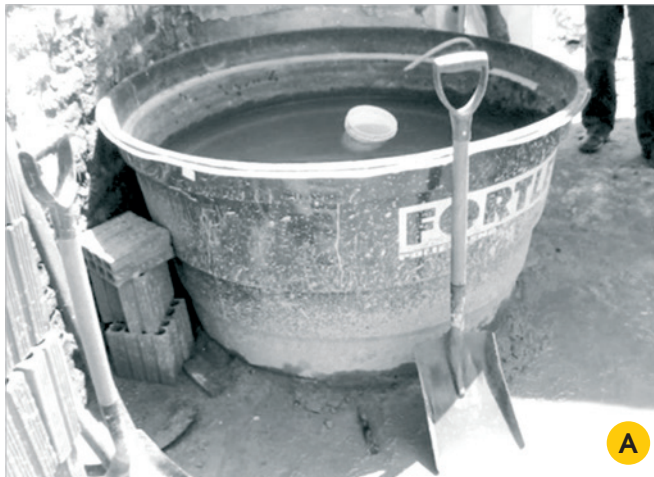
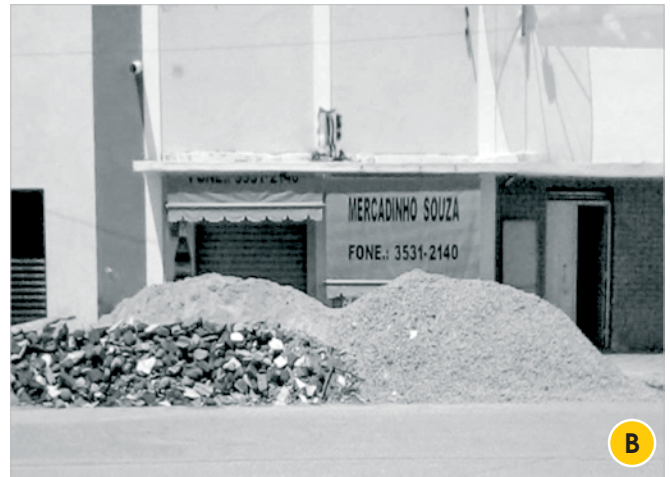
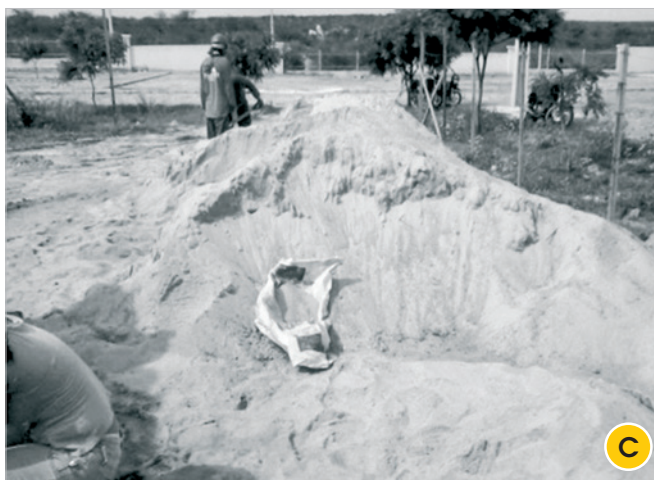
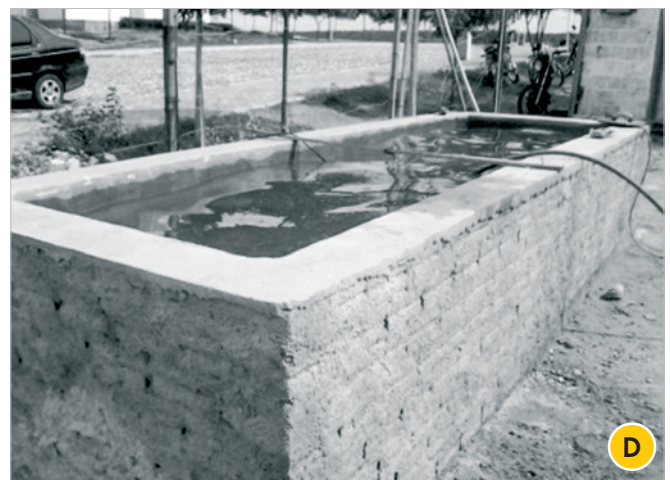
Figure 3 - Layout of materials: a) and d) water tanks, b) materials stored on public streets and close to rubble, c) sand storage

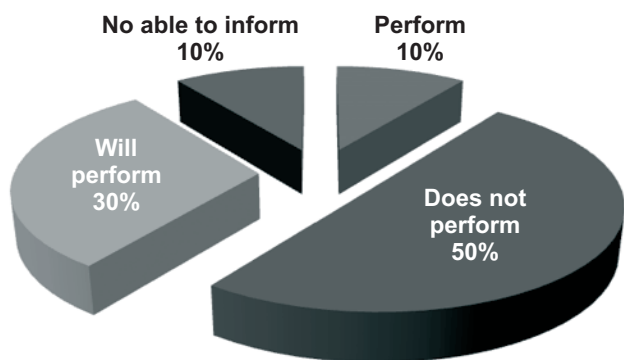
Figure 4 - Construction sites that perform or not the technological control of concrete

When asked if the concrete had shown any irregularities, all the managers immediately said no. However, Figure [4] shows that 10%, or only one construction (3), had performed the technological control of concrete till then, which implies that in the other cases the actual mechanical properties of the used concrete were not really known.

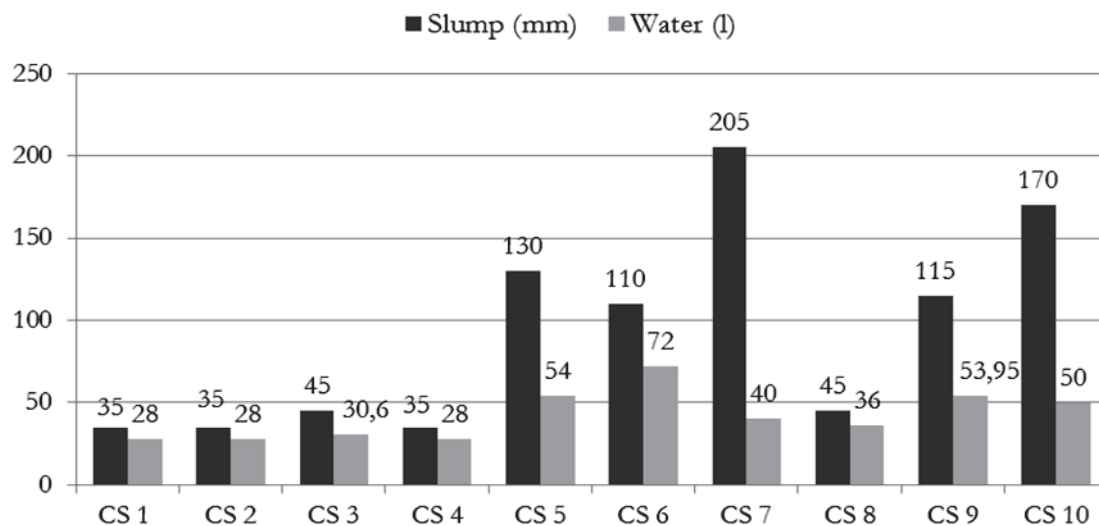
Figure 5 - Slump of concrete and water volume

The first analyzed property was the consistency of the concrete (Figure [5]). It was observed that 50% of the buildings preferred a "slightly dry" concrete, and the lower rebate, of 35 mm, reported for the sites 1, 2 and 4. The remaining ones opted for a more plastic consistency, seeking greater workability, thus requiring a larger amount of water, since additive was not used in any site.

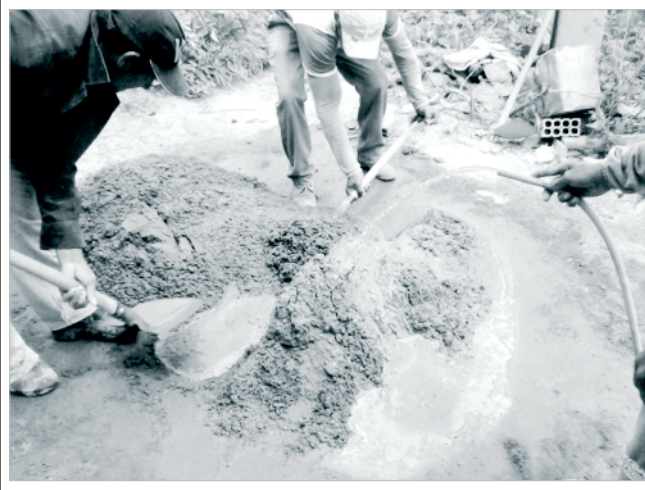
Figure 7 – Incorrect addition of water to the concrete

seems to be much higher than reported, since at certain times there was no control of the amount of water added to the mixture, as seen in Figure [7].
