# Effect of corrosion degree on mechanical properties of reinforcements buried for 60 years

## *Efeito do grau de corrosão em propriedades mecânicas de armaduras enterradas por 60 anos*

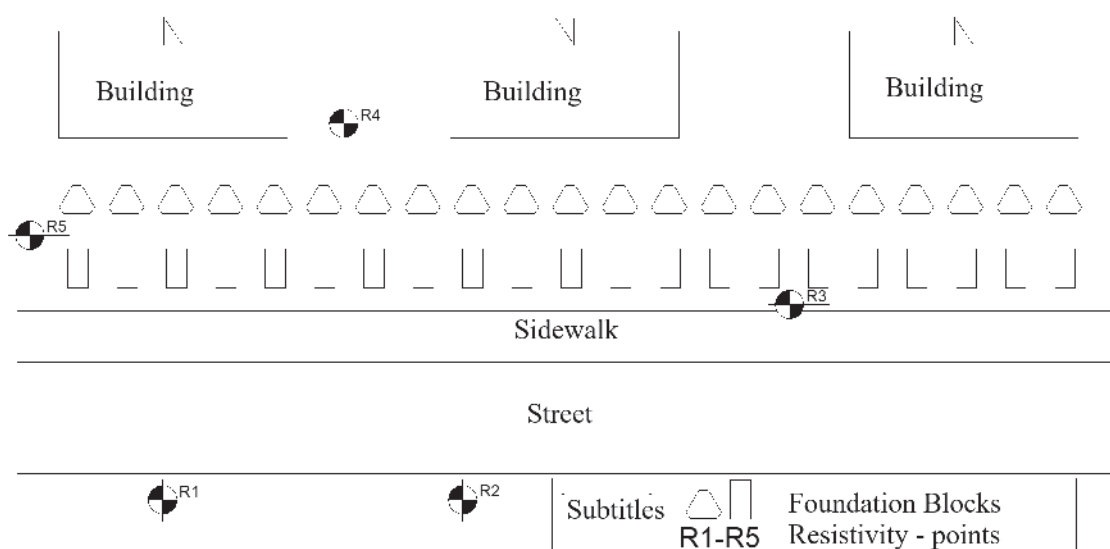
**Figure 1** Scheme of the location of old foundations and points of determination of soil resistivity (R1-R5)

The materials used for obtaining the specimens for the tensile test are from protruding reinforcing steel, not corroded, removed from the lower face of a foundation block (reference) and of protruding reinforcing steel in process of natural corrosion. It must be highlighted that this protruding reinforcing steel had 60 years. The protruding reinforcing steel remained buried in process of natural corrosion in the soil during this period, while the protruding reinforcing steel of the foundation block (lower region of the block) remained protected by the concrete and did not have corrosion. Figure 1 shows a scheme of the location of the old foundations.

Besides that, an analogical terrometer was used to determine the soil resistivity in five points (R1-R5) in the place where the foundations were present (Figure 1). In each point two measurements were made, varying the distance between piles (5 and 10 meters). The values of soil resistivity are presented in Figure 3.

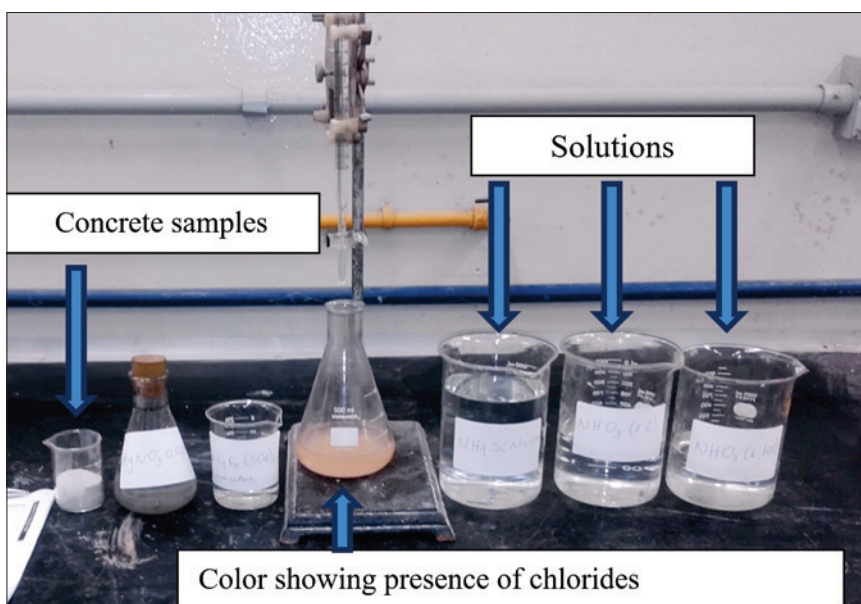
**Figure 2**  
Analysis for verification of the presence of chlorides in foundations

is a complex activity, because the water from rain penetrates the soil and may carry and unequally distribute the chlorides present in it. Thus, samples of concrete powder were collected in seven points of the block by making holes with diameter equal to 19 mm, until a depth of 20 mm in the proximities of the concrete surface. The powder material was collected and analyzed by titration using a solution of ammonium thiocyanate (0.05M), as described in the procedure of RILEM TC 178-TMC [28]. The titration is conducted until the solution of thiocyanate produces a brownish color that does not disappear with shaking, thus indicating the presence of chlorides (Figure 2).

from power samples removed from the upper part of the foundation block, as presented in Figure 2.

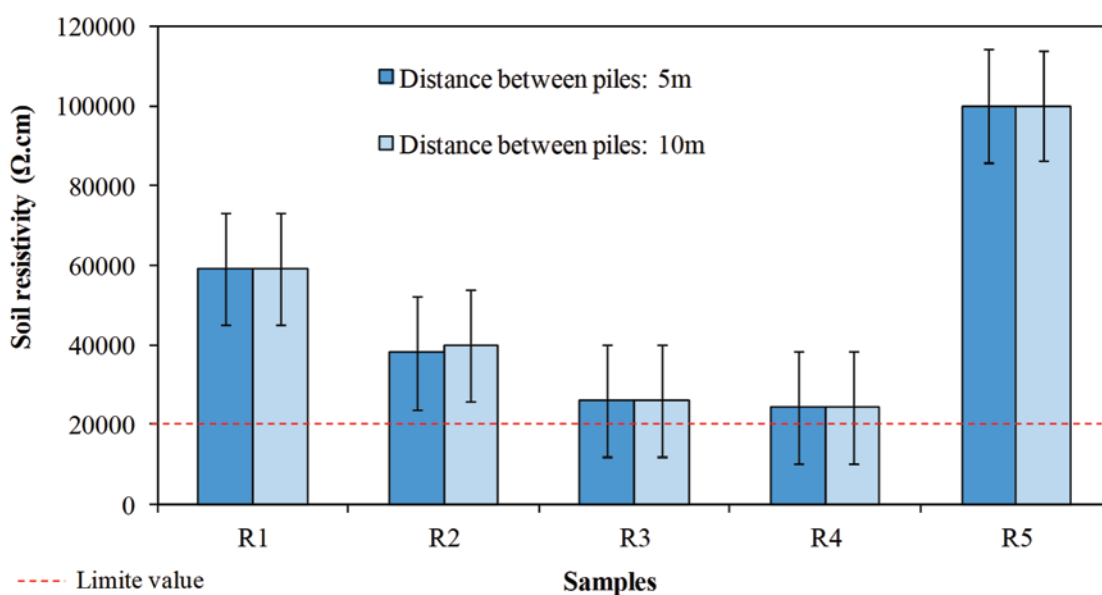
**Figure 3**  
Soil resistivity at the study site

The results of resistivity presented, with values over 20000  $\Omega$ .cm, classify the soil as essentially non aggressive for both distances between piles (5 and 10 meters). Besides, it is possible to observe that the distance between piles did not cause great variations in resistivity values obtained by a single point.

The analysis of Figures 3 and 10 result in an interesting observation. Even if the soil of the place was classified as essentially non corrosive (Figure 3), high corrosion speeds were obtained (Figure 10), demonstrating that expressing the corrosiveness of the soil only using the criterion of measuring its resistivity may not properly represent its aggressiveness with buried protruding reinforcing steel. Thus, other facts must also be taken into consideration in order to better describe the aggressiveness of soil, such as aeration, moisture, pH, presence of microorganism activity, and others. Even if all values lead to high corrosion speeds, results presented in Figure 10 by corroded protruding reinforcing steel where very diversified. The mean corrosion speed measured was 0.0246 mm/year, however with a standard deviation of 0.0089 mm/year, representing a coefficient of variation of 36%. This is a reflex of the characteristics of heterogeneity of the soil, as also discussed by Norhazilan et al. [20].

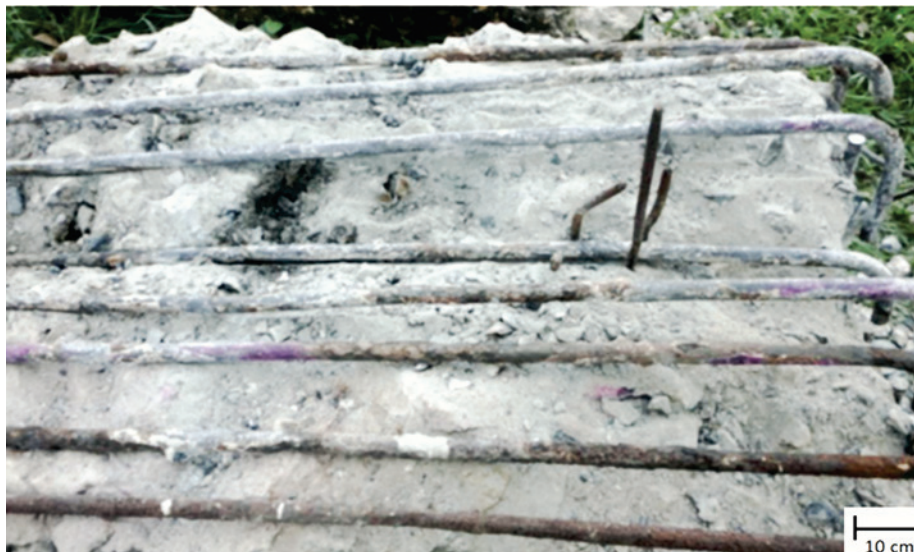
**Figure 4**  
Full exposition of the foundation block protruding reinforcing steel

present in the foundation block, and a grinder for cutting the bars. A set of eight bars with original diameters of 5/8" (15.88 mm) was obtained, as observed in Figure 4. It must be highlighted that in this procedure, the integrity of the bars was preserved, taking care to avoid the tip of the equipment making contact with the bars, causing deformation, fissures or eventual ruptures, damaging the samples.

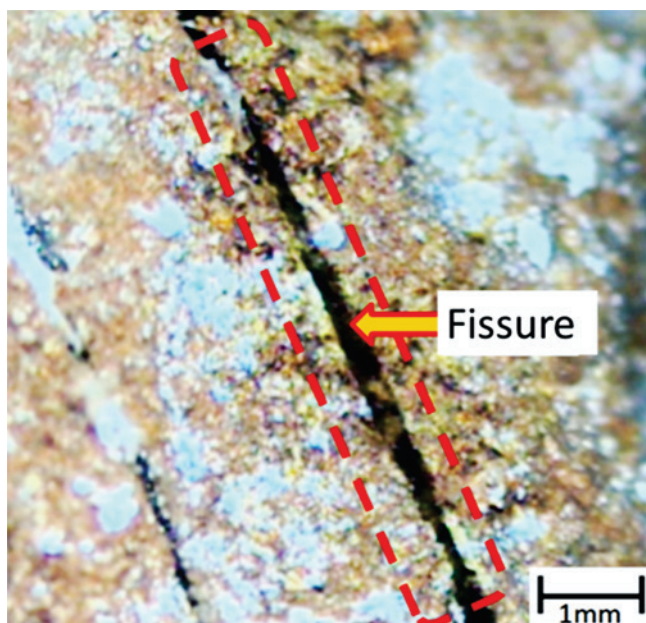
**Figure 6**

Fissure observed on the surface of one of the foundation block protruding reinforcing steel

besides being located in the contour of grains. This fact may cause the fragility of the steel during stages of mechanical conformation, resulting in fissures. This behavior was observed in bars studied in this paper. Figure 6 shows a fissure identified in a discharged segment of bar, obtained from protruding reinforcing steel of the foundation block.

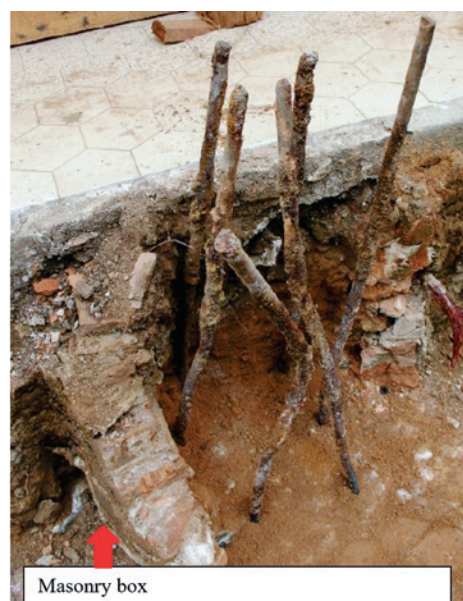
**Figure 7**

Exposure of some protruding reinforcing steel after opening the masonry box

Regarding the protruding reinforcing steel, bars with original nominal diameter of 5/8" (15.88 mm) were collected from the upper faces of the foundation blocks. For that, a grinder was used for cutting and collecting the bars. This procedure was executed as much closer to the upper surface of the blocks as possible, in order to get greater possible lengths of the bars. It is worth to highlight that in most of the cases, the protruding reinforcing steel was directly recovered by local soil; however in some cases, masonry boxes without caps or bottoms were built for mew the protruding reinforcing steel. In this case, the masonry boxes were built around the protruding reinforcing steel and filled with sand for mew the bars. Figure 7 shows a detail with the exposition of protruding reinforcing steel after opening one of those boxes.

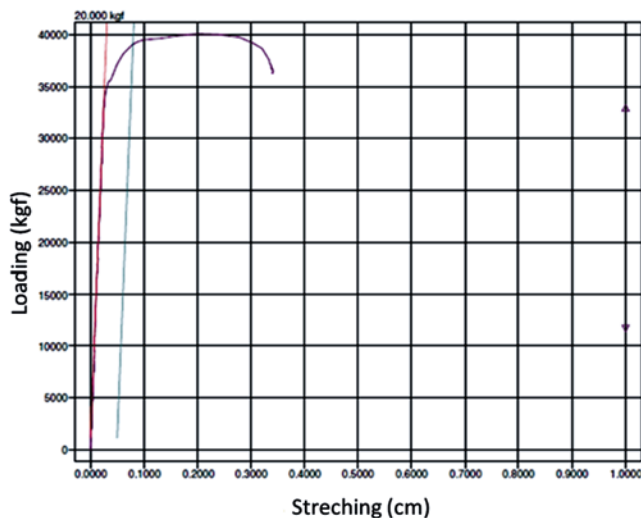
**Figure 8**  
Diagram loading versus stretching – illustrative example of a test body

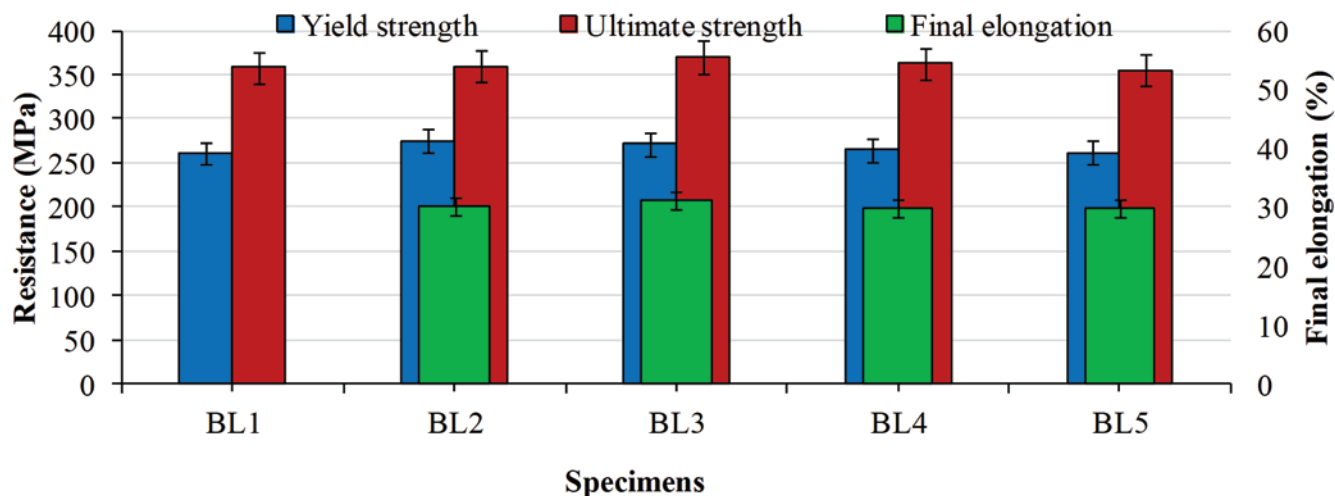
**Figure 9**  
Yield strength, ultimate strength and final elongation of test specimens BL1-BL5

The values of mechanical properties of the reference test specimens BL1-BL5 are presented in Figure 9, their mean values equal to: 267 MPa ( $\pm 6$  MPa), 361 MPa ( $\pm 6$  MPa) and 30% ( $\pm 0.7\%$ ), corresponding to the yield strength, ultimate strength and final elongation, respectively. Those values will be used as reference to be compared with the corroded protruding reinforcing steel in this paper. It was not possible to determine the elongation of test specimen BL1 due to a problem in the used extensometer, this being replace for the continuity of the tests. It is possible to observe that test specimens BL1-BL5 had closer values regarding the measured mechanical properties, with standard deviations relatively small compared with absolute values.

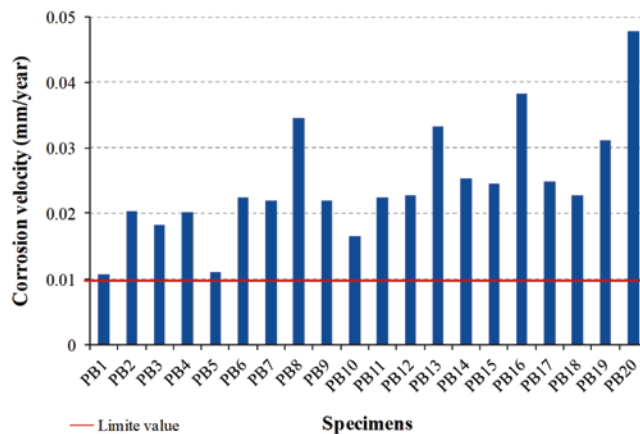
**Figure 10**  
Corrosion velocity of specimens PB1-PB20

The corrosion speeds of test specimens PB1 to PB20, calculated from the smaller diameters (Eq. 1) are shown in Figure 10, where points above the straight line of the graph have high corrosion speeds according to methodology proposed by CEMCO [37].

First of all, it is possible to observe in Figure 10 that all test specimens had high corrosion speed, according to criterion described by CEMCO [37]. Some test specimens had values dissonant from the average behavior, such as, bars PB 16 and PB 20. In this case, the protruding reinforcing steel from where those test specimens were taken remained closed in masonry boxes, built to mew them. Thus, a part of the bars remained in contact with the sand of the box and another part in contact with the clay from the local soil. This fact triggered the emergence of differential aeration stacks, favoring the corrosion process and, in consequence, contributing to raise the corrosion speeds. This behavior is in according to literature [38].

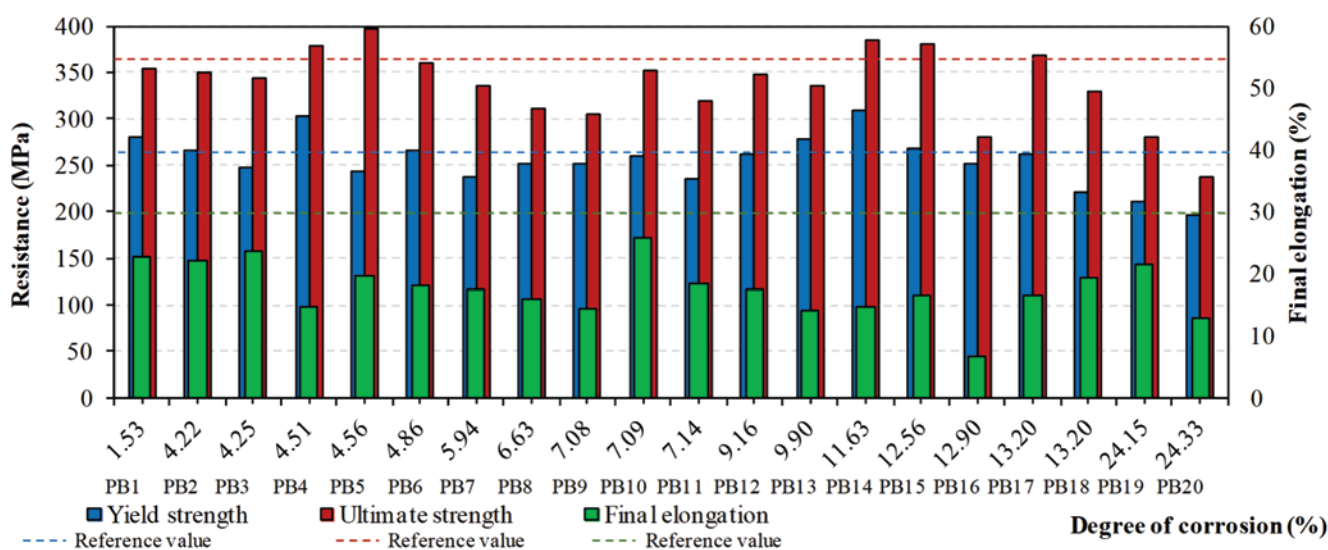
**Figure 12**  
 Ratio between degree of corrosion and yield strength, ultimate strength and final elongation of test specimens PB1-PB20

According to Figure 12 and 13, 25% of the test specimens (PB1, PB4, PB13, PB14 and PB15) had yield strength over the average value of the reference test specimens BL1-BL5 (dashed). The same percentage was observed regarding the ultimate strength,

A trend of decreasing yield strength and ultimate strength is observed in Figure 12 from a loss of mass of 12%, according to study from Almussallan [12]. For values below the cited one, a progressive trend of decreasing strength is not observed, where even test specimens with loss of mass of 5% had lower strength values than test specimens with two times the loss of mass. This is clearly observed comparing bars PB4 and PB14, for instance. The justification for this occurrence is related with effects of corrosion by pits to the transversal section of the reinforcement. This means that, in the case of corrosion by pits, expressing the corrosion degree by means of the gravimetric variation of bars may not be enough to represent the variations in strengths, at least until a corrosion degree of 12%.

Figures 12 and 13 also reveal that the final stretch has an irregular

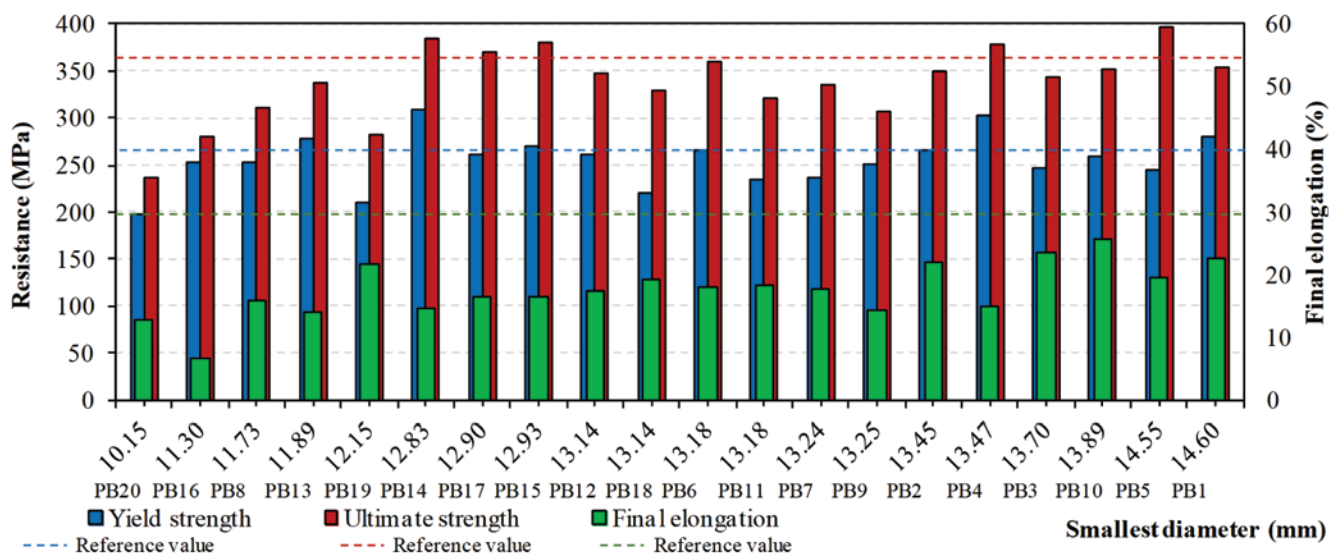
**Figure 13** Ratio between the smallest diameter with yield strength, ultimate strength and final elongation of the specimens PB1-PB20

In Figure 13 it is possible to see an irregular behavior between the smaller diameter with yield and ultimate strengths. However, it is possible to observe a decreasing trend of strength regarding the diameter reduction for values less than 12mm, representing a loss of transversal section over 20% regarding the original transversal section. This means that for losses of transversal section over 20% there is a trend of a progressive decrease of strengths (yield and ultimate) of the corroded reinforcement.

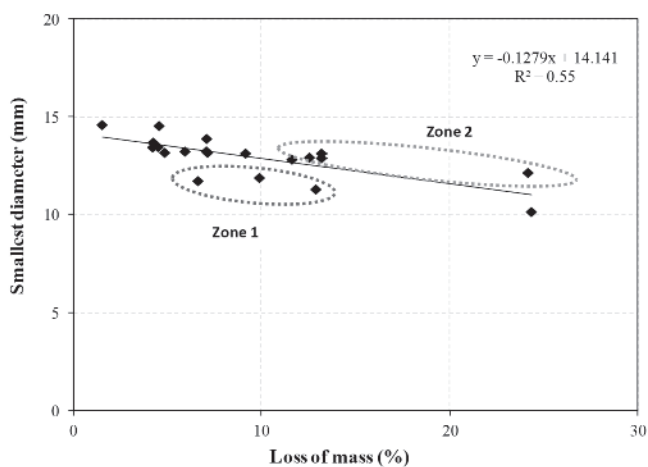
**Figure 14** Ratio between smallest diameters and the loss of mass of the test specimens PB1-PB20

behavior in both cases (loss of mass and smaller diameters), making difficult to express a behavior trend. However, it is possible to state the effects of corrosion are more evident in the decrease of the final stretch of the bars when compared with reference values (dashed lines), agreeing with studies in literature [8, 10]. In this sense, all test specimens, even having a small loss of mass, demonstrated values under the mean stretching of the reference bars (BL1-BL5). This demonstrates that the corrosion effects were more pronounced over the ductility of the corroded reinforcement. Figure 14 shows the relation between loss of mass and the smaller diameters of test specimens PB1-PB20. Figure 14 shows a trend to decreasing diameters as the loss of mass increases. Besides, it is also possible to observe the presence of two distinct zones. In is interesting to see that zone 2 indicates the occurrence of test

specimens with smaller diameter and greater loss of mass. This fact is associated with corrosion by pits, as verified in Figure 11. Under this strand the pits have as characteristics being able to generate decreases in the transversal section as they go deeper, however without noticeable loss of mass.
