Mixed linear model for the prediction of infiltration rates in urban pervious concrete pavements in dense wooded parks

José Tadeu Balbo^a

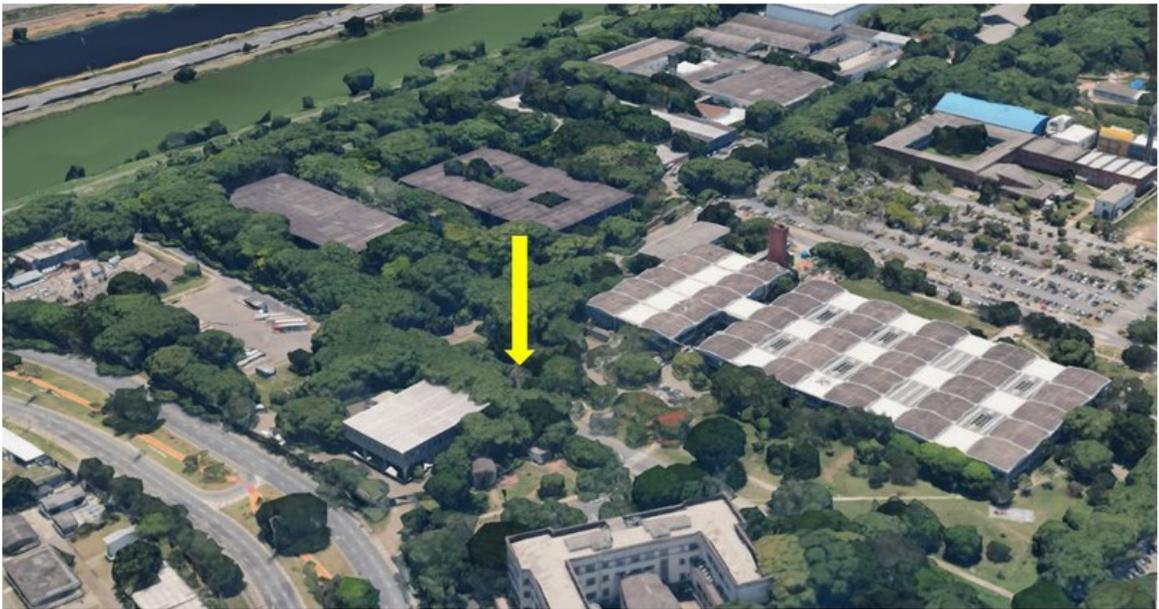
Figure 2. Aerial view of the sidewalk surroundings (sidewalk location indicated by a yellow arrow) – Source: Google Maps. USP Campus at São Paulo, 2020.

The vegetation surrounding the area of the sidewalk test site (Figure 2) was of paramount aspect for achieving rapid natural clogging in pervious concrete, associated to climate conditions. The falling of organic debris from the surrounding vegetation would contribute, adding to the rainfall period, for the decay of the organic material and its penetration inside the pervious concrete porous structure. Therefore, site choice was selected in a dense vegetation area within the gardens of the Civil Engineering building (Lat. 23°33'44" S). Several tree species located in the neighborhood of the sidewalk were identified. In Table 2, a list of identified ones is presented, based on Mendonça [29], and Figure 3 represents the location of the sidewalk and surrounding trees.

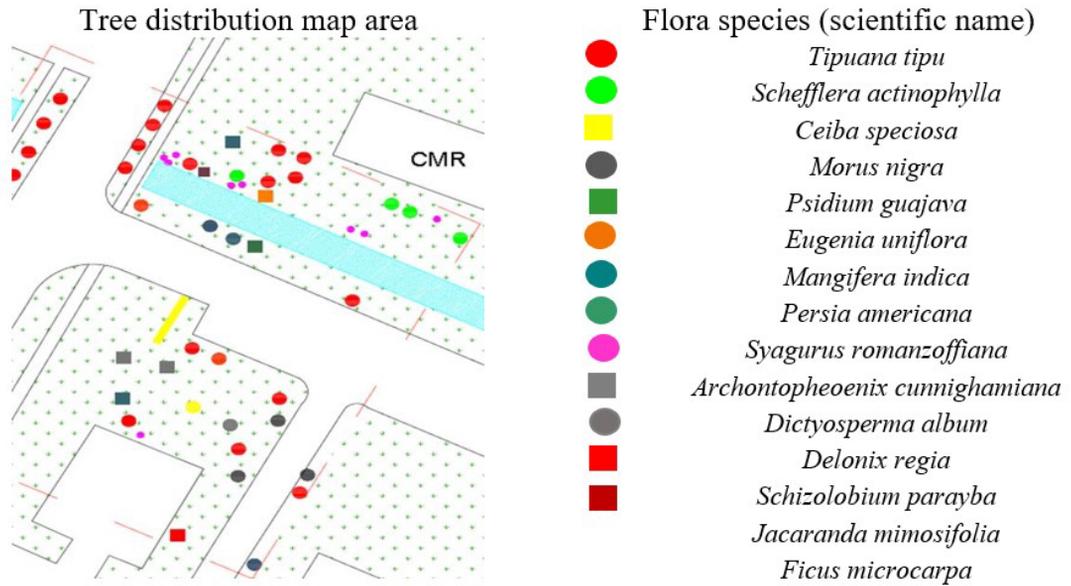
Figure 3. Distribution of trees at the sidewalk (yellow line) surroundings (courtesy: Guilherme Nunes Kalleder)

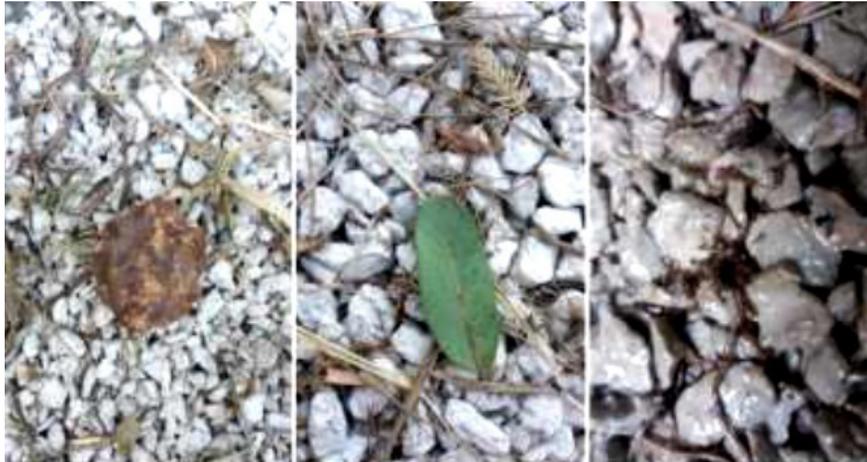
Figure 4. Debris over sidewalk porous concrete surface: dry leaf (left); green leaf (center); rotting organic matter in between aggregates (right).

It is worth noting that the year rainfall of 1,351 mm/year at the location, although not so high as a tropical forest itself, but still remarkable compared to most temperate climate regions. The rain is well concentrated in the meridional spring and summer (October to March), with maximum average daily rainfall of 7.3 mm in December. Most of the fructifying periods come along with the warm seasons; this is true for the blooming periods too. However, blooming of some surrounding trees happens every year or during drought seasons, leading the surface to be charge by dry organic matter any month during the year (Figure 4).

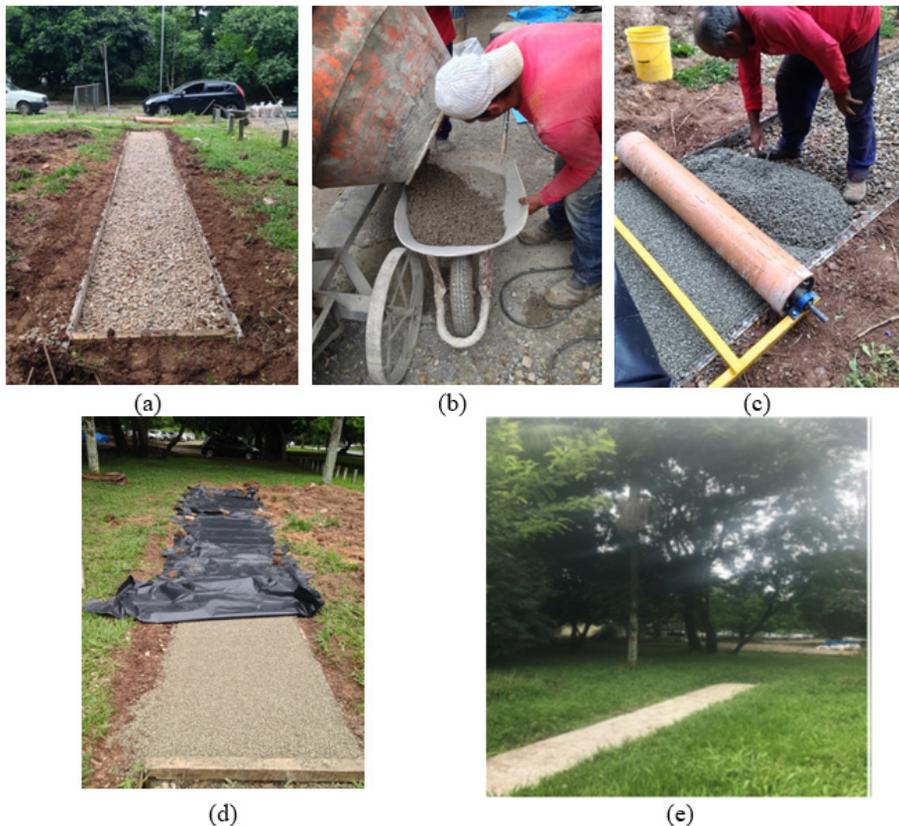
Figure 5. (a) Recycled aggregates sidewalk base and lateral metallic forms for concrete pouring; (b) in situ concrete provision with small concrete-mixer; (c) Concrete pouring and compaction with light roll; (d) concrete curing using polyethylene fabric (7 days); (e) Final pervious concrete sidewalk view (December 2015).

The 8.65 m length by 1 m width sidewalk was built with light equipment (manual 60 kg roll over lateral steel forms) inside the above-described garden area, using a 150 mm-thick recycled aggregate base prepared from debris of demolition of an old civil construction building. It was not provided any specific sub-superficial drain pipeline to collect the rainwater passing through pervious concrete and this open-graded base; no geotextile fabric over the subgrade clay soil was used. Base aggregates were spread and lightly compacted over the natural subgrade. The pervious concrete thickness was 100 mm and was poured on December 3, 2015, [32], [33]. Pouring pervious concrete begins from the upper to the lower part, taking four batches to be completed in the project area. Figures 5a to 5e present some essential construction pictures from the sidewalk pavement construction steps and techniques used.

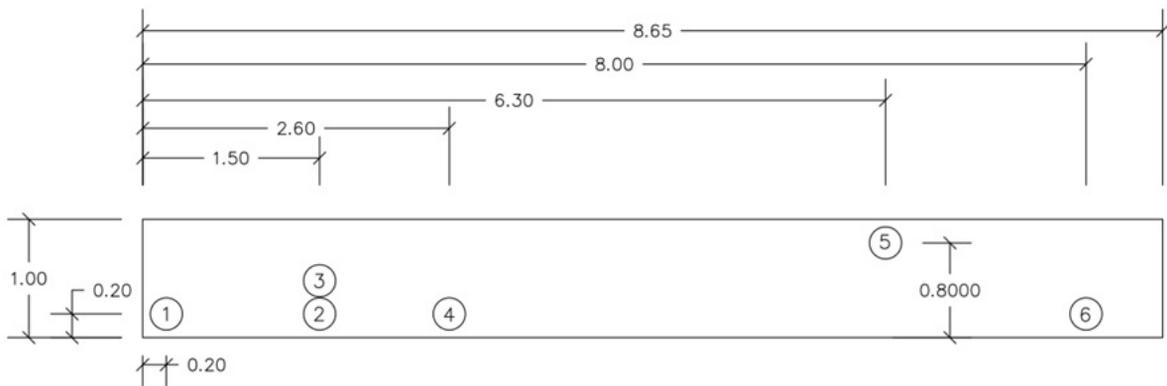
Figure 6. Plan view with the location of infiltration tests during the experiment (dimensions in meters)

In order to monitor the infiltration rate evolution with time, the location of repetitive tests over the pervious concrete slab surface were defined by six points, as represented in Figure 6. Most of the infiltration test locations were fixed close to slab borders except for one point. Infiltration tests were carried out during the period from December 11, 2015 to November 7, 2019 (46 months comprising 11 field measurements series). Criteria adopted for clogging evaluation along the period was to clean locally the surface prior to infiltration tests only, with no maintenance over months, as previously mentioned.

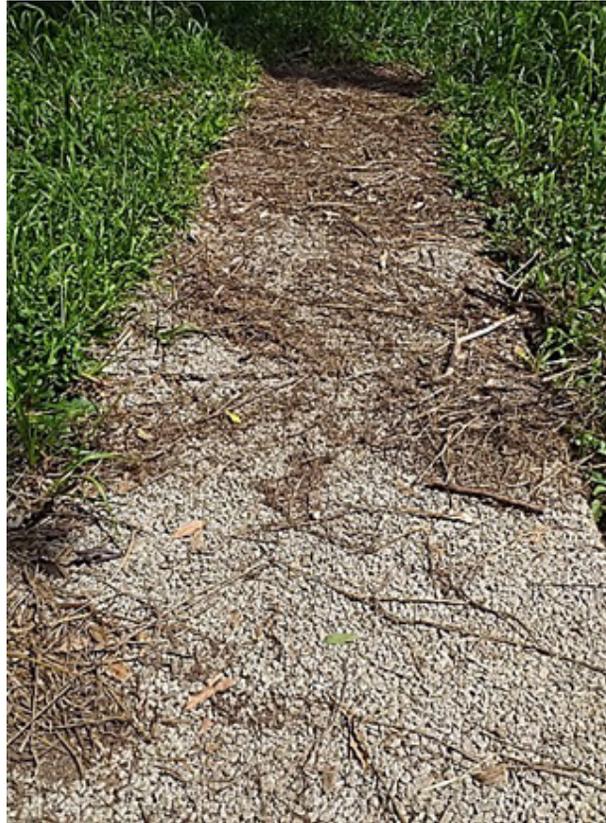
Figure 7. Surface with vegetal debris before tests

Figure 7 presents the surface with accumulated vegetation debris as of the tests in April 2016. Prior to tests, as aforesaid, the circular position to fix the PVC ring was cleaned before every test. In Table 6, the average values for infiltration rates gathered along the months of permeability monitoring are presented.

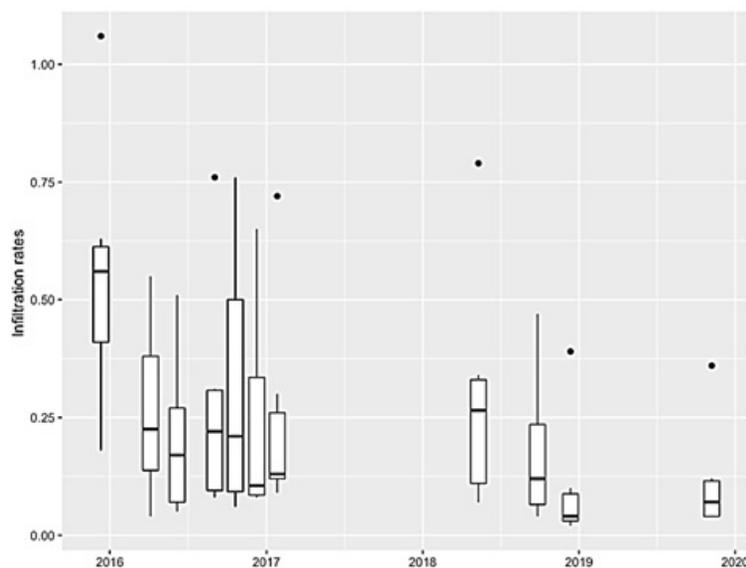
Figure 8. Boxplot of infiltration rates over the time.

Boxplots of the infiltration rates over time are shown in Figure 8. It is worth noting that the observations from the location #5 are identified as outliers. A scattered plot of infiltration rates over time per location is shown in Figure 9.

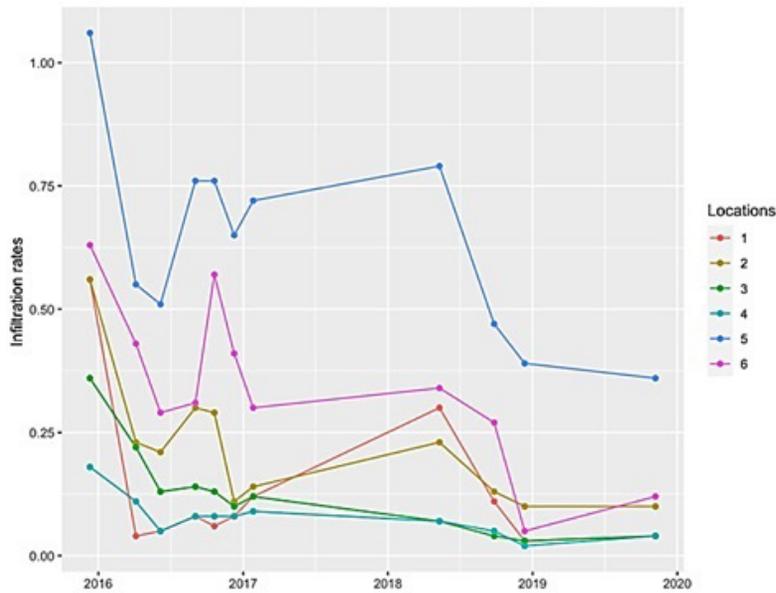
Figure 9. Measurements of infiltration rates over the time.

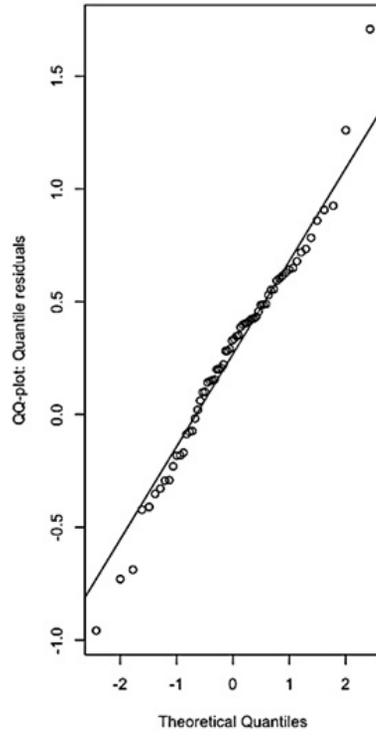
Figure 10. Diagnostic plots - QQ-plot of the quantile residuals

It can be highlighted that, for each location, the infiltration decreases averagely at a rate of $\cong 0.00118$ cm/s ($1 - \exp(-0.00118) = 0.00118$) per day. To evaluate the goodness of the fit, some diagnosis procedures were conducted. Frequently residual analysis by using normalized randomized quantile residuals is used to evaluate the adequacy of the model [39], [40]. Figure 10 to 11 show the diagnostic plots. All residuals appear satisfactory, as the quantile residuals follow the normal distribution. Estimated means and medians of infiltration rates are obtained using the expression (2) and plotted together with the Boxplots (drawn with the observational data previously show in Figure 8) in Figure 12.

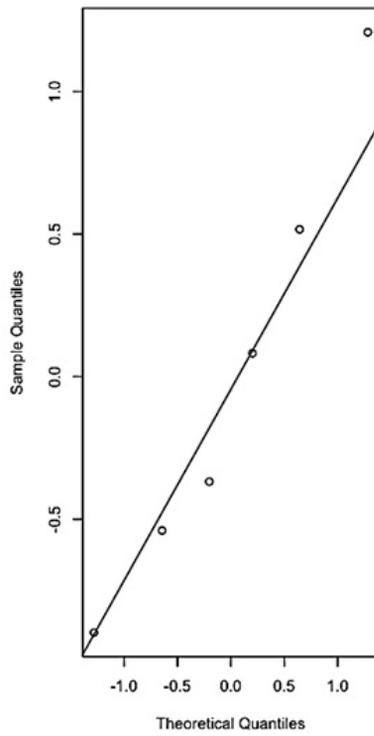
Figure 11. Diagnostic plots - QQ-plot of the random intercept

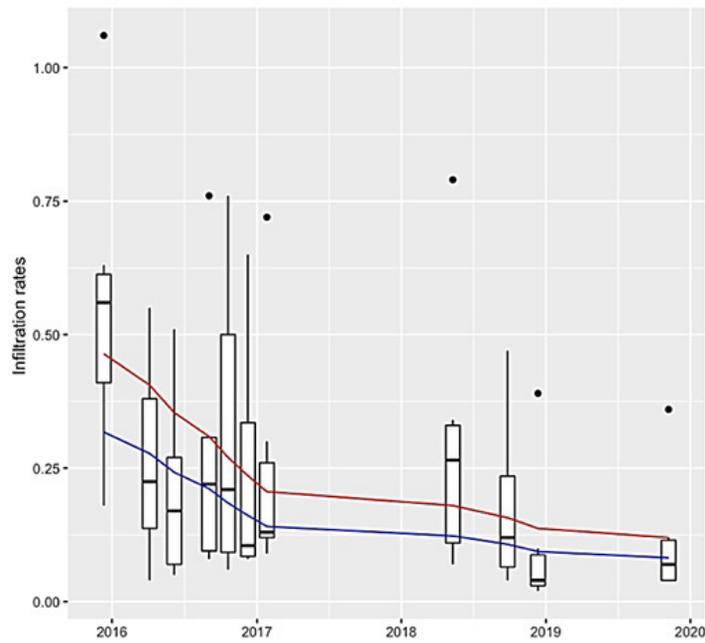
Figure 12. Boxplots of infiltration rate versus fitted values (mean per locations, color red and median per locations, color blue) over the time.

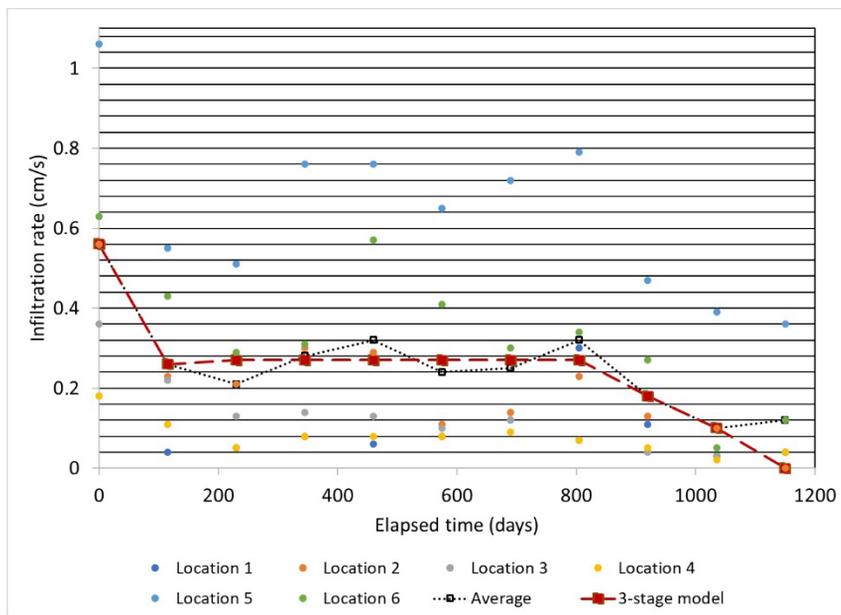
Figure 13. Interpreting infiltration rate loss as three phases' phenomena

where I is the estimate infiltration rate at any time (cm/s), I_0 the initial infiltration rate (cm/s), t is the elapse time (months) for infiltration rate estimation and t_a the initial abrupt period of clogging herein taken as 4 months. By looking Figure 13 is evident that there happens some intermediary stabilization of the infiltration rate loss. For its assembly it was sectioned the first stage by 115 days, when it is observed a very quick loss of infiltration rate for any location. From 115 days ahead locations 1, 2 and 6 were taken to the limit of 920 days; location 3 to 690 days; and locations 4 and 5 to the limit of 80 days.

The present data suggests that a three-phase model for clogging prediction is a fair alternative, especially for the case when very quick clogging (like the sidewalk amid a very wooded area surrounding it), to determine the first low point in terms of infiltration rate, making aware of the need of maintenance intervention other than sweeping (note that locations 1 and 4 meets the minimum infiltration rate requirement at this point). Therefore, two-phase model described through Equations 5 and 6 has the same usefulness. However, to take a future time prediction to the beginning of the third stage is uncertain because the clogging tends to be differentiated over the entire area of the porous pavement. As aforementioned, Figure 11 was built on assuming different times for beginning of the third stage on the basis of the numerical results presented in Table 6. Therefore, the end of the supposing mitigation phase as proposed by Cui et al. [27] could not be defined precisely through the carried experiment in field. Hence, Equations 1 and 2 can be used as a second slow phase for prediction of clogging for medium term analysis and management.
