## Performance of fire damaged cement and geopolymer concrete slabs retrofitted with BFRP laminates under static loading

### ABSTRACT

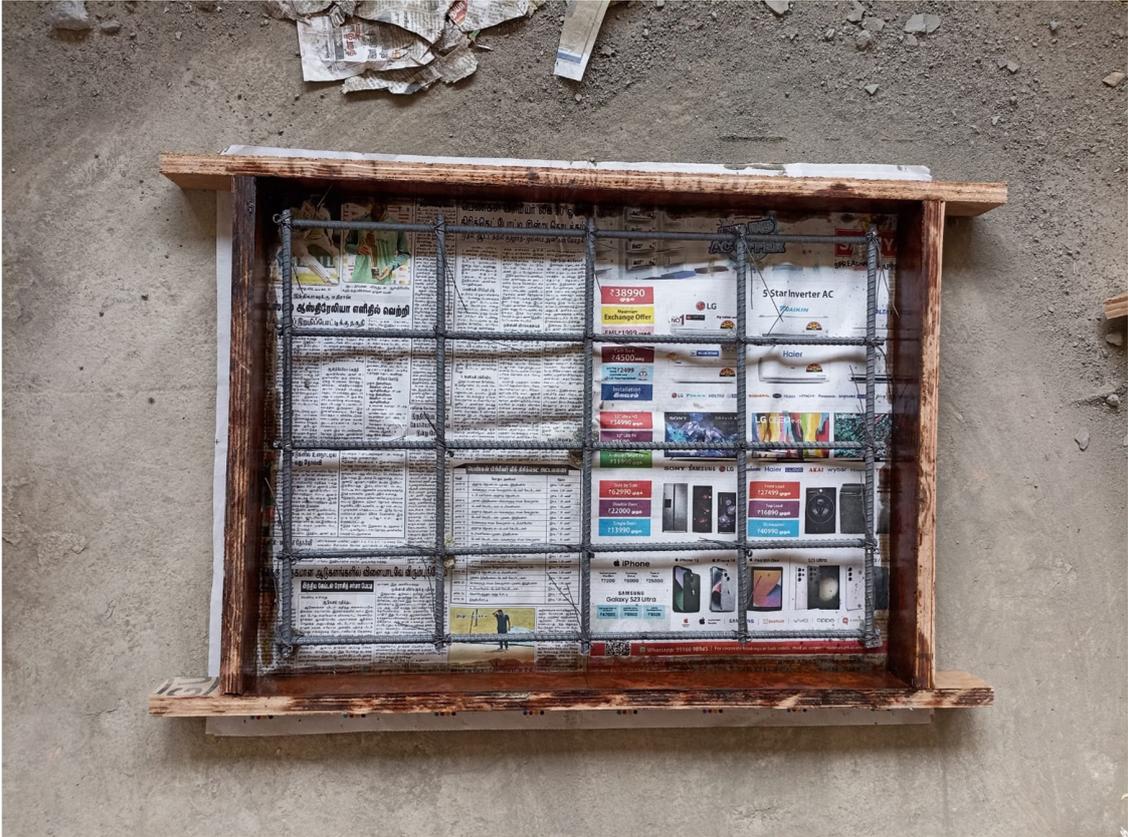
Figure 1: Placing of reinforcement.

Plywood moulds measuring 600 × 450 × 50mm were prepared, and necessary reinforcements were assembled before the casting process. To facilitate demoulding, the sides of the moulds were greased before placing cover blocks and positioning the reinforcements. Concrete casting was completed, and the specimen was carefully surfaced. After 24 hours, demoulding took place, followed by a curing period of 28 days in water for cement concrete slabs. For geopolymer concrete slabs, curing took place under ambient conditions during the same period. Figures 1 and 2 illustrate the sequential steps involved in casting a RC slab specimen, encompassing the placement of reinforcement within the mould. Figures 3 and 4 visually depict the curing process for both conventional and geopolymer concrete.

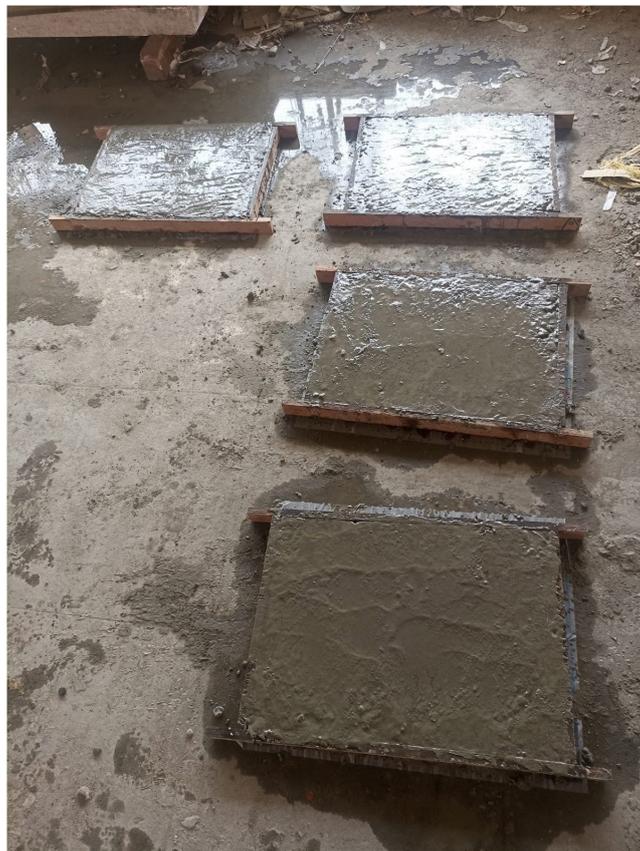
Figure 2: Casting of specimens.

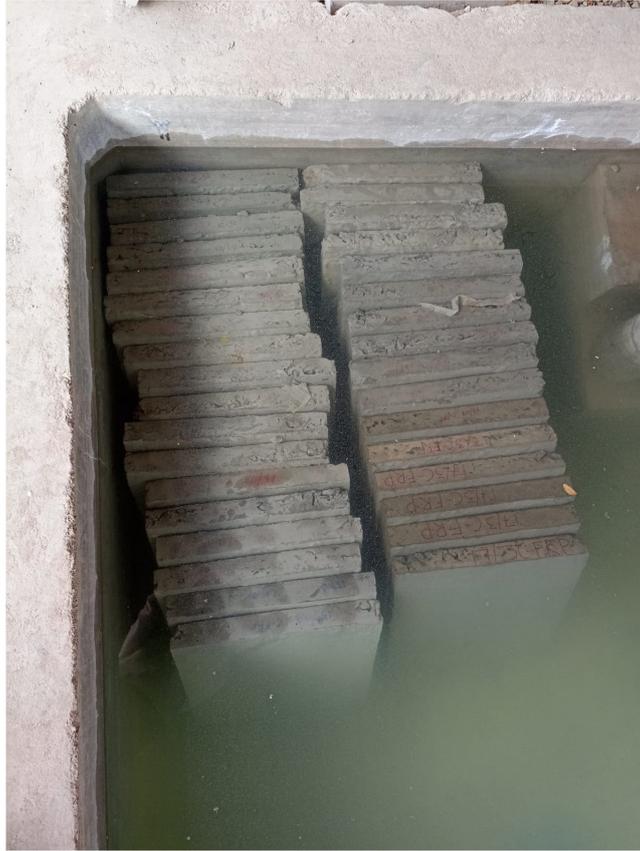
Figure 3: Water curing of cement concrete slabs.

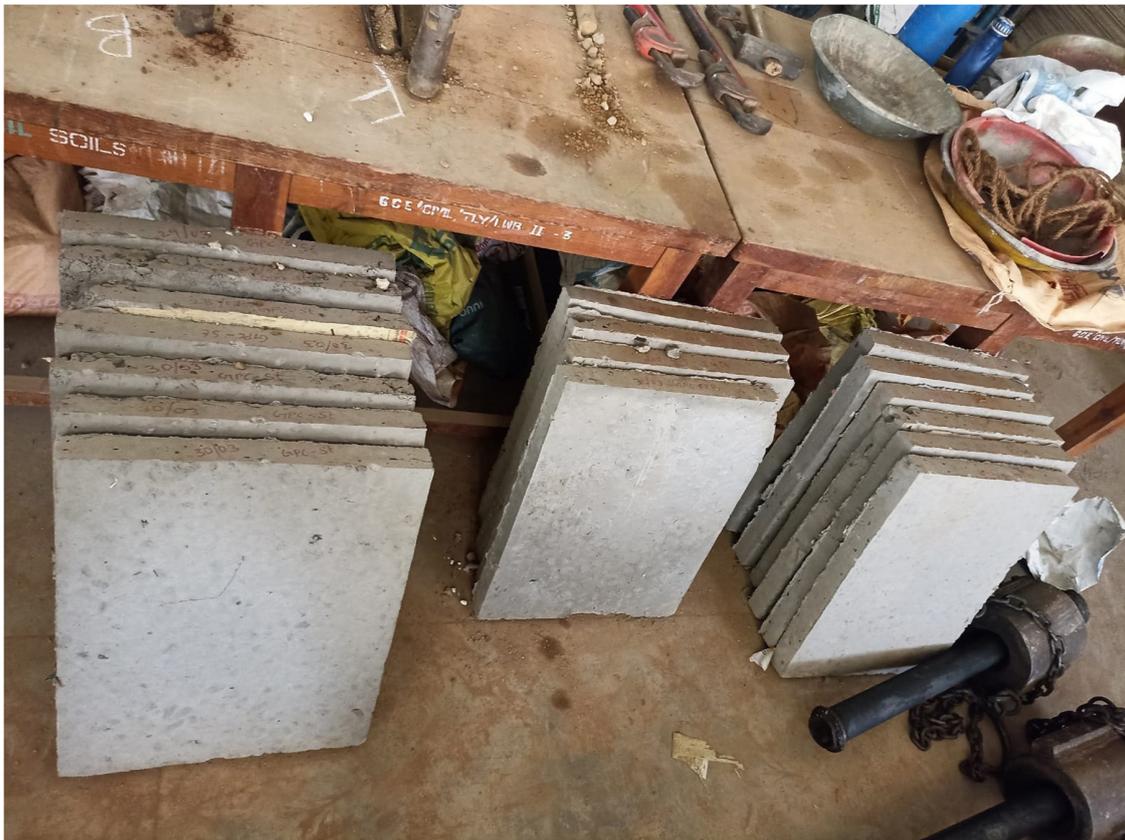
Figure 4: Ambient curing of geopolymer concrete slabs.

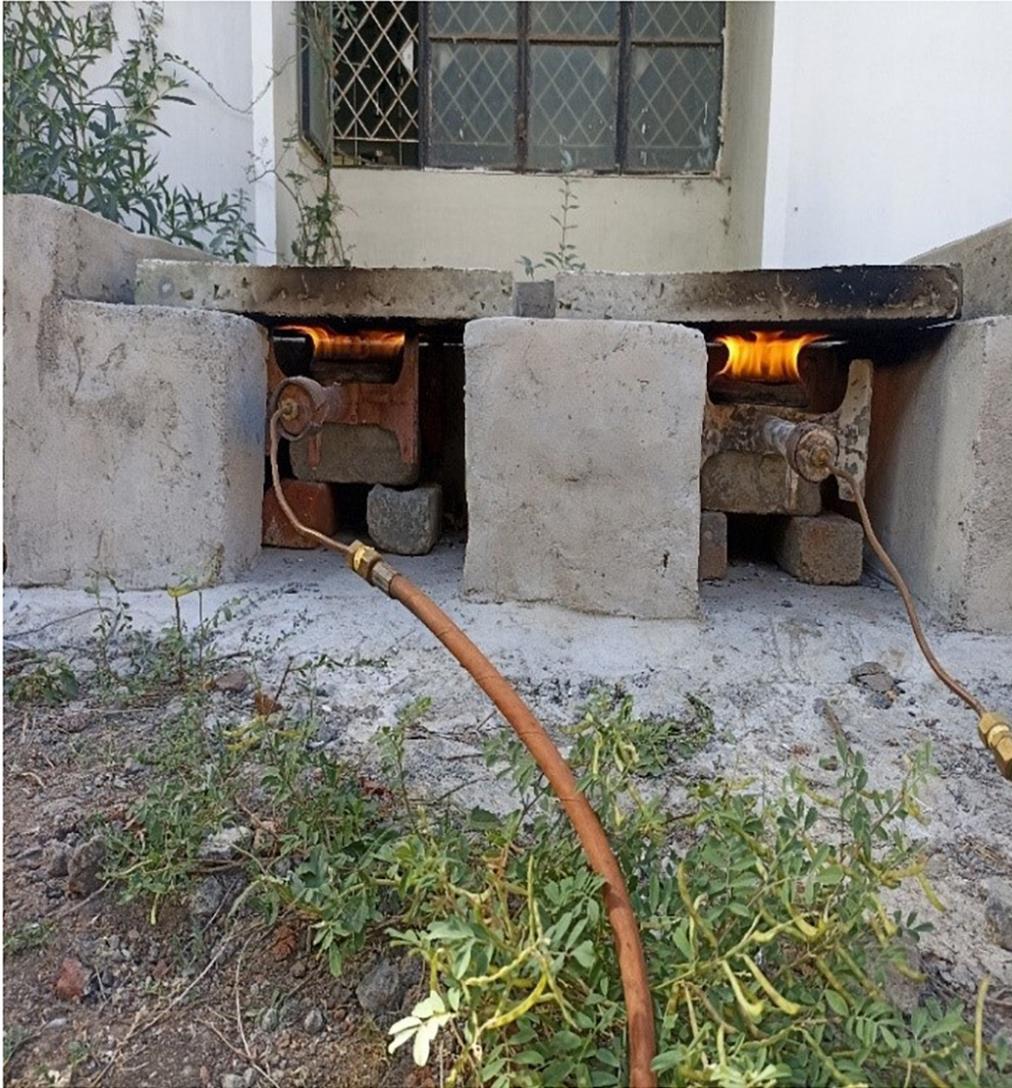
Figure 5: Set up for firing.

A high-speed burner, as depicted in Figure 5, was utilized to burn both cement and geopolymer slabs. To maintain the fire temperature, the temperature range was monitored employing a K-type thermocouple (Utc4202 model), as illustrated in Figure 6. Following exposure to fire for different durations (1h, 2h, and 3h), the temperature range was continuously monitored using the specified time intervals before allowing the specimens to cool inside the furnace. Figures 7 and 8 visually represent the firing process and the resulting fire-damaged slabs.

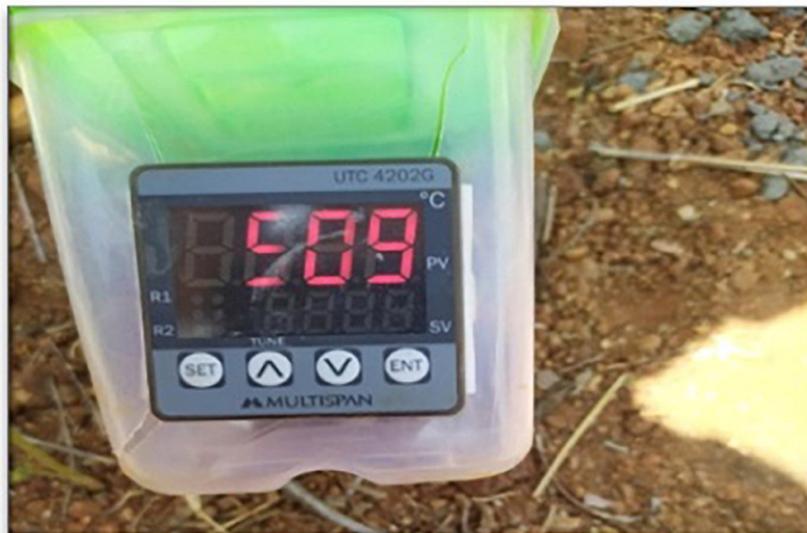
Figure 6: Thermocouple.

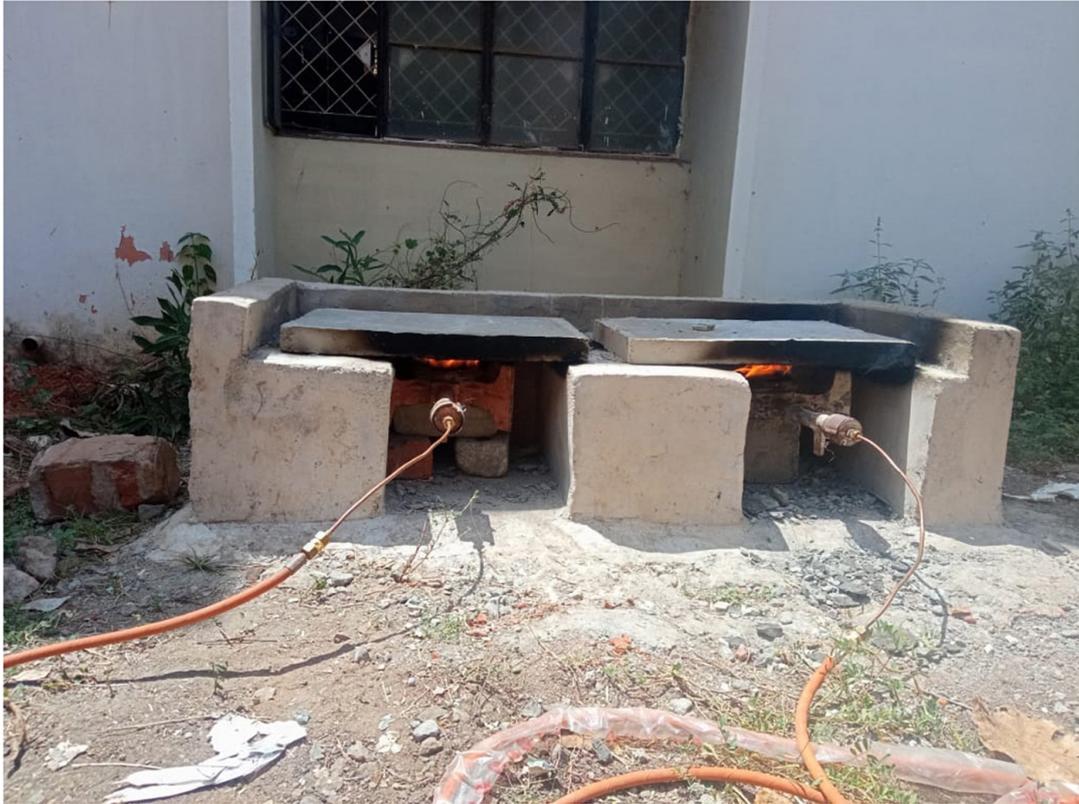
**Figure 7:** Exposure of fire on concrete slab.

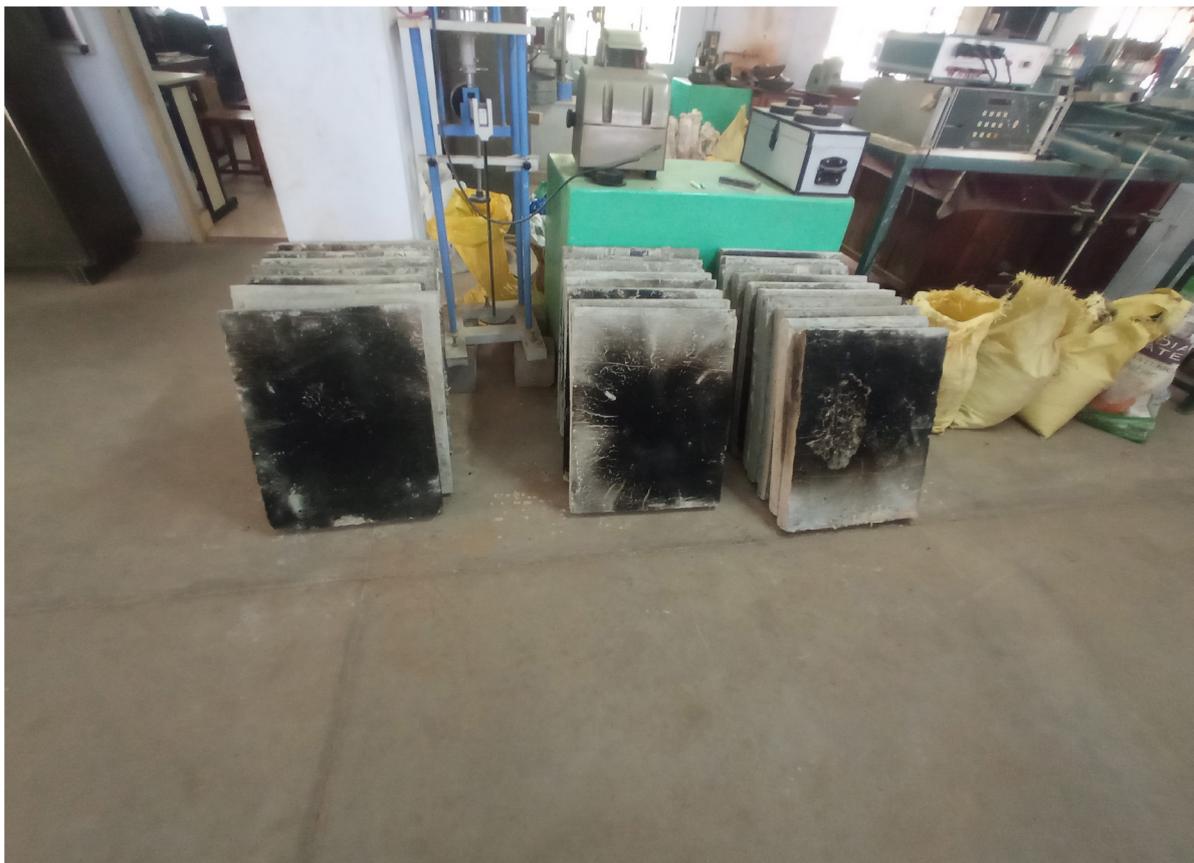
**Figure 8:** Fire damaged slabs.

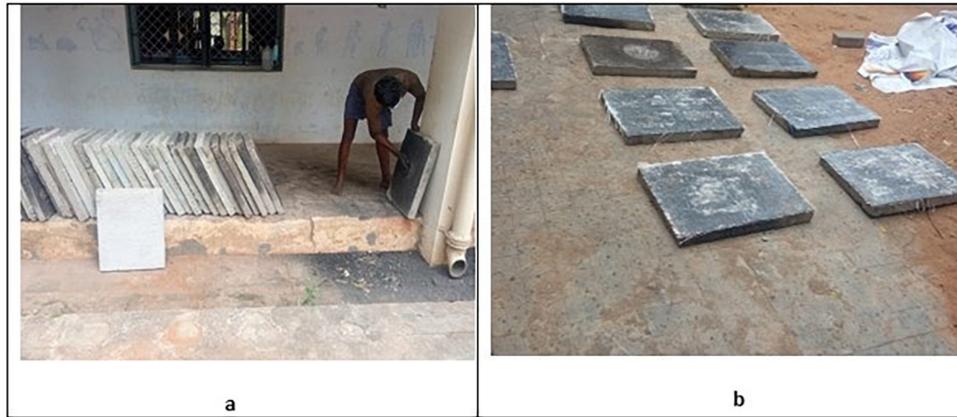
Figure 9: a) Surface cleaning process. b) Slab wrapped with BFRP laminates.

The FRP laminates were wrapped to the bottom of the slabs, with the fiber orientation positioned perpendicular to the load application. The air-cooled specimens were taken out of the furnace and smoothed on all sides before the wrapping process. The necessary quantity of epoxy and hardener was blended and uniformly applied to the bottom of the slab. Figure 9a illustrates the process of surface cleaning, followed by the depiction of the slab wrapped with BFRP laminates in Figure 9b.

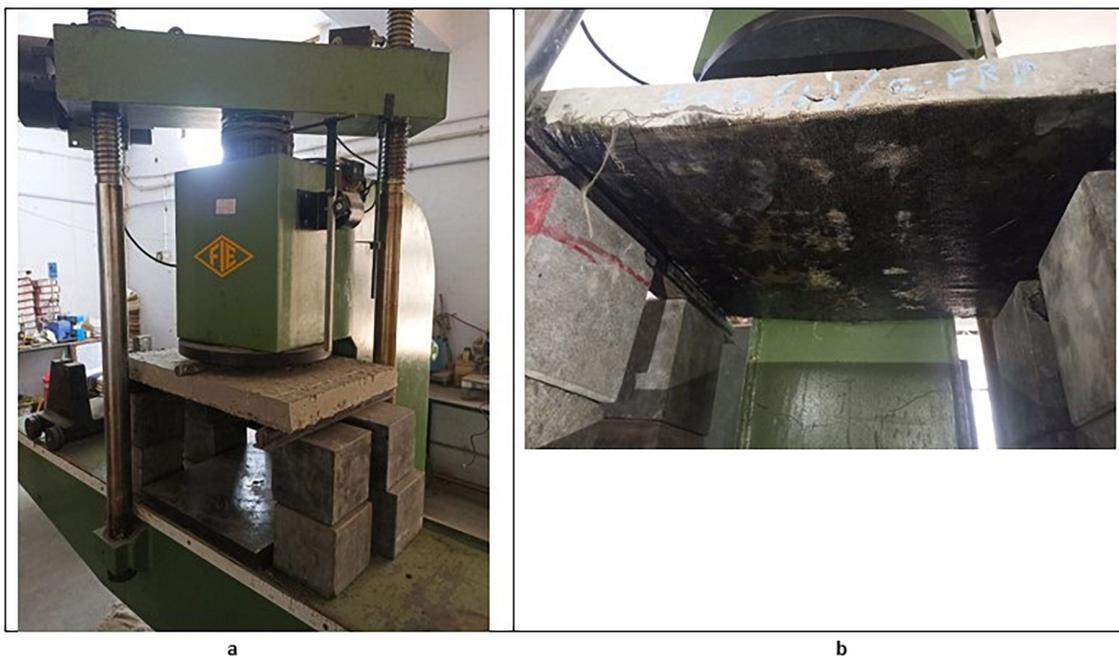
Figure 11: a) Testing of fire damaged slab without wrapping. b) Testing of fire damaged slab retrofitted with BFRP laminates.

1828/BS1610 standards. Figure 10 illustrates the schematic diagram depicting the supporting condition of the slab. Figure 11a depicts the test setup for fire-damaged slabs without wrapping, while Figure 11b illustrates the test setup for fire-damaged slabs wrapped with BFRP Laminates.

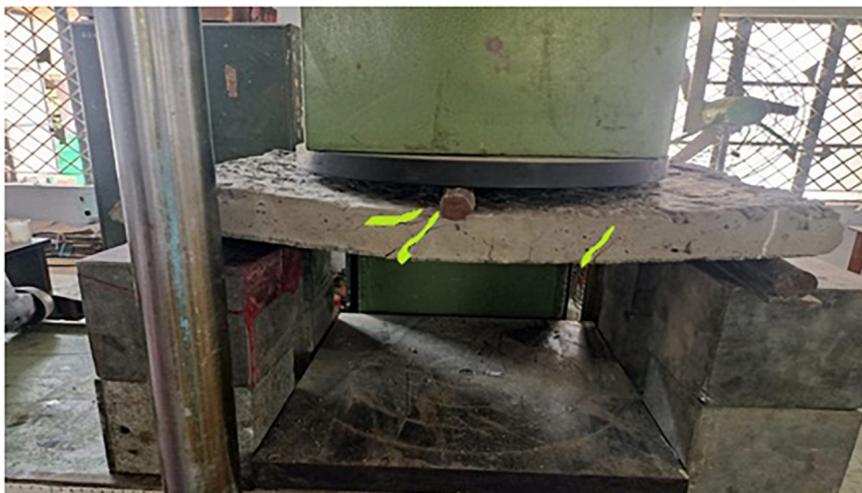
**Figure 17:** Failure mode of fire damaged CC slabs wrapping with BFRP laminates.

In all slabs exposed to temperatures of 400°C and 600°C, cracking initiated in the concrete layer between the BFRP and the embedded longitudinal steel reinforcement. The failure of the slab occurred through the crushing of the concrete on the top surface, and no BFRP debonding was observed. The failure was highly brittle and localized at one end of the slab, originating from the support, for slabs exposed to fire for varying durations. This mode of collapse has been previously documented as a failure mechanism for externally bonded FRP on RC one-way slab systems, as reported by [28]. Figures 15, 16, 17 and 18, demonstrate the failure modes observed in fire-damaged conventional concrete and geopolymer slabs both before and after being wrapped with BFRP laminates.

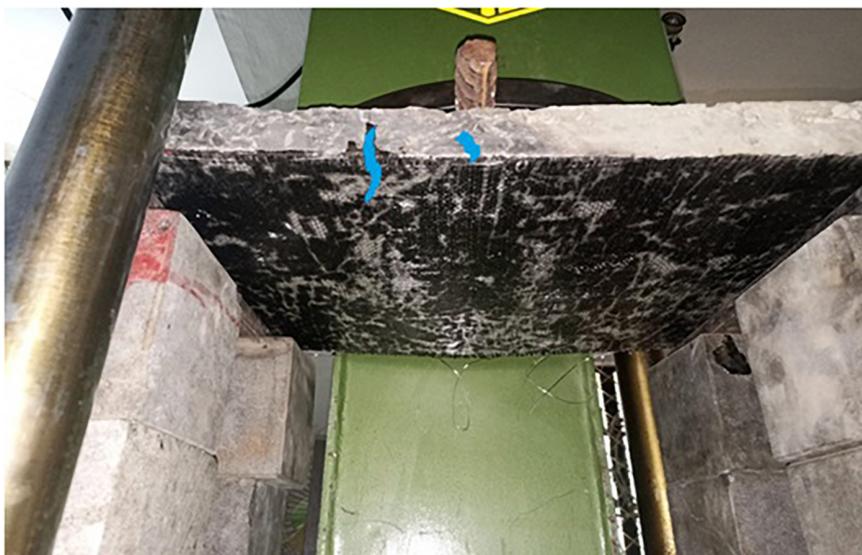
**Figure 18:** Failure mode of fire damaged GPC slabs wrapping with BFRP laminates.
