Experimental determination of the level of damage suffered by rigid PVC pipes under quasi-static impact load

This paper presents a approach to determining the level of damage on rigid PVC pipes (polyvinyl chloride), destined for the supply of drinking water, and previously subjected to quasi-static impact. The originality of the work has been to experimentally characterize the level of damage via readily measurable physical quantities obtained under operating conditions. For this purpose, a wide range of experiments were performed. Firstly, trials involving impact with a hemispherical-end hammer weighing 16kg, dropped from a height of between 0 – 2m on portions of rigid PVC pipe. Thereafter, the dimensions of the affected area on the portions of the pipe are measured using a Tridimensional Measuring Machine (TMM). Finally, tensile tests on flat test pieces from around the impacted area of the pipe section were used to determine the post-impact residual mechanical strength. This investigation on post-impact properties allows the definition of the level of damage reached via the unified theory model of Bui Quoc. By analogy to the latter, the damage is expressed as a function of the

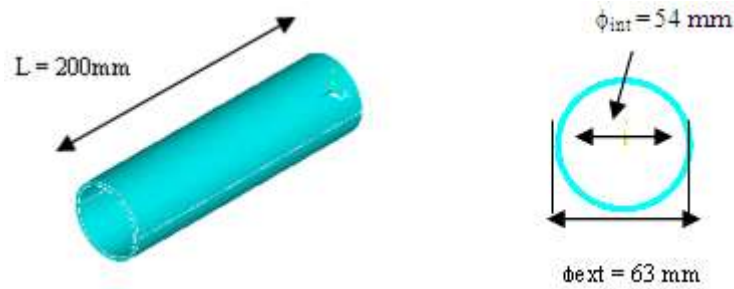
Specimens used are tubes made of polyvinyl chloride (rigid PVC), gray in color, according to the standard (NFT 54016). They come from the same casting. The tube's dimensions are: diameter 63mm and thickness 4.5mm (Figure 1).

Figure 1: Geometry of tube piece specimen type, used for impact tests (falling weight).

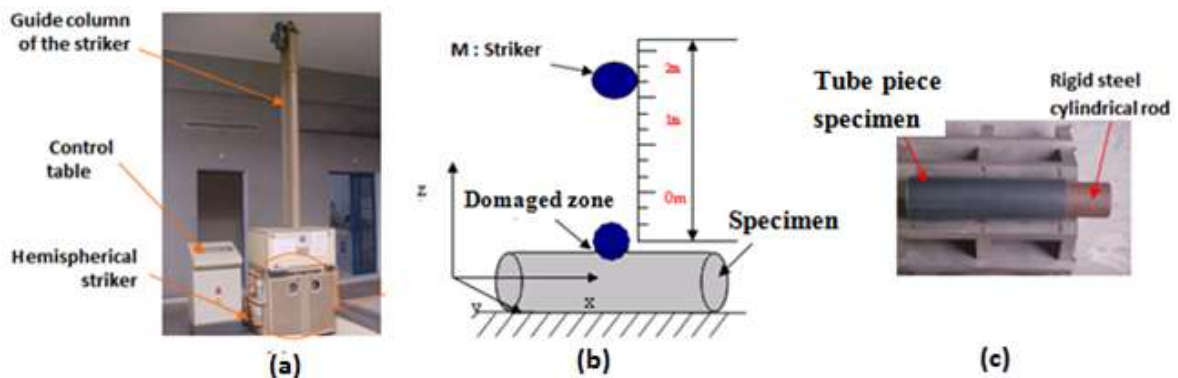
This device allows the release of a weight called striker from a selected height on a tube piece (Figures 2a and 2b). The tube piece is positioned on a “V”-shaped support. A cylindrical steel rod is inserted into the tube. We used a hemispherical striker (radius R = 50 mm) weighing 16kg (Figure 2c). Released heights are between 0 and 2m.

Figure 2: (a) The impact machine bearing the German brand UTS TESTSYSTEME, (b) Block diagram of the impact machine (c) Positioning the specimen.

The impact of the striker on the tube being tested leaves there on an elliptical footprint (affected or damaged zone shown in Figure 2b).

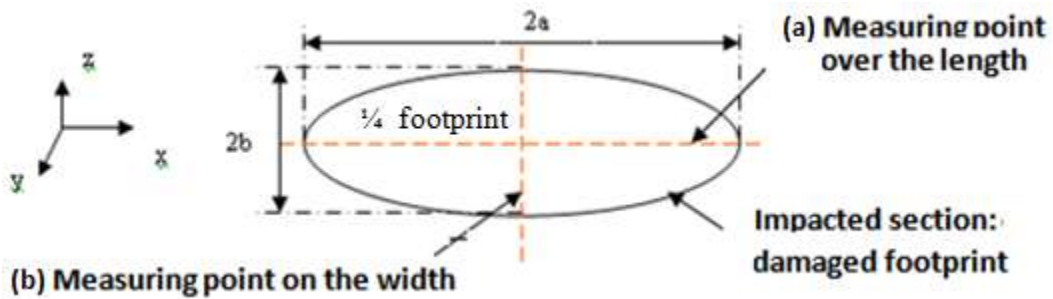
The displacements of the probe of the TMM is programmed according to the direction of the radii of the big and small axis of the elliptical footprint (affected or damaged area) in order to determine the dimensions “a” and “b” (Figure 4). The probe displacement increment in these directions is chosen as 0.5mm.

Figure 4: Elliptical footprint and desired dimension: (a) The probe contact points along the length, (b) The measuring points (contact) of the sensor along the width with an increment of 0.5mm.

It was operated here the discrete series of points obtained from the three-dimensional measuring machine (TMM) with the aim of determining the dimensions of the radii of minor axis and major axes of the impacted area as shown in Figure 4.

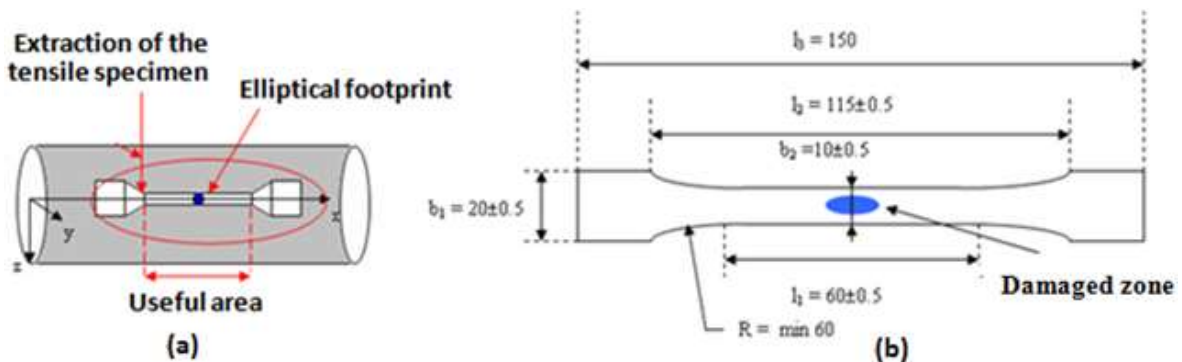
Following the impact test, tensile test specimens are taken around the affected area, as presented in Figure 5.

Figure 5: (a) Machining area of tensile specimens on the tube. (b) Tensile specimen dimensions.

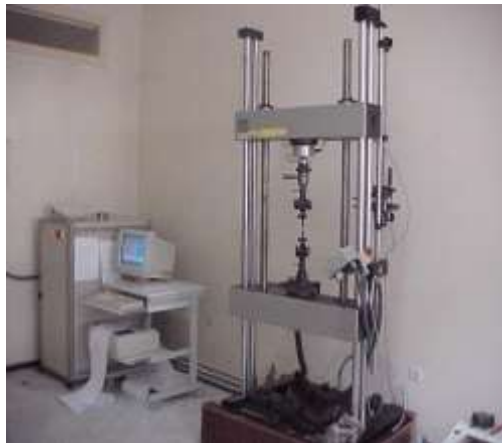
The tensile test machine used bears the mark UTS TESTSYSTEME (Figure 6). Tensile tests are performed there at room temperature, with low deformation speeds of $0.06\text{m}\cdot\text{s}^{-1}$, so as to limit the phenomena of self-heating of the material.

Figure 6: Tensile test machine UTS TESTSYSTEME.

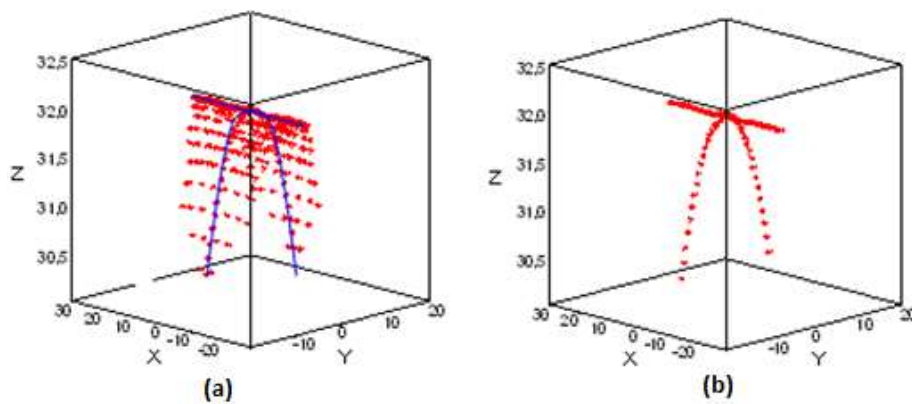
Initially all the probed point coordinates obtained with the TMM for the case of a 16kg mass impact test dropped from 1.25m (Figure7) are represent in 3D.

Figure 7: 3D graphical representation of the series of coordinates obtained by TMM from an impression on an impacted tube; mass 16kg / height 1.25 m. (a) For all the measuring points, (b) Representation of the measurement points along the length and width of the tested tube.

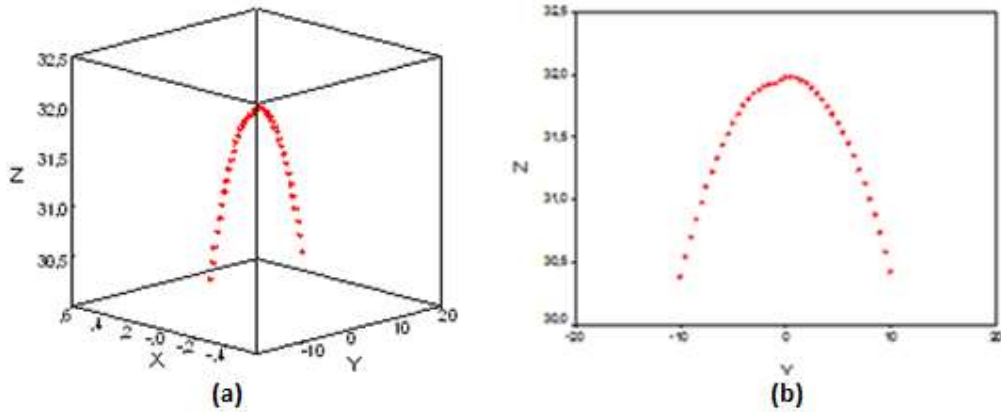
Figure 8: Graphical representation of points probed only on the width of the footprint with $x = 0$, (a) in 3D and (b) in 2D.

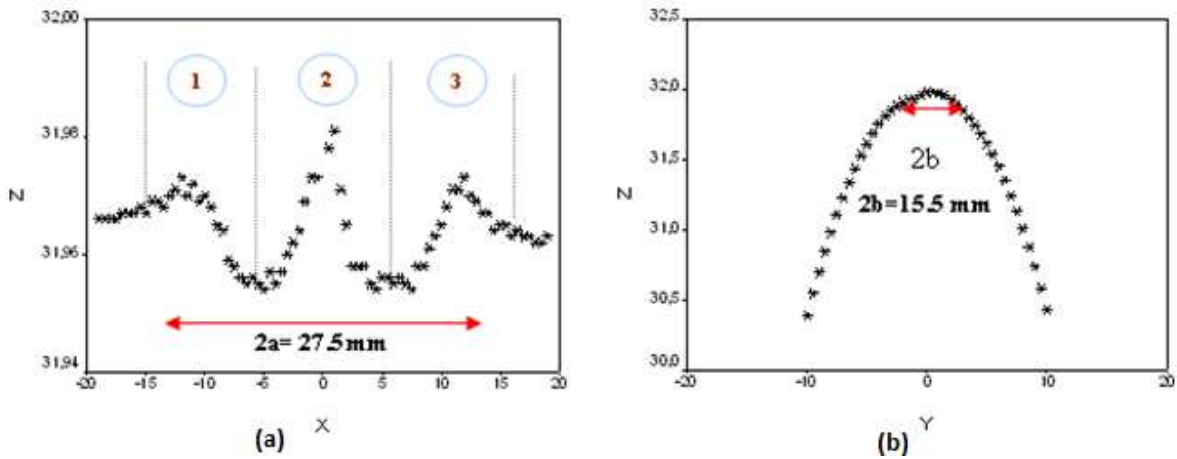
The two-dimensional representation allows easier determination of the impacted area (dimensions “a” and “b”) by observing the variation in height between the boundaries of the area affected by the impact and the remainder of the upper generatrix of the tube (Figure 9).

Figure 9: 2D graphic representation (small scale) of certain series of measurement points of the probe, (a) Graphic representation of the measurement points scanned only over the length (x, z), (b) Graphical representation of the measurement points scanned only over the width (y, z).

Domains 1, 2 and 3 identified in Figure 9 are attributed to the adhesion between the striker and the polymer material during impact. The curvature of the tube makes it more difficult to measure the “b” dimension using the TMM. Areas (in mm^2) of the impacted zones are summarized in Table 2, for all the impact tests.

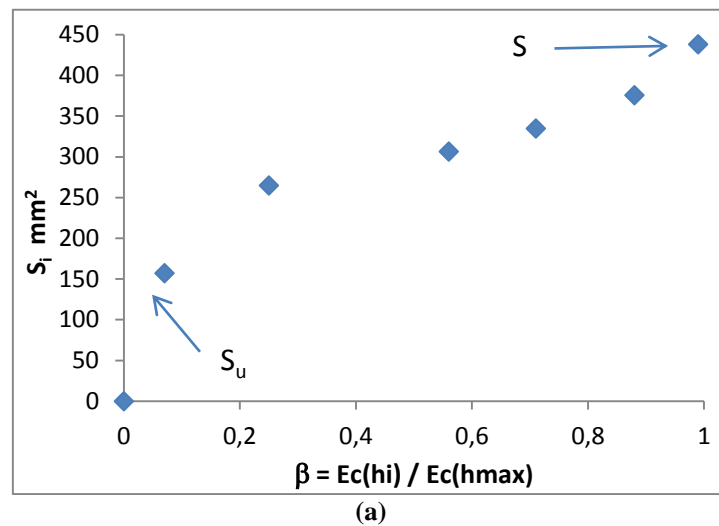
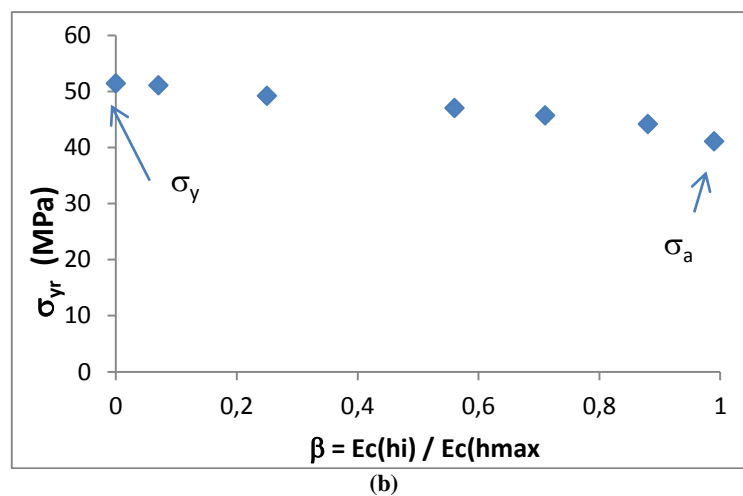
The evolutions of the area of the affected zone and of the tensile stress elastic limit σ_{yr} according to β are shown in Figure 10.

Figure 10: Evolution based on the level of impact suffered β : (a) the area of the affected zone " S_i " and (b) the residual ultimate stress " σ_{yr} ".

From Figure 10, it is found that the curve of the residual ultimate stress changes in a manner opposite direction to that of the area of the impact zone. Indeed, the stress σ_{yr} decreases by 51.4MPa (virgin material: not affected) for $\beta = 0$, to 41.1MPa value for $\beta = 1$ (representing the rupture during the impact test). While the area of the affected zone increases gradually from zero (not impacted tube) to a maximum value of 438.2 mm² measured before fracture due to impact. This divergence between the area of the affected zone, and loss of strength of the material can be explained from the observation of the impacted area (Figure 11).

- σ_{yr} : residual ultimate stress for any level of impact,
- σ_y : ultimate stress of virgin material ($\sigma_y = 51.49\text{MPa}$),
- σ_a : critical residual ultimate stress $\beta = 1$ (Figure 10b).

- S_i : the area of the impact zone measuring any impact,
- S_u : the minimum area below which no loss of strength is observed, it characterizes in a certain way the virgin material (figure 10a),
- S_a : critical area beyond which the tube breaks during impact, $\beta = 1$ (Figure 10a),
- α : correlation coefficient ($\alpha = 2$).

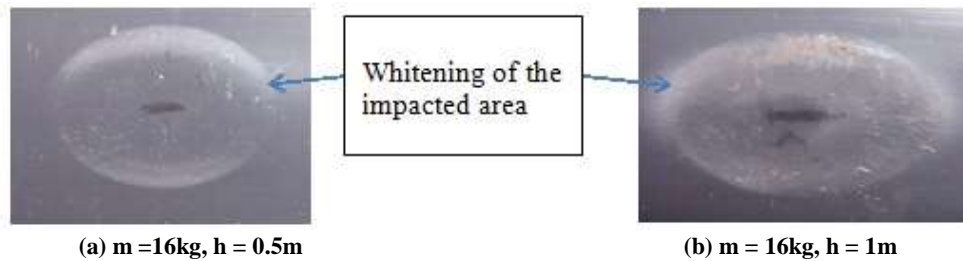
Figure 11: Photographs of the affected area of the pipe section for different heights of the released firing pin.

Note in these photographs, the area of the affected zone is completely bleached. In literatures on amorphous polymers, bleaching allows the macroscopic localization of microscopic damage phenomena [8, 9]; recent studies have confirmed that bleaching was linked to the appearance of microscopic defects in the polymer structure [10]: cracks, cavities etc. It is therefore clear that the extent of the area of the impact zone determines to a certain proportion the morphological damage caused by the impact. The damage caused is detected by the loss of mechanical properties in this study. The evolution of the residual ultimate stress versus the area of the affected zone, is represented in Figure 12.

Impact tests using a 16kg mass dropped from different heights, have enabled the observation of bleaching of the area of the affected zone (whose dimensions depend on the level of impact). Tensile tests performed later on specimens collected from the affected zone of the tubes showed a loss of material strength. Thus, it was evaluated the level of damage of the material through the Bui Quoc model (damage coupled with the ultimate residual stress). By analogy to the expression of the damage obtained by Bui Quoc, a formulation of damage combined with the area of the impact zone was proposed. Having thus defined the damage, its comparison with that of Bui Quoc qualitatively shows good agreement, as well as quantitatively for $\beta \geq 0.25$.

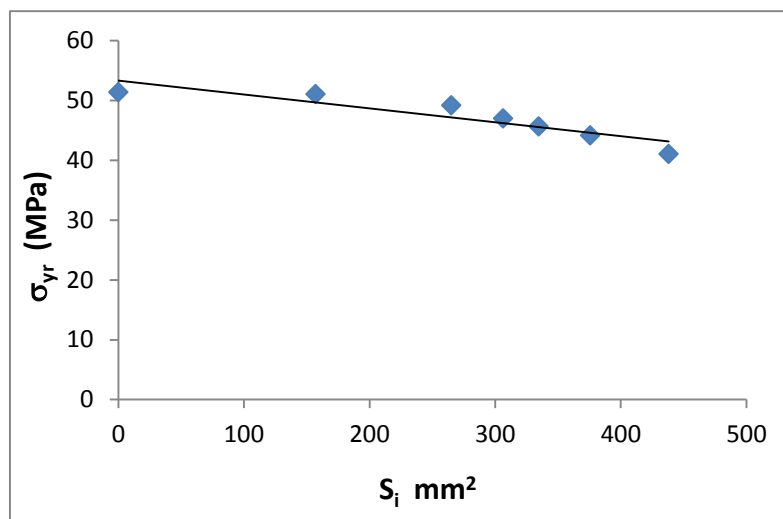
Figure 12: Evolution of the ultimate residual stress as a function of the size of the affected zone.

Note in Figure 12, the residual ultimate stress can be linearly correlated to the area of the impacted area. This correlation shows that the area of the impact zone is also a size capable of realizing the damage caused by the impact (relative to the size of the tip of the firing pin).

The correlation established in Figure 12, allows to consider the area of the affected zone as a macroscopic property characterizing the damage caused by the impact. By analogy to the damage model of equation (1), a formulation of damage combined with the area of the impact zone (S_i): is proposed.

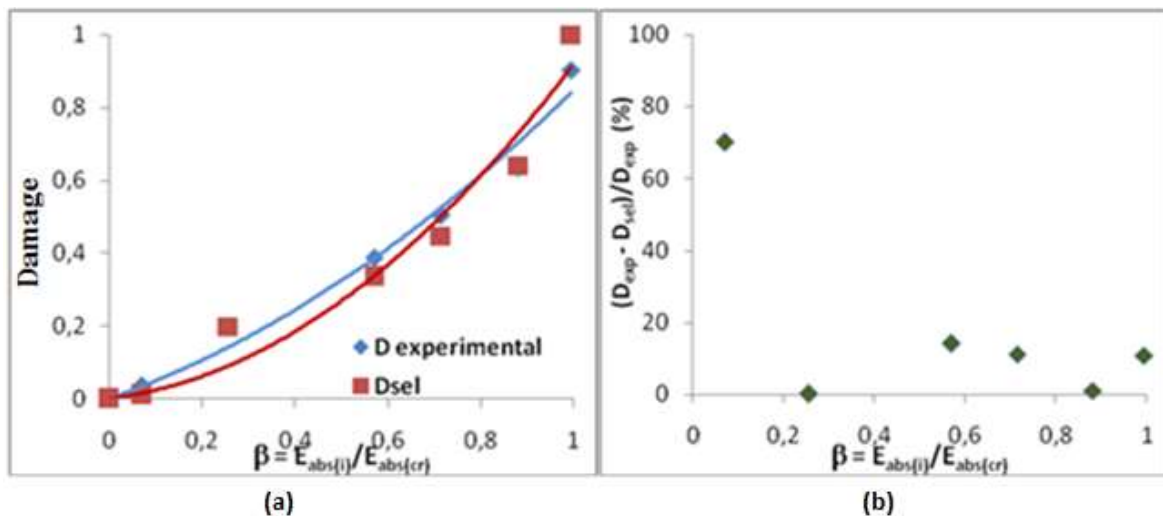
Figure 13: (a) Comparative evolution of the damage D_{exp} and D_{sel} for $\alpha = 2$. (b) Differences arising between the curves D_{exp} and D_{sel} .

In Figure 13, the experimental damage of D_{exp} gradually rises from $D = 0$ (undamaged material) to a value $D = 1$ (completely damaged material). The D_{sel} damage (with $\alpha = 2$) correctly reproduces qualitatively the D_{exp} damage. However quantitatively for $\beta \leq 0.7$, the D_{sel} damage underestimates the damage level and beyond $\beta > 0.7$, the D_{sel} damage slightly overestimates the level of damage. Except for $\beta \leq 0.25$ with the relative deviations of the order of $\pm 85\%$, the D_{sel} estimates are sufficiently close to D_{exp} quantitatively and the relative differences are of the order of $\pm 15\%$.

Despite the relatively high gaps for low values of β , D_{sel} damage predictions are considered satisfactory if one wishes to determine the critical damage leading to collapse of the structure (which corresponds to β beyond 0.25 for polymeric materials).
