## Geogrid mechanical damage caused by recycled construction and demolition waste (RCDW) under in-field cyclic loading

Article

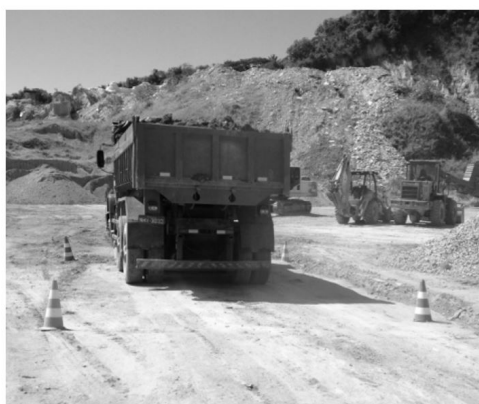
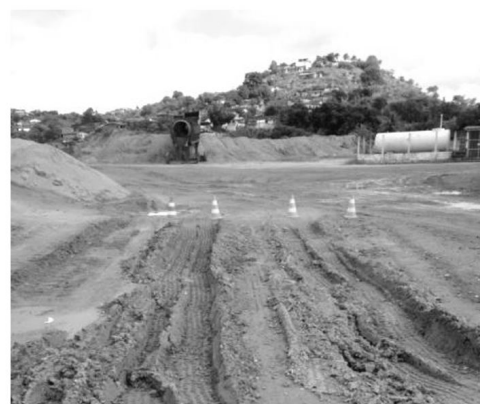
**Figure 3.** Experimental section #2: (a) truck traffic; (b) formation of grooves after intense rain precipitation.

Figure 3a illustrates the traffic of trucks over the experimental section on the second day of cyclic loading (September 9<sup>th</sup>, 2016). The third day of cyclic loading (September 12<sup>th</sup>, 2016) was adversely affected by an intense rain precipitation that occurred during the weekend. According to Pernambuco State Agency for Water and Climate (APAC, in Portuguese), an average rain precipitation of 18 mm was recorded on the day before the cyclic loading. Due to the lack of drainage system at the recycling plant area, this precipitation was enough to keep the experimental area flooded during the whole precipitation period. Therefore, in order to prevent additional damage, 5 (five) specimens of each geogrid were exhumed before the recycling plant started its operation. After this, the traffic caused the section failure, which was characterized by the formation of grooves of 45 to 110 mm deep, as illustrated in Figure 3b. However,

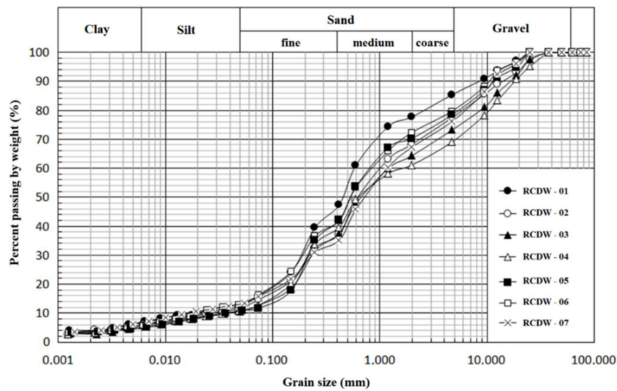
**Figure 4.** Grain-size distribution curves of RCDW – tested according to NBR 7181 (ABNT, 1984a).

The grain-size distribution curves of RCDW revealed a low variability for samples tested (Figure 4), with predominance of sand and gravel fractions (Table 5). The RCDW presented an average coefficient of uniformity ( $C_u$ ) equal to 38.86, with coefficient of variation ( $COV$ ) of 40.44%, and coefficient of curvature ( $C_c$ ) equal to 1.73, with  $COV$  of 35.76%. The percentage of grains smaller than 0.42 mm was 40.49% ( $COV = 9.80\%$ ).
