Seismic evaluation and partial retrofitting of concrete bridge bents with defect details

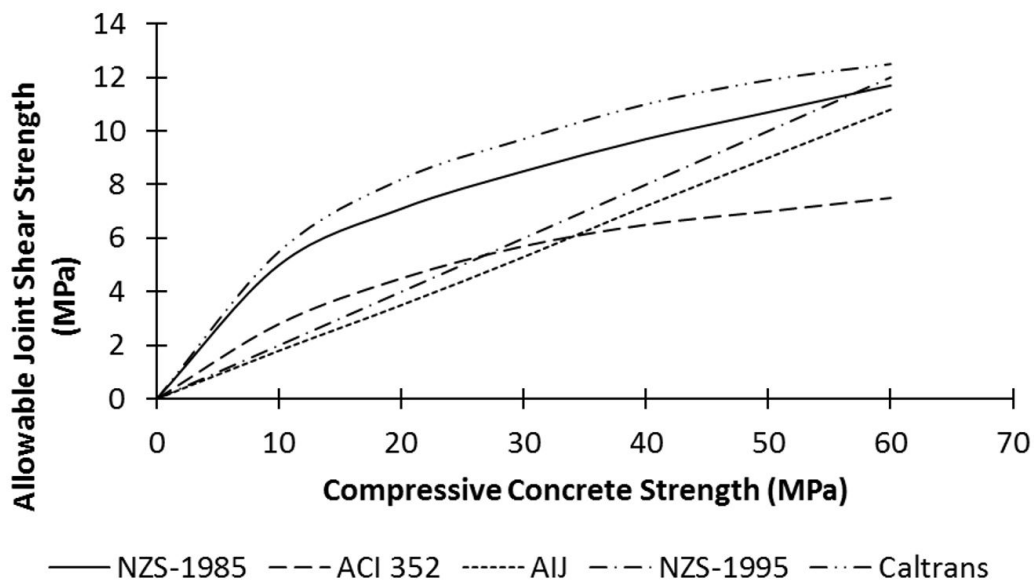
Figure 1: Shear stress limitations for interior joints by different Codes (Naito et al., 2001).

Some limitations are applied to the amount of stress at joint to make sure that beam-column connection can withstand plastic hinge mechanism. A study in Japan showed that the shear strength of joint strongly depends on compressive strength of concrete and on transverse bars in the hinge (Kitayama et al., 1991). Fig. 1 shows the relationship between the allowable shear strength and the compressive strength of concrete in different codes. Accordingly, the compressive strength of concrete is one of the important parameters for determining the shear strength of the connection (Naito et al., 2001).

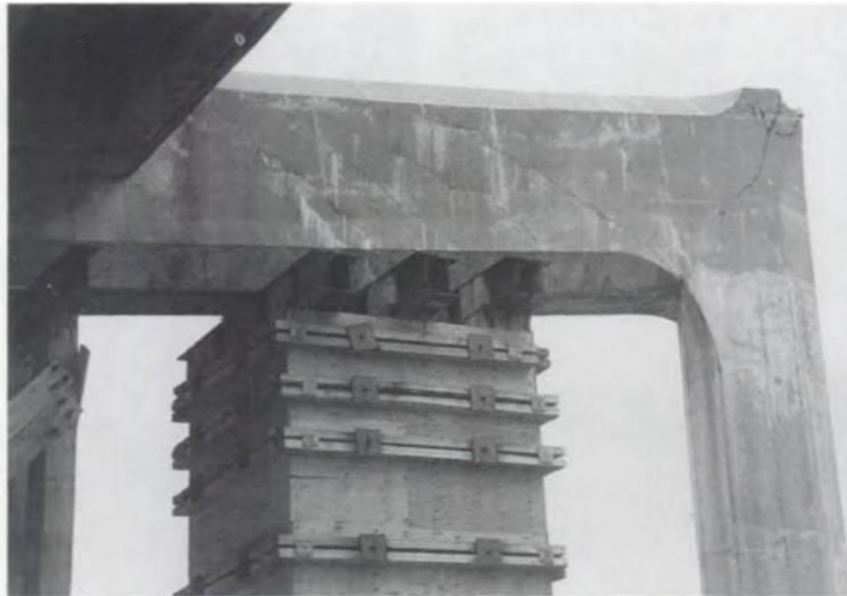
Figure 2: Cap beam flexural-shear failure (Priestley et al., 1996).

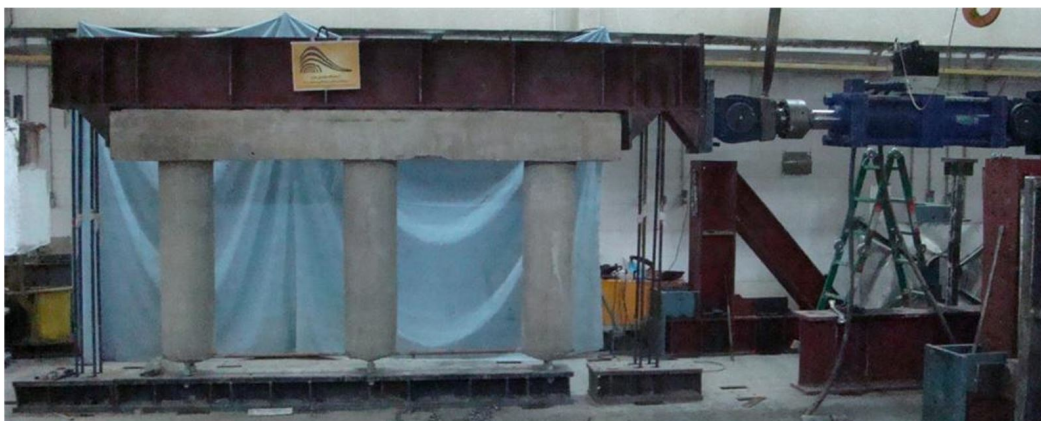
Figure 4: Specimen designed based on 90s code (specimen A).

The scale of the experimental specimen was considered as 30% of average values of six present bridges. Specification of materials was selected based on field studies and available test results. For concrete, the strength of the standard cylindrical specimen was 24 MPa and compressive strength of the cap beam and column were 28.6 MPa and 27.5 MPa, respectively. The details of the longitudinal and transverse reinforcements are presented in Table 4. A general comparison between specimens designed by 80s codes, as stated by Bahrani et al., (2017), and 90s codes is also shown in Table 5. As is seen, there are no differences between the two models in terms of type, size and strength of reinforcement. The major difference is the spacing of transverse reinforcements, which is reducing this value especially in the connection region, as presented in the 90s codes, causes better seismic behavior for bridge. Specimen B that is also a retrofitted type of specimen A was strengthened by transverse pre-stressing in the external connection region. Specimen A and B are shown in Figs. 4 and 5, respectively. For better understanding of the retrofitting in specimen B, details of pre-stressing are also shown in Fig. 6.

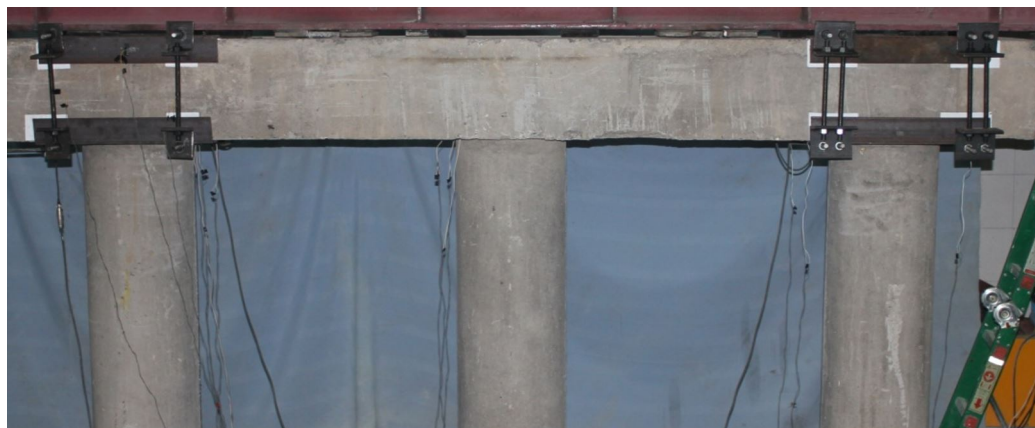
Figure 5: Retrofitted specimen with one side external pre-stressing (specimen B).

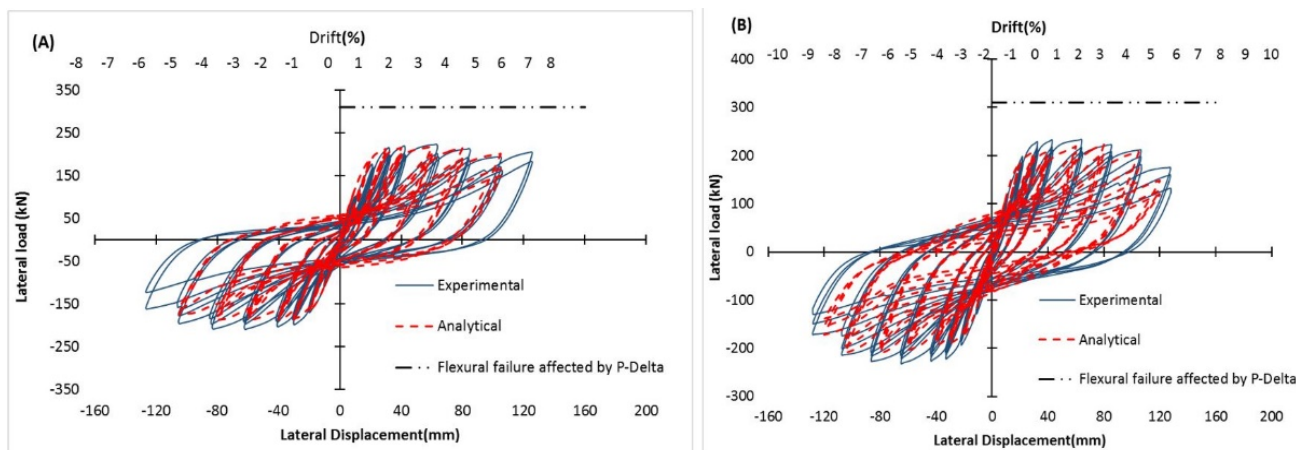
Figure 9: Experimental and numerical hysteresis results of the specimens designed by 1990s codes. a) Specimen A b) Specimen B

This section presents and compares the hysteresis behavior of the experimental specimens with the numerical method. Concrete frames were subjected to cyclic loading up until the ultimate capacity of the bars and complete failure of the concrete core were seen. Fig. 9 shows the experimental and numerical hysteresis behavior of the specimens A and B.

Hysteresis curves of the specimens designed by older codes, show significant in-cycle and out-cycle strength degradation and little plastic behavior by entering the nonlinear range (Bahrani et al., 2017). For determination of the ductility, the behavior and performance of the specimen and damage progression pattern should also be considered. In terms of energy absorption and damping, the hysteresis curve is thin and its energy absorption is negligible due to the slip of longitudinal reinforcement. The hysteresis curve of the specimen A (Fig 9a) shows high and low in-cycle and out-cycle strength degradation, respectively, by entering to the nonlinear range. This in-cycle strength degradation can be attributed to the slippage of the bars. Due to the lack of formation of a desirable mechanism in the members, the hysteresis curve is thin and does not have high energy-absorption. Fig. 9b shows the hysteresis curve of specimen B with slight strength degradation. This specimen also has a lower pinching behavior, which indicates a decrease in the bar slippage in the connection region compared to the other specimen. Improving the seismic behavior of the specimen A and B compared with the specimens designed with older codes is clear from the results. In addition, the specimen B showed better behavior compared to the specimen A. The envelope curves of the specimens are extracted and illustrated on Fig. 10 for a better comparison between the results.

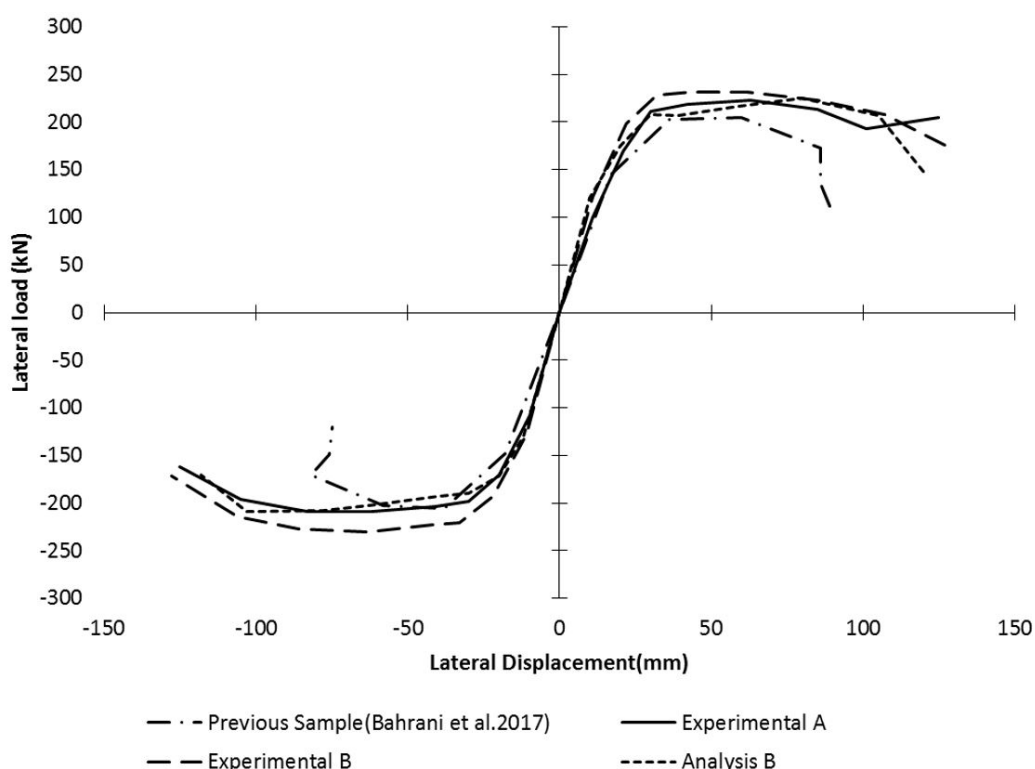
Figure 10: Envelope curve of the specimens.

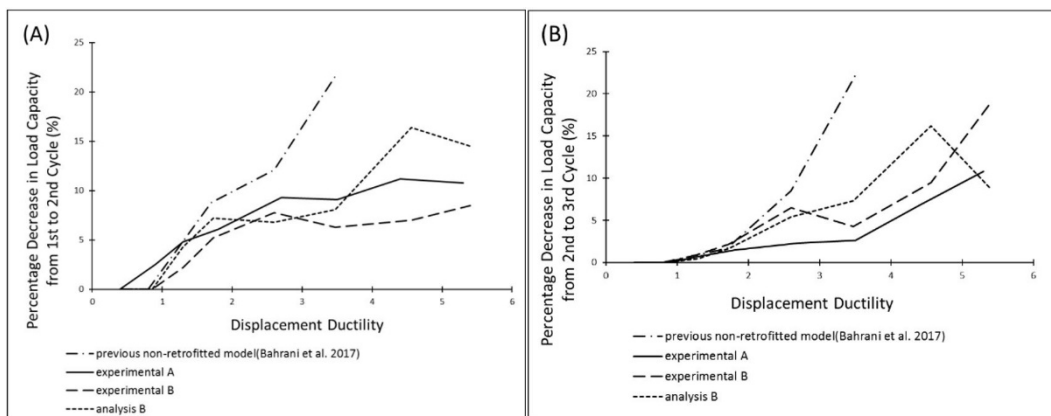
Figure 11: Experimental and numerical results of the strength degradation of all specimens

a) Between first and second cycles b) Between second and third cycles.

The percentage of strength degradation is defined as the difference between loads resisted in the two cycles divided by the load resisted in the first cycle of that pair of cycles for that displacement amplitude. Overall, specimen B showed low-strength degradation. The strength degradation index to the relative displacement is shown in Fig 11. Relative displacement is calculated by dividing the structural displacement on the ideal displacement. Up until the relative displacement of 1, less than 2% of the strength degradation between the first and second cycles in particular displacement amplitude was observed in specimens A and B as is seen in Fig. 11a. At this relative displacement, strength degradation in the second and third cycles was neglected (less than 1%) based on Fig. 11b. For specimen A, the first cracks appeared in relative displacement of 0.5 as flexural capillary cracks in cap beam, whereas the flexural cracks in the specimen B appeared at a relative deformation of 0.7. The behavior of the specimens at this displacement range only leads to the formation of capillary cracks on the concrete surface. For specimen A, the strength degradation of cap beam was strongly influenced by loading in relative deformation of 1. For the specimen B and at relative displacement of 1.5, the cracks caused by the bar confinement first appeared in the left connection and then in the middle and right side connections, as seen in Fig. 11a.

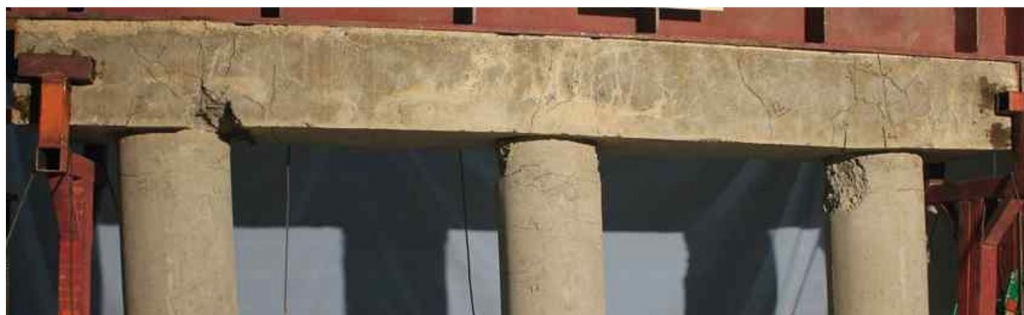
Figure 12: Damage modes in specimen A, spalling of concrete in side cap beam and middle and right column and rotation of column at relative displacement of 4.1.

There is a significant difference between the strength degradation in the second and third cycles at the relative displacement ranges of 2 to 3 between the two specimens, as shown in Fig. 11b. The reason is the difference between start of bar slippage and its value between the two specimens. In specimen A, the failure of the upper sides of side columns increased after relative deformation of 3.5 and reached the maximum damage at the relative displacement of 4.1. In addition, concrete spalling at cap beam occurred at this relative displacement which is shown in Fig. 12. This caused an increase in the slope of the strength degradation in relative displacement of 3.7 and upper due to the onset of the concrete spalling in side columns.

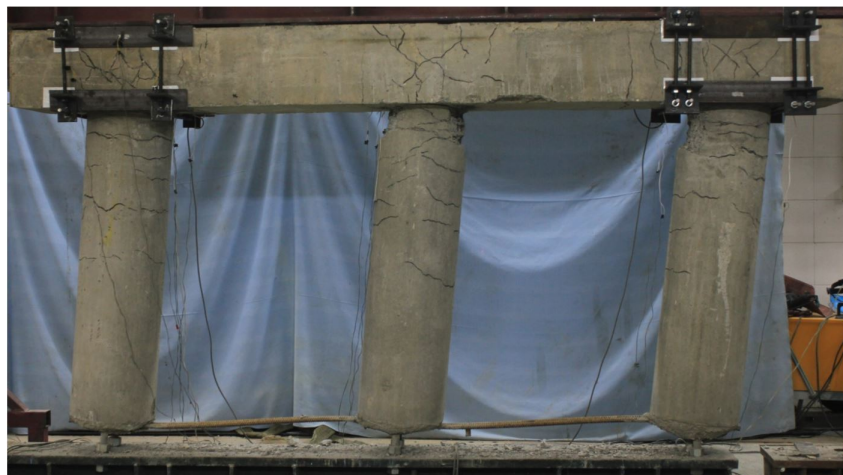
Figure 13: Damage modes of specimen B, Fracture of the longitudinal bars of the middle column, complete failure of plastic hinge, bar slippage of the longitudinal bars of the external columns and failure in cap beam of the left connection at relative displacement of 5.6.

Concrete spalling for specimen B occurred at the middle column in relative deformation of about 3 and at the top of the left column and right column in relative displacement of 4. In addition, concrete spalling was observed in the left column at relative deformation of 5.6. This concrete spalling in different relative deformations for the three columns of specimen B increased the slope of the strength degradation from the relative deformation of 4, as is seen in Fig. 11b. In specimen B, the bar slippage occurred after the concrete spalling, and decrease of bond slip and after the degradation strength of 5%. In addition, in the same strength degradation, significant damage was observed in the right column of specimen B and cracking progressed to the concrete core. Overall, the retrofitted specimen (specimen B) showed better behavior compared to the specimen A and the plastic hinge formed well at the middle connection, which is seen in Fig. 13. Moreover, in the right and left connections of the specimen B, where the steel angle with different transverse stress was used, the behavior slightly improved.

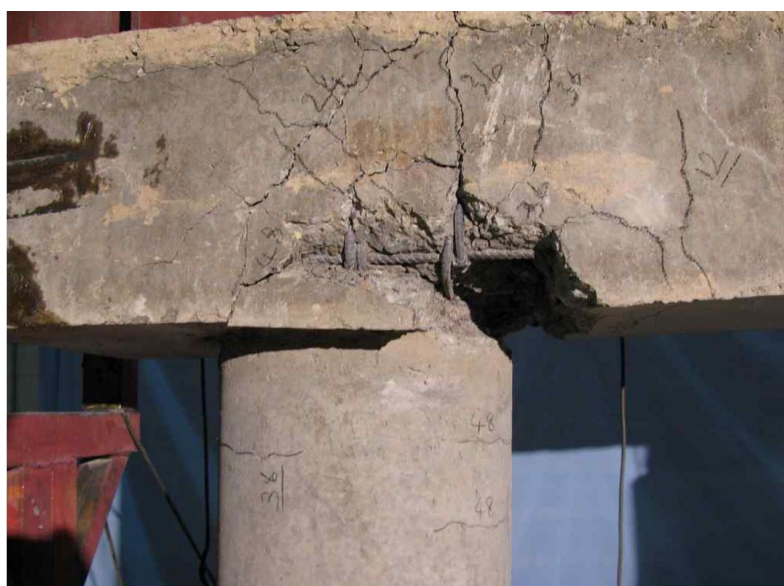
Figure 14: Spalling of the external column cap beam at relative displacement of 5.3.

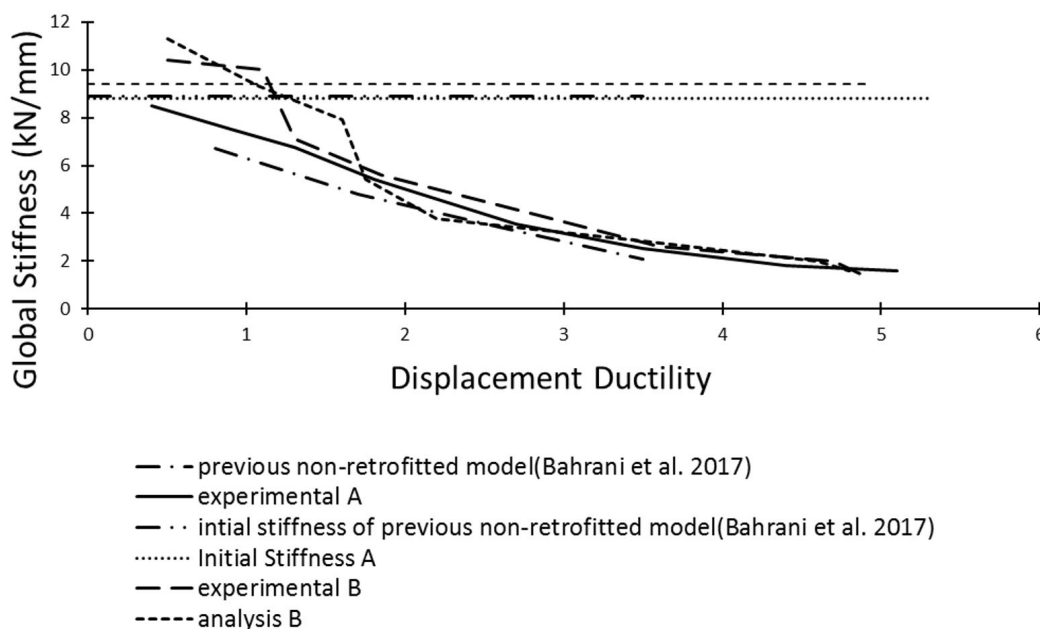
Figure 15: Specimen stiffness to the relative displacement.

The lateral and initial stiffness of the specimens with maximum ductility are shown in Fig. 15. As is seen in Fig. 15, the initial stiffness is calculated somewhat more than the actual value due to the lack of consideration of the pre-loading cracks. Due to the presence of steel angles on both sides of the connection regions of the specimen B, the stiffness for this specimen is higher than that of specimen A. Moreover, the stiffness of the specimen B in the last cycle remains almost constant that indicates that the concrete frame is failed in the last cycle. The lateral stiffness during loading for specimen A, especially in the final cycles, is also greater than the previous non-retrofitted specimen (Bahrani et al., 2017). The numerical model was also able to provide a good approximation of the stiffness of each specimen and the results are presented beside the experimental results.

The sudden drop of curves in figure 15, showing the degradation of stiffness, is due to the use of rubber neoprene bearings between the steel crossbeam and the top of cap beam. The rubber deformation related to cross beam internal deflection was enough large thus the rubber bearing axial loads were approximately the same.

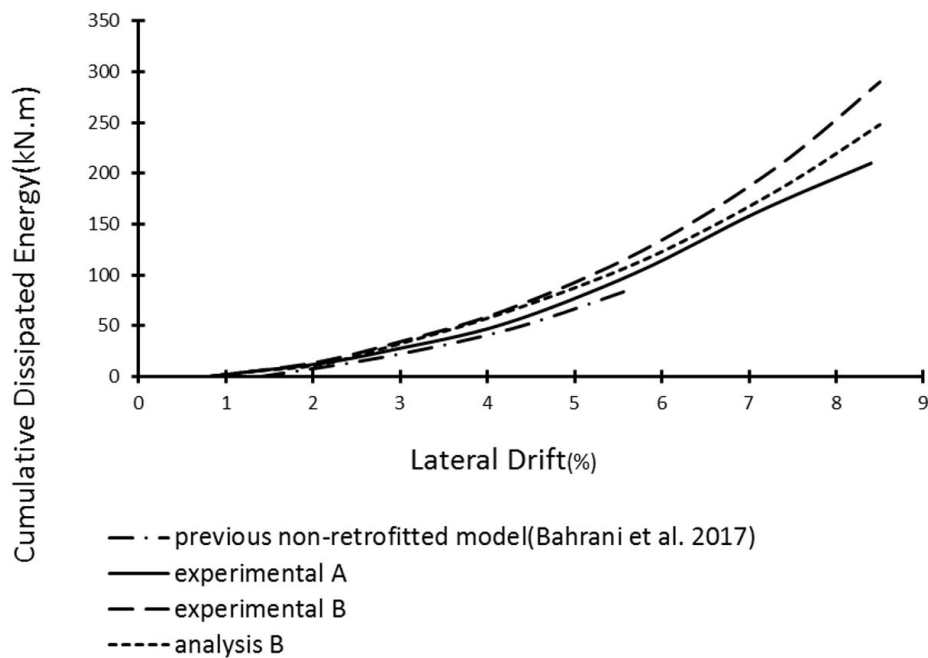
Figure 16: Energy dissipation.

Fig. 16 shows energy absorption for the specified cycles, increase, and decrease in the energy absorption capacity. Specimen A had modest energy absorption due to defects in design details and the lack of formation of complete plastic hinge; whereas, specimen B had the best energy absorption. Increasing the energy absorption capacity of specimen B improved compared to specimen A, especially in the last cycles. Due to the success in improving the non-linear behavior of the specimen B, the behavior of the frame changed and its energy absorption increased. The numerical results for specimen B also shows this absorbed energy, so one can conclude that in the 1990s codes, the energy absorption has significantly improved. This improvement was about 140% and 233% for specimen A and B, respectively, compared to the specimens of previous similar studies used for 1980s codes. In terms of the cumulative

energy absorption, the values were 290 kN.m and 210 kN.m for specimen A and B, respectively, which shows retrofitting leading to a growth of about 38% in energy absorption.
