# Evaluation of pyrite and pyrrhotite in concretes

### Abstract

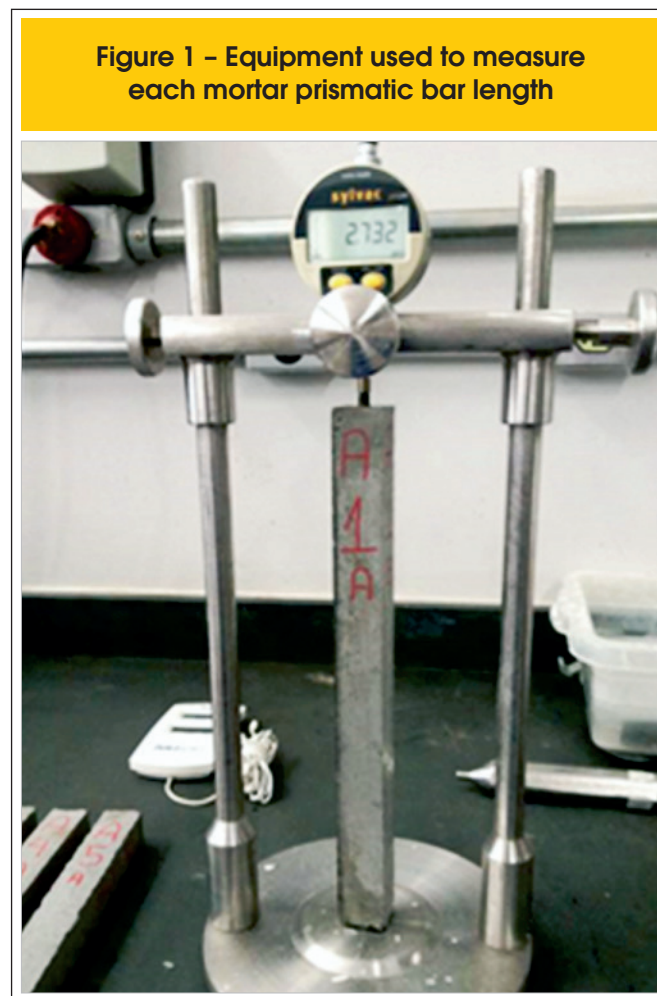
The prismatic cast bars were used in the mortars' expansion evaluation over time. Each bar initial length (L<sub>0</sub>) was determined 24 hours after casting using the equipment shown in Figure 1. After this initial length measurement, the bars were then subjected to

three different exposed conditions. Mortar bar lengths were measured weekly from which the corresponding strains were calculated. The corresponding strain at each age was determined according to the following equation:

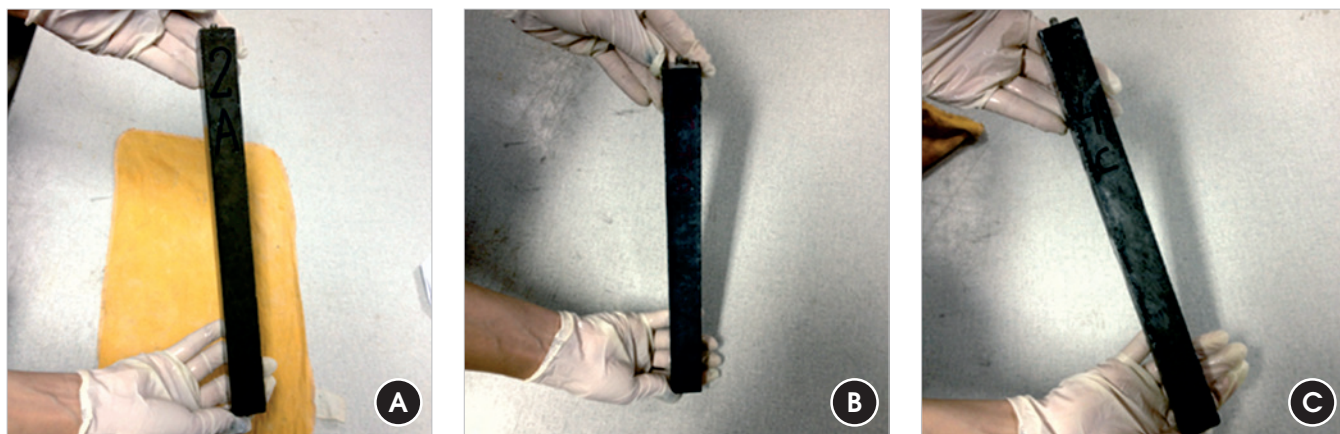
**Figure 5 – Prismatic bars used in the expansion evaluation (a) placed in curing room after 327 days – (b) placed in the Ca(OH)<sub>2</sub> solution kept at room temperature after 320 days (c) placed in the Ca(OH)<sub>2</sub> solution kept at 50°C after 313 days**

measured strains did not exceed the E 251 [20] limiting value of 0.05 % in any case and that no apparent mortar deterioration was found (Figure 5).
