# Fretting Fatigue In-service Failure of X20CrMo13 Stainless Steel Turbine Blade

To identify the probable causes that led to premature failure of the X20CrMo13 steel turbine blade of a 25 MW cogeneration power plant, techniques of chemical analysis by optical emission spectroscopy, infrared absorption

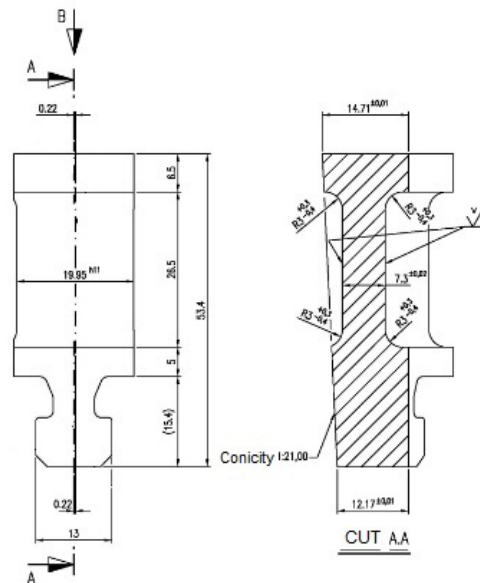
Figure 2. Geometry and dimensions(mm) of the turbine blade.

The turbine of a 25 MW cogeneration power plant operates according to the parameters shown in Table 1. The blade geometry and dimensions analyzed in this work is shown in Figure 2.
