Surface Contact Fatigue Failure of a Case Hardened Pinion Shaft

An investigation was made to determine the causes of surface contact fatigue failure of a case hardened driver pinion located in the intermediate shaft of a reducer gearbox used in a sugar and alcohol mill. The examination of the component revealed the presence of a cemented layer substantially thicker than that generally specified for pinions devised for this application. This, associated with the massive presence of brittle threadlike carbon-rich cementite phase (Fe_3C) in prior austenite grain boundaries of the pinion teeth, favored surface crack nucleation and propagation during cyclic loading, leading to spallation of the contact surface with the counterpart gear, which impaired the system's operation. Poor carburization practice was discovered as the root cause of the mechanical failure, thus demanding the implementation of a new manufacturing route to avoid problems in similar load-bearing rotating components.

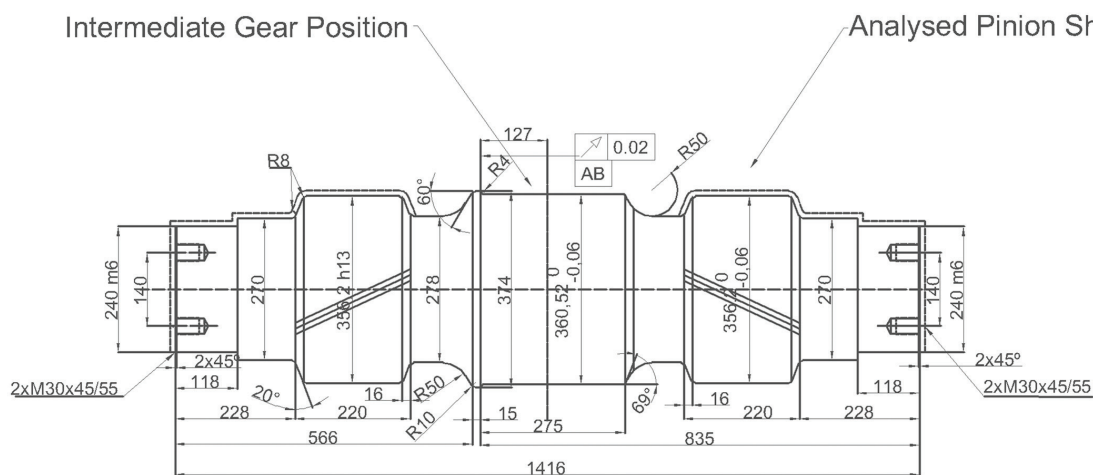
Figure 1. Draft of the intermediate reducer shaft, where the fractured pinion shaft is indicated by an arrow. The location of the corresponding idler (intermediate) gear is also arrowed.

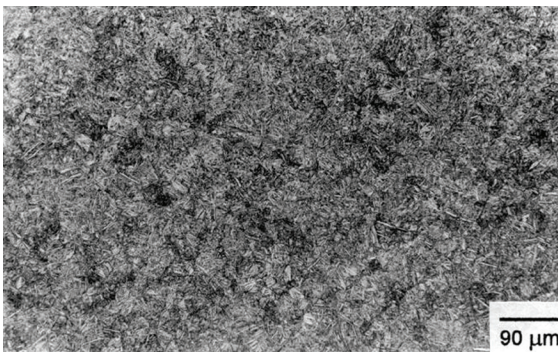
Figure 6 shows the typical microstructure of a pinion tooth core after Q&T heat treatment, which appears to be homogeneous and to consist mainly of tempered martensite, a highly desirable microconstituent for the mechanical application of the alloy steel in question.

Figure 6. Typical microstructure of the pinion tooth core. Etched with Nital 2%.
