Failure of Stainless Steel Welds Due to Microstructural Damage Prevented by In Situ Metallography

Abstract: In stainless steels, microstructural damage is caused by precipitation of chromium carbides or sigma phase. These microconstituents are detrimental in stainless steel welds because they lead to weld decay. Nevertheless, they are prone to appear in the heat affected zone (HAZ) microstructure of stainless steel welds. This is particularly important for repairs of industrial components made of austenitic stainless steel. Non-destructive metallography can be applied in welding repairs of AISI 304 stainless steel components where it is difficult to ensure that no detrimental phase is present in the HAZ microstructure. The need of microstructural inspection in repairs of AISI 304 is caused because it is not possible to manufacture coupons for destructive metallography, with which the microstructure can be analyzed. In this work, it is proposed to apply in situ metallography as non-destructive testing in order to identify microstructural damage in the microstructure of AISI 304 stainless steel welds. The results of this study showed that the external surface micrographs of the weld

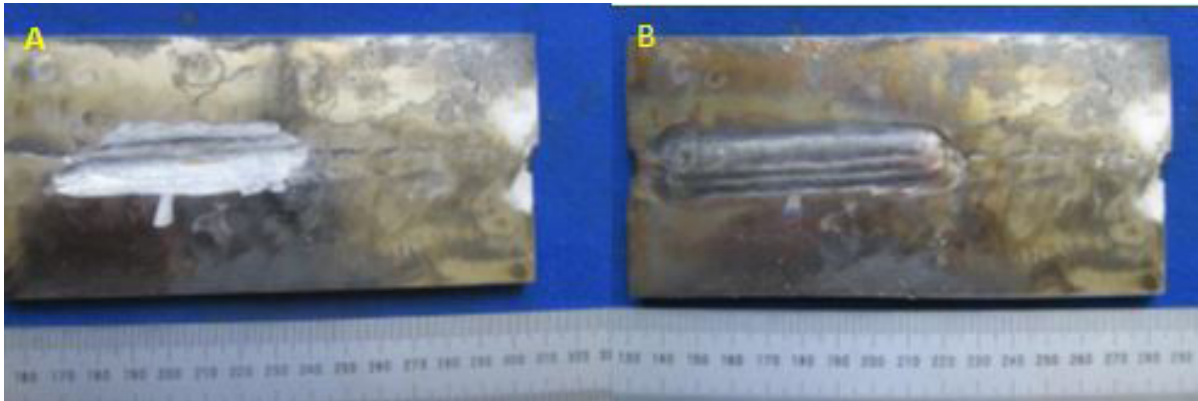
Figure 7. A - Example of the specimens after mechanical grinding in the weld metal. B - Example of the repaired areas of the specimen through manual GTAW.

The welding repairs were carried out selecting the area of interest and then this area of the welded specimen was grinded by abrasive silicon carbide disc. After that, they were grinded for repairing in the locations that the nondestructive testing showed evidence of indication. The specimens were welded through manual GTAW process. One example of the repairs is shown in Figure 7. The welding conditions were: ER 309L electrode with a wire diameter $\phi = 1/32$ as filler metal, a Syncrowave 350Lx Miller welding machine; and welding current around 70A.
