Judgement in geotechnical engineering practice

José António Mateus de Brito^{1#}

Lecture

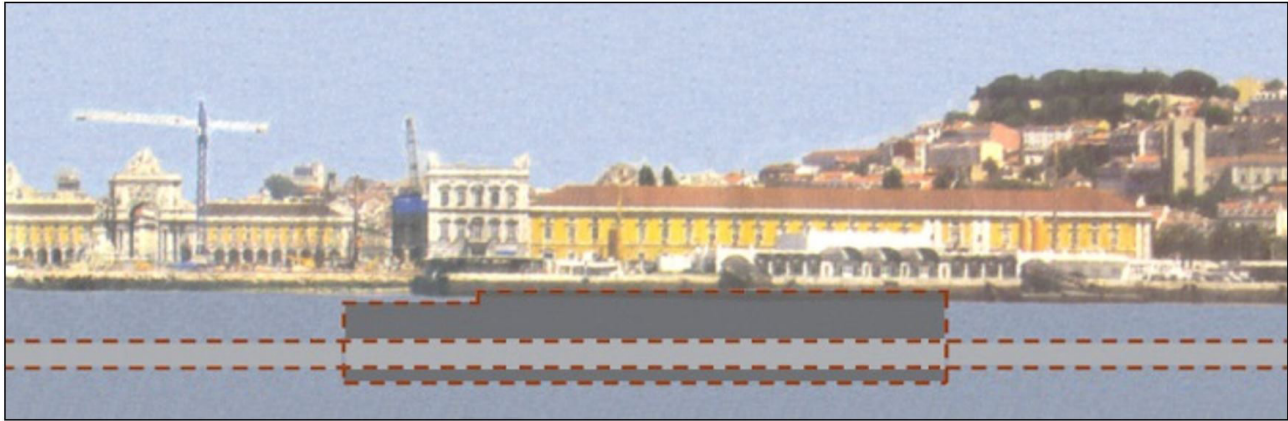
Figure 4. View of the eastern area of Terreiro do Paço square and the Finance Ministry building, with the location of the tunnel and the station (Brito & Fernandes, 2006a).

The metro tunnel was previously executed with a tunnel boring machine (TBM) between 1997 and 1999. At the site, the tunnel axis is located at an average depth of 19 m (-16.00 m elevation), all its section excavated in the smooth alluvial deposits of the Tagus River, where thickness reaches about 26 m in the station area (Figure 4).

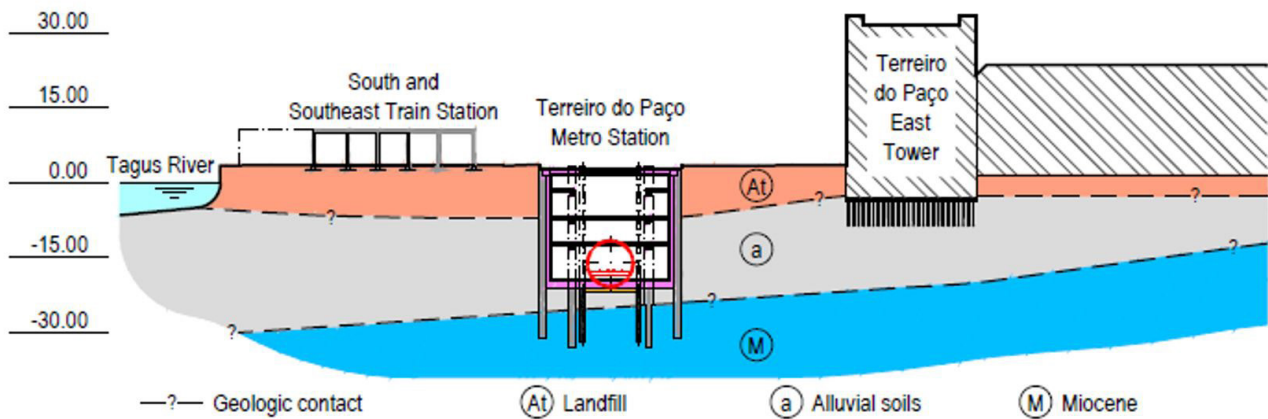
Figure 5. Schematic section across the Tagus River, the station and the east tower of Finance Ministry (Brito & Fernandes, 2006a).

Figure 5 includes a simplified geological transversal section to the station axis. The substratum is composed of Miocene formations, covered by soft alluvial deposits and fills. The surface of the substrate descends progressively towards the river with a slight inclination towards S-SW.

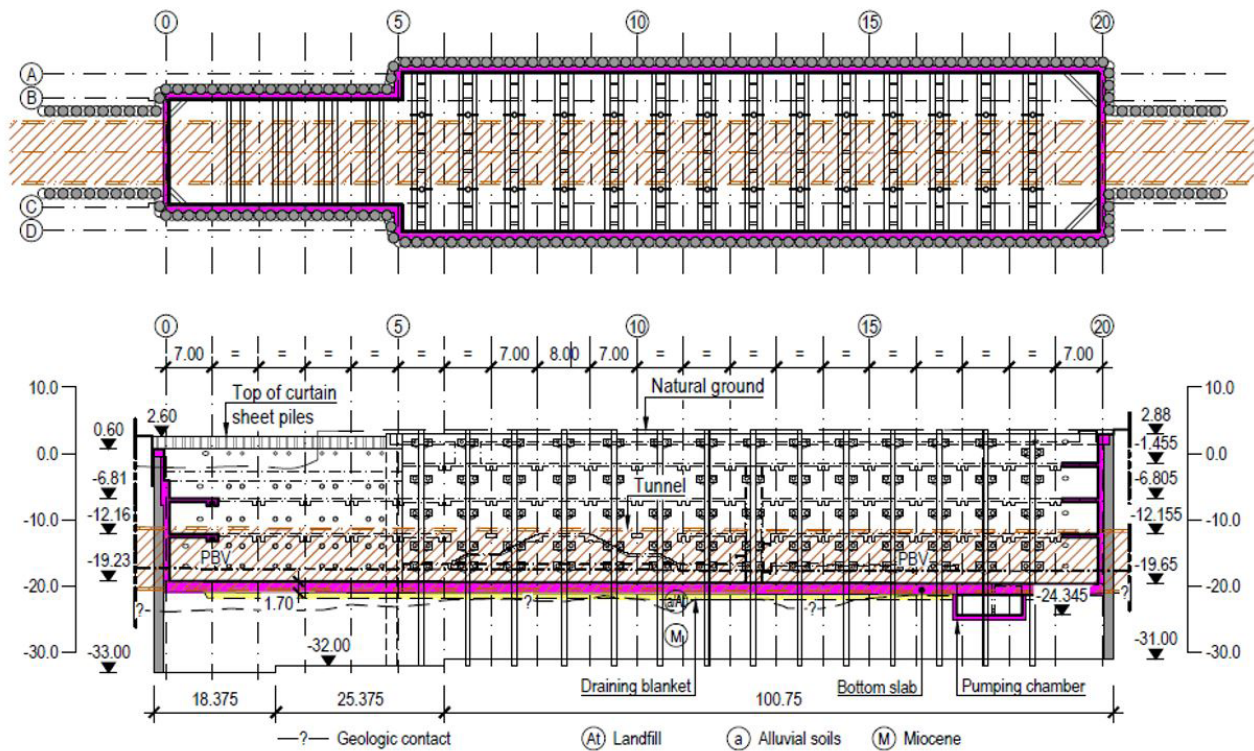
Figure 11. Plan and northern elevation of the peripheral curtain of secant piles and the shoring system (Brito & Fernandes, 2006a).

The base of the curtain was between the elevations -31.00 m (north and east) and -33.00 m (south and west) and the maximum depth of the excavation was of 25 m (Figure 11).

5, and the second on June 2, at the re-entrant corner of the south side coinciding with the axis 20 (Figure 11).

As shown in Figures 19a and b, the solution consisted of surrounding the tunnel sections adjacent to the station with a mass of soil treated with jet grouting which would have to fulfil two essential conditions: be practically impermeable and also be resistant to water and soil pressures on its outer face. In order to meet these conditions, it was essential, on one hand, to ensure good penetration of the jet grouting mass into the Miocene substrate and, on the other hand, to make a good connection between itself, the tunnel lining and the station structure. To achieve this last requirement, the peripheral pile wall of the station was extended about 16 m beyond the plane of the portals, in order to confine the tunnel and the jet grouting, as can be seen in Figure 11.

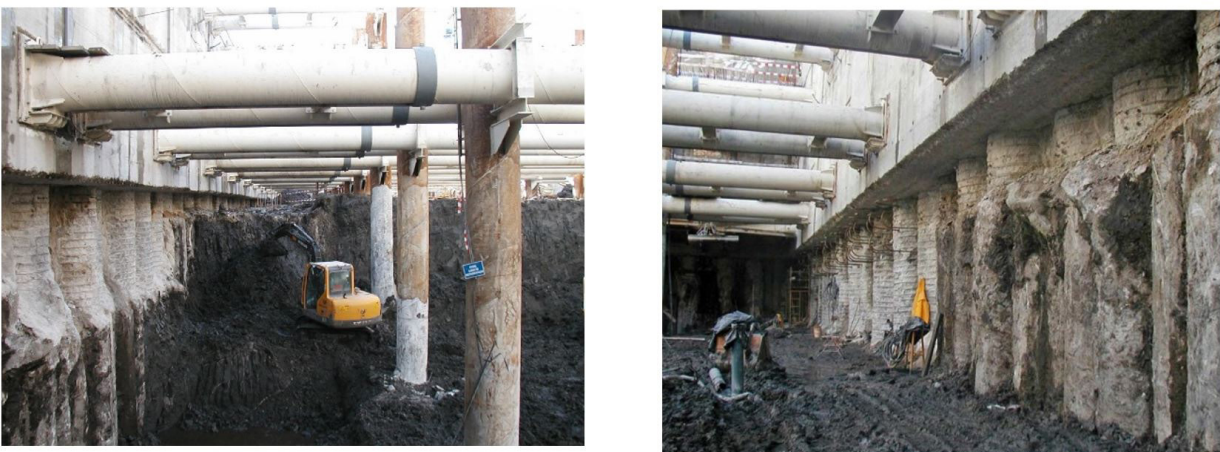
Figure 16. Excavation phase below the 3rd struts level on the south and north walls (Brito & Fernandes, 2006a).

Figure 16 shows the south and north walls of the station in the excavation phase below the 3rd strut level.

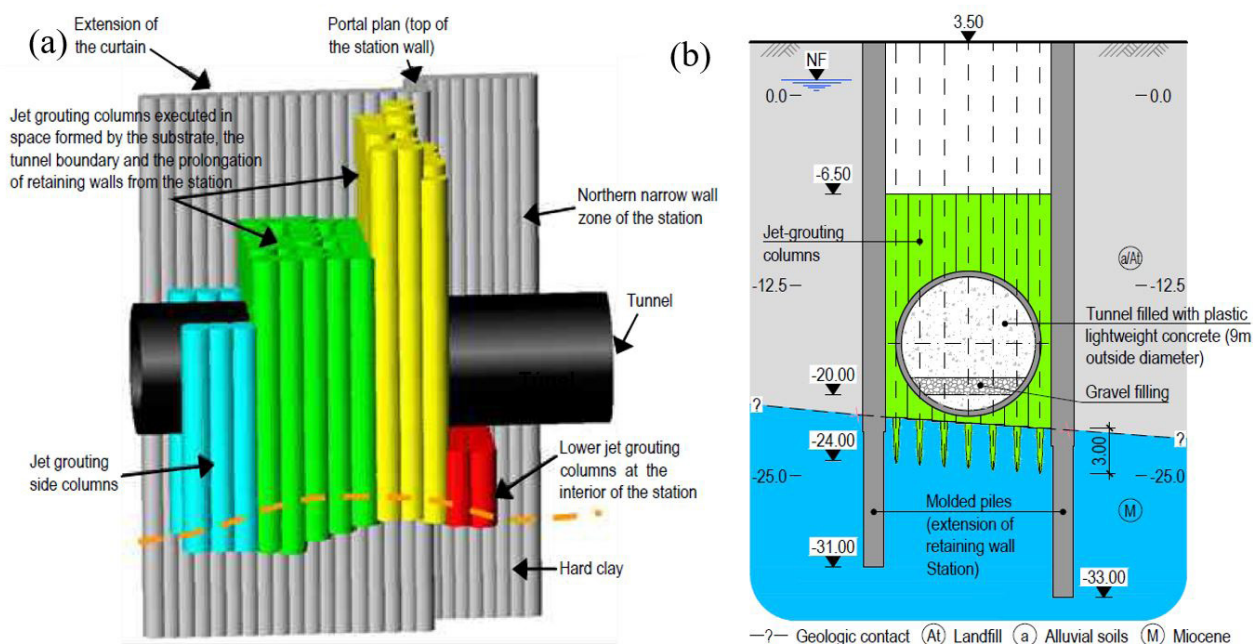
Figure 19. (a) 3D view of the jet grouting treatment on the west portal; (b) Cross section of the west portal plane, showing the area treated with jet grouting (Brito & Fernandes, 2006a).

Only vertical jet grouting columns were decided to be used, which meant, for the columns under the tunnel, that the lining of the tunnel would be crossed by drilling at two points, as shown in Figure 19b). This option was taken on

the basis that the tunnel at these locations was filled with concrete and that there was no immediate adverse effect of these holes on the internal stability of the tunnel. In any case, an attempt has been made to minimise the number of holes so as not to weaken the concrete lining, in order to ensure the stability conditions of the tunnel in the phase of the concrete filling removal. For this purpose, large diameter jet grouting columns ($\varnothing > 2.0$ m) were used, executed with triple jet method (Candeias et al., 2005, Matos Fernandes et al., 2007).

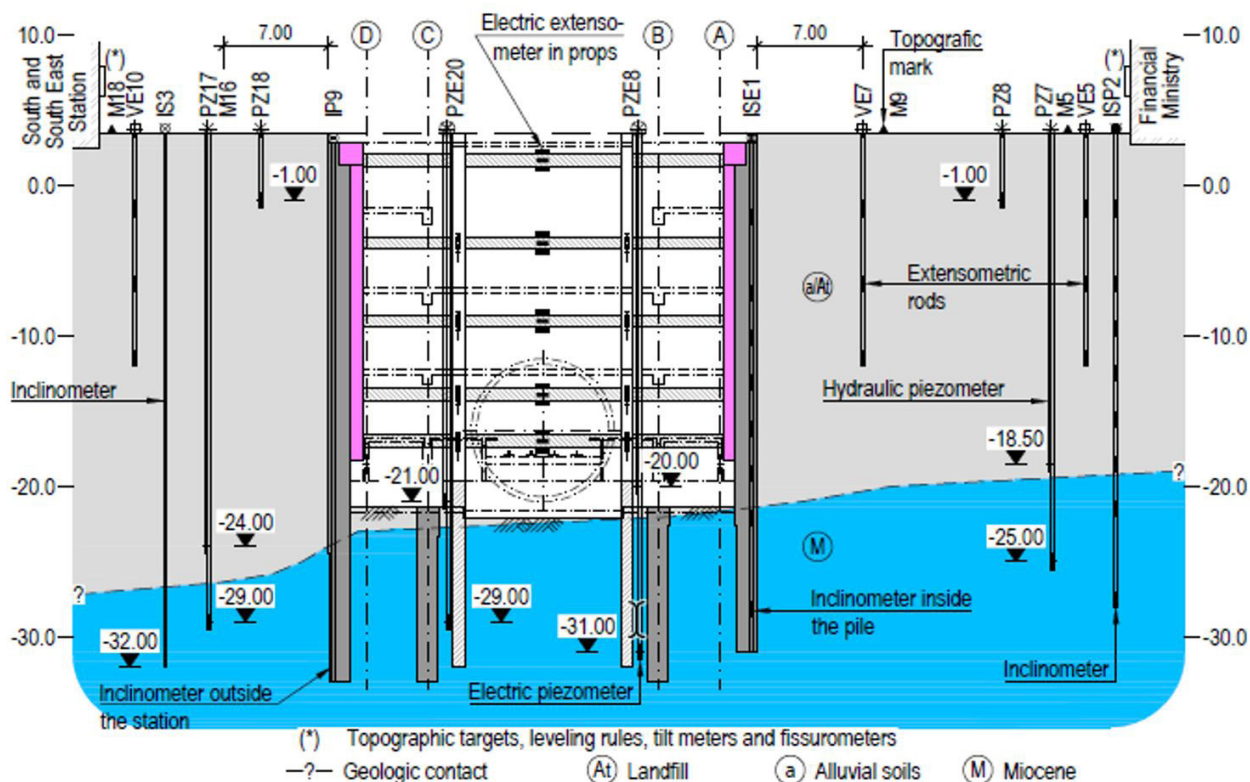
Figure 20. Typical cross-section of observation devices (Brito & Fernandes, 2006a).

The construction was monitored throughout the construction period by a very complete system of observation devices, whose transversal profile is shown in Figure 20. This system proved to be extremely useful in the critical phases of the station execution and in the sequence of incidents that occurred and in the subsequent outside treatment of the curtain.
