Analysis of strengthening procedures of reinforced concrete highway bridges: a brazilian case study

D. M. CARVALHO ^a

J. M. F. CALIXTO ^a

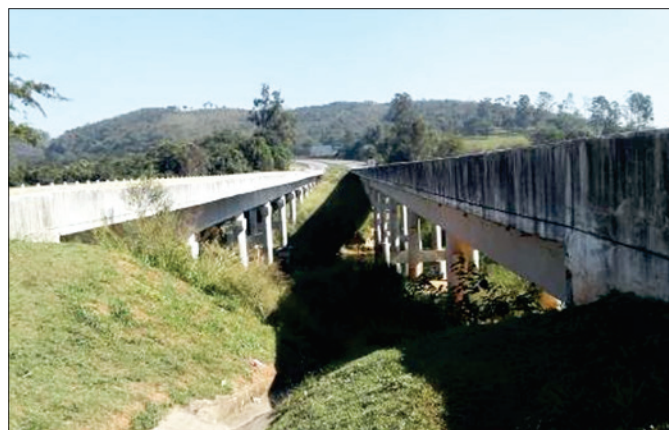
Figure 1

Overview of the evaluated bridges. To the left is the rehabilitated bridge and to the right the new bridge

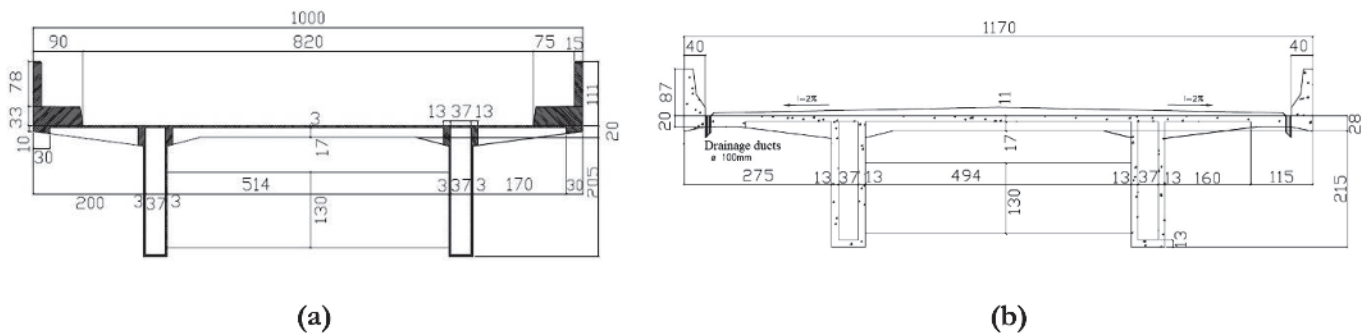
Figure 3
Details of the strengthening procedure. (a) Demolition parts, (b) Formwork and concrete replacement (dimensions are in centimeters)

The method used for increasing the bridge width consisted of extending the existing slabs at both sides without the addition of new supports and new beams; conventional reinforced concrete was employed. The strengthening of the superstructure was based on the increase of the cross section of the structural elements with addition of new reinforcement (increase in the dimensions of the main beams and addition of new overlay on the slab). Details of these procedures are shown schematically in Figure 3.

The initially design plan included the demolition of the guardrails, of wheel guards and of 30 cm at the ends of the slabs on the sides of the bridge. In addition a 3 cm concrete layer was removed from top surface of the slab and from the faces of the two main beams, aiming to prepare these surfaces for the new repairing concrete. Then, a new 11 cm top slab was cast, along with the new slab with a width of 1.15 m on each side of the bridge (30 cm demolished + 85 cm for the widening). New Jersey barriers and a new 13 cm concrete layer on the faces of the main beams were also cast. The concrete characteristic compressive strength was equal to 30 MPa. Drainage ducts with a diameter of 100 mm were installed on both sides of the bridge.

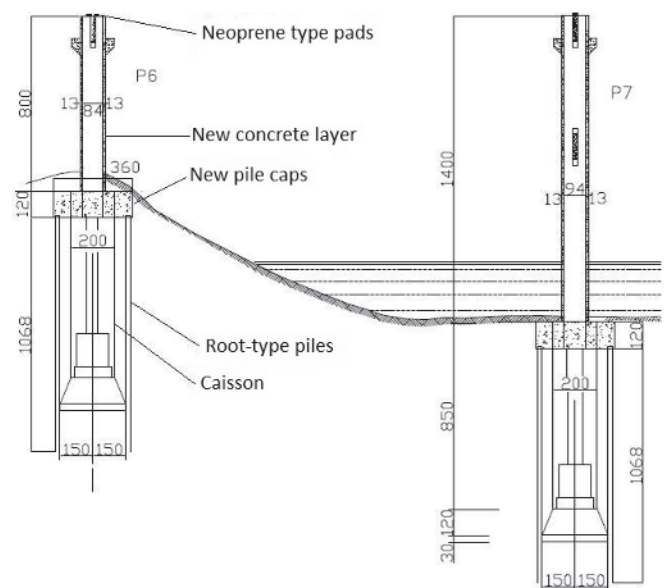
Figure 4
Details of the strengthening of the foundations (dimensions are in centimeters)

tic compressive strength was equal to 25 MPa. Corbels were also built at the tops of the columns with the objective of supporting the hydraulic jacks that were used for the replacement of the support devices. Mobile 39 mm thick neoprene type pads were installed in all supports: their horizontal dimensions were 35 x 45 cm on the columns at the ends of the bridge and of 45 x 60 cm on the others. Twenty-two new pile caps around each column were built as shown in Figure 4. The concrete characteristic compressive strength was equal to 25 MPa. A deep foundation system consisted of four root-type piles (200 mm diameter) for each pile cap.
