# Fracture Process Characterization of Fiber-Reinforced Dental Composites Evaluated by Optical Coherence Tomography, SEM and Optical Microscopy

This study used optical coherence tomography (OCT) compared to scanning electron microscopy (SEM) and optical microscopy (OM) to evaluate qualitatively crack propagation and final fracture in restorative composite materials - Filtek Z250 and Filtek Z350 (3M ESPE) - with fiber reinforcement after cyclic loading. Samples were made using a split mold. Initially, 3-point bending tests were performed to determine the maximum force and tension at the fracture moment using samples without fiber reinforcement. Then, mechanical cycling tests were performed using samples with glass fiber embedded internally. The failures were analyzed using the 3 methods described before. OCT permitted good characterization of internal crack propagation of the dental composites, which, however, could not be visualized by either SEM or OM. OCT was proven to be laboratory research tool that is easy to use, does not require any specific preparation of the samples, and is less expensive than SEM.

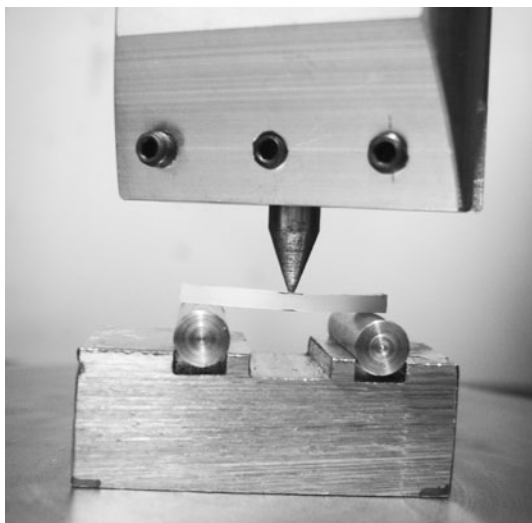
Figure 1. Test platform.

It was made of machined stainless steel and aluminum, and comprised a knife that conveyed the tension to the specimen and a base with 2 supports, in which the distance from center to center was 20 mm (Fig. 1).

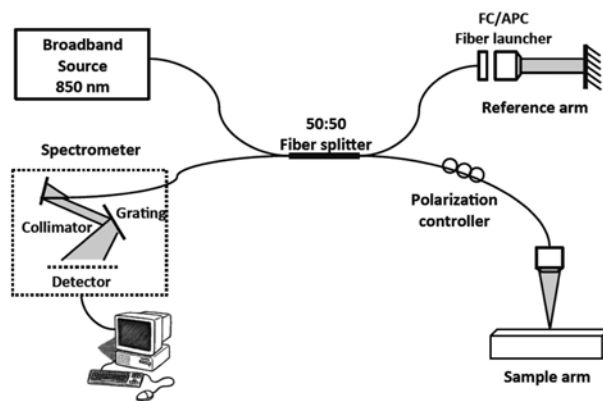
Figure 2. Schematic setup of SD-OCT 840 nm.

The experimental OCT setup was similar to the one used before (7) in the spectral domain (SD-OCT). The SD-OCT setup (Fig. 2) uses a broadband light source (Superluminescent Diode; Broadband SLD Lightsource S840; Superlum, Moscow, Russia) operating at 840

nm, spectral width of 50 nm, fiber output power of 25 mW and a measured spatial resolution of 10  $\mu\text{m}$ . The system is based on the Michelson interferometer setup: in the reference arm, there is a mirror mounted on a piezoelectric base; in the sample arm, a mirror controlled by a Galvo motor is required for the scanning of light at the sample. Light from the source is first split by a beam splitter and travels down the reference and sample arms. The reflected and backscattered light coming from both arms are then recombined at the beam splitter and collected by a spectrometer, consisting of a lens collimator system, a diffraction grating (1200 L/mm), and an optical detector (linear CCD cam, ATMEL, 2048 pixels, 12 bits; Atmel, San Jose, CA, USA), connected to a computer. The system is controlled by the software OCT 800 - Complex Square, developed from LabView program language, which collects data and generates the image. The image acquisition time is less than 1 s.

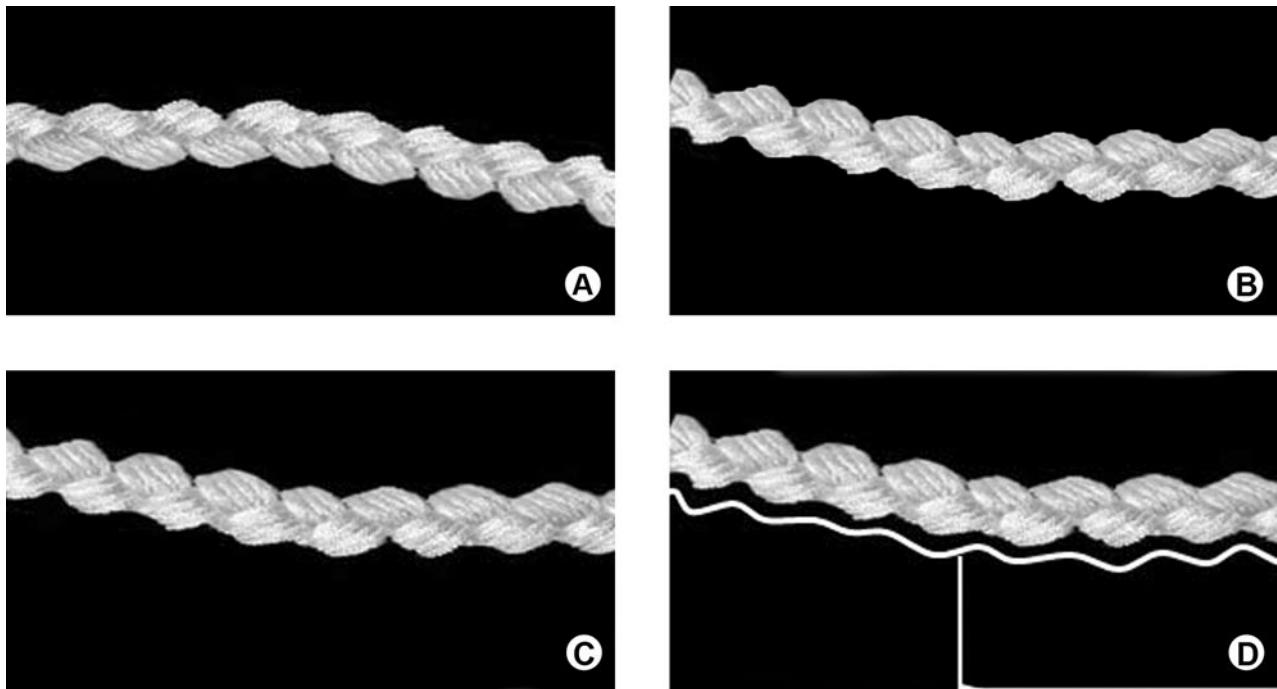
Figure 3. Diagram of the imaging process before cycling test with the fiber inserted (A); during cycling test (B); with the crack propagation (C); and with the extension of crack on the horizontal and vertical directions showing the whole fracture process (D).

A diagram was constructed to illustrate how the mechanical cycling test occurs and the process of crack formation and propagation (Fig. 3). In this diagram, it is indicated the deformation occurred in the dental composite and fiber in the direction of the force. The failure may begin at the interface fiber-composite and spread toward the lower surface of the sample, or may originate in the bottom portion and going in the force opposite direction. In the last situation, crack hits the fiber and surrounds the fiber-composite interface.

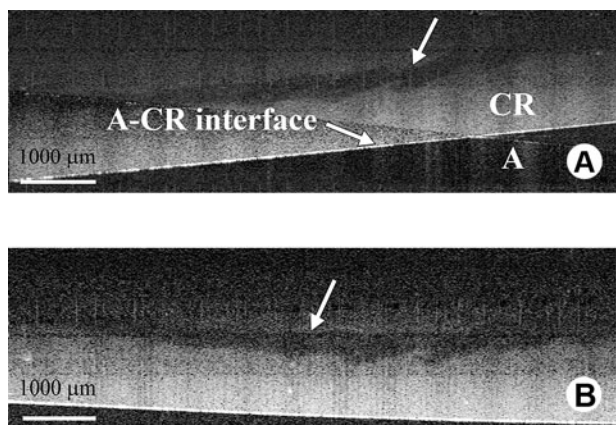
Figure 4. Z250 sample (OCT images). The arrows indicates the region of the fiber insertion featured as a black shadow. A = sample before mechanical cycling test (A: air; A-CR: air-composite resin; CR: composite resin); B = after test without crack propagation.

Figures 4, 5 and 6 present representative examples of OCT images. Figure 4A shows in the internal region the glass fiber found with the braided aspect and a darker color representing the fiber structure. In Figure 4B,

after mechanical cycling, it is possible to see the same structure without crack propagation, the fiber structure remained without deformation. From bottom to top, in all OCT images, the black region corresponds to the air, the strong white line corresponds to the air-composite interface and the scattering due to the porous composite is seen as the whitish uniform small spots.

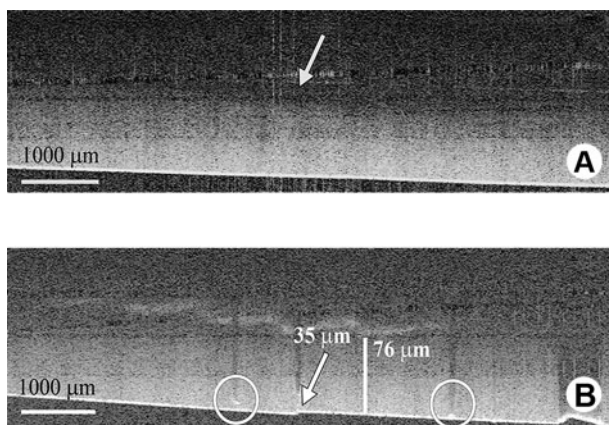
Figure 5. Z350 sample (OCT images). A = before mechanical cycling test; B = after test showing vertical and horizontal crack propagation. Circles show regions of small microcracks, which probably obliterated the light passage producing these shadows.

Figure 5A represents the image of the bottom portion of the Z350 composite sample before mechanical cycling. These samples had their test interrupted with 60 cycles because crack propagation was macroscopically observed. The maximum force in which the test has been realized was 50.9 N. It is possible to verify a suggestive image of glass fiber in the internal region, as a darker color indicated by arrow. After mechanical cycling, images were performed in the same region of the sample and it was detected some structures that seems regions of small microcracks, which probably obliterated the transmission of the light producing these apical shadows under them, indicated by the circles (Fig. 5B). At the bottom portion and on the right hand side of the image, it can be seen a surface defect, probably formed during the production of the sample. In this image, crack propagation in the horizontal direction can be seen surrounding the glass fiber and, in the vertical direction, it appears from the air-composite line perpendicular to the long axis of the sample to the glass fiber. The crack can be identified on the bottom surface through the discontinuity of surface (air-composite line). Using the software Image J (version 1.32j) the distance

between the edges of the crack was measured to be 35  $\mu\text{m}$ . The appearance seen in the image in relation to the horizontal crack has an ondulatory form since the fiber has the braided shape, and the distance between the air-composite interface and the glass fiber structure is the 76  $\mu\text{m}$ .

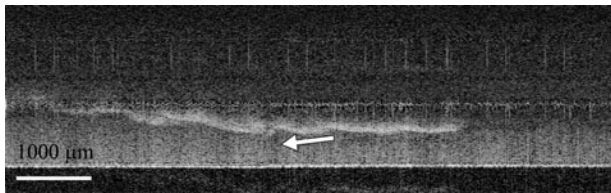
Figure 6. Z350 sample (OCT image) after sanding, showing the crack propagation on the horizontal direction and vertical direction, as indicated by the arrow.

The bottom portion of the Z350 sample was sanded in order to verify more accurately the horizontal crack propagation. Horizontal crack became more evident because the wavy aspect represents the surface of the glass fiber, localized perpendicular to vertical crack (Fig. 6).

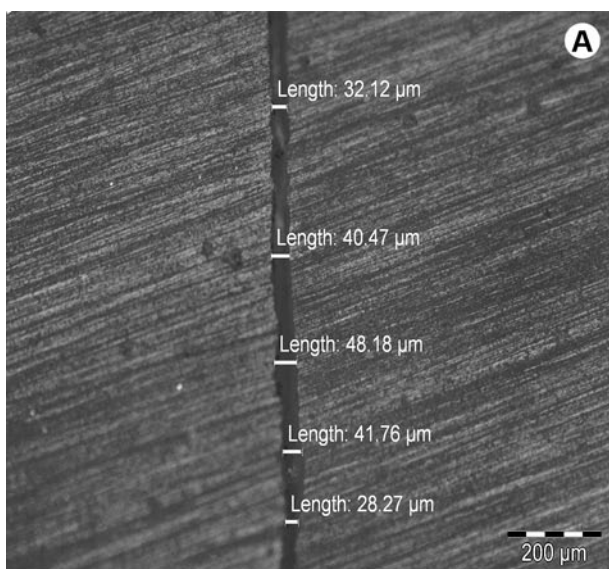
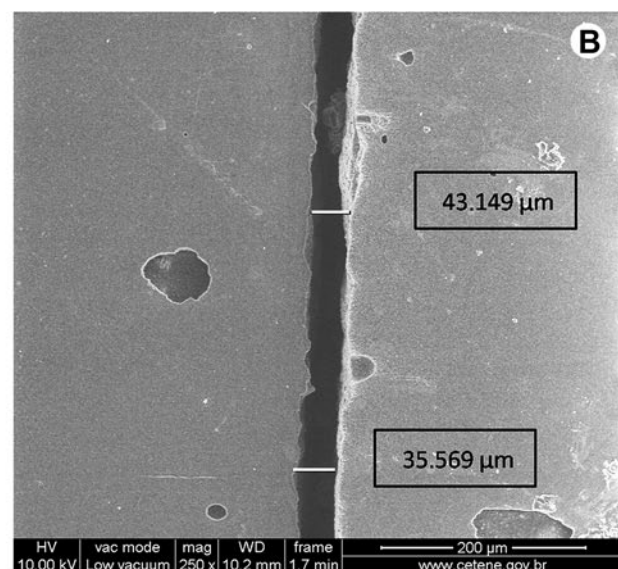
Figure 7. Distance between the edges of the failure in a Z350 sample, as seen by OM (A) and SEM (B).

Some samples were imaged under SEM and OM to analyze the external propagation of cracks. OM images of Z350 sample in Figure 7 show the minimum individual width value at 28.27  $\mu\text{m}$  and the maximum at 48.18  $\mu\text{m}$ . The SEM measurements corresponded to the values obtained by optical microscope: to Z350 sample, the minimal individual value for the width was 35.57  $\mu\text{m}$  and the maximum, 43.15  $\mu\text{m}$ . This means that the superficial failure found in the Z350 sample has the same measurement in both techniques, optical microscopy and SEM.
