# Characterization of Fly Ash and a Protective Coating for Brazilian Thermal Power Plant Boilers

Thermoelectric power plants that use mineral coal show high wear in heat exchanger due to the action of several damage mechanisms associated with the impact of hard particles from the residue of burnt coal, the ashes. The employment of coatings should be given into consideration particularly for critical components, which are subject to severe erosive conditions is one of the solutions. However, the choice of material will depend on several factors, including the properties of aggressive ashes. This paper aims to characterize ashes generated by a Brazilian coal-based power plant and a FeCrNbNi-based metallic coating obtained by the electric arc spraying process. No trace of sulfur content was found in fly ashes and it was defined that wear is mainly related to the impact and energy of hard particles are the leading causes of degradation in coal-fired boiler equipment. According to the assessment, applied coating showed  $(5 \pm 2)\%$  by volume of pores and cracks, with 1.6% of oxides after the spraying process and hardness 35% greater than ash particles. Preliminary results in field o

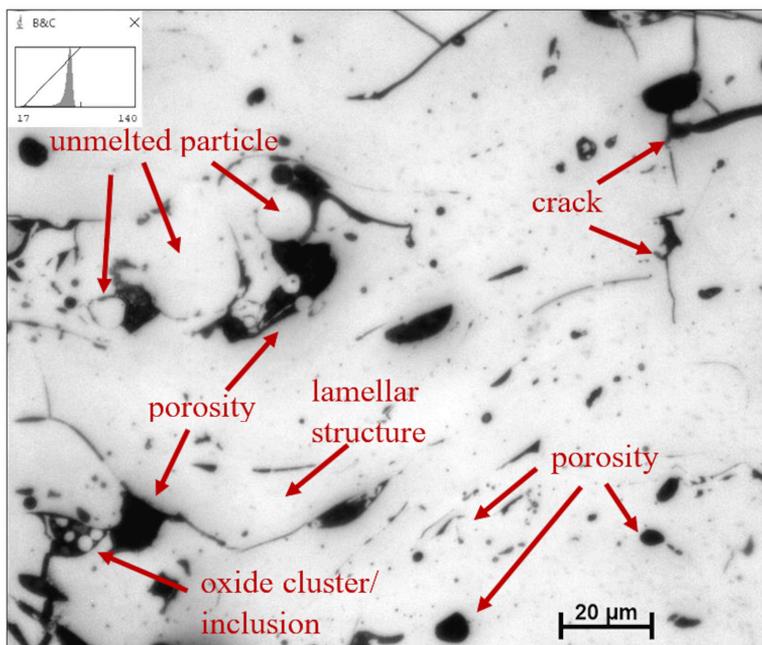
**Figure 1.** Coating cross-section. The dark tonal regions are pores and cracks. Unmelted particles were also observed.

Figure 1 exemplifies one of images used and its respective histogram (left and above) generated for quantification process. In the image, the principal elements and defects of coatings obtained by arc thermal spraying were also identified: lamellar structure generated by deposition of molten and solidified droplets on the substrate surface, unmelted particles, pores, and cracks<sup>36,37</sup>.

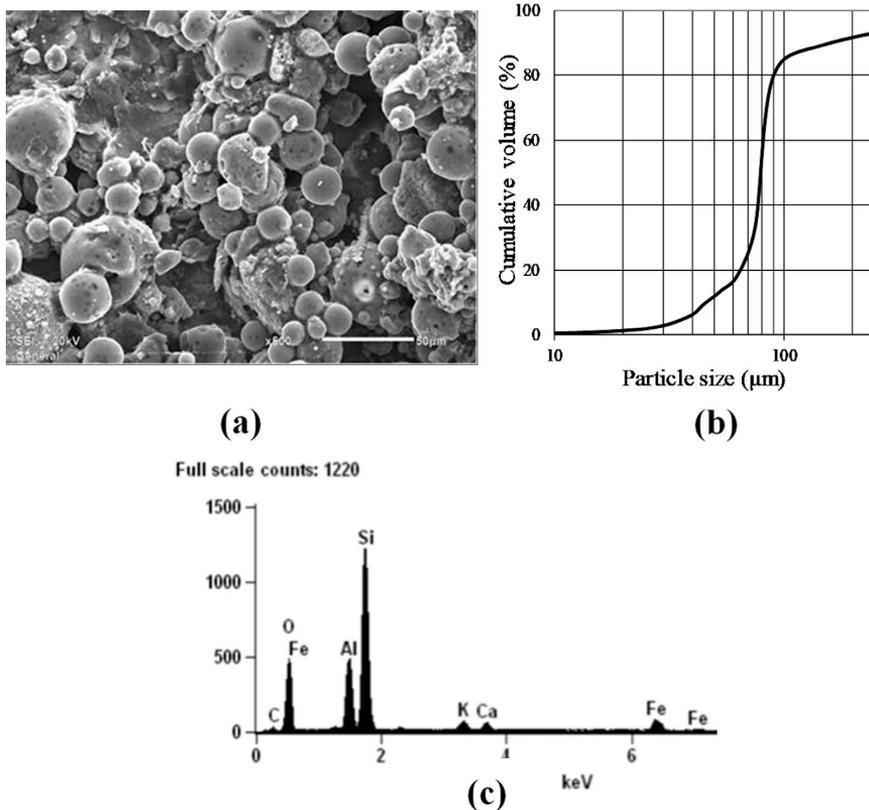
**Figure 2.** (a) SEM morphology of fly ashes particles; (b) Particle size distribution of Brazilian fly ash; (c) EDS spectrum of coal fly ash studied.

The ashes were predominantly massive and spherical, a few hollow or irregularly shaped (Figure 2a), in accordance with other studies<sup>38</sup>. The diameters calculated by DIA varied between 5 and 45  $\mu\text{m}$  (68% of analyzed particles). The granulometric distribution obtained by sieving (Figure 2b) revealed that 60% of the material was made up of particles between 60 and 90  $\mu\text{m}$  in diameter. Thus, the result obtained by DIA showed only finer particles of material.

EDS's semi-quantitative elemental results revealed the presence of silicon, iron, aluminum, potassium, and calcium (Figure 2 c). The results of quantitative chemical analysis are in agreement, as they showed the presence essentially of silicon, iron, and aluminum, according to Table 2. In all analyses, not even traces of sulfur were found; this is considered to be strongly responsible for hot corrosion processes in steam boilers<sup>6,39</sup>. Fuels used contain impurities and often tend to form ash deposits. In particular, vanadium, sulfur, and alkali metals cause corrosion when the metal surface temperature is 580–650  $^{\circ}\text{C}$ <sup>6,40</sup>. The presence of iron can be associated with a probable oxidation of pyrite and/or related to the segregation of minerals containing this element during a probable pre-treatment of coal.

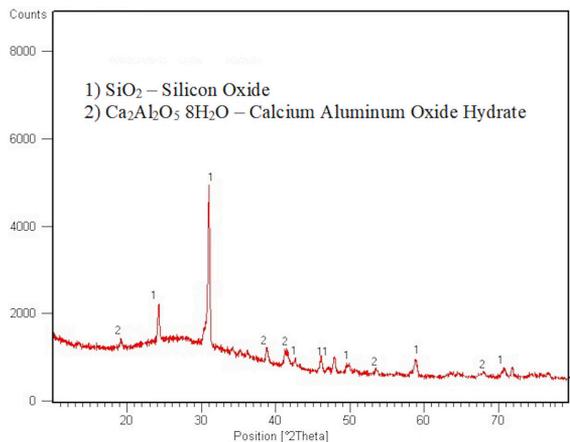
**Figure 3.** XRD patterns of fly ash sample.

Figure 3 exemplifies one of the many results obtained for X-ray diffraction (XRD). Phases of silicon dioxide ( $\text{SiO}_2$  – peaks of higher intensities) and calcium aluminat ( $\text{Ca}_2\text{Al}_2\text{O}_5$  – peaks of lower intensity) were identified. All analysis confirms the basic character of ashes and the absence of sulfur. The obtained results were in accordance with the literature, which essentially mentions sulfide's presence, carbonates, and quartz as the most common elements in mineral coals<sup>29</sup>.

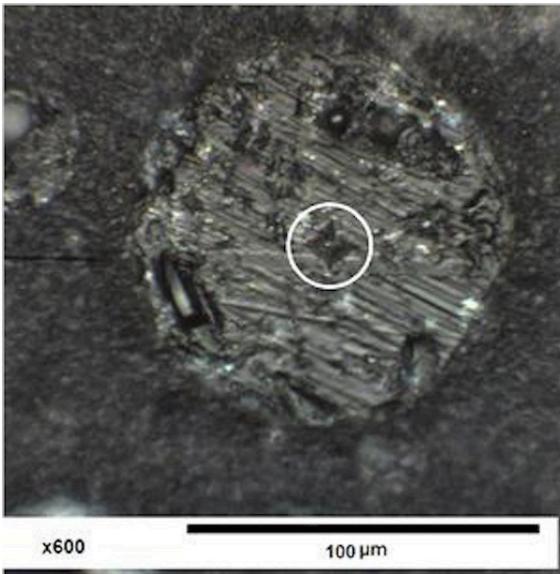
**Figure 4.** Cross-section of coal ash particle with Vickers microhardness penetration identification.

Microhardness measurements were made on various solid particles of ashes. Figure 4 exemplifies a mark generated by Vickers penetrator on a particle embedded in resin. Only hardness values were found in literature for sintered ash briquettes or hard materials such as quartz, alumina, or silicon carbide, whose values differ from individual ash particles' hardness<sup>42,43</sup>.

The average microhardness was  $(825 \pm 155) \text{HV}_{0.1}$ . The dispersion was due to internal porosity in some particles, as well as the variety of existing oxides. The value found was close to silica (quartz), with a hardness of about  $800 \text{HV}_{0.1}$ .

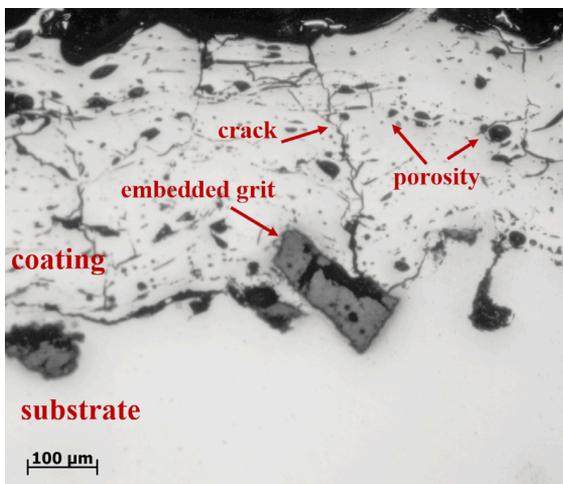
**Figure 5.** Coating cross-section on the substrate. OM, 100X. The presence of alumina used for surface preparation could be observed at the coating–substrate interface.

The micrographic aspects obtained from OM revealed the presence of regular layers that follow the substrate profile. This aspect was already expected since the impact of fused particles that solidify on the coated surface generates this aspect, being typical of the arc spraying process (Figure 5)<sup>37</sup>. The average coating thickness was  $(410 \pm 36) \mu\text{m}$ .

The substrate's surface preparation by blasting may have added some alumina at the substrate-coating interface. This contamination can affect the adhesion performance of the

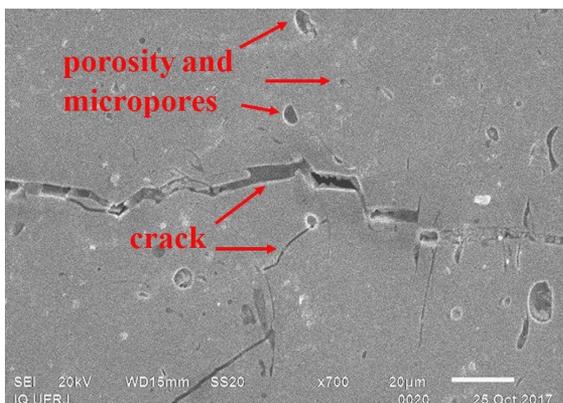
**Figure 6.** Coating cross-section. SEM, 700X. Cracks and pores (regions with more intense shades of gray) are defects typically associated with the spraying process used.

Cracks and pores associated with coatings obtained by arc thermal spraying were also observed by SEM (Figure 6). Among the deposited metallic layers, some oxides were identified, which was expected, due to the oxidation of some elements with greater chemical activity and oxygen affinity in the deposited alloy<sup>45-47</sup>.

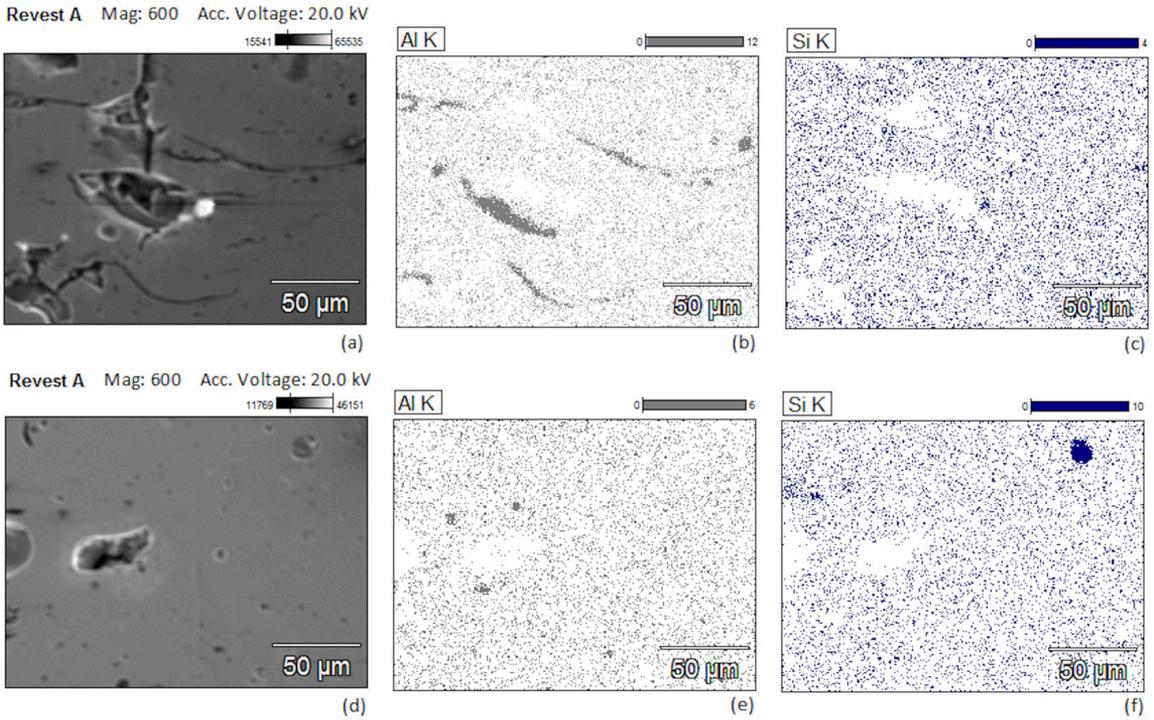
**Figure 7.** EDS mapping showing the predominant regions of Al and Si where oxides of these elements were probably formed.

The volumetric fraction (Vv) of defects in coating, including cracks and pores by DIA for OM images, was  $(5 \pm 2)\%$ . DIA was also performed for images obtained by EDS mapping to present elements more reactive when presence of oxygen. These regions contained high concentrations of aluminum (Vv = 1.4%) and silicon (Vv = 0.2%) formed between layers or concentrated in points of metallic matrix, as exemplified in Figure 7<sup>49,50</sup>.

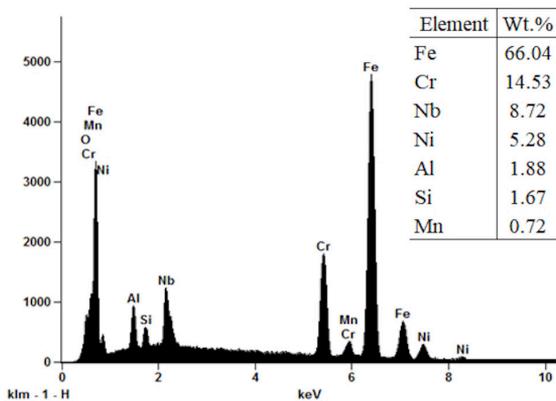
**Figure 8.** Spectrum features of energy to the elements in coating. Significant presence of Fe, Cr, Nb, Ni, Al, Mn and Si, in a semi-quantitative method, the elements being in accordance with wires used.

The chemical composition determined by EDS of sprayed alloy was as indicated by the manufacturer for the wires used (Table 1), where the significant presence of Fe, Cr, Nb, Ni, B, Al, Mn and Si was identified. Figure 8 exemplifies a qualitative microanalysis (spectrum) obtained in one of the several coating regions analyzed by EDS. Chemical reactions, such as metal alloy oxidation during heating, can change chemical compositions and phases of sprayed materials and modify coating's functions<sup>56</sup>.

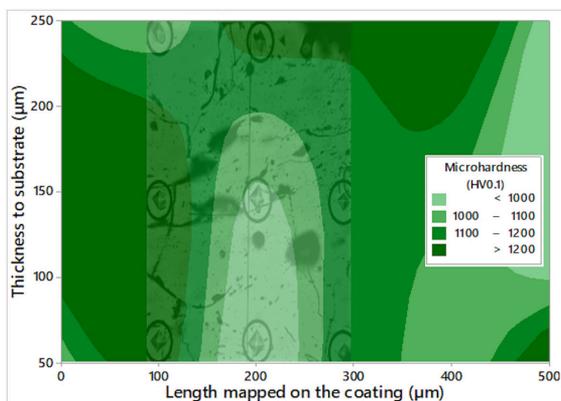
**Figure 9.** Microhardness mapping of coating cross-section.

Microhardness measurements showed local variations in this property, most likely due to the presence of contaminating oxides, cracks, pores, and thermal gradients between layers sprayed during the process. Figure 9 shows a mapping of microhardness in the cross-section of the studied coating. According to the literature, hardness for coatings must be 20% higher than erosive particles resulting in a minimized erosion rate<sup>44</sup>. Although hardness is only one of the many desirable properties to mitigate erosion of water wall panels, it is one of the most important properties for wear protection against particle impact.
