Tensile properties and color and mass variations of GFRP composites under alkaline and ultraviolet exposures

ABSTRACT

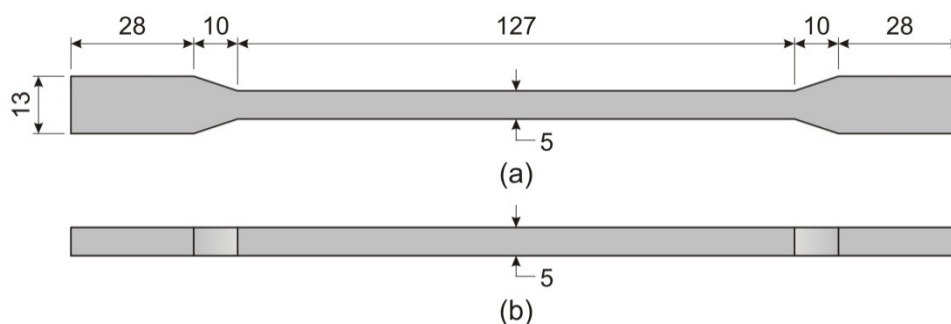
Figure 1: Dimension of the specimens used in the tensile properties tests (values in mm). Top (a) and lateral (b) views.

The GFRP pultruded profiles used in this study were fabricated using a standard pultrusion process in a composite company in São Paulo, Brazil. In the pultrusion process, fibers were impregnated with a low viscous liquid polymer in a resin bath and then the pre-impregnated composites were pulled and cured through a heated die [13]. The profiles were made with matrices of vinylester and phenolic resins reinforced with E-glass fiber (fiber content of 50 and 60 wt.%, respectively) in the longitudinal direction. The E-glass fiber had a diameter of 20 µm, density of 2570 kg.m⁻³, tensile strength of 1.2 GPa, and modulus of elasticity of 70 GPa. The vinylester resin was made with 1.7 wt.% of methyl ethyl ketone peroxide, 0.5 wt.% cobalt chloride as catalyst and accelerator, respectively. The phenolic resin was cured in an oven at 210 °C for 15 min. Specimens for the different tests were accurately extracted from the pultruded profiles using a Discovery 560 Romi vertical machining center. Figure 1 shows the dimensions of the specimens that were based on the studies performed by Vieira [14].

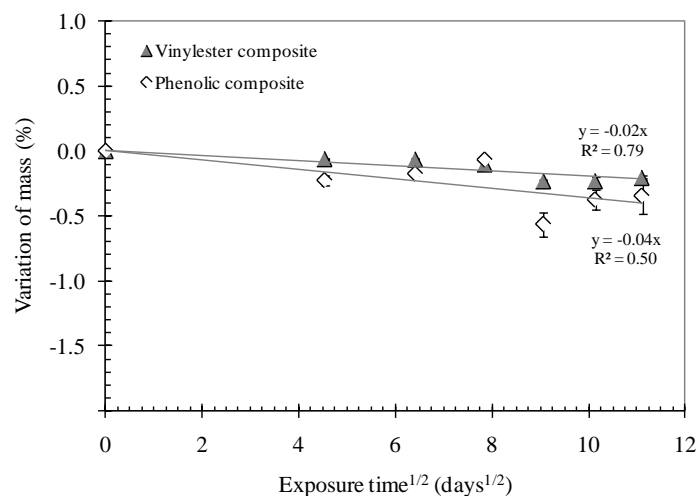
Figure 2: Mass variation over time (square root) of the vinylester and phenolic composites exposed to the UV/water spray cycles.

The mass variation of the vinylester and phenolic composites during cycles of UV/water spray is presented in Figure 2. There was no expressive mass variation irrespective of the composite type. As can be seen, 0.2 and 0.3% loss of mass values were observed to vinylester and phenolic composites, respectively, after 480 UV/water spray cycles, indicating only a surface phenomenon. This behavior was confirmed by SEM analysis as discussed in section 3.4. In this case, the loss of mass is likely to be due to the volatiles and residual moisture in the specimens.

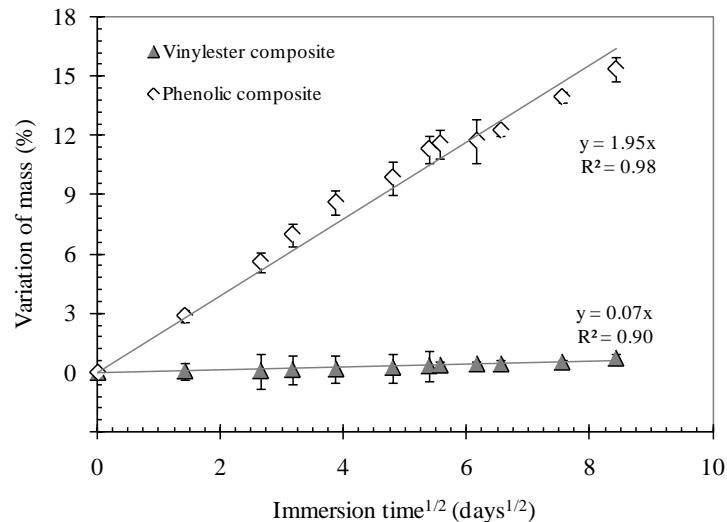
Figure 3: Mass variation over time (square root) of the vinylester and phenolic composites exposed to the alkaline solution.

The mass variation was more pronounced in the alkaline exposure than those in UV/spray cycles, mainly for the phenolic composites. Figure 3 shows that the vinylester specimens presented a 0.7% gain of mass after 71 days of continuous alkaline immersion. The gain of mass for the phenolic composite was about 15% in the same immersion period. In both composite types, the gain of mass over the square root of time increased with a constant rate (linear curves with R^2 higher than 90%). This behavior roughly follows a Fickian diffusion behavior, as it was observed by KIM *et al.* [6]. Severity of alkaline exposure on the loss of mass for polyester GFRP was also reported by CORREIA *et al.* [4]. Results of gain in mass for vinylester GFRP were also previously observed [4,6]. However, the gain of mass determined in this study for phenolic composites was much higher than verified by other works. This behavior can be explained to a progressive visible delamination observed in all phenolic GFRP specimens during the alkaline immersion period. In this case, the longitudinal delamination of the phenolic composite can be attributed to a progressive swelling (Figure 4).

of immersion. However, both alkaline-exposed composites presented significant lower modulus of elasticity values (70%) than the phenolic reference. The loss of tensile strength in the phenolic composites exposed to the alkaline solution was linked with the high mass variation (Figure 3), fiber degradation, and delamination (Figure 4).

exposure has been previously reported by others authors [10-12,10]. After 120 days in alkaline immersion, both vinylester and phenolic composites presented evidence of resin erosion, which induced the appearance of microcracks (Figures 7e and 7f, respectively). This behavior was more pronounced on the phenolic composites, where delaminations along the side of the specimens (longitudinal) were visually observed. This was consistent with the results of mass variation shown in Figure 3.

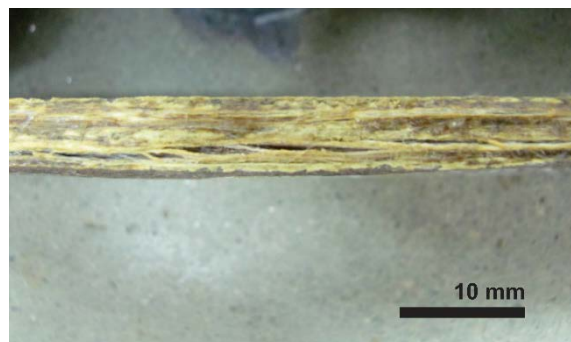
Figure 4: Lateral view of a phenolic composite specimen after 71 days of alkaline exposition.

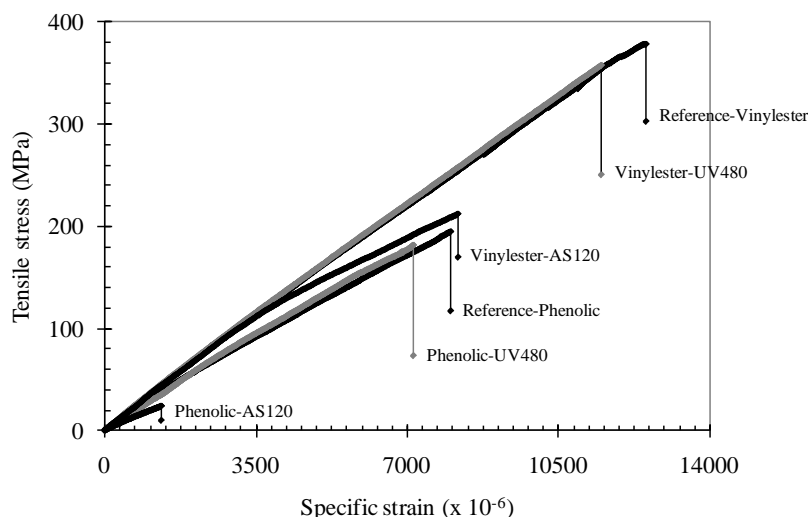
Figure 5: Typical stress *versus* strain curves of the vinylester and phenolic GFRP specimens.

Figure 5 shows the stress versus strain curves for unexposed (reference) and all ultimate exposed composites, where expressive differences in strength and modulus of elasticity were observed due to the studied degradation environments. Both UV/water spray and alkaline exposures reduced the tensile strength of the composites. Based on the obtained values of tensile strength (Table 1), it can be observed that both types of composites presented different strength in relation to the references after 480 UV/water spray cycles. In this case, a reduction in strength of about 10% was observed for both types of composites. A similar reduction was observed in GFRP with isophthalic matrix after about 80 days of UV exposure [4].

The differences in the stress-strain curves of the reference and the alkaline specimens (Figure 5) clearly showed the aggressive action of the alkaline environment on the tensile properties. In fact, the reduction in tensile strength of both composites was more pronounced in the alkaline solution immersion than those in the UV/water spray exposure. After 120 days of immersion, significant reductions of about 40 and 90% in strengths were observed for the vinylester and phenolic composites, respectively, in relation to the references. Reductions of about 20 and 80% were observed for the vinylester and phenolic composites, respectively, after 90 days. In spite of the alkaline-vinylester composites presenting similar modulus of elasticity values in relation to the reference, the final slope of the curves decreased while strain increased. For phenolic composites, no significant differences were observed between the modulus of elasticity values after 90 and 120 days

The clean surface of a fiber from the vinylester composite exposed to the alkaline solution, shown in Figure 8a, confirmed that the microcracking indicated in Figure 7e was a surface phenomenon. This corroborated with the mechanical behavior of the vinylester composite (Figure 5 and Table 1). It was confirmed that the vinylester resin could inhibit the penetration of alkalis into GFRP composites immersed in alkali solutions [21]. On the other hand, the continuous exposure to the alkaline solution affected the fiber surface of the phenolic composite. In this case, with the delamination, there was a direct contact between the glass fibers and the alkaline solution. Thus, clusters of hydrated compounds were observed around the fibers, as shown in Figure 8b. This helped to understand the expressive reduction in tensile strength observed with the alkaline-exposed phenolic composite in comparison with the reference composite. Moreover, it seems evident that the damage mechanisms of phenolic composite exposed to the alkaline solution were mainly interfacial (fiber-matrix bond) and fiber related mechanisms.

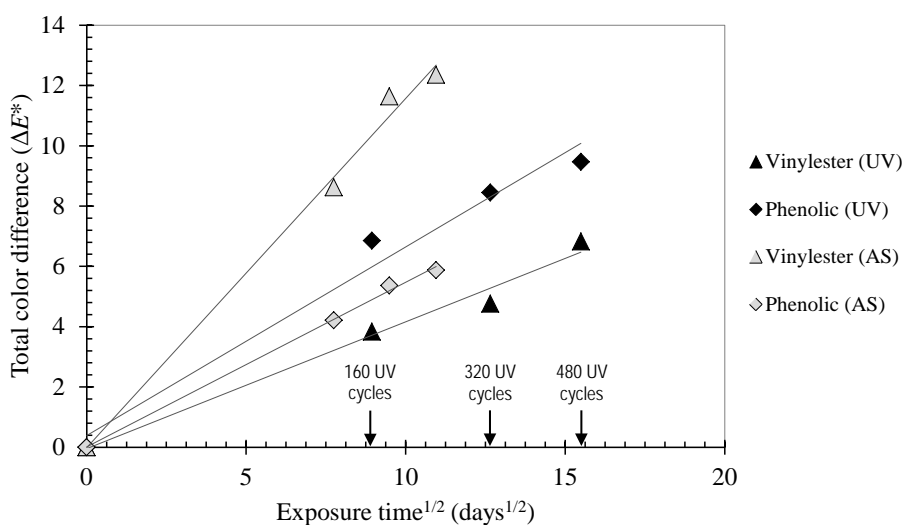
Figure 6: Total color difference (ΔE^*) values of vinylester and phenolic GFRP specimens exposed to the UV/water spray cycles (UV) and alkaline solution (AS).

The total color difference (ΔE^*) values for all exposed composites increased with the exposure time, as can be seen in Figure 6. Based on statistical analysis (ANOVA), the ΔE^* was significantly influenced by the number of cycles and immersion time for UV/water spray and alkaline exposure, respectively. A good linear correlation between the ΔE^* and the square root of time was found for all curves ($R^2 > 0.97$). The vinylester composites had the ΔE^* values between 3.8 (after 160 cycles) and 6.8 (after 480 cycles) and the ΔE^* values of the phenolic composites ranged between 6.8 and 9.5 after 160 and 480 UV/water spray cycles, respectively. Considering the measurements performed immediately after 60 days of alkaline immersion for both composite types, the ΔE^* values were 8.6 and 4.2 for vinylester and phenolic composites, respectively.

It is important to note that the visual observations of the discoloration of the specimens were very informative. In fact, the specimens of both phenolic and vinylester composites presented detectable color changes after all observed times indicated in Figure 6. This occurred because the ΔE^* values were higher than the difference values ($\Delta E^* = 3.3$) recognizable by all people [19], i.e., the color changes after the exposure was easily distinguished by the human eye. The photodegradation of the vinylester composite was manifested by yellowing of the composite (increase of b^* value in the CIE 1976 $L^*a^*b^*$ color system), while the UV/water spray exposure darkened the color of the phenolic specimens (decrease of L^* and increase in a^* and b^* parameters). The results showed that the continuous exposure in the alkaline solution also darkened the color of the phenolic specimens. On the contrary, the vinylester composites exposed to the alkaline solution lightened, with increases in L^* value.

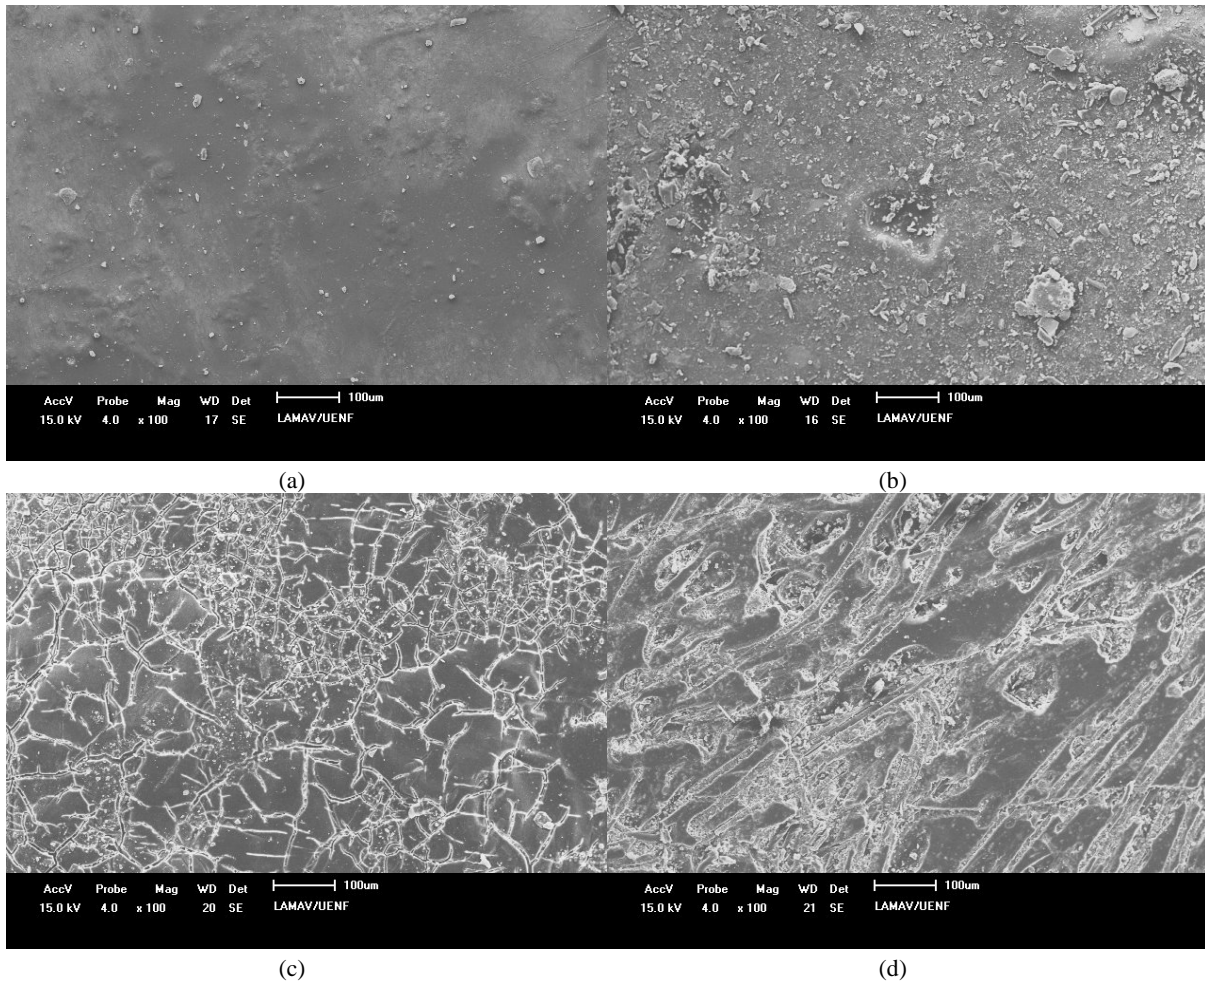
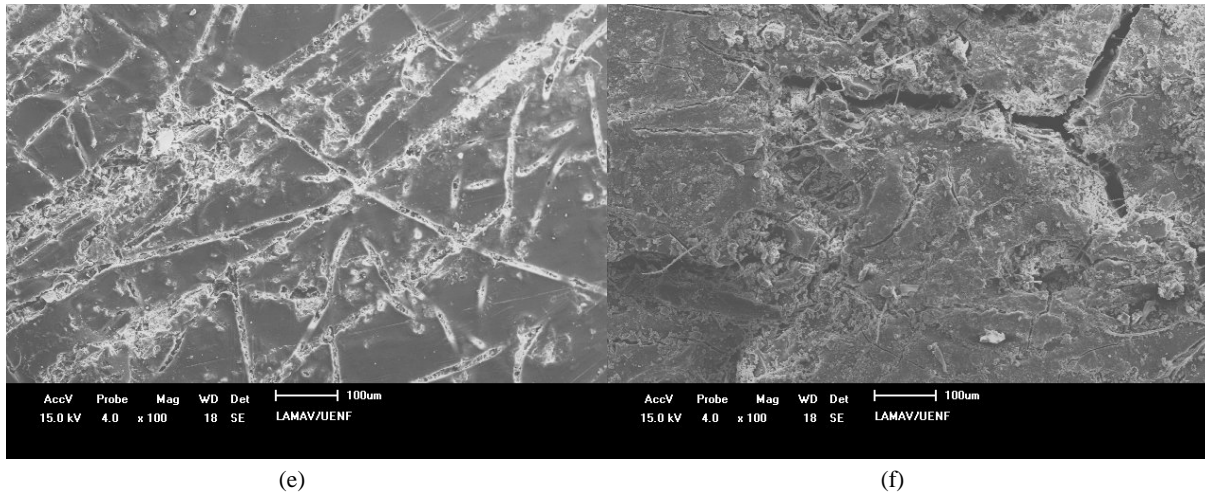
Figure 7: SEM micrographs of composites: (a) unexposed vinyl ester composite; (b) unexposed phenolic composite; (c) vinyl ester composite exposed to 480 UV/water spray cycles; (d) phenolic composite exposed to 480 UV/water spray cycles; (e) vinyl ester composite exposed to 120 days in alkaline solution; (f) phenolic composite exposed to 120 days in alkaline solution.

SEM micrographs of the surface morphologies of different specimens before and after both UV/water spray and alkaline exposures are shown in Figure 7. Both vinylester and phenolic unexposed composites were initially smooths (Figures 7a and 7b, respectively). The surface of vinylester and phenolic composites was expressively degraded after 480 cycles of the UV/water spray, as indicated in Figures 7c and 7d, respectively. In fact, microcracks appeared on each composite indicating, as expected, that the photodegradation of polymeric composites caused apparent surface microcracking. A similar microcracking phenomenon under UV

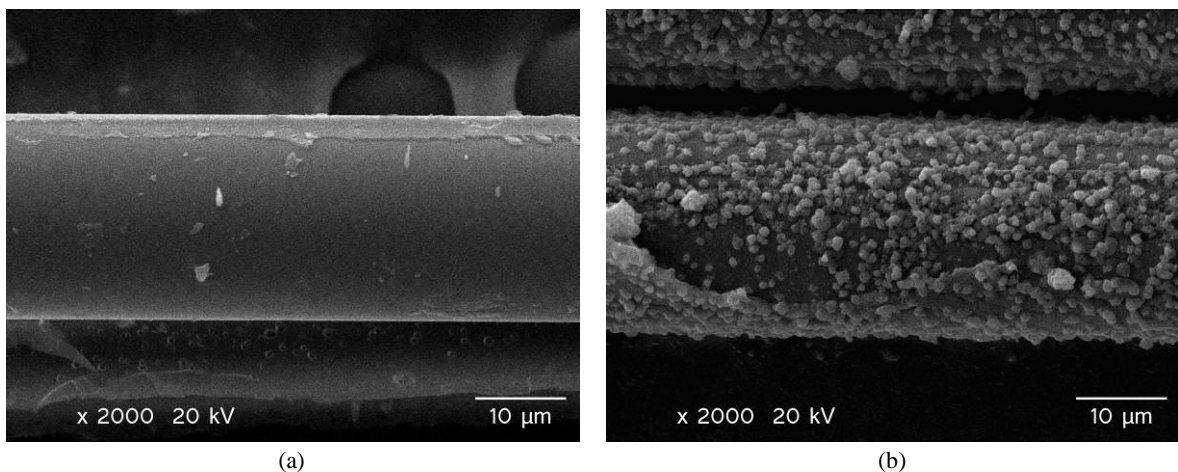
Figure 8: SEM micrographs of glass fiber of the (a) vinyl ester and (b) phenolic composites exposed to 120 days in alkaline solution.
