Kirschner Wire Migration after the Treatment of Acromioclavicular Luxation for the Contralateral Shoulder – Case Report*

Rev Bras Ortop 2019;54:202–205.

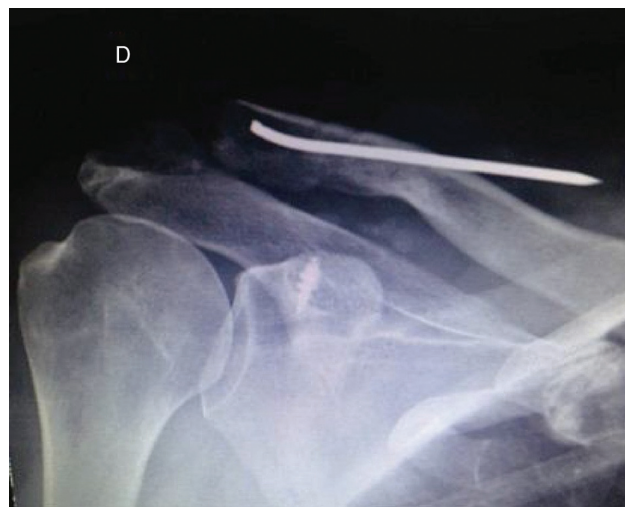
Four days after the trauma (▶**Fig. 1**), the acromioclavicular dislocation was surgically treated using ligatures with anchor wires, coracoacromial ligament transfer, and fixation with Kirshner wires from the acromion to the clavicle.

Fig. 1 Fifteen days postsurgery, right shoulder.

At the 12-day follow-up visit, the migration of the Kirschner wire to the acromion was identified. The patient was informed of the need for a more frequent follow-up and that the wire would be removed 45 days after the surgery. At the 20- and 30-day follow-up visits, radiological findings remained similar to the ones observed at the 12-day visit, with no migration progress.

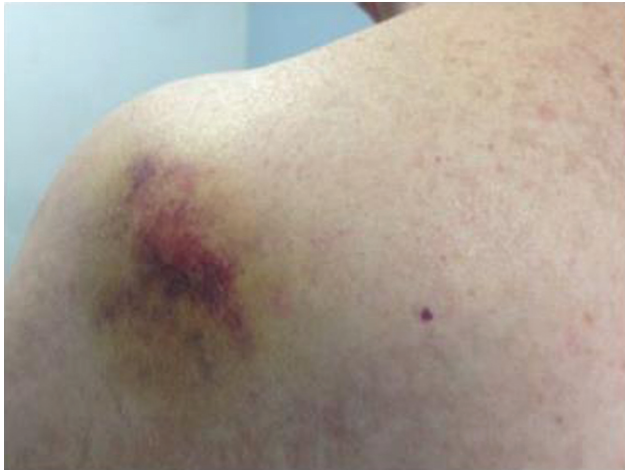
The patient did not show up for his 6-month visit. Nine months after the surgical treatment, the patient started to present with pain on the left shoulder (contralateral side), reduced arc of movement, ecchymosis, and a protrusion (▶**Figs. 2 and 3**). Bilateral radiographs showed that the Kirschner wire originally from the right shoulder was in the left shoulder (▶**Figs. 4 and 5**).

Fig. 2 Hematoma and a small skin protuberance, left shoulder, 9 months after the procedure.

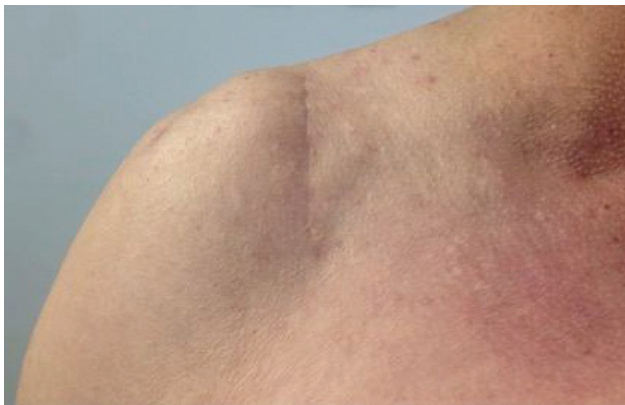
Fig. 3 Surgical approach, 9 months after the procedure.

Thus, a new surgical procedure was performed to remove the metallic wire from the left shoulder.

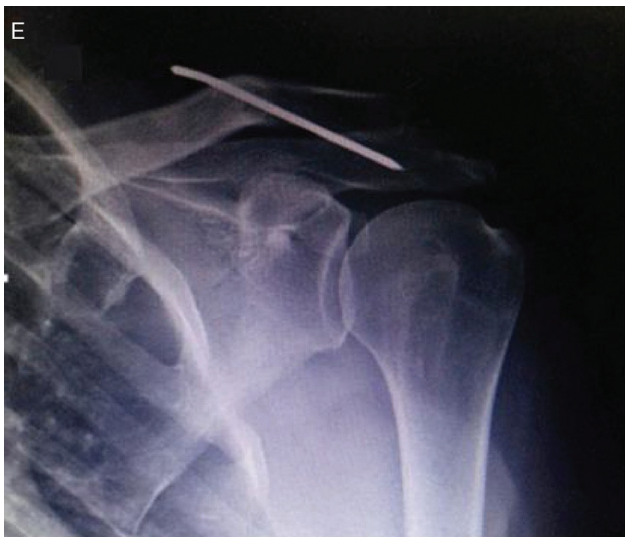
Fig. 4 Nine months postsurgery, left shoulder.

The present case was followed-up with serial radiographs; moreover, the metal wire was folded to difficult its migration, the patient was properly oriented when the metal wire migration was noticed and at the end of the treatment period. However, the fold at the distal end of the wire did not reach the necessary angulation to prevent migration, allowing this complication to occur.

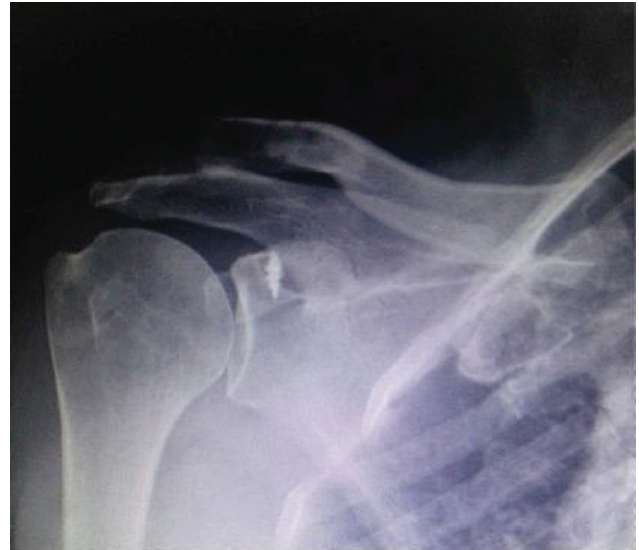
Fig. 5 Nine months postsurgery, right shoulder.
