# SURFACE ROUGHNESS AVERAGE AND SCANNING ELECTRON MICROSCOPIC OBSERVATIONS OF RESIN LUTING AGENTS

The objective of this work was to evaluate the surface roughness changes of three current resin cements after tooth brushing simulation, as well as discuss its relation with scanning electron microscopic observations. The materials employed were Enforce Sure Cure (Dentsply), Rely X (3M-ESPE) and Variolink II (Vivadent). They were subjected to brushing abrasion (100,000 strokes for each specimen) and the surface roughness alterations (before and after strokes) were detected. For each roughness test condition, specimens were coated with gold-palladium and observed on a DSM 900 Zeiss scanning electron microscope. Roughness changes values (Ra) were statistically increased after brushing strokes. Based on the microscopic observations and roughness changes analysis, all cements studied became rougher after brushing strokes.

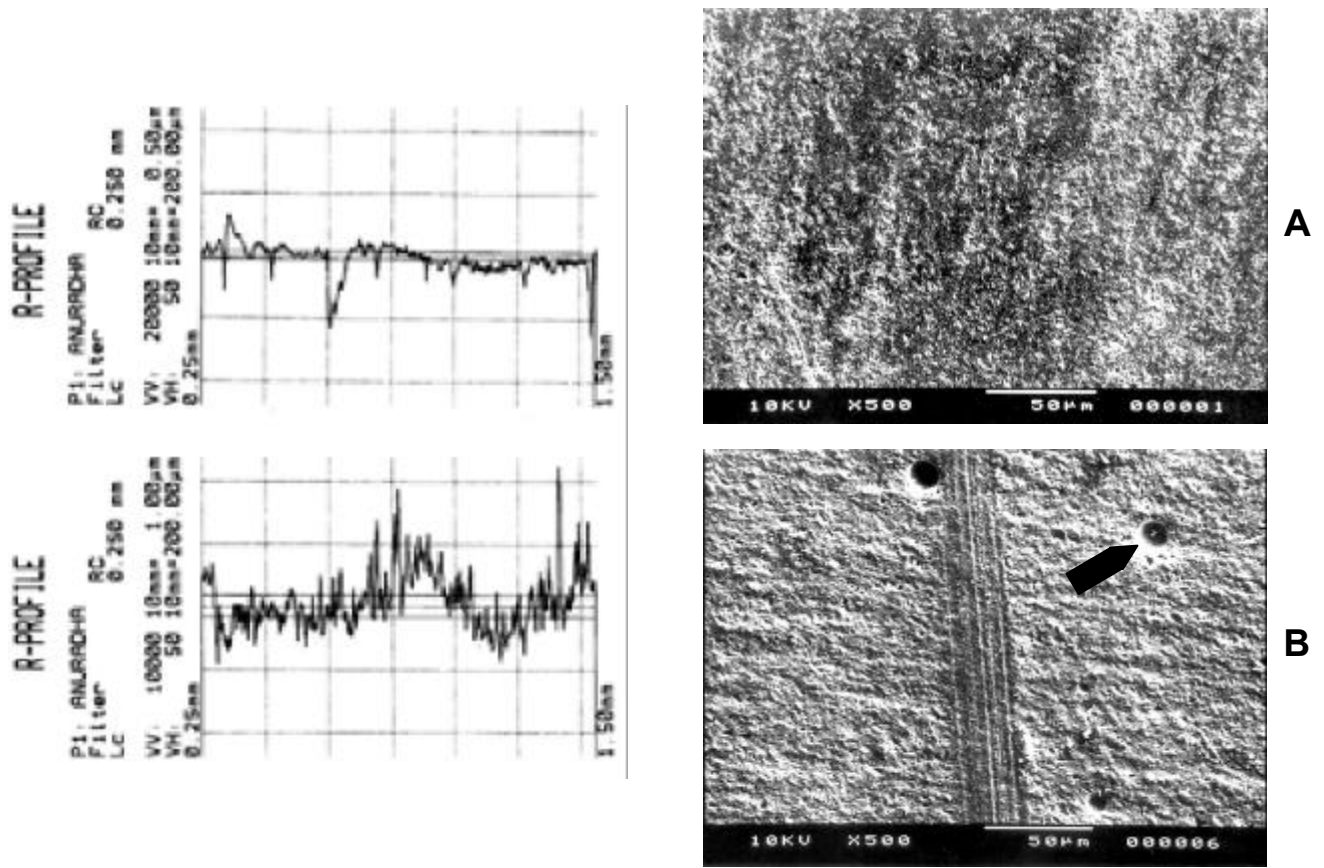
FIGURE 1- Roughness and microscopic evaluation of Enforce (Dentsply) resin cement before (a) and after (b) brushing simulation

All materials presented an increase in Ra values after brushing strokes, they were statistically significant (Table 2). The variance analysis showed no statistically differences in the roughness changes between the materials tested ( $F=2.40$ ,  $P=0.2$ ). The roughness tracings and SEM of cements are shown in Figures 1, 2 and 3. Generalized wear of the luting agents was minimal.

While comparing Enforce (Dentsply) and Rely X (3M-ESPE) profiles with microscopic photographs before and after the abrasion test (Figs. 1 and 2), loss of organic matrix and inorganic particle protrusion were observed. These characteristics were also observed in fig. 3, in a less expressive way, what may be explained to Variolink II medium filler size,  $0.7\mu\text{m}$ , which is smaller than Enforce and Rely X,  $1.0\mu\text{m}$  and  $1.5\mu\text{m}$  respectively (Figures 1, 2 and 3). For specimen's preparation, the base and catalyst luting composite were mixed. This type of manipulation can guide to bubble incorporation<sup>1</sup> as it is shown in figs. 1 and 3 (arrows). In these cases there must be a concern, since the diamond needle of some equipments can penetrate in these bubbles and neglect the internal surface contact, omitting the correct surface average roughness description. In the present study these readings were disregarded.

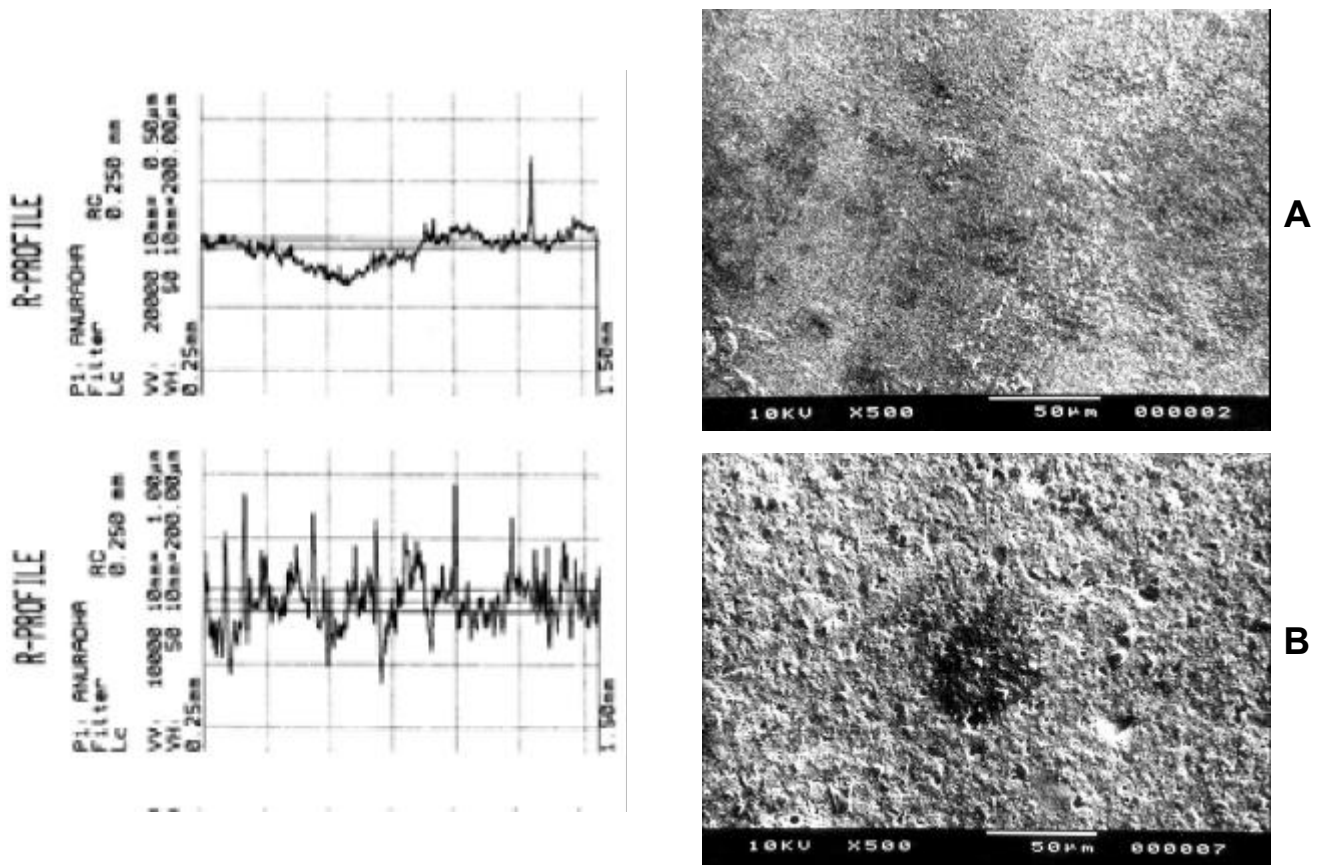
FIGURE 2- Roughness and microscopic evaluation of Rely X (3M) resin cement before (a) and after (b) brushing simulation

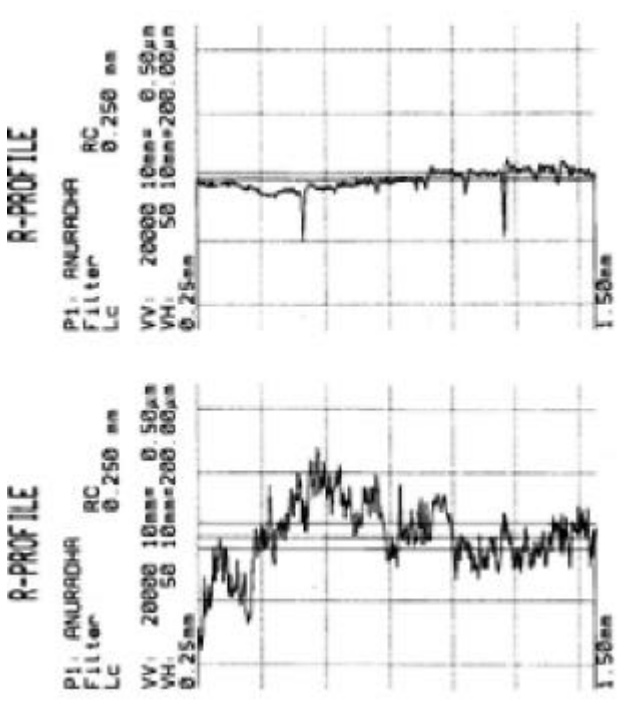
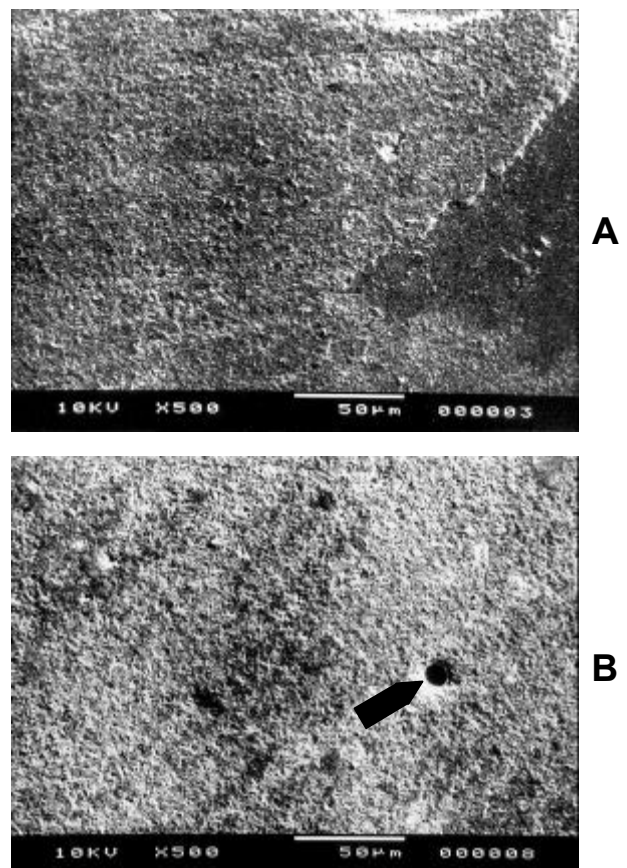
FIGURE 3- Roughness and microscopic evaluation of Variolink II (Vivadent) resin cement before (a) and after (b) brushing simulation
