Unusual Pattern of Osteochondral Marginal Impaction in Acetabular Fractures: A Report of Two Cases

Rev Bras Ortop 2024;59(Suppl S1):e83–e87.

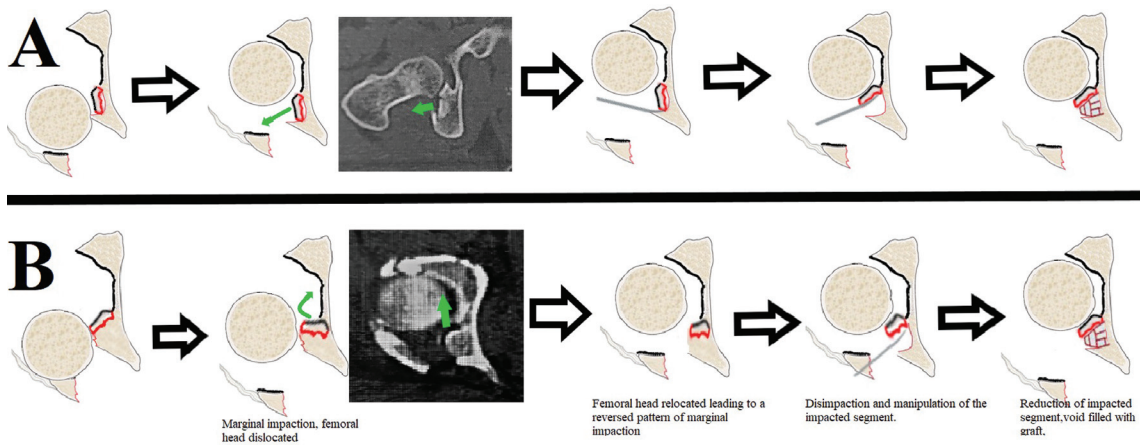
Fig. 1 A schematic diagram showing the differences between, (A) the commonly described marginal impaction pattern, and (B) the unusual pattern we described in the current report.

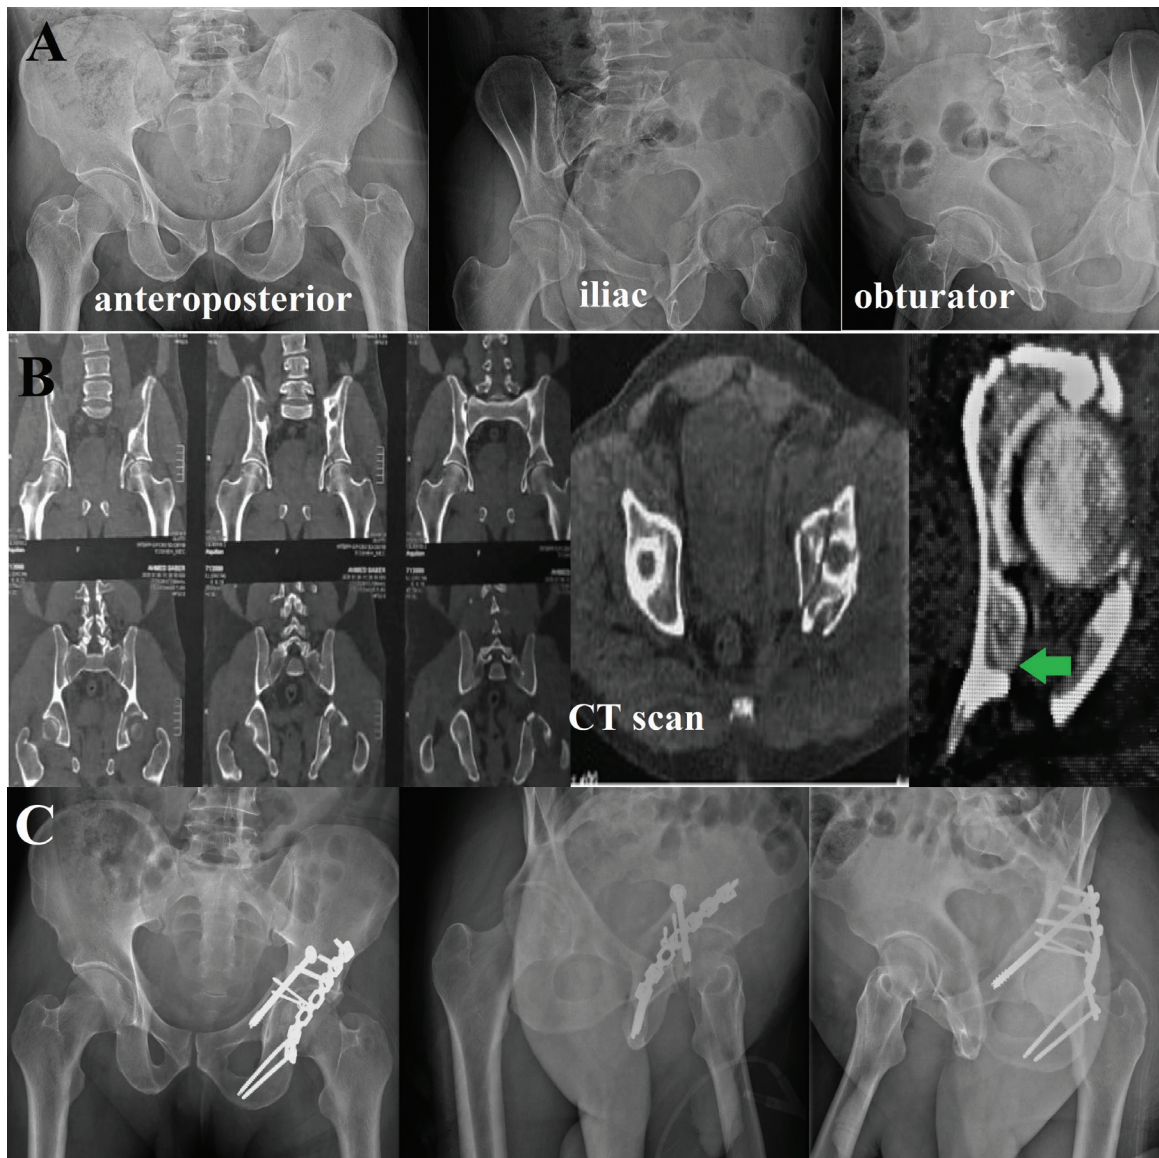
Fig. 2 Patient A: Diagnosed as transverse type acetabulum fracture with posterior wall fracture. (A and B) Preoperative plain radiographs and computed tomography scans (green arrowhead points to the impacted segment). (C) Postoperative pelvis plain radiographs.

Open reduction and internal fixation through the Kocher-Langenbeck approach were performed intraoperatively after joint distraction; we noticed that the orientation of the impacted fragment is reversed compared with the usual marginal impaction appearance, meaning that, instead of having the articular surface of the impacted fragment presented enface (the surgeon having a clear look at the shining articular cartilage of the impacted segment [▶Fig. 1A]), it seemed reversed (the articular surface is looking toward the joint cavity hinged on its inner attachment to the acetabular articular cartilage and the surgeon is looking at the cancellous surface of the impacted segment [▶Fig. 1B]). After re-evaluating the preoperative CT of both patients, we found that the marginal osteochondral impacted fragment is looking toward the acetabulum articular cavity instead of the classic appearance description (▶Figs. 2 and 3).

The impacted fragment was first disimpacted using an osteotome; then, it was manipulated to its bed, keeping its inner hinge as intact as possible and using the femoral head as a template to ensure perfect reduction. Autogenous bone graft from the greater trochanter was used to support the reduced fragment and to fill the void created by the impaction. Lastly, reduction of the main fracture element and fixation using plate and screws were performed (▶Fig. 2 and 3).

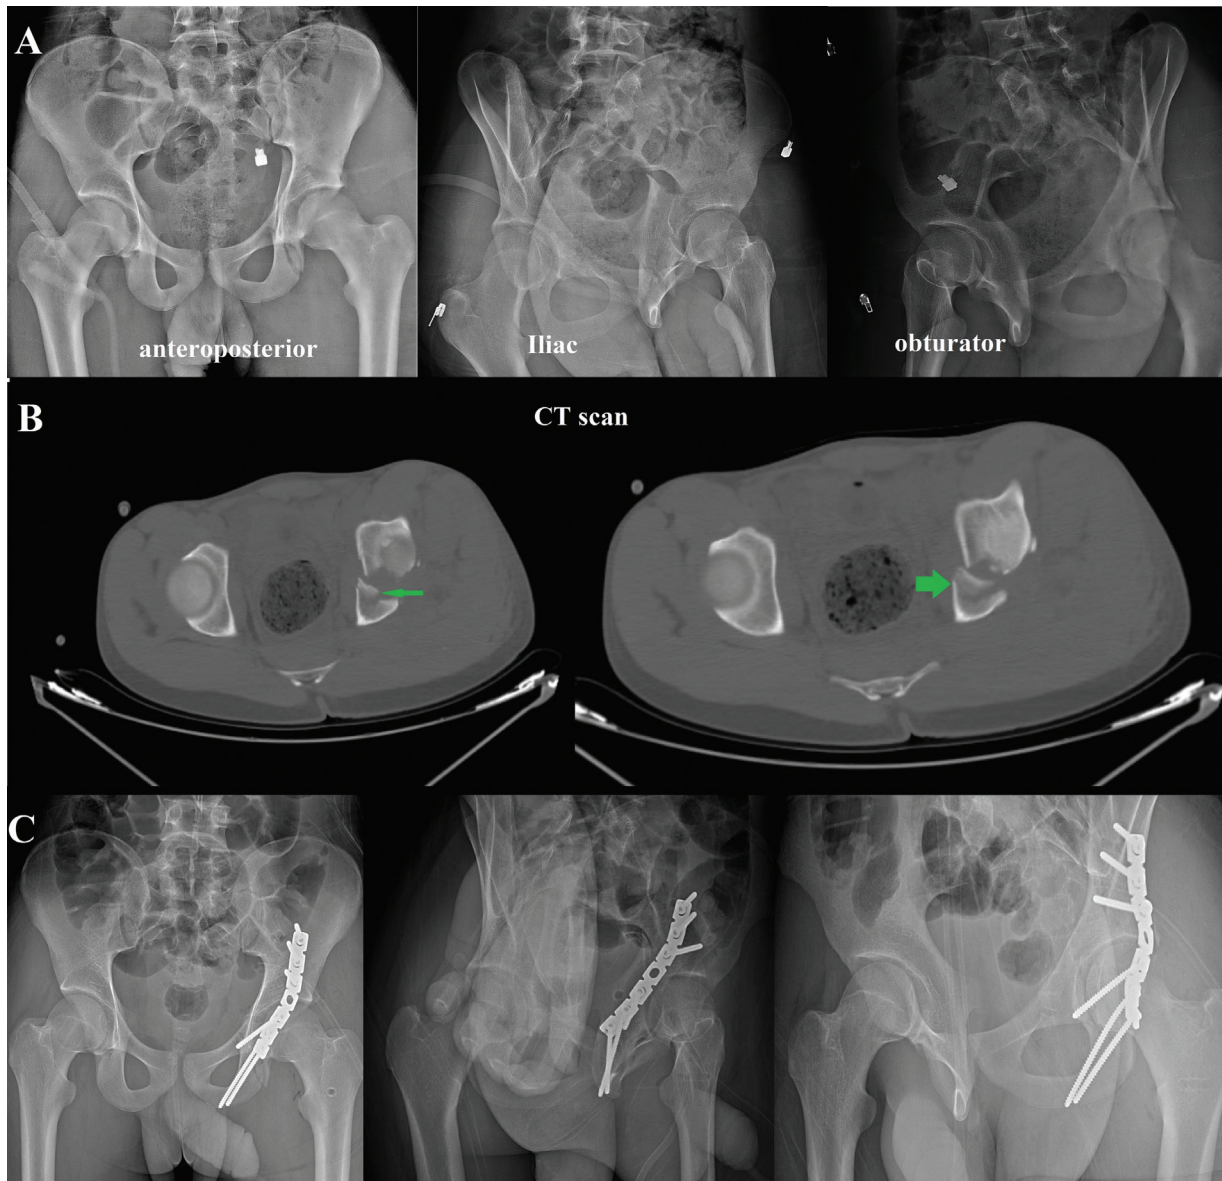
Fig. 3 Patient B: Diagnosed as a posterior column fracture. (A and B) Preoperative plain radiographs and computed tomography scans (green arrowhead points to the impacted segment). (C) Postoperative pelvis plain radiographs.
